## **NATIONAL TRANSPORTATION SAFETY BOARD**

# **AIRFRAME AND ENGINE EXAMINATION SUMMARY**

**WPR19LA213**

| Aircraft: | C-GEYP, Cessna 150M |

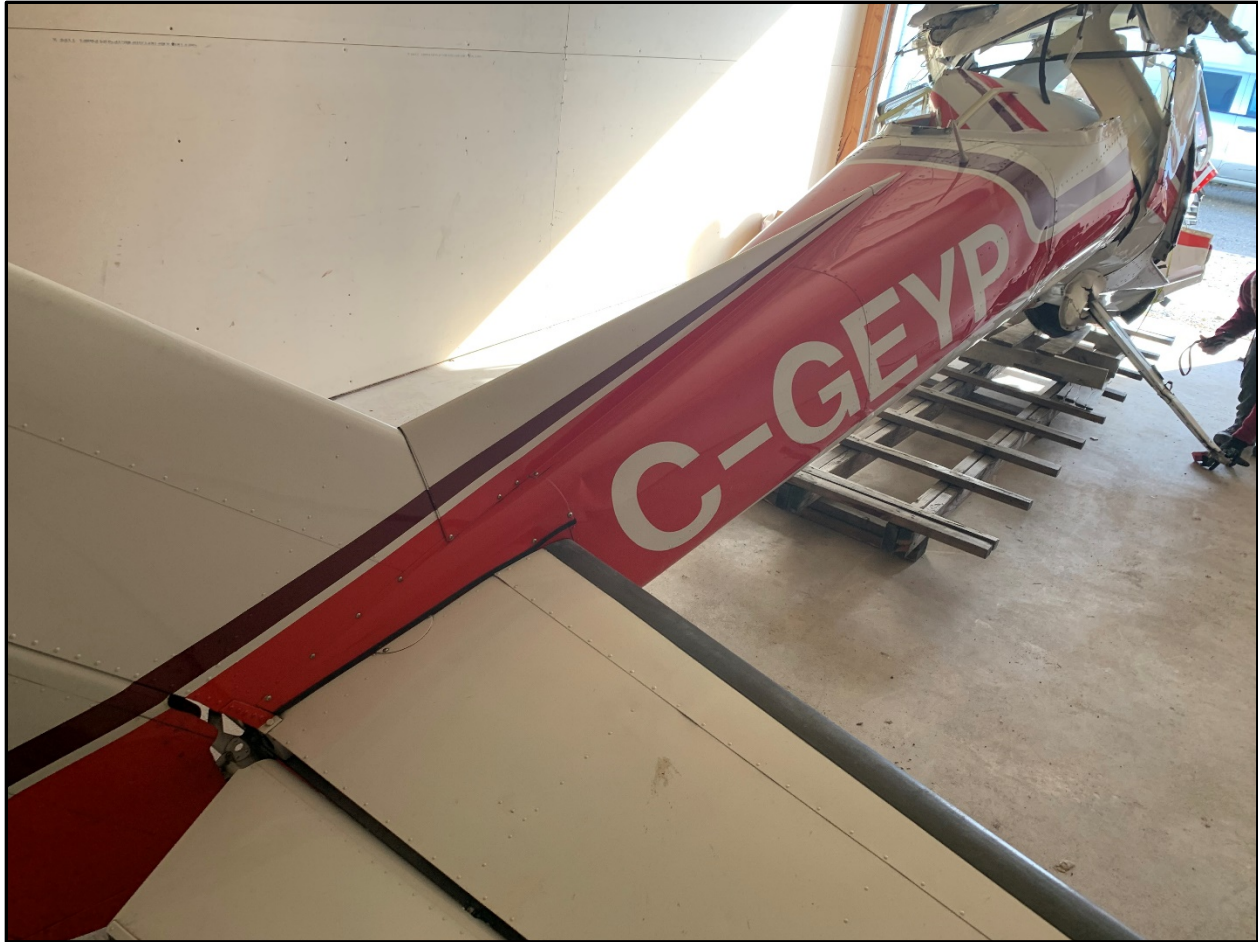
The airframe sustained impact damage to the fuselage and cabin area. The bottom of the fuselage was bent upwards behind the front seats of the cabin. The left wing was cut and removed from the fuselage for recovery. The right wing was separated from the fuselage. Both wings sustained impact damage to the leading edges. The empennage was relatively intact, and the rudder was attached. The left horizontal stabilizer was cut near the root and the right horizontal stabilizer and elevator were attached. The engine and propeller assembly were separated from the fuselage.

The right wing sustained a large circular impact with compression damage about mid-span. The right wing also sustained leading edge impact damage about 4 ft outboard to the wing tip. The right flap and aileron were attached. The right flap sustained impact damage about 1 ft inboard and was bent upwards. The left wing had leading edge damage on the inboard portion and the tip. The left aileron outboard portion was damaged. The fuel cap was attached, and the cap seals were intact and undamaged.

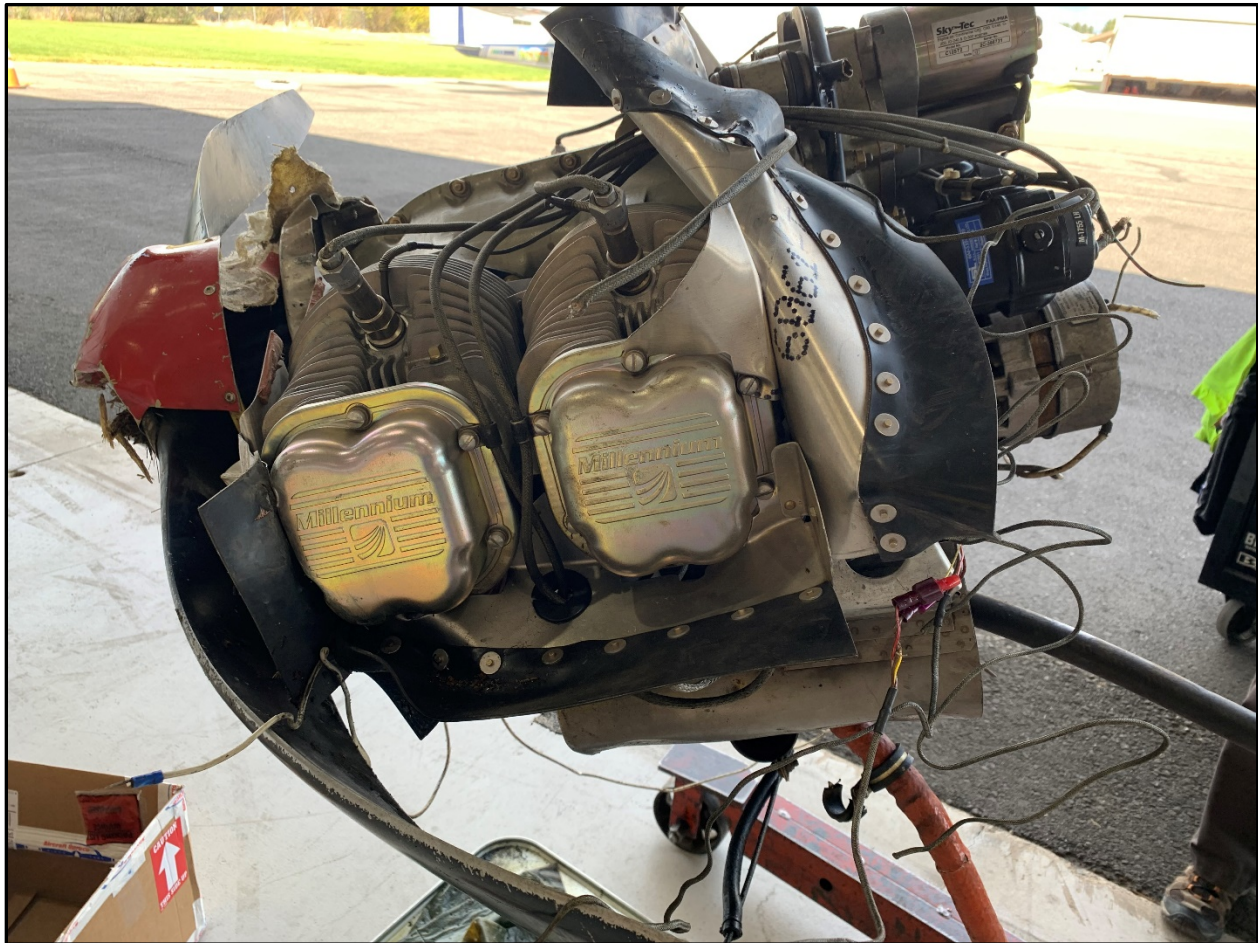
The engine was separated from the fuselage engine mount assembly and was relatively undamaged except for the bottom portion. No catastrophic damage was noted. The rocker covers were removed and there was no evidence of heat distress, and all valves were appropriately lubricated. Rotational continuity could not be established through hand rotation of the propeller because the crankshaft was observed to be bent to the left in the front of the engine, consistent with impact damage. The top spark plugs were removed, and electrodes were undamaged and exhibited coloration consistent with normal wear.
