# ENGINE EXAMINATION REPORT

| ENGINE MODEL | IO-520-A5B |
| AIRCRAFT MAKE & MODEL | Cessna 206 |
| FILE NUMBER | 19-053 |

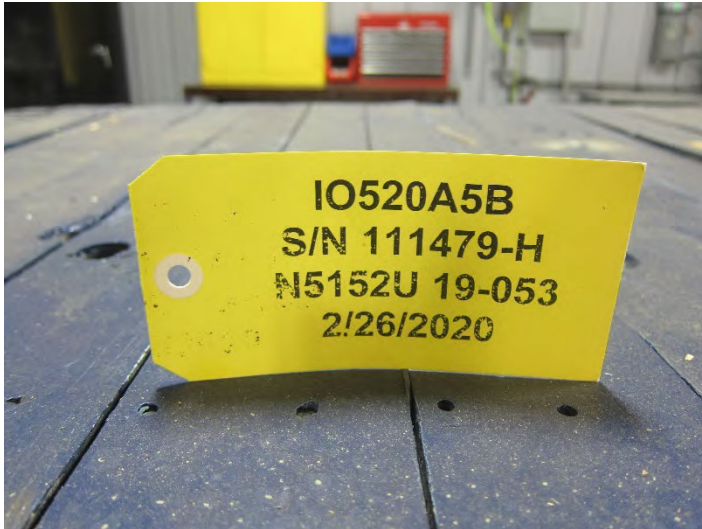
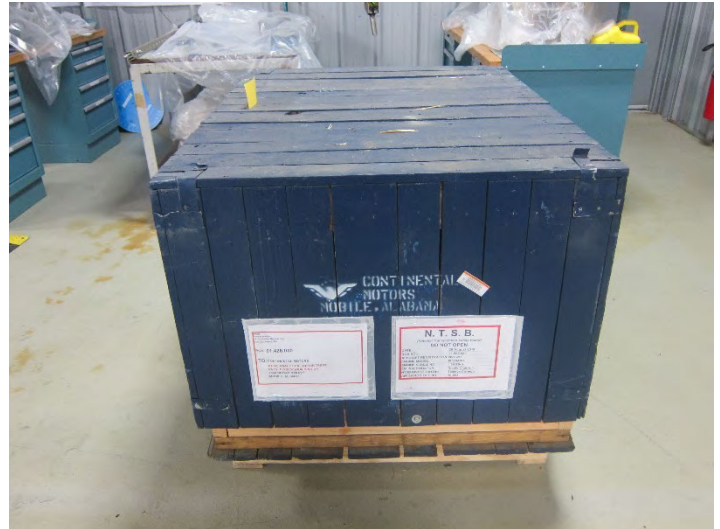
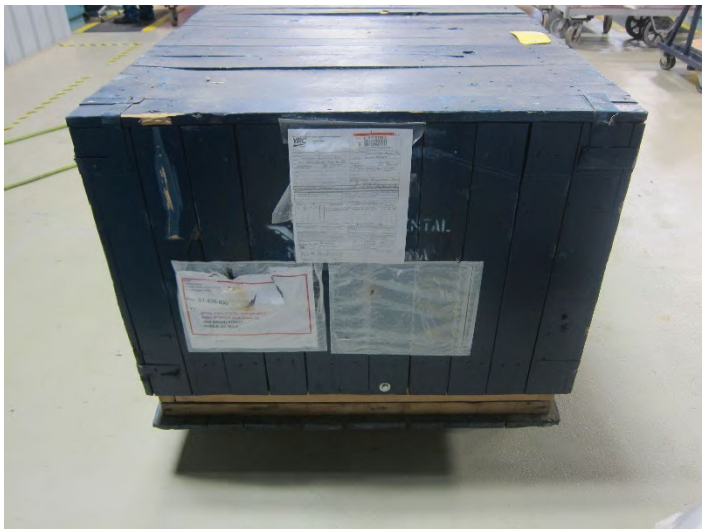
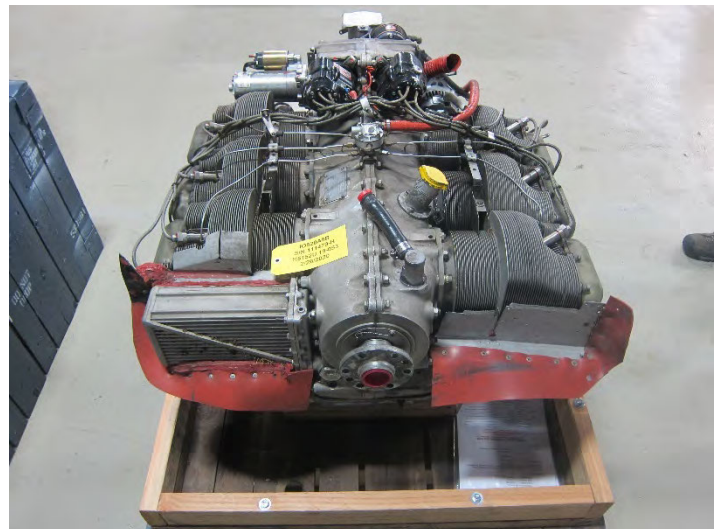
The engine was secured to the crate with no obvious external anomalies noted. The engine was removed and placed on a stand for disassembly.

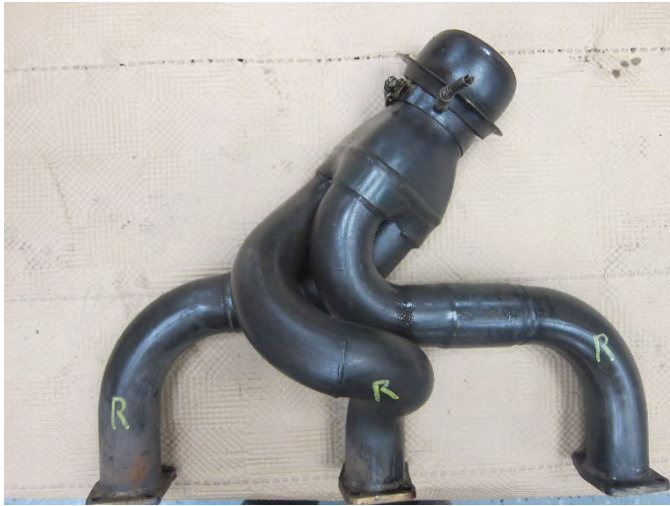
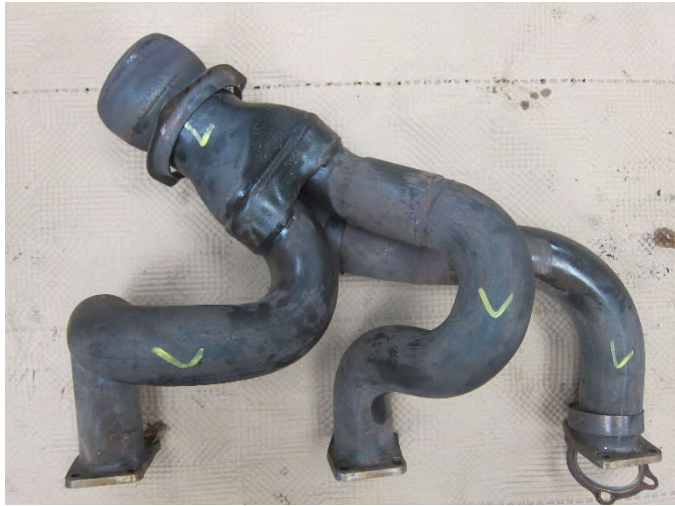
| Condition: | The exhaust system was removed and exhibited normal operating signatures. |

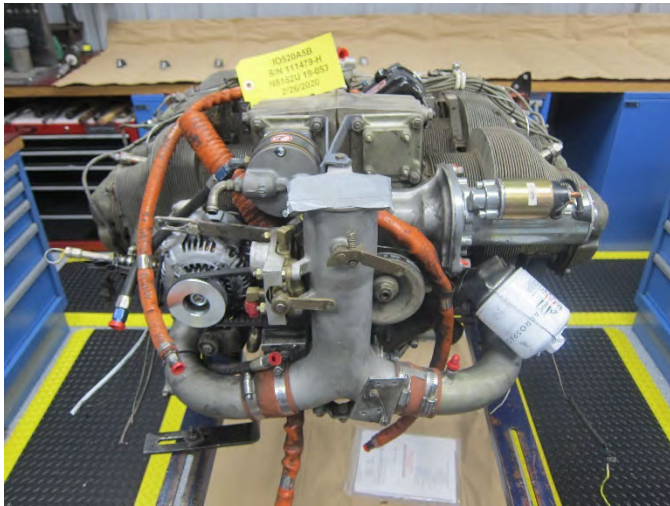
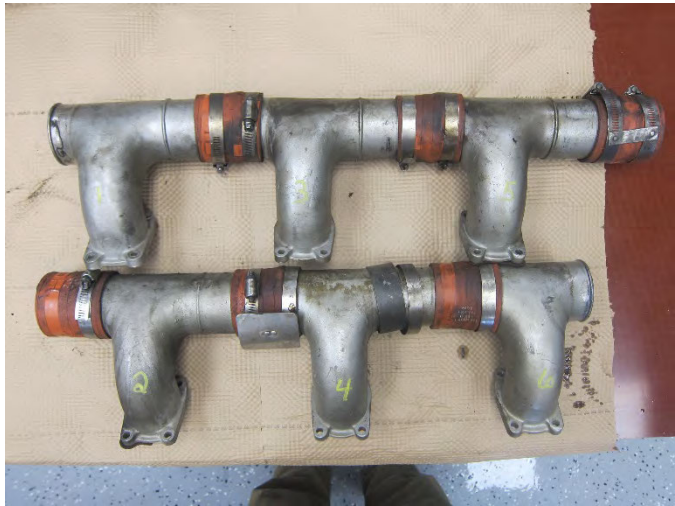
| Condition: | The induction system exhibited normal operating signatures. |

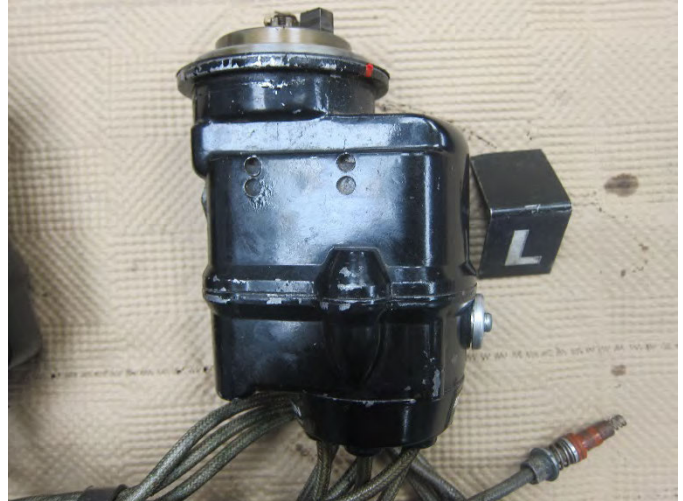
| LEFT MAGNETO | Manufacturer: Champion Slick | P/N: 6310 | S/N: 98110708 |
|---|---|---|---|
| Condition: | The left magneto remained in place with torque putty applied to the attaching hardware. A slip stripe was applied to the base of the magneto and the mounting area, with no evidence of magneto rotation observed. Removal of the magneto revealed no pre-event anomalies. | | |

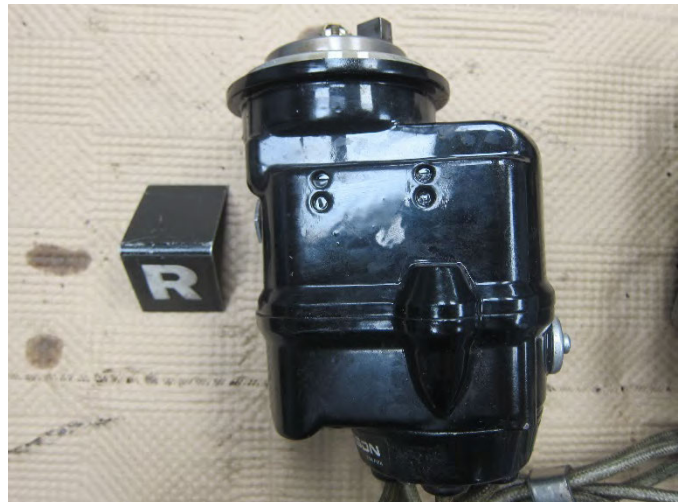
| RIGHT MAGNETO | Manufacturer: Champion Slick | P/N: 6310 | S/N: 14060274 |
|---|---|---|---|
| Condition: | The left magneto remained in place with torque putty applied to the attaching hardware. A slip stripe was applied to the base of the magneto and the mounting area, with no evidence of magneto rotation observed. Removal of the magneto revealed no pre-event anomalies. | | |

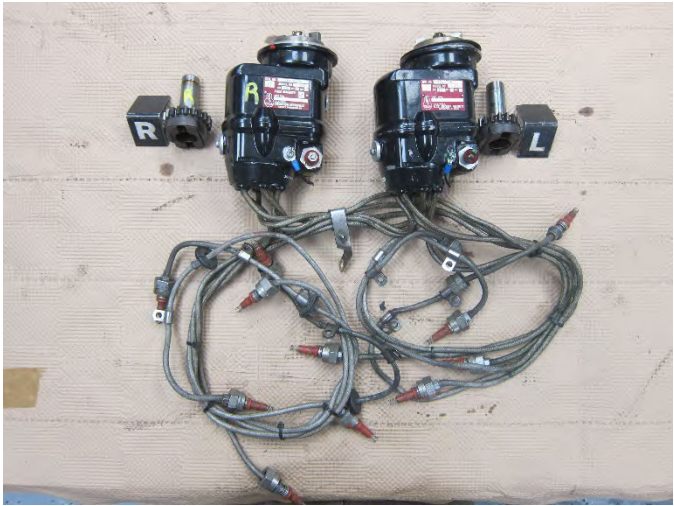
| Condition: | The harness remained attached to the magnetos and each terminal was secured to it respective sparkplug. No pre-event anomalies were noted. | | |

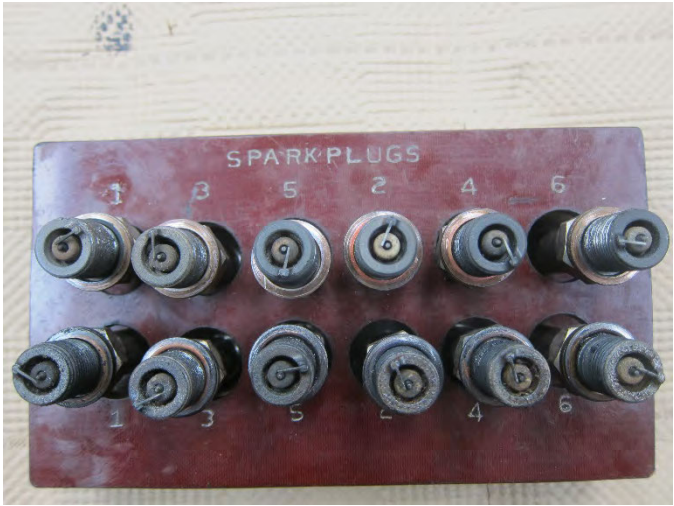
| Condition: | The sparkplugs displayed a normal worn condition with darker soot and dirt observed on the bottom sparkplugs. | |

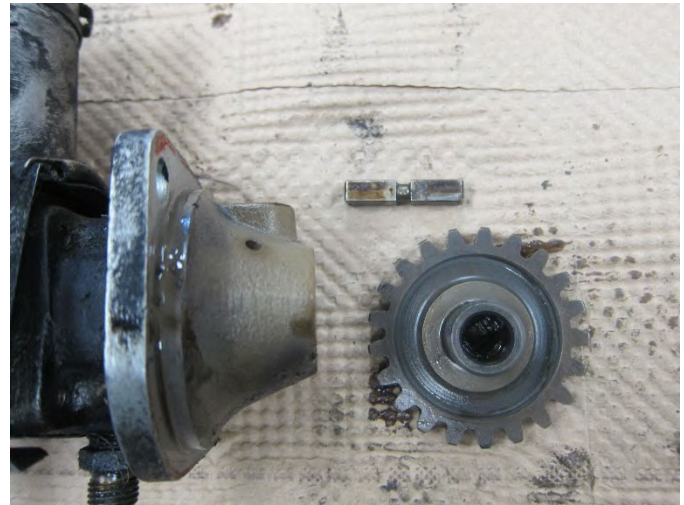
The engine-driven fuel pump remained secured to the backside of the engine. The pump shroud was coated in black dirt (likely from the alternator drive belt). Removal of the pump revealed no pre-event anomalies with the coupling or drive gear.

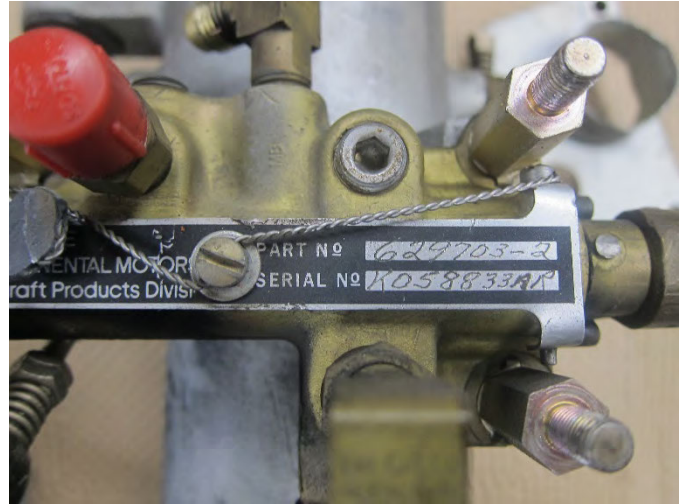
| Condition: | The throttle body remained secured to the backside of the engine and the bronze control levers remained pinned to the throttle and mixture controls shafts. No pre-vent anomalies were observed externally. | | |

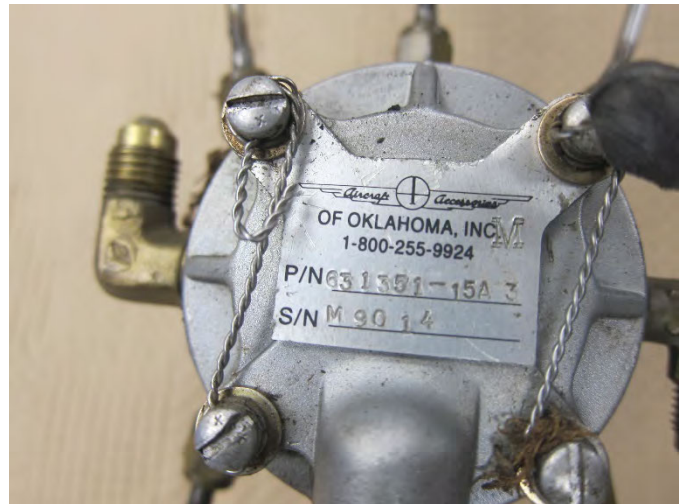
| Condition: | The fuel manifold valve remained secured to the topline of the engine with the fuel lines to and from the housing secured in place. | | |

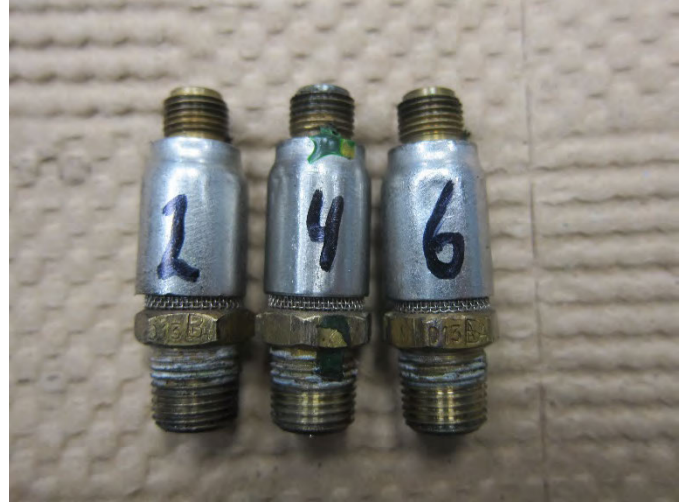
The fuel lines and nozzles remained secured to their respective cylinders. No external pre-event anomalies were noted.

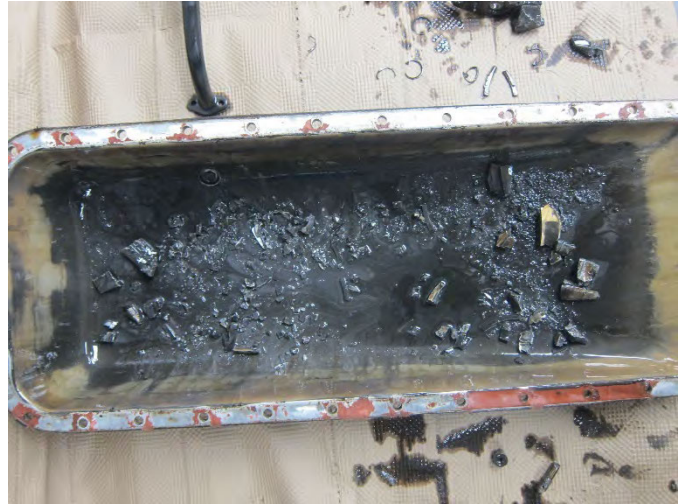
Condition: The oil sump remained secured to the bottom side of the engine. Removal of the sump revealed numerous pieces and parts had been released from the engine's internal components.

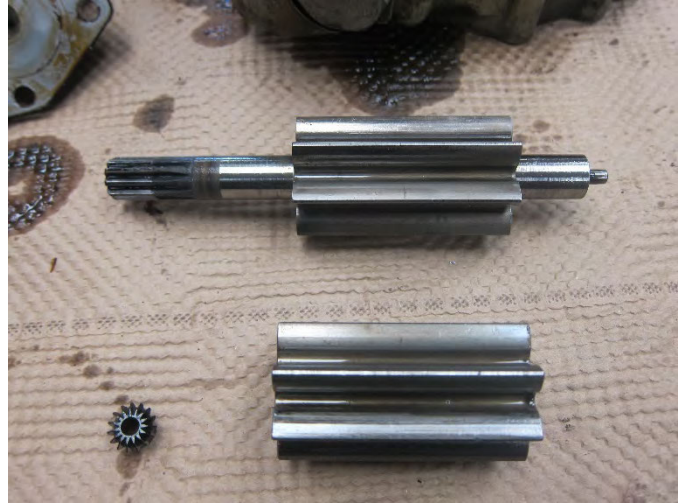
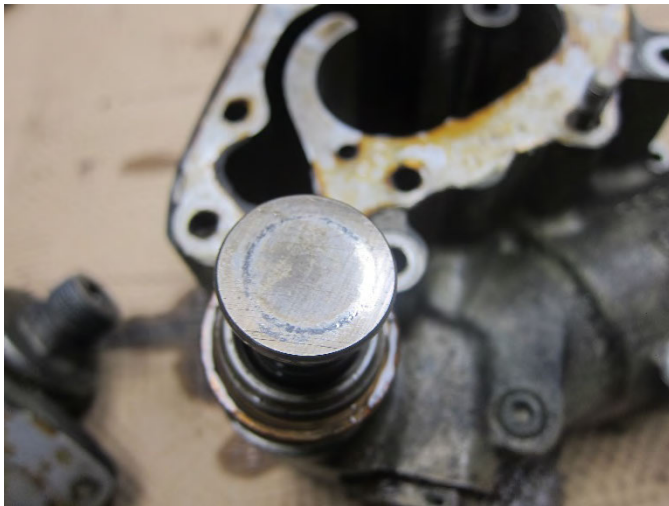
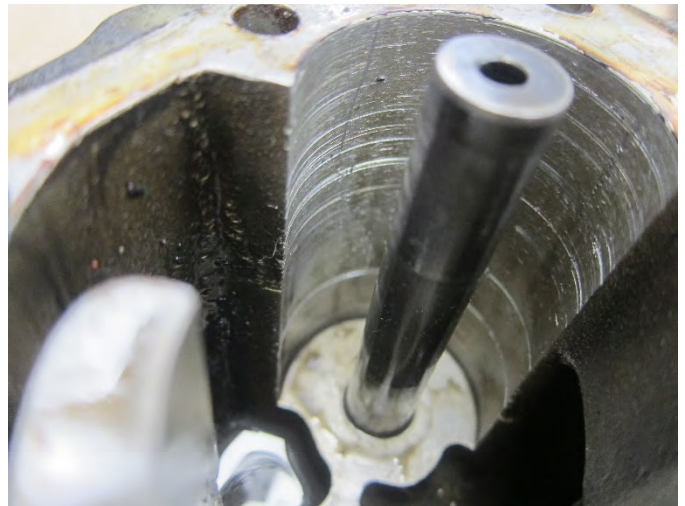
The oil pump displayed circumferential scoring on the pump cavity walls, indicative of hard particle passage. Additionally, the oil pressure relief valve face showed evidence of hard particle impingement.

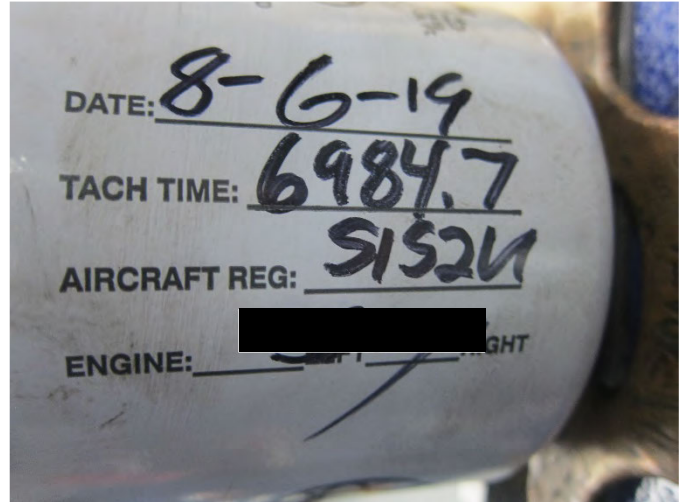
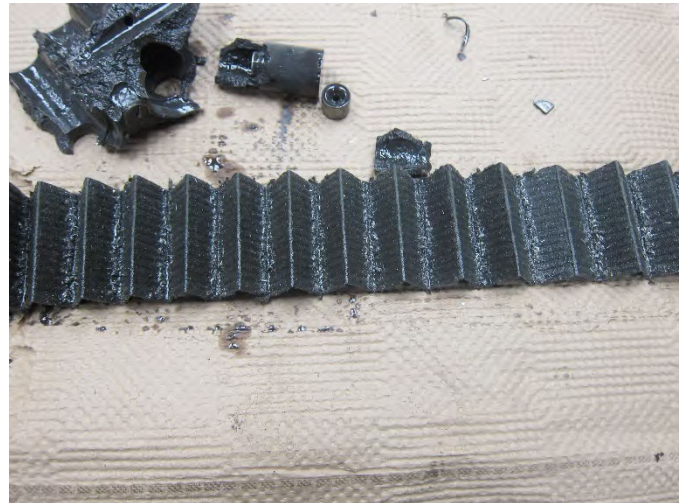
The oil filter remained secured to the adapter and had a tachometer time of 6,984.7 and a date of 8-6-19 hand-written on the side. The filter was cut open to reveal metallic debris within the filter pleats.

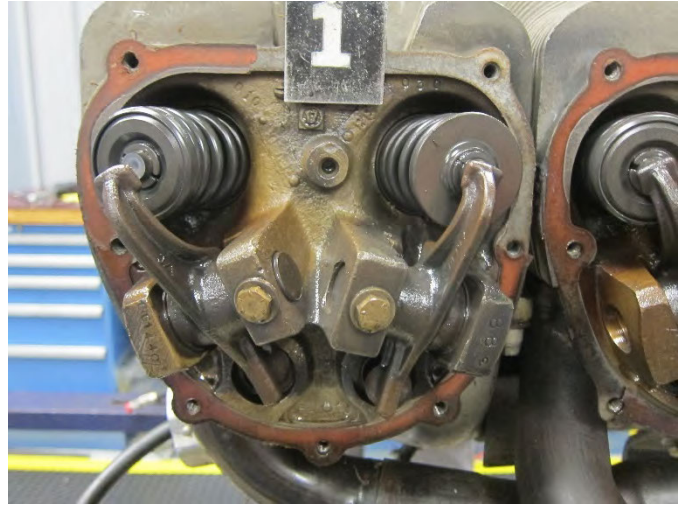
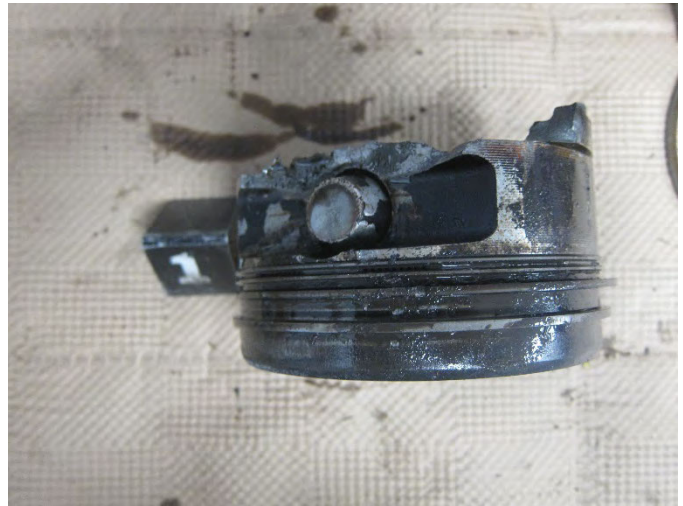
Condition: The cylinder remained attached to the crankcase and no torque putty was observed on the attaching hardware. One of the cylinder mounting studs was displaced outward from base of the cylinder. Removal of the cylinder revealed that the #1 piston displayed a semicircular impact impression consistent with a valve strike and it also sustained mechanical damage to the skirt. There were no pre-event anomalies noted with the rockers, valves, valve springs, and valve seats.

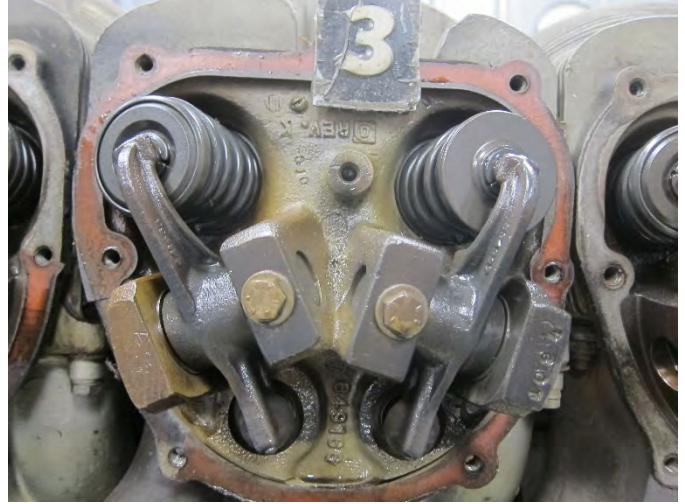
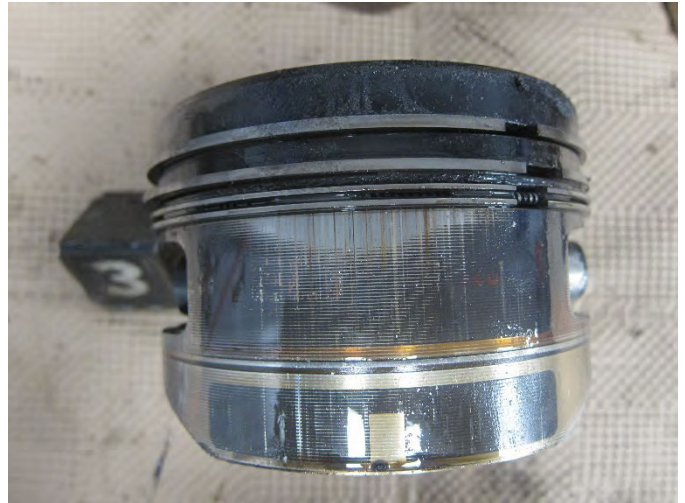
The cylinder remained attached to the crankcase and no torque putty was observed on the attaching hardware. Removal of the cylinder revealed no pre-event anomalies with the cylinder, piston, rockers and springs, or valves and valve seats.

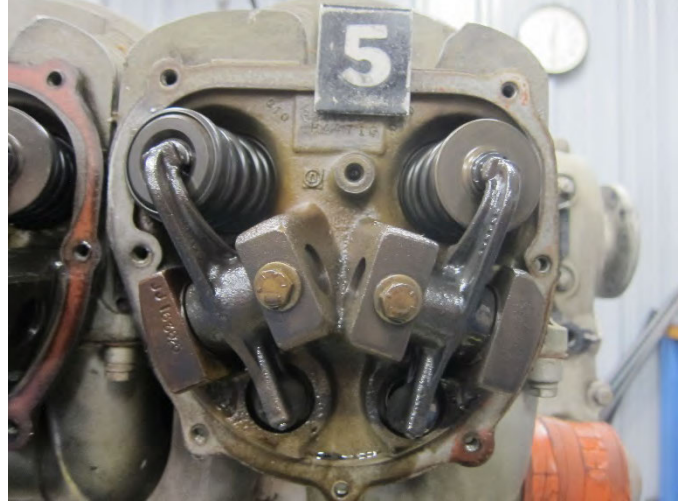
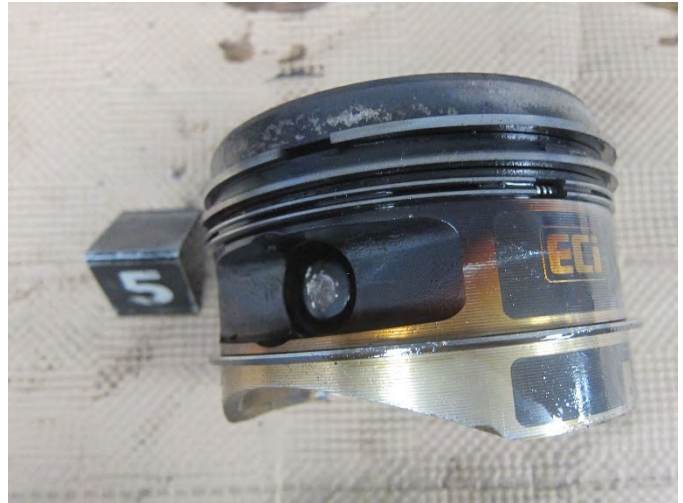
The cylinder remained attached to the crankcase and no torque putty was observed on the attaching hardware. Removal of the cylinder revealed no pre-event anomalies with the cylinder, piston, rockers and springs, or valves and valve seats.

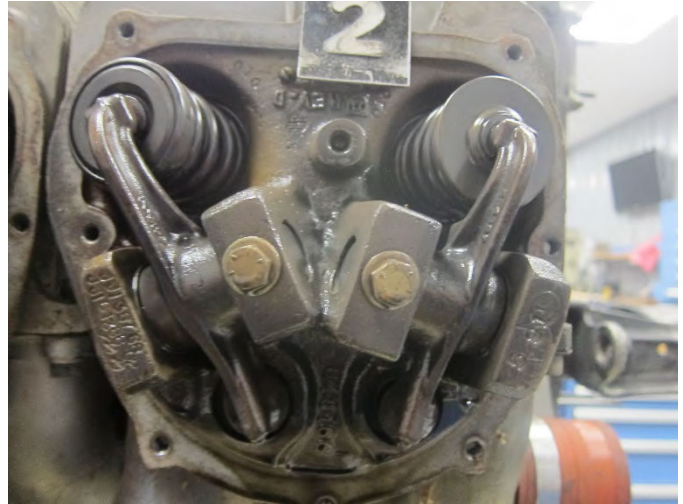
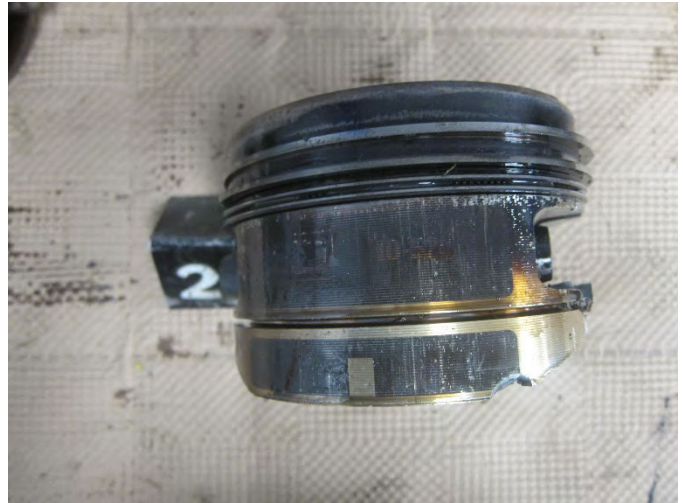
Condition: The cylinder remained attached to the crankcase and no torque putty was observed on the attaching hardware. Removal of the cylinder revealed that the #2 piston displayed a semicircular impact impression consistent with a valve strike and it also sustained mechanical damage to the skirt. There were no pre-event anomalies noted with the rockers, valves, valve springs, and valve seats.

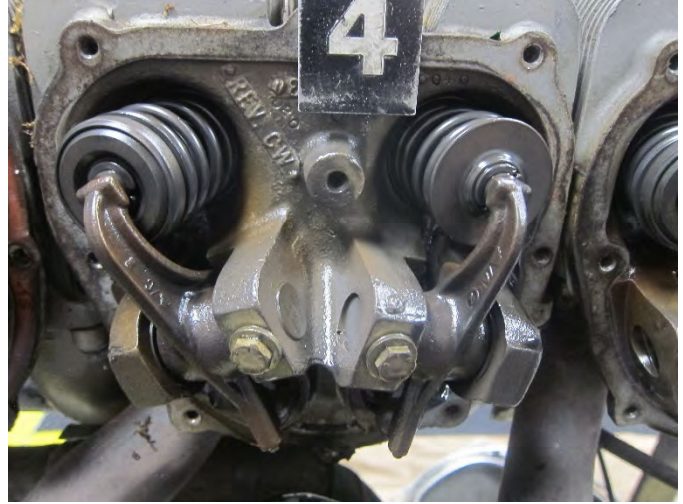
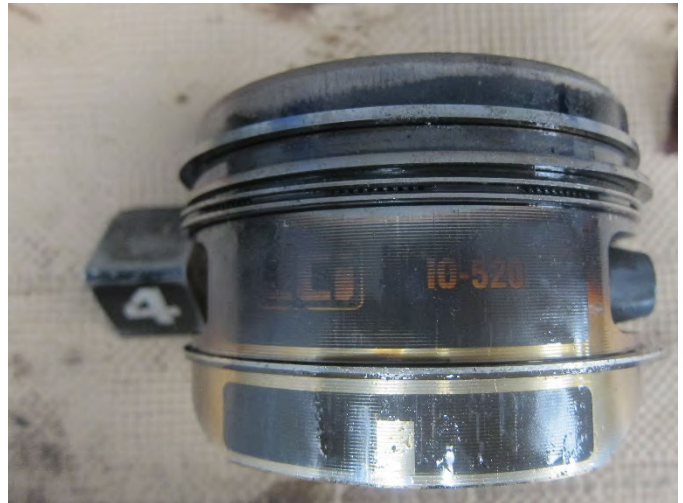
The cylinder remained attached to the crankcase and no torque putty was observed on the attaching hardware. Removal of the cylinder revealed no pre-event anomalies with the cylinder, piston, rockers and springs, or valves and valve seats.

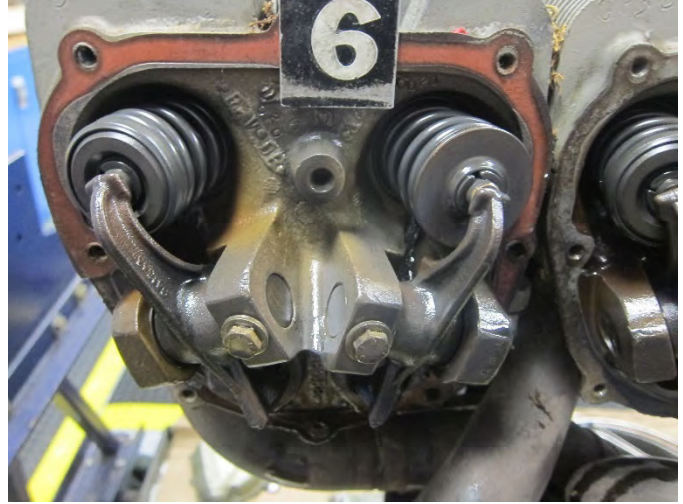
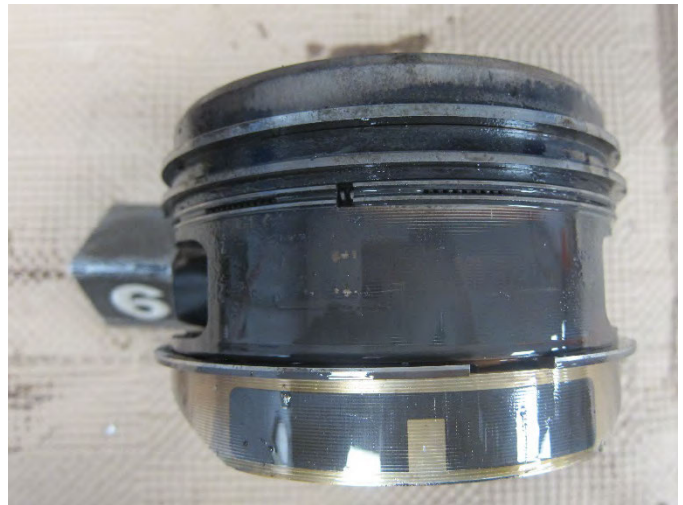
The cylinder remained attached to the crankcase and no torque putty was observed on the attaching hardware. Removal of the cylinder revealed no pre-event anomalies with the cylinder, piston, rockers and springs, or valves and valve seats.

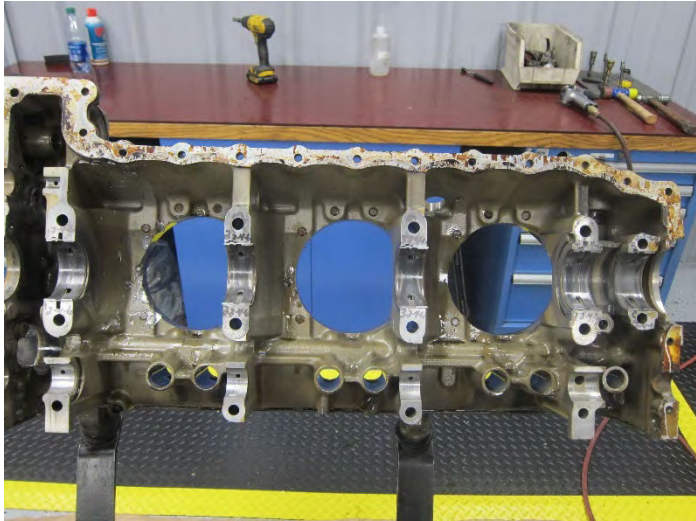
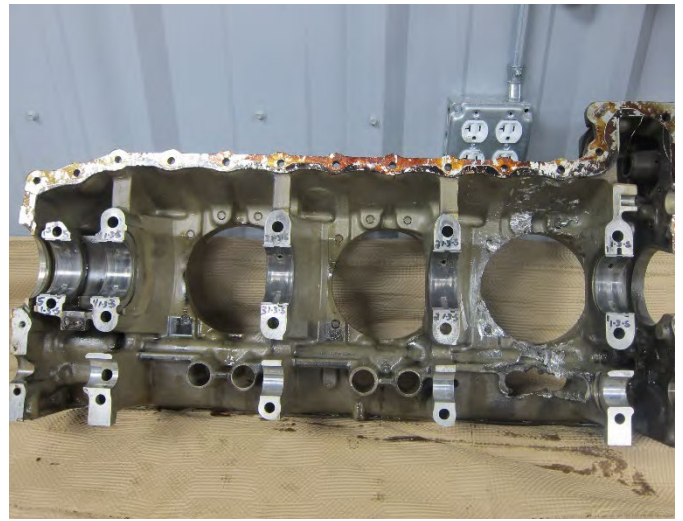
| CRANKCASE | Casting Number: | 1-3-5: 653961 | 2-4-6: 653960 | S/N: 210003R |
|---|---|---|---|---|
| Condition: | The crankcase halves remained intact with some internal mechanical damage observed in the areas of the #1- and #2-cylinder bays. It should be noted that lock slot elongation, which is consistent with inadequate through-bolt torque and bearing migration, was observed on the #2 and #3 main bearing support saddles. The break-away through-bolt torque associated with these main bearing saddles was significantly lower than the 790-810 inch-pounds as specified for this engine model. | | | |

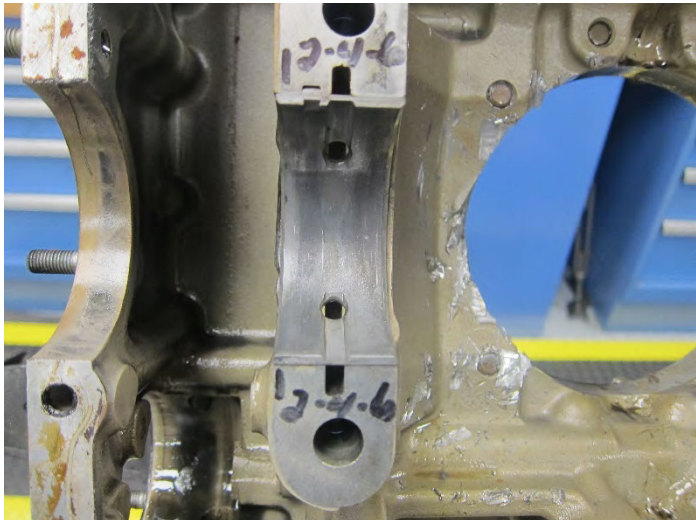
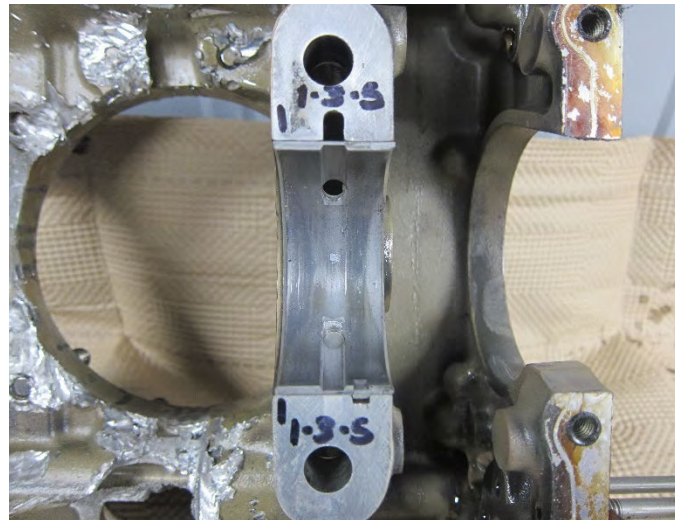
| #1 MAIN BEARINGS | P/N: AEC642720M010 | Date Code: Rev B AJ |
|---|---|---|
| Condition: | The bearings remained in place with indications of normal wear. | |

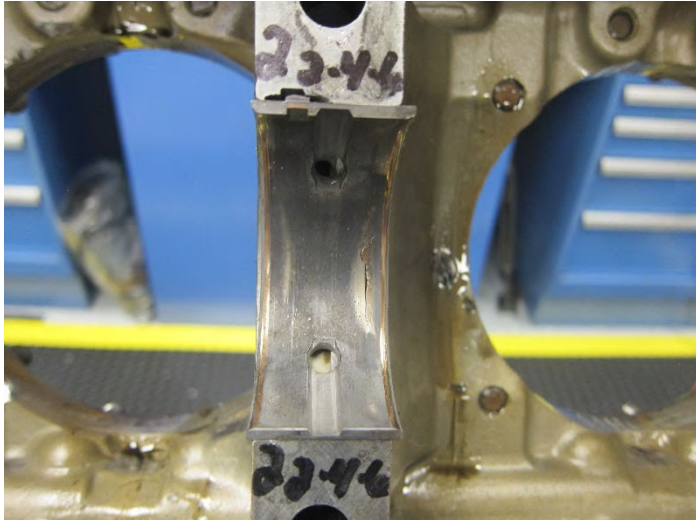
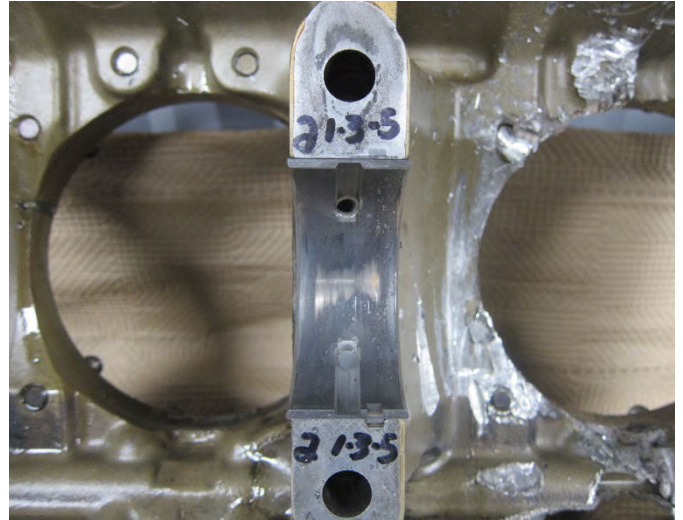
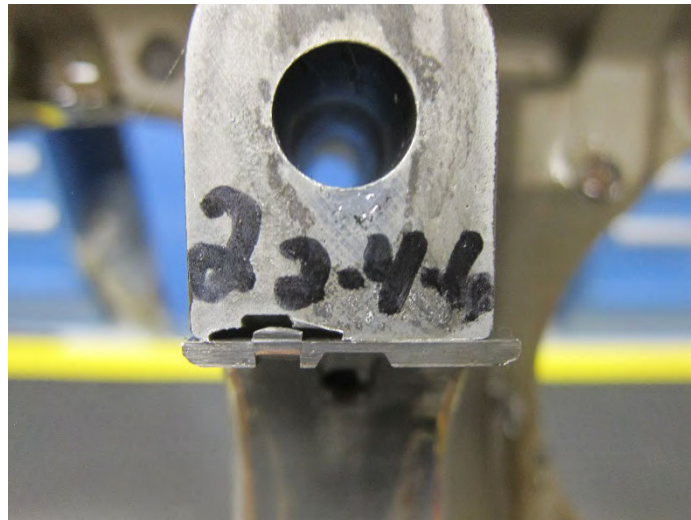
The bearing showed evidence of migration that elongated the lock slot. One half of the bearing show evidence of cracking and edge wear below the babbitt layer.

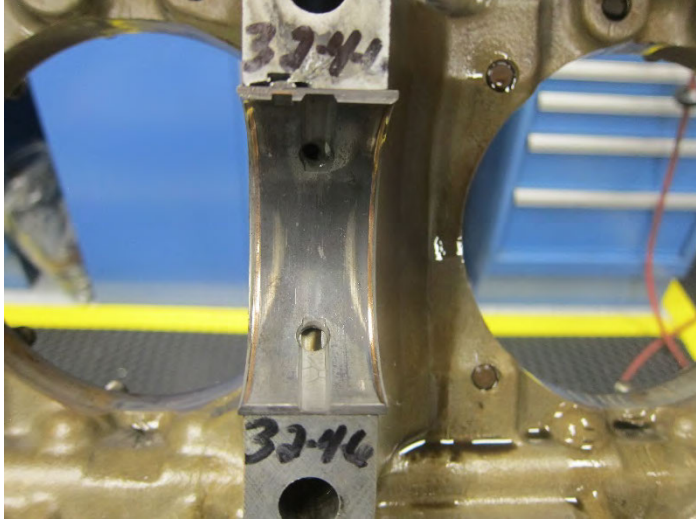
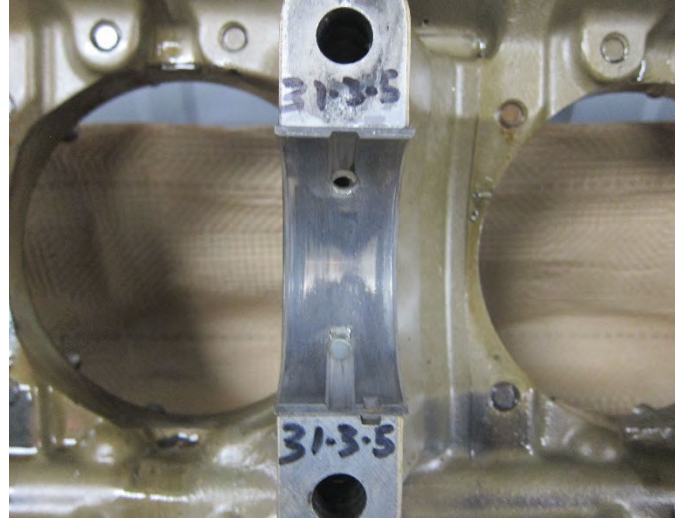
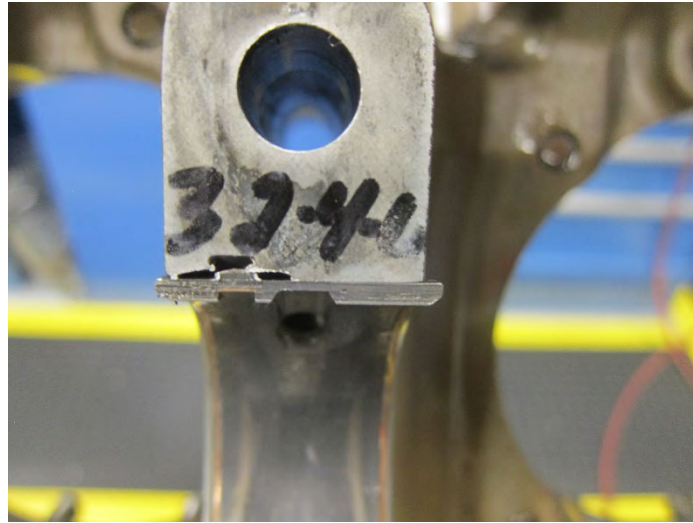
The bearing showed evidence of migration that elongated the lock slot. One half of the bearing show evidence of edge wear below the babbitt layer.

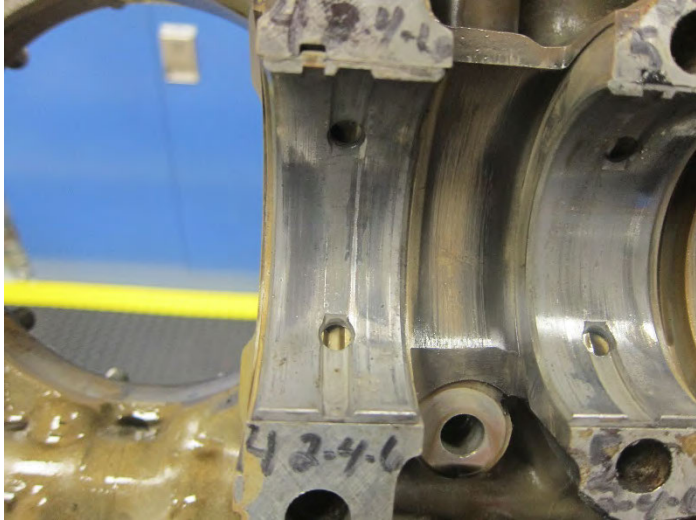
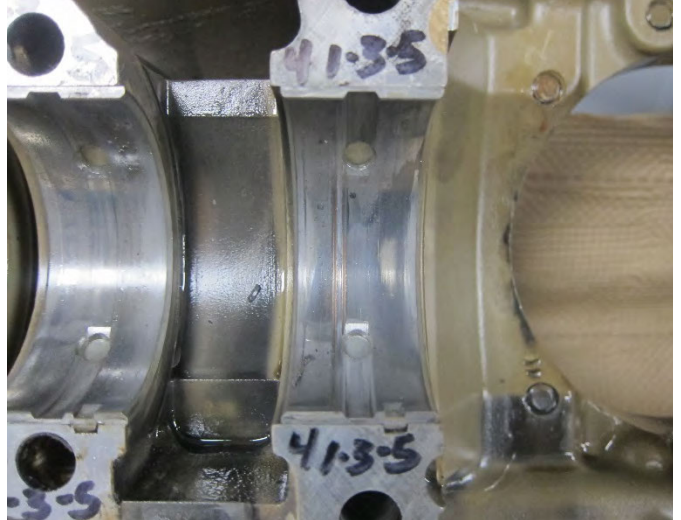
| Condition: | The bearings remained in place with indications of normal wear. | |

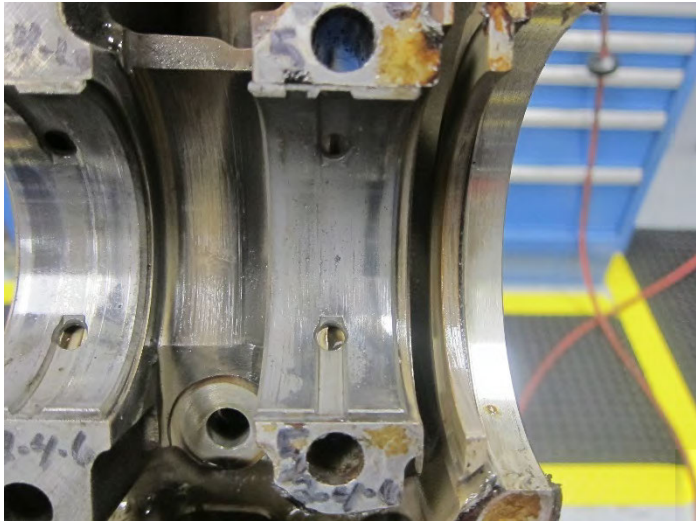
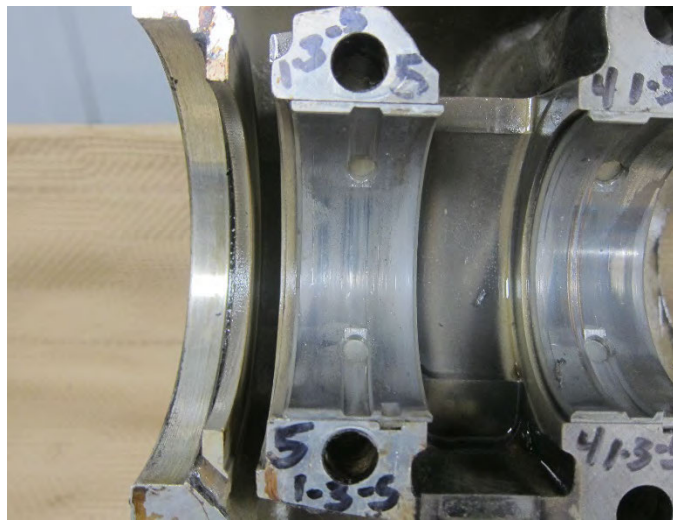
| Condition: | The bearings remained in place with indications of normal wear. | |

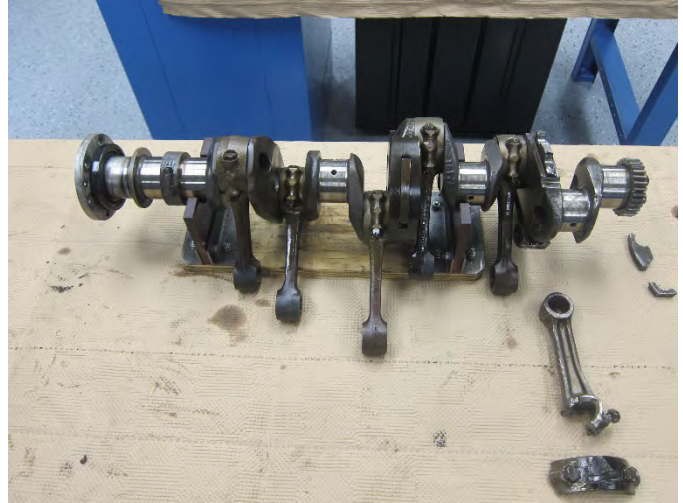
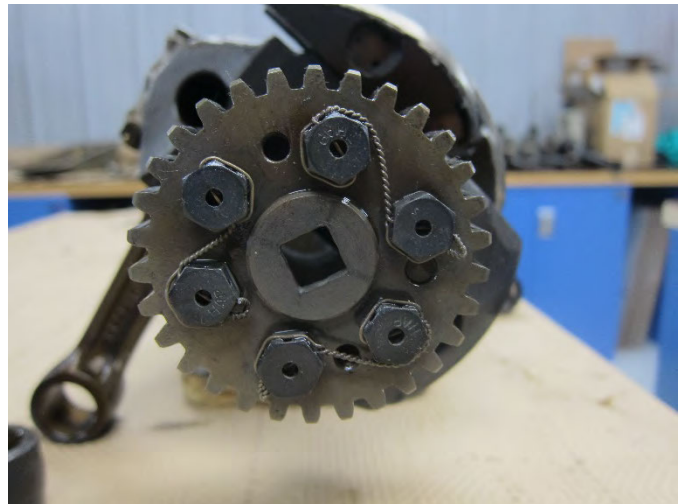
The crankshaft remained intact with the exception of the #2 bottom hanger blade, which was fractured. The #2 bottom counterweight was separated and fractured in numerous pieces. The #2 top counterweight sustained mechanical damage.

The #2 bottom hanger blade was fractured, and the #2 bottom counterweight was separated and fractured in numerous pieces. The hanger blade fracture displayed a flat surface with visible beach marks consistent with fatigue cracking. However, it is presumed that the fatigue cracking was a result of a missing counterweight pin. All four of the #2 bottom counterweight's plates and snap rings, along with both pins were found in the oil sump. One of the four plates was fractured into 5 pieces and displayed a relative lack of deformation damage. It also displayed a deep circular groove consistent in circumference as the counterweight pin circumference. Metallurgical examination of the hanger blade and the counterweight pieces is pending.

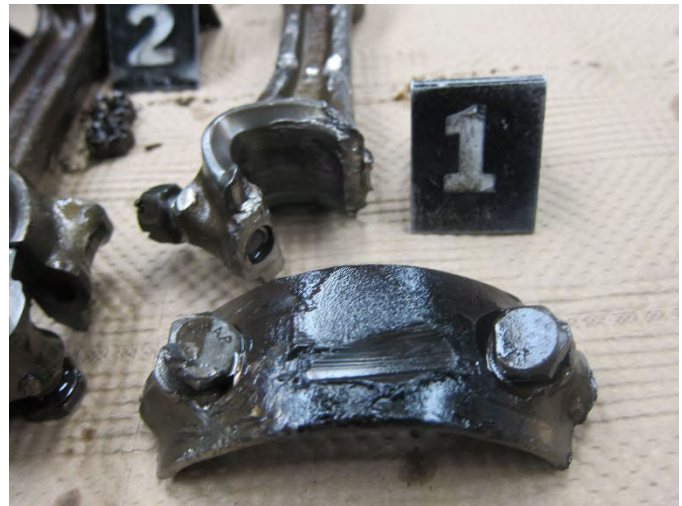
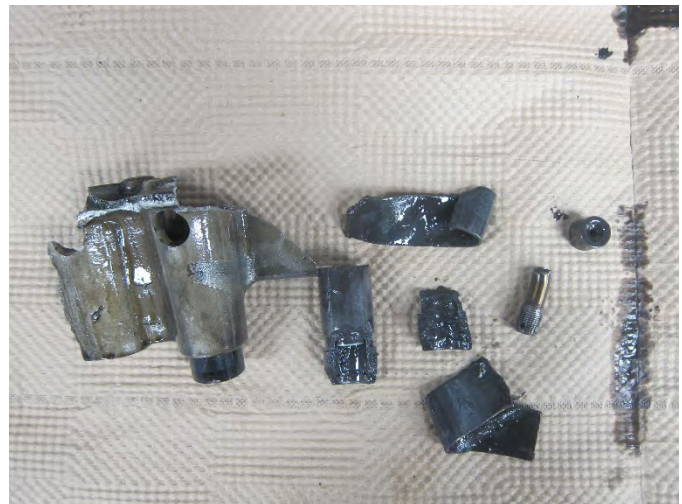
**Condition:** One of the shoulders was fractured as were the connecting rod bolts, and the rod was separated from the crankshaft. The connecting rod displayed mechanical deformation damage that likely resulted from the separated counterweight components. The fractured bolts showed deformation damage near the fracture areas. There was no sign of thermal discoloration associated with oil starvation.

**Condition:** The bearing halves were located in the oil sump. They sustained mechanical deformation damage.

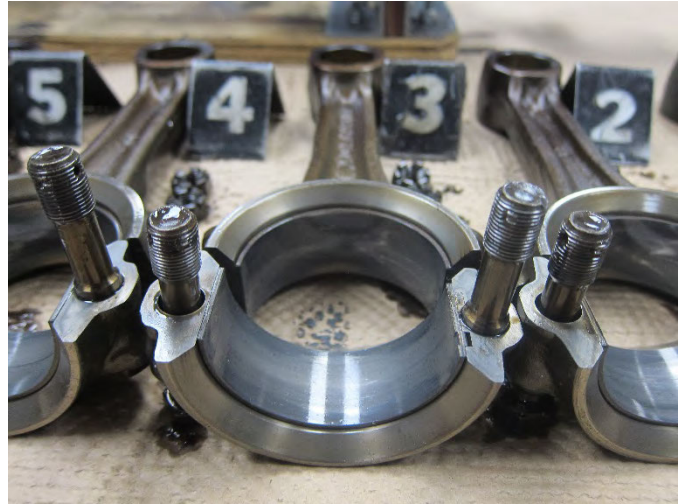
The connecting rod remained attached to the crankshaft and its piston pin. No pre-event anomalies were noted with the connecting rod.

The bearing remained in place and displayed normal wear.

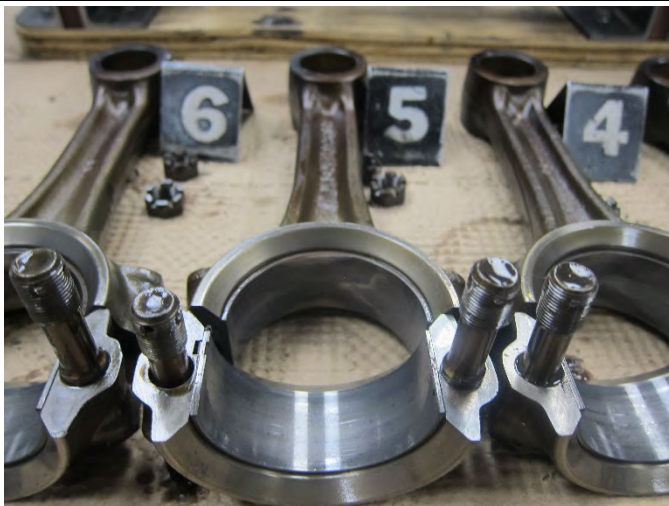
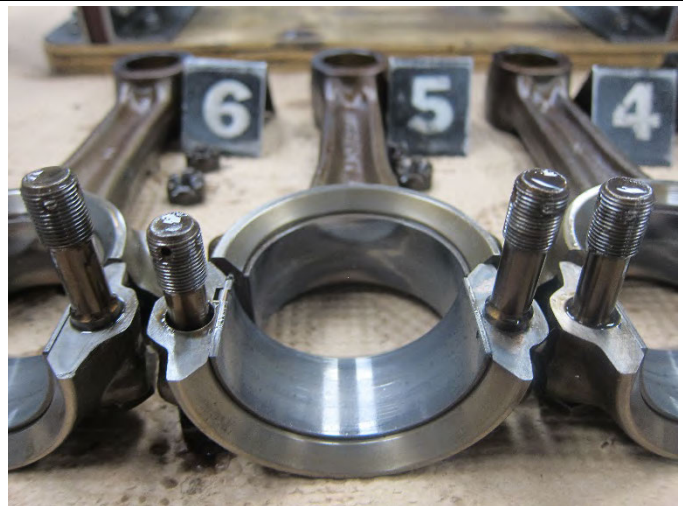
The connecting rod remained attached to the crankshaft and its piston pin. No pre-event anomalies were noted with the connecting rod.

The bearing remained in place and displayed normal wear.

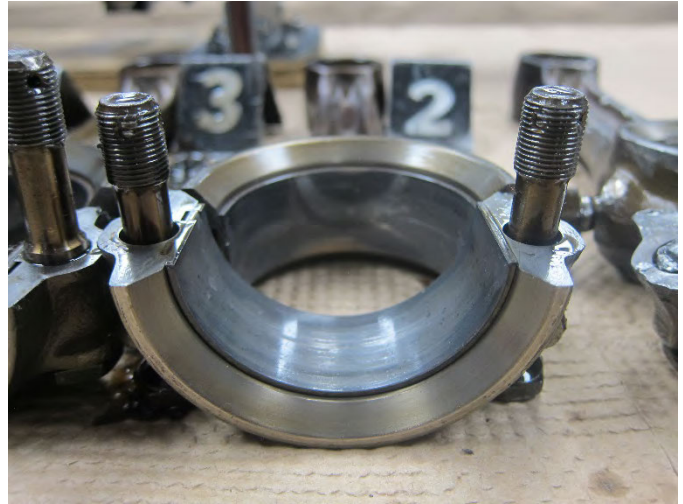
Condition: The connecting rod remained attached to the crankshaft and its piston pin. No pre-event anomalies were noted with the connecting rod.

Condition: The bearing remained in place and displayed normal wear.

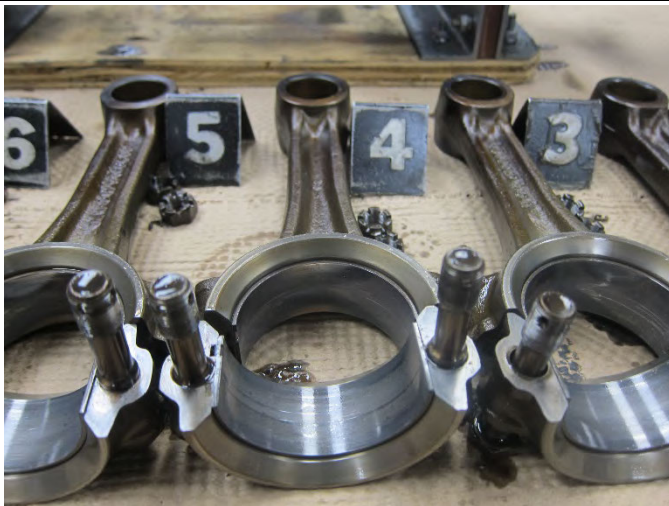
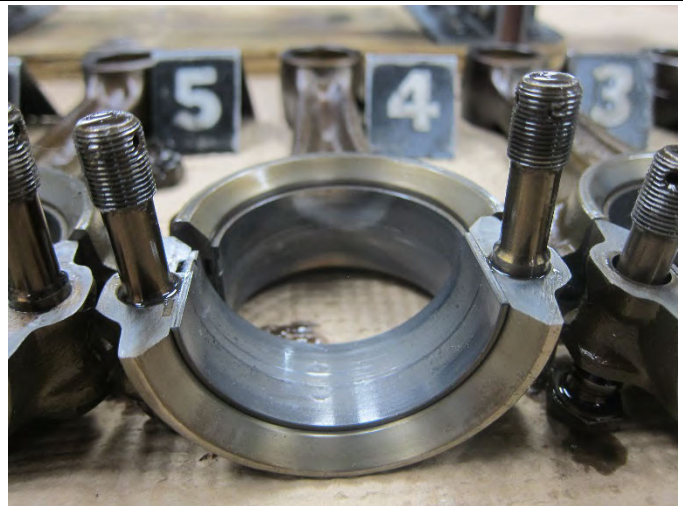
Condition: The connecting rod remained attached to the crankshaft and its piston pin. No pre-event anomalies were noted with the connecting rod.

Condition: The bearing remained in place and displayed normal wear.

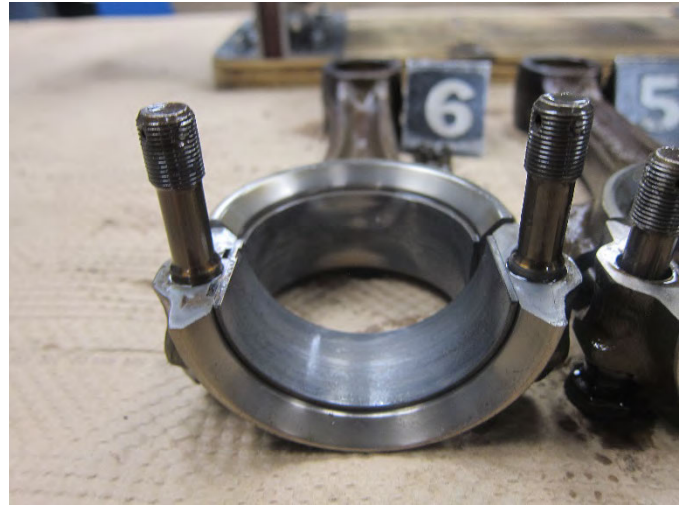
The connecting rod remained attached to the crankshaft and its piston pin. No pre-event anomalies were noted with the connecting rod.

The bearing remained in place and displayed normal wear.
