# ENGINE EXAMINATION REPORT

| ENGINE MODEL | IO-520-A5B |
| AIRCRAFT MAKE & MODEL | Cessna 206 |
| FILE NUMBER | 19-053 |

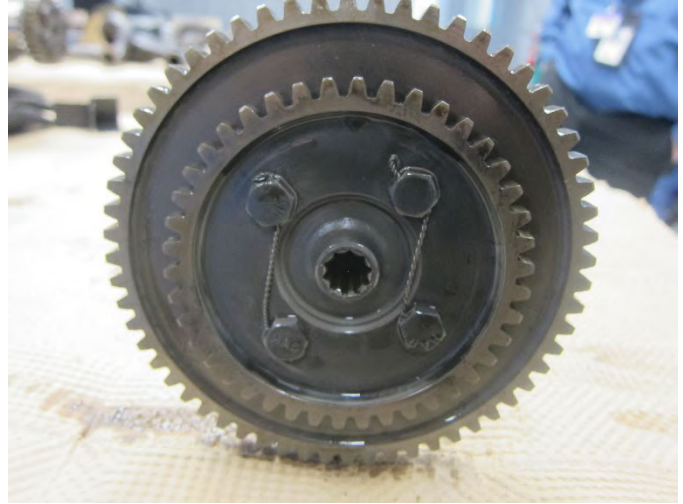
| Condition: | The camshaft remained intact and the gear was secured in place |

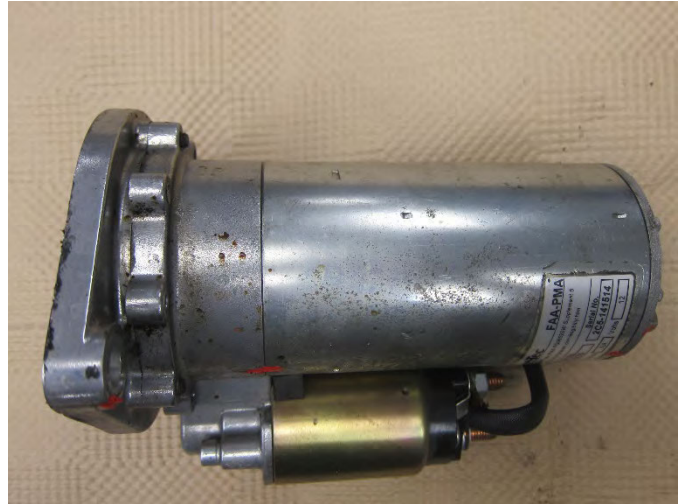
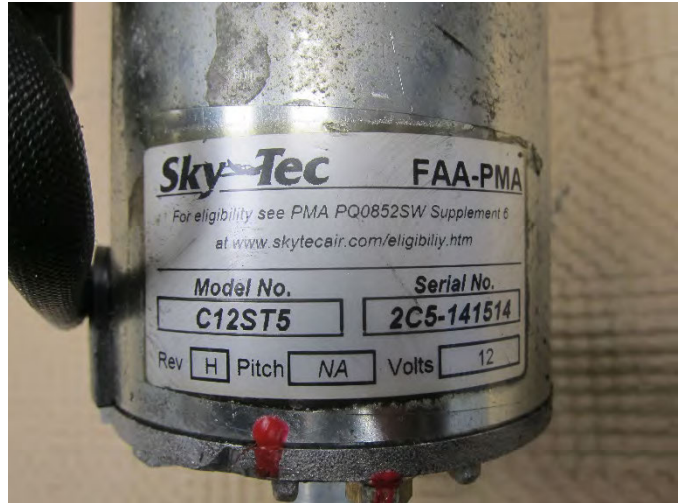
| STARTER | Manufacturer: Sky-Tec | P/N: C12ST5 | S/N: 2C5-141514 |
|---|---|---|---|
| Condition: | The starter motor remained attached to the adapter and exhibited normal operating signatures. | | |

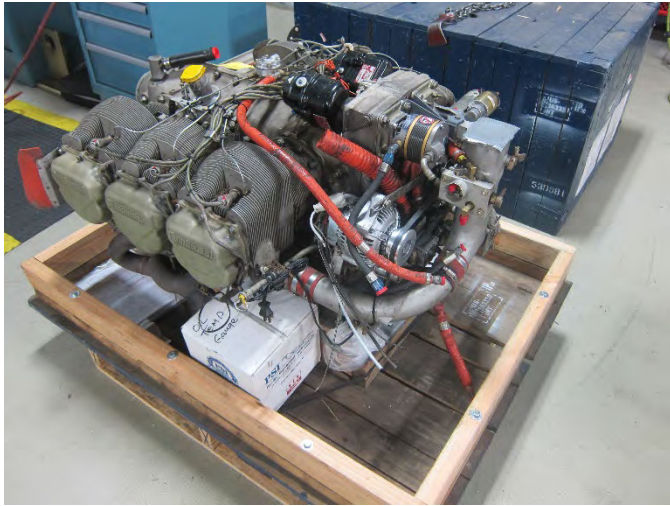
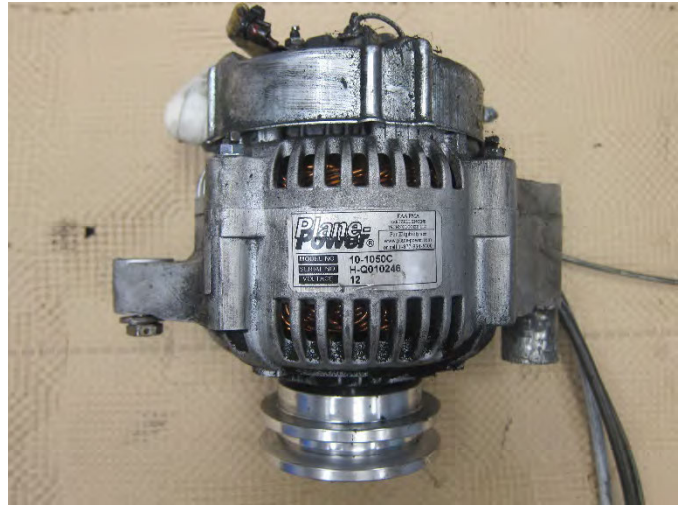
| Condition: | The alternator remained secured to the back side of the engine and the drive belt was in place. It exhibited normal operating signatures and was not examined as part of this investigation. |

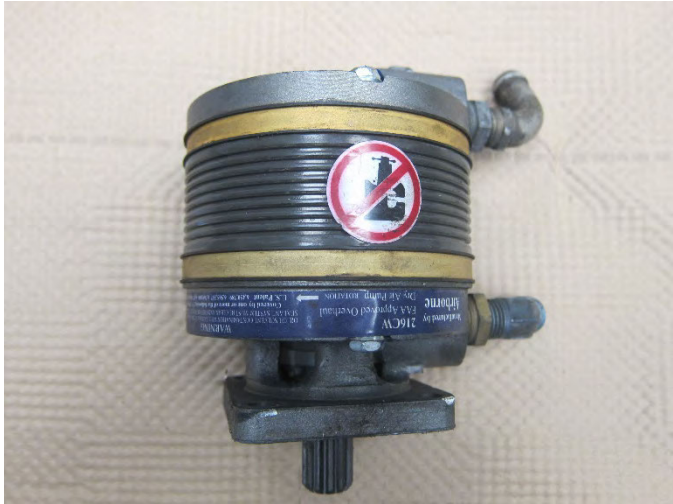
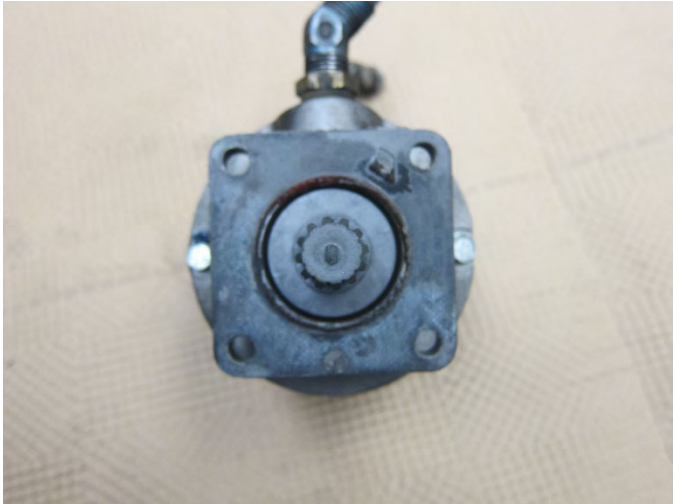
| Condition: | The vacuum pump exhibited normal operating signatures and was not examined as part of this investigation. |

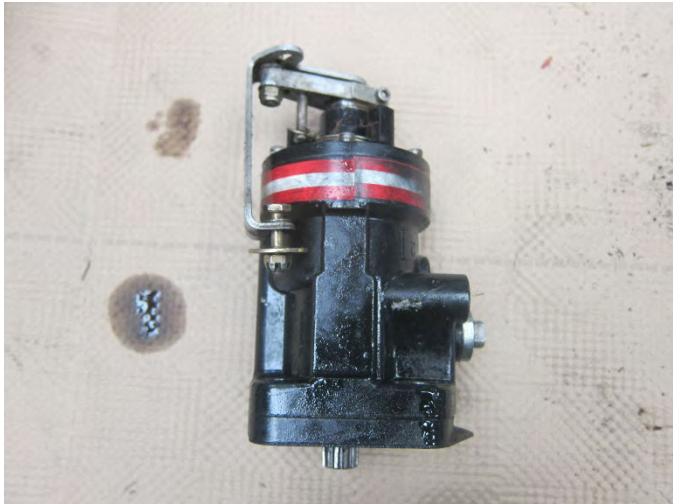
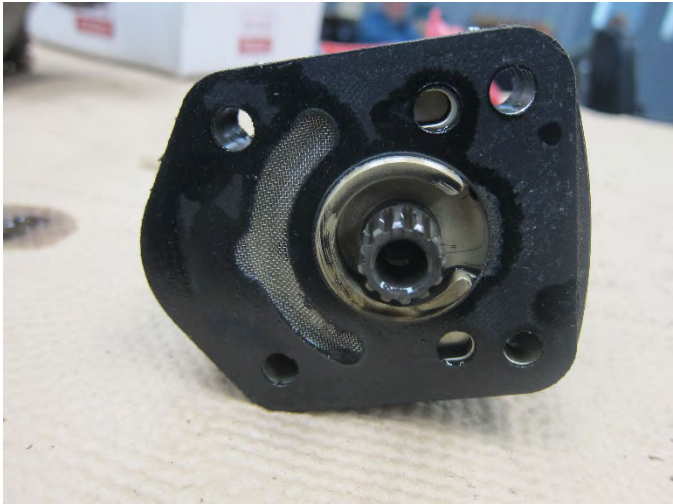
| Condition: | The propeller governor exhibited normal operating signatures. | | |
