**Evaluation of Auxiliary Fuel Boost Pump  
P/N B8120-M, Non-Weldon Serial Number: 1807225  
From Make: Extra, Model: EA300 L, Aircraft: N19AM  
for NTSB Case: WPR19LA218**

Evaluated 27/Feb/2020

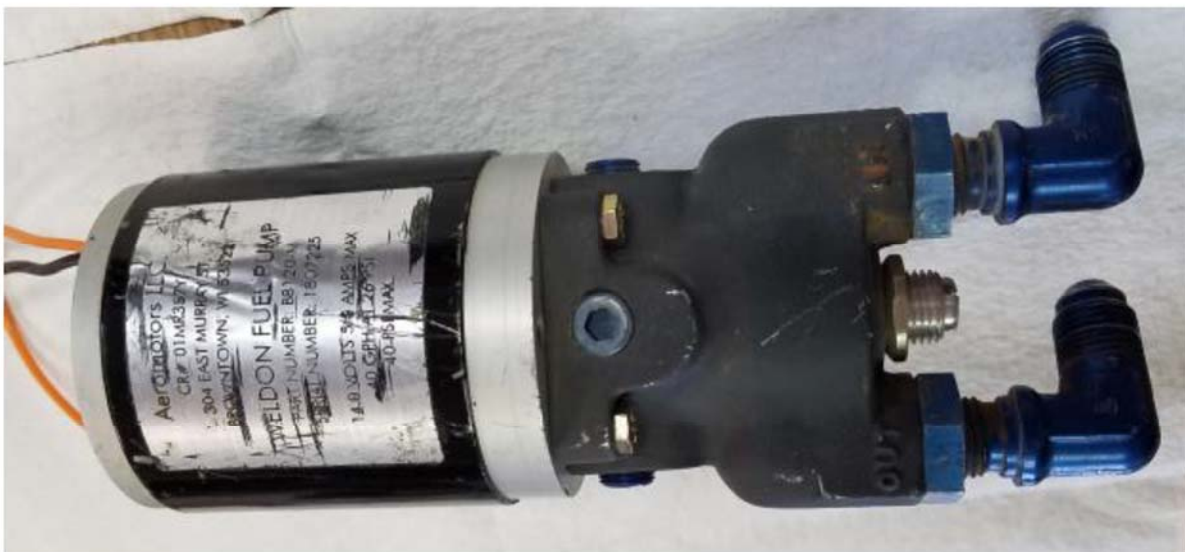
Figure IV  
Label View of Pump-Motor Assembly

This report documents the inspection, evaluation, and testing of the auxiliary fuel boost pump from the Extra EA300 L aircraft with registration number N19AM. Note, this article has NON-Factory “part marking” with the following header to its’ label (shown in Figure IV):

Aeromotors LLC.  
CR# 01MR357Y  
304 East Murray ST.  
Browntown, WI 53522

Immediately below the header is “Weldon Fuel Pump” followed by the known/valid Weldon part number of B8120-M. Next, the label states a NON-Weldon serial number of 1807225 (as of this writing Weldon isn’t into seven digit serial numbers). Note, due to the lack of a Weldon factory serial number traceability to original factory condition is not possible. The label concludes with “14.0 Volts 5.5 Amps Max, 40 GPH at 26 PSI, 40 PSI Max”.

The article was removed from packaging and inspected, see Figure IV for image of the article as first unpacked. At first glance the Pump-Motor Assembly's configuration was a close approximation to that of a Weldon Pump B8120-M. Upon closer scrutiny the motor was obviously not of Weldon factory origin. The motor’s factory label was not present. The motor field shell was devoid of the stamped keying features at both ends. The hook-up wires exited the motor’s endframe thru a non-factory grommet (See Figure VI for image). The wire strands being silver plated unlike the factory non-plated strands. The “anti-drive end” endframe was machined aluminum as opposed to the factory die cast component. The motor case bolts were Phillips head as opposed to the factory socket head (prior factory revisions employed slotted head - but never Phillips). The drive endframe was devoid of the correct factory chamfered edge break and countersunk case bolt hole chamfers. The motor was mounted to the pump assembly such that both the case bolts and lead wire exit were 90° off radial position relative to the factory design data. Further, the relief valve adjusting screw was not a factory Weldon part as it was not anodized and had an alternate profile (not of any known lineage of approved design data) to the unthreaded slotted area (See Figures IV, V, & X for images). The cast pump body was the only, non-COTS, item visible from the exterior that was believed to be of Weldon factory origin.

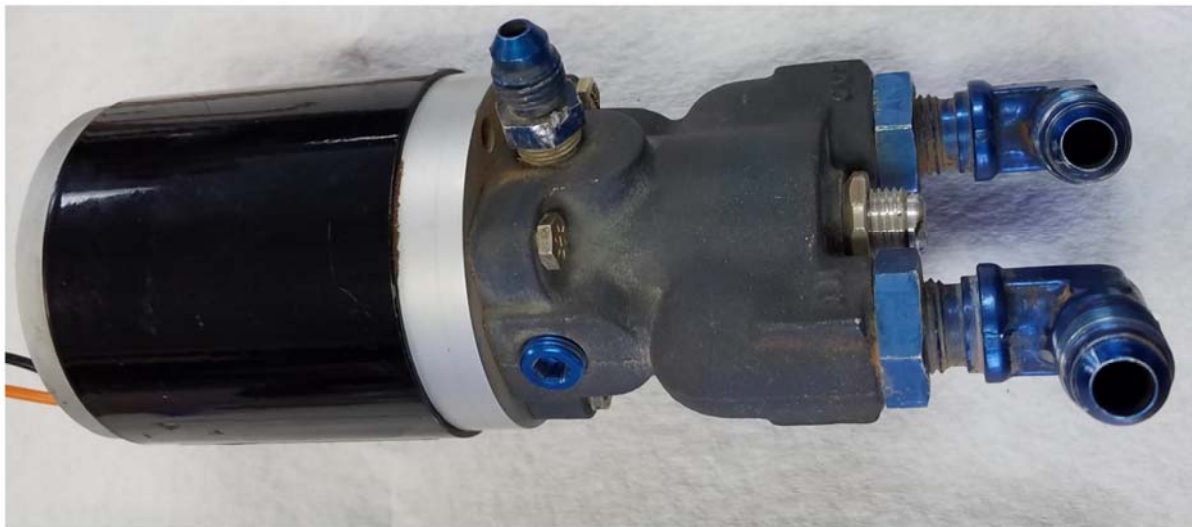
Figure V  
Opposite Label View of Pump-Motor Assembly

- Overboard seal drain port fluid fitting;
  - Fitting body appearing to be AN816-4D “*Adapter, Straight, Pipe to Tank*” or equal. quantity one (See Figure V for image).

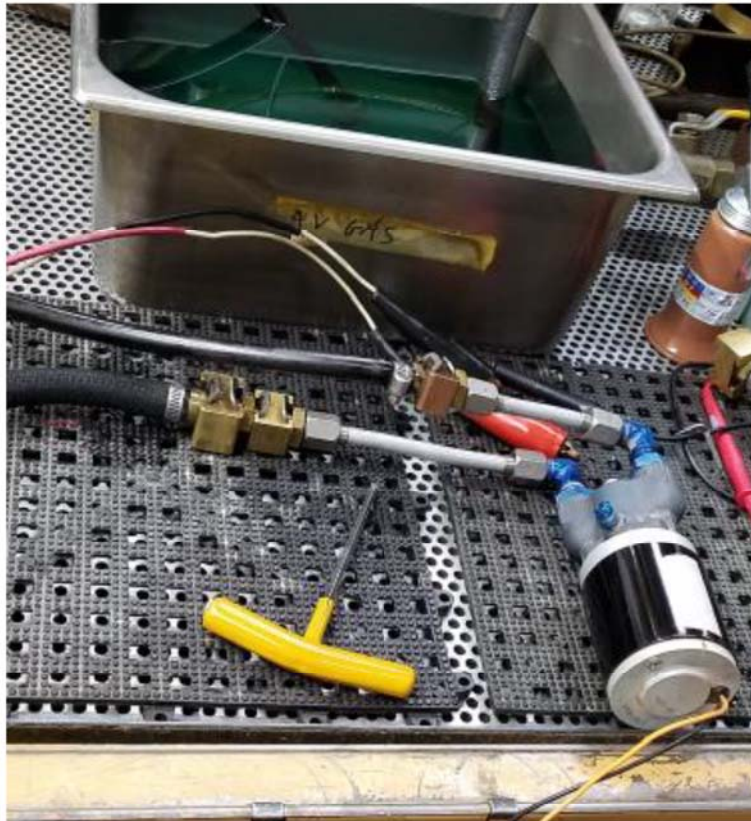
Figure VII  
Pump-Motor Assembly installed in ATP set-up

The Pump-Motor Assembly was installed into the ATP set-up (exception from standard ATP used for the B8120-M is connection was made to the reinstalled inlet and outlet fitting assemblies instead of installing the lab quick connect fittings directly into fluid ports) and then powered. The article failed to prime within the ATP set-up (See Figure VII for image).

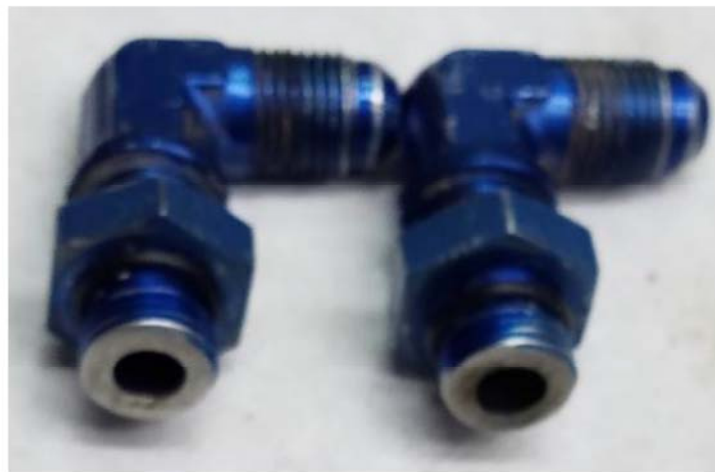
Figure VIII  
Inlet & Outlet Port Fitting Assemblies

Both the Inlet and Outlet fittings were checked for blockage – no blockage was found.

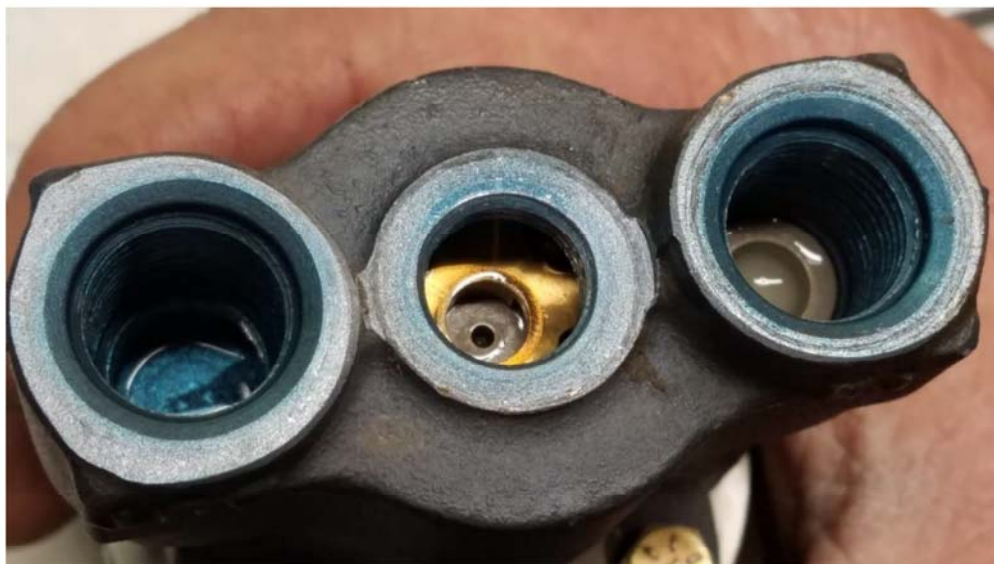
The Inlet and Outlet port fitting assemblies were removed and a visual inspection of the bypass valve conducted (See Figure IX for Image). Next, a successful leak down test of the bypass valve was conducted by filling the Pump body's inlet port with isopropyl alcohol and finding no detrimental/rapid leakage.

Image of Outlet Port, Relief Valve Port, & Inlet Port (including Bypass Valve)

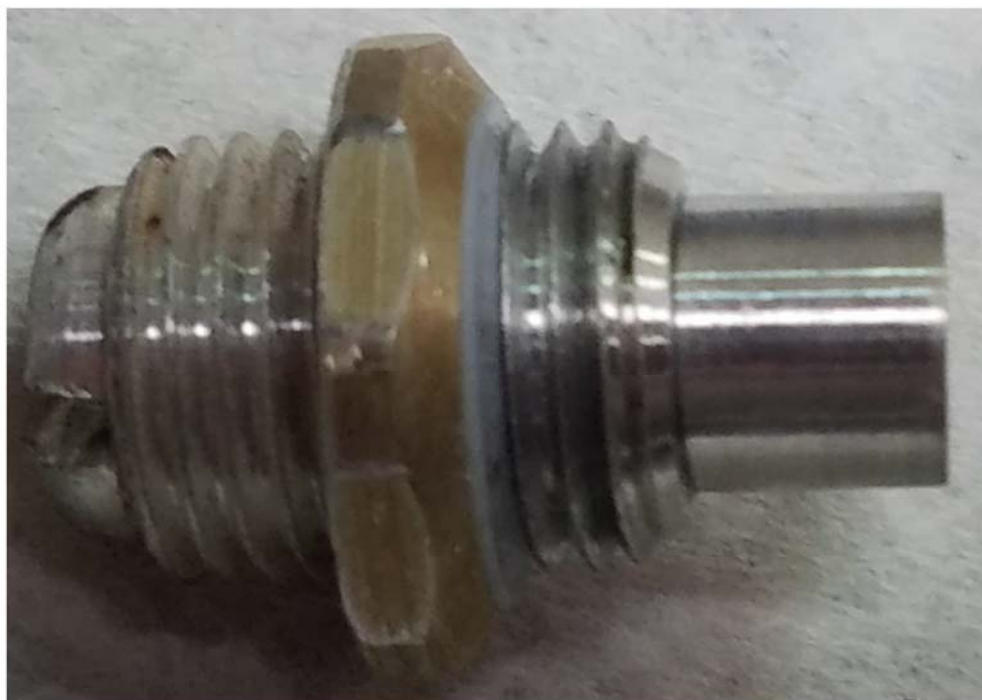
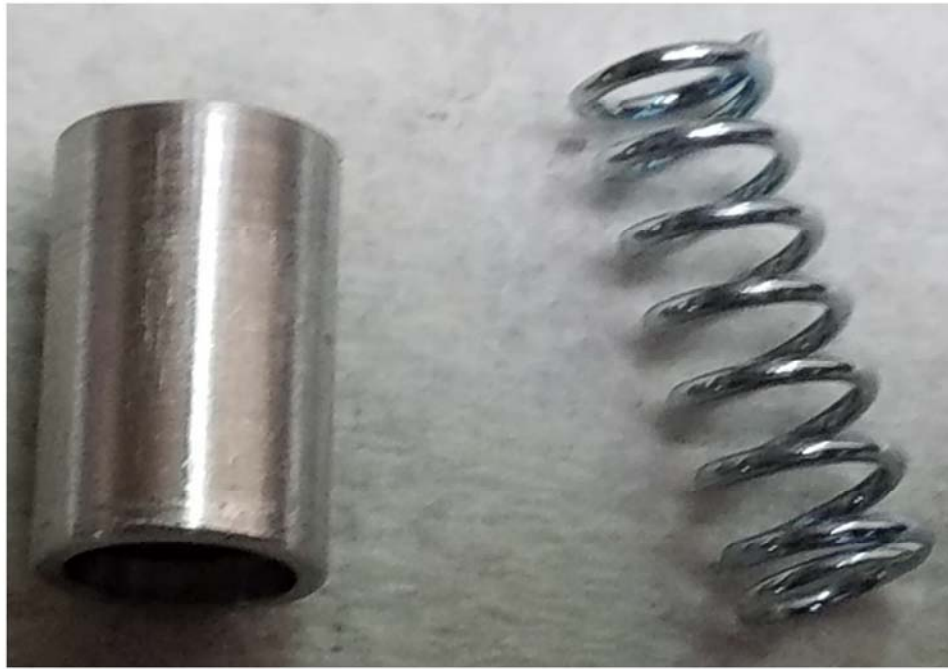
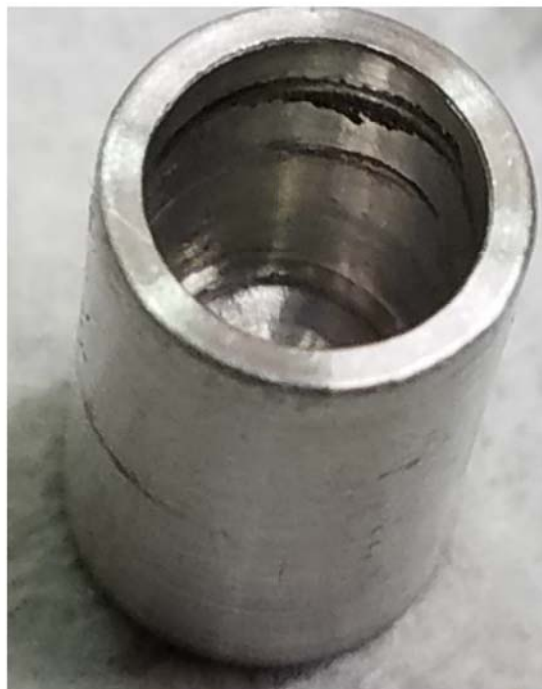
The relief valve assembly was removed and it was discovered that (in addition to the aforementioned relief valve adjusting screw not being of any know lineage of approved design data) the relief valve spring & poppet were not of Weldon factory origin. Although it didn't appear that the relief valve assembly was a contributing factor to failure at hand (See Figures X, XI, & XII for images).

Image of Relief Valve Assembly

Figure XI  
Image of Relief Valve Poppet and Spring

Figure XII  
Image of Relief Valve Poppet

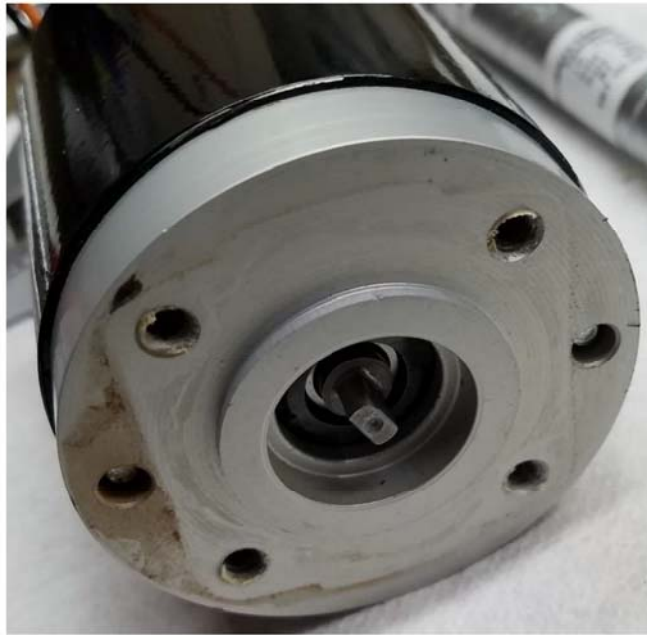
- The motor's drive shaft was of a foreign design (not per any known lineage of approved design data) having a male drive tenon (See Figure XIII for Image). Factory motor drive shaft has a

female drive slot to couple directly to the pump rotor's male drive tenon without any intermediate part.

Figure XIII  
Image of Motor Assembly's Drive End

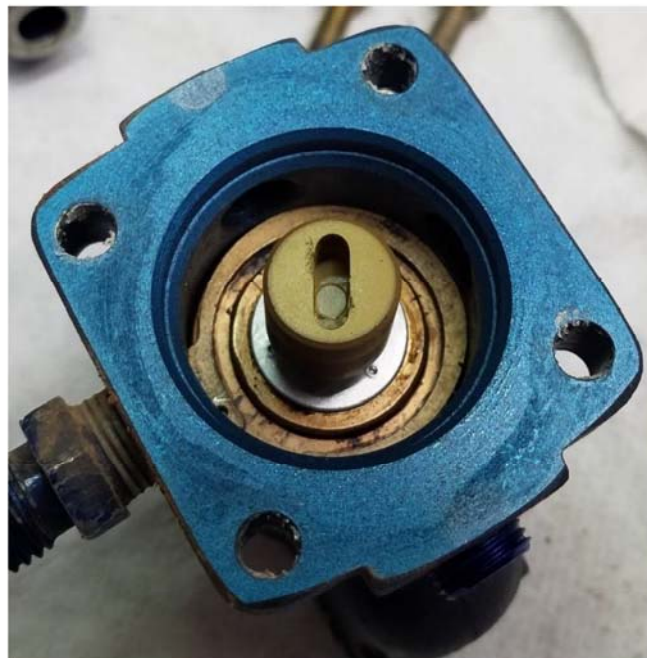
One of the three factory overboard seal drain port plugs was removed. A small flashlight was used to view into this port and view/discover the non-factory (not of any known lineage of approved design data) motor shaft to plastic intermediary coupling to rotor shaft (See Figures XIII & XIV for images). A mark was applied to the OD of the plastic intermediary coupling with a felt tip marker to aid in the following. Momentary application of power was repeated while viewing the rotating assembly. This determined that the motor shaft, plastic intermediary coupling, and rotor shaft were all spinning when power was applied thus ruling out a worn out or broken drive shaft to rotor interface.

- There was plastic intermediary coupling of a foreign design (not per any known lineage of approved design data) between the male drive tenons of the rotor and motor (See Figure XIV for Image).

Figure XIV  
Image of Plastic Intermediary Coupling

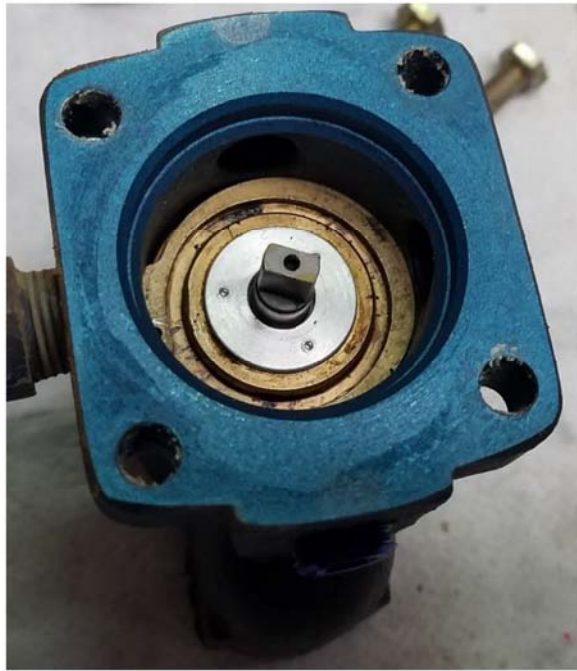
- The Weldon factory "face seal" employed on the B8120-M model of pump was not present. Instead it appears that the factory bronze insert had been heavily modified/machined to add a counterbore accepting a replacement foreign seal design (not per any known lineage of approved design data). *It should be noted that, based on experience, Weldon would never machine this type of feature after the close tolerance blade slots, rotor head counterbore, and rotor shank bore are finished as it is nearly impossible not to distort these critical features...* (See Figure XV for Image).

Image of Heavily Modified/Machined Factory Bronze Insert with Foreign Seal Installed

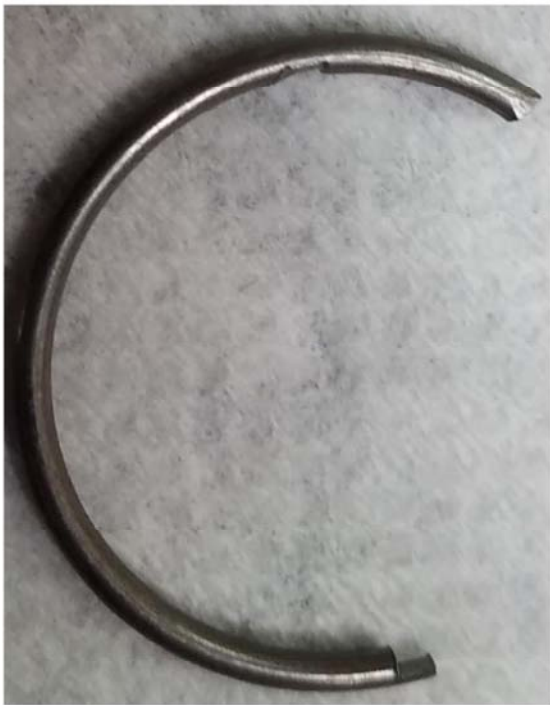
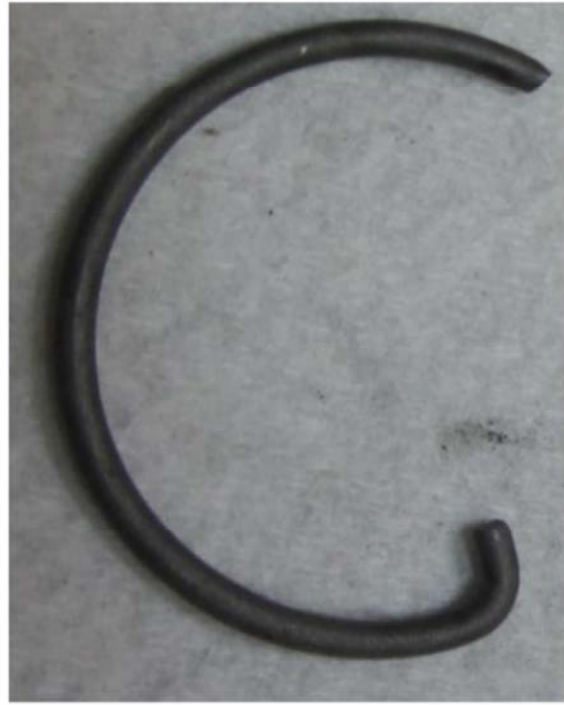
The pump cartridge was removed from the pump body by removing the internal snap ring and pushing on the large end of the rotor per the service manual. The failure mode of the pump-motor assembly was immediately apparent once the pump cartridge was removed, a failed blade retaining ring (see Figure XVI of Images). Said blade retaining ring had two notches cut/worn, one thru, by the blade/vane interaction (Due to the extreme wear it is suspected that an additional contributing factor may be the blade retaining ring isn't of the correct alloy steel and/or may not meet the required temper. During this evaluation it wasn't feasible to test for this theory). The pump cartridge was disassembled by removing the four cover screws, the cover. Also of significance was that the blades/vanes were not moving as freely, as designed, within their corresponding slots in the insert. The blades were carefully pushed out to allow for measurements without damaging the parts. Although having heavy abrasion and badly worn blade retaining ring notch the blades/vanes were measured for service manual wear limits be in tolerance. Utilizing inspection pin/plug gages the width of the blade slots within the insert were measured and found to allow a maximum size of 0.0445". This value is under the approved design data's low limit and creates a potential "press fit" with the blades/vanes tolerance range (*this "closing of the slots was likely caused by the aforementioned modifying/machining of the insert*). Additionally it was apparent that the "cover" was not per any known lineage of approved design data based on the profile of the O-ring gland as well as what appeared to be an alternate alloy bronze by virtue of a significantly different patina (See Figure XVII for Image). Utilizing the 0.4993 No Go Ring Gage the rotor was checked for wear per the service manual and found to easily pass thru therefore it is deemed under the Ø0.4993" low limit.

The evidence suggests that the pump-motor assembly, having been produced with defective and inferior subcomponents, wasn't operating "freely" as designed and thereby caused accelerated mechanical wear at the blade retaining ring to blade notch interface. This accelerated wear rapidly cut through the blade retaining ring as shown in figure XVI. Once cut thru, the blade retaining ring no longer applied force to the cut thru side blade. The cut thru side blade came to rest in its' most retracted position due to the rotor lobe forcing it there and having no motive force to move it back. With this blade retracted there was a direct leak path between the inlet and outlet port holes in the insert thereby rendering the pump inoperable.

LEFT; Image of the Failed Blade Retaining Ring From the Subject Pump.

RIGHT; Image of Example Normal/Healthy Weldon Factory Blade Retaining Ring.

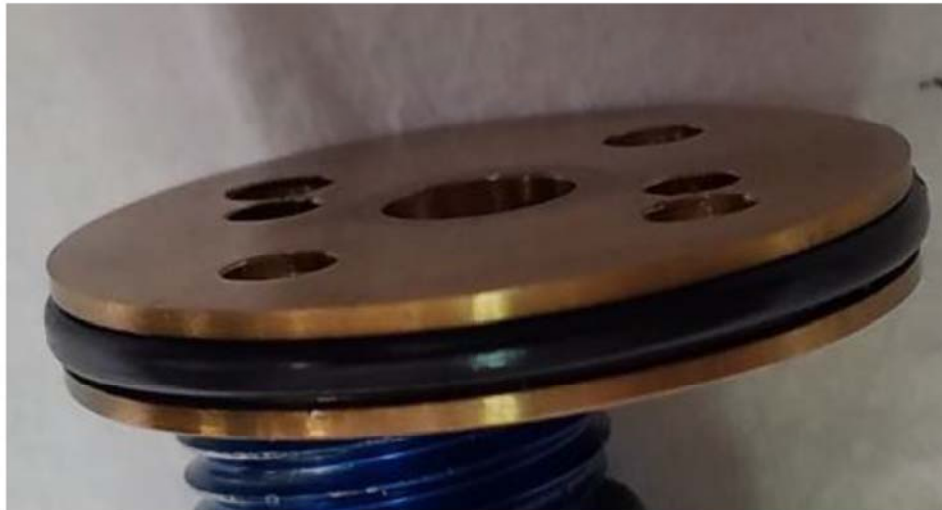
Figure XVII

Image of Non-Factory Cover (Missing O-Ring Gland Edge Breaks)

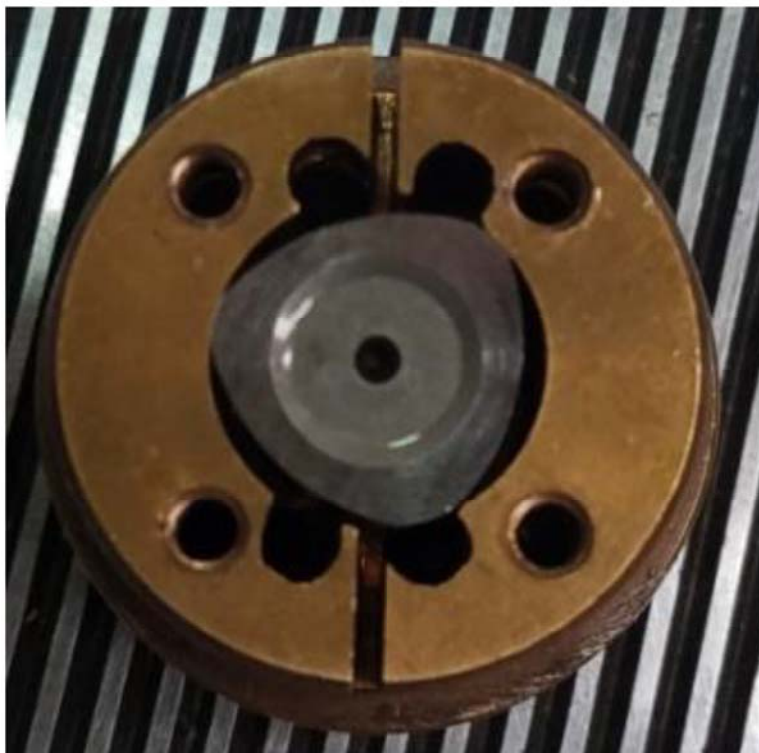
Figure XVIII

Image of Heavily Modified Insert, Note “Out of Round” Distortion of two center bottom port holes.

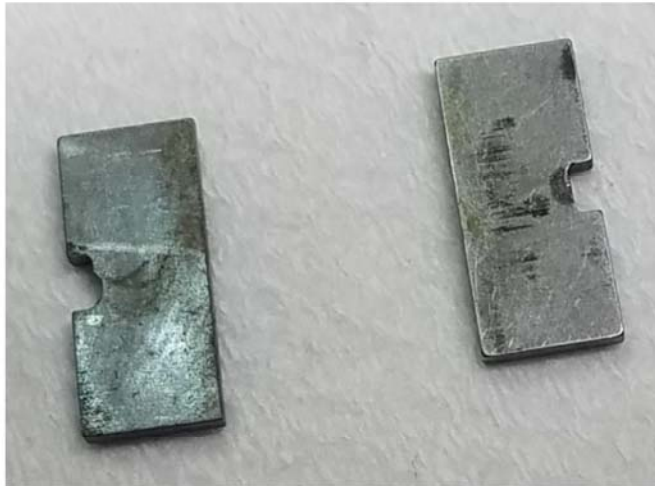
Figure XIX

Image of Heavily Abraded Blade/Vanes. Note Blade Retaining Ring Notch Wear on the left component.
