**NATIONAL TRANSPORTATION SAFETY BOARD**

**Examination/Accident Summary**

**WPR19LA218**

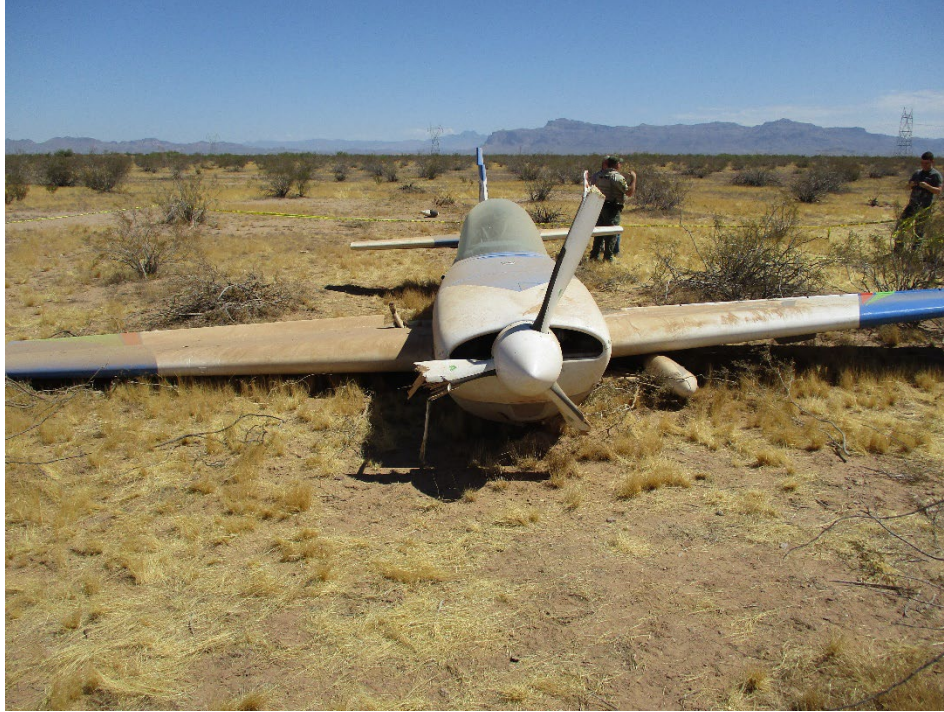
The airplane landed on rough, uneven desert terrain overlaid with heavy brush like vegetation. The airplane sustained impact related damage to the propeller, wing assembly and the landing gear was collapsed. The right main landing gear leg fractured near the fuselage attachment point and was imbedded in the right wing, near the wing root.

The three-blade adjustable pitch wooden propeller remained attached to the crankshaft flange. The spinner assembly was in place, secure and no damage was noted. Two consecutive propeller blades were fractured midspan and the third was fractured near the propeller tip. The fractures were consistent with rotational torque at the time of impact.

The main wing assembly sustained impact damage; however, the wing fuel tanks were intact and there was no evidence of fuel escape. The wing fuel tank filler caps were secure and in place. The Acro/center fuel tank filler cap was secure, in place, and there was no evidence of fuel escape from the center tank assembly.

**Figure 1 Wreckage at Accident Site – Source FAA**

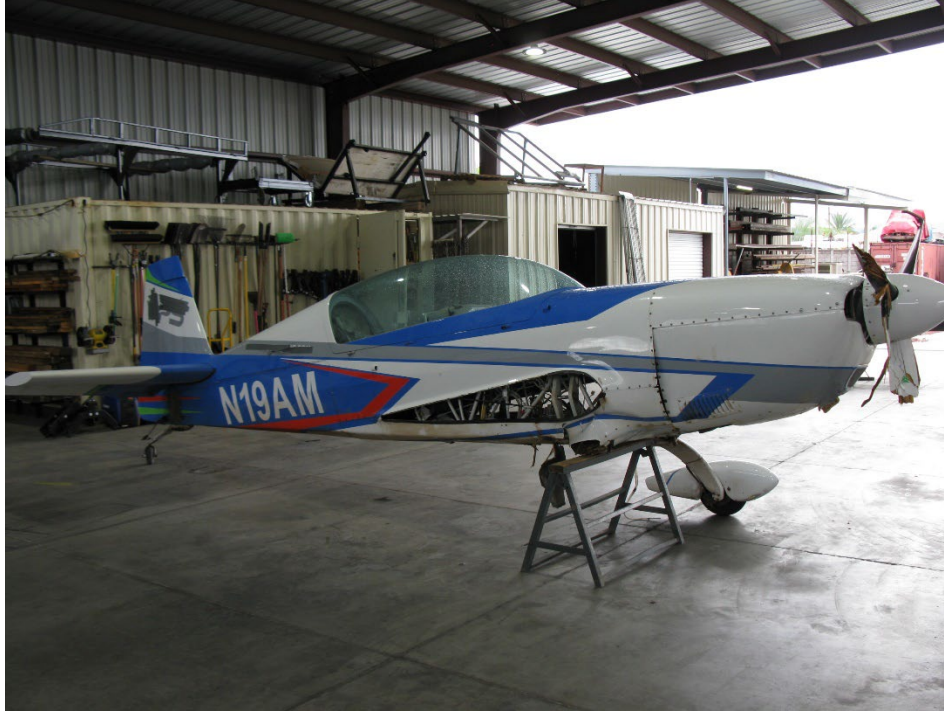
Preliminary examination of the airframe and engine showed negligible damage to the forward section of the fuselage and engine bay, however, the three-blade propeller showed extensive impact related damage. The propeller assembly and engine cowling were removed to facilitate the exam.

**Figure 2: Recovered Wreckage -NTSB**

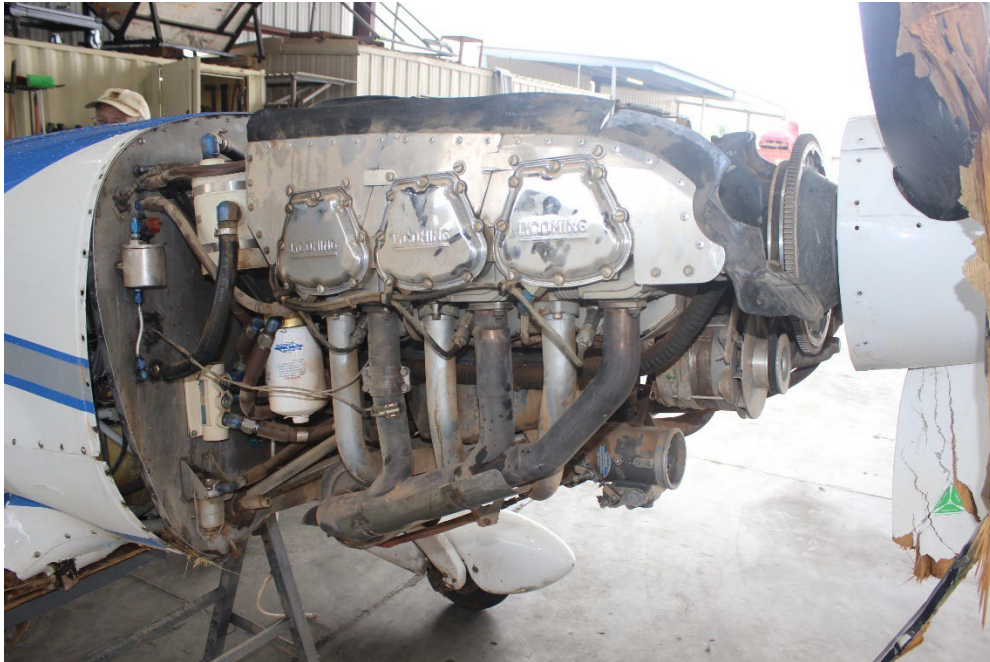
Rocker arm, valve train and accessory gear continuity was established by rotating the engine's crankshaft by hand. All six cylinders developed pressure when the crankshaft was manually rotated. Internal examination of the piston cylinders, utilizing a lighted bore scope, revealed no evidence of a mechanical damage or FOD. The Spark plugs were removed; the electrodes were intact, and no mechanical damage was noted. The spark plug electrodes displayed coloration consistent with normal operation.

**Figure 3: Postaccident – Starboard Side View of the Engine - NTSB**

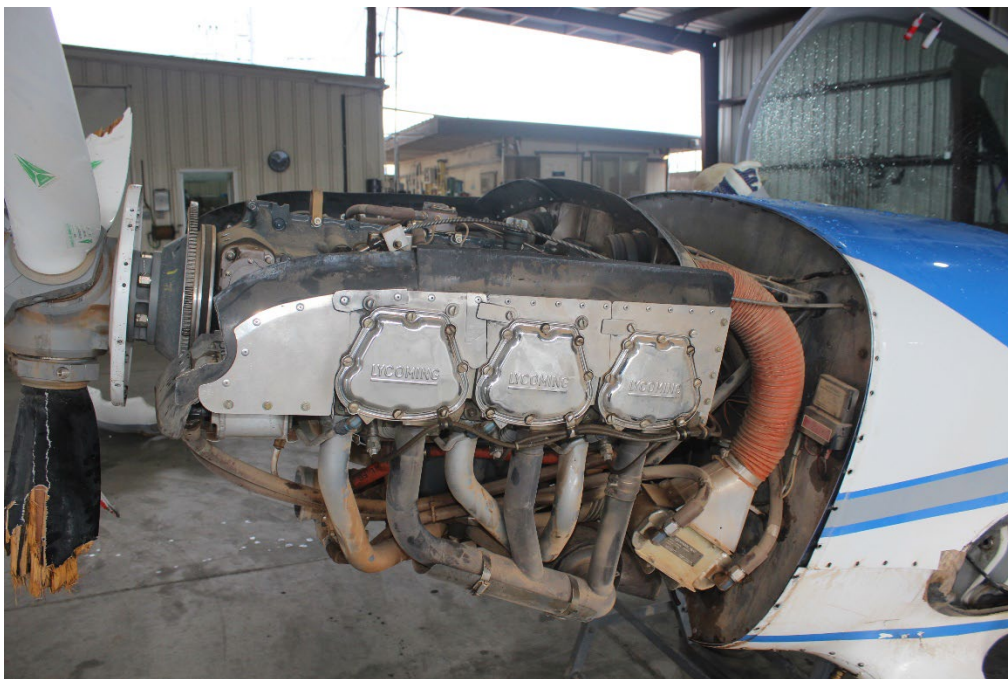
**Figure 4: Postaccident – Port Side View of the Engine - NTSB**
