## **NATIONAL TRANSPORTATION SAFETY BOARD**

### **FUEL SERVO EXAMINATION**

**WPR19LA218**

Location: Mesa, Arizona  
Date: August 14, 2019  
Aircraft: Extra Flugzeugbau 300/L, Registration N19AM  
NTSB IIC: Dennis Hogenson

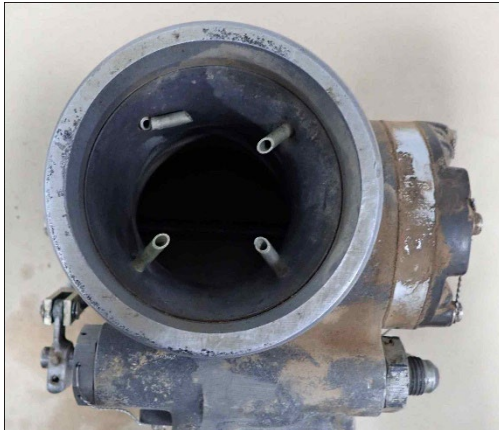
**Figure 1 - Fuel Injection Servo - NTSB**

The unit was coated in fine sand, and one of the four impact tubes on the throttle side had bent perpendicular to the direction of airflow (Figure 1). The damaged tube was subsequently removed to prevent it from falling off during the flow test, and damaging the test apparatus. The throttle and mixture arms were not present. Fine metallic and non-metallic particles were found on the inlet fuel screen.

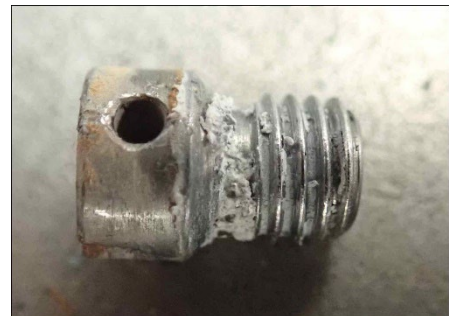
**Figure 2 - Metered Fuel Pressure Plug - NTSB**

The unit was installed on an airflow bench that had been calibrated for the RSA10 servo. During installation the metered fuel pressure port was removed, and unapproved white sealant was observed on the plug threads (Figure 2).

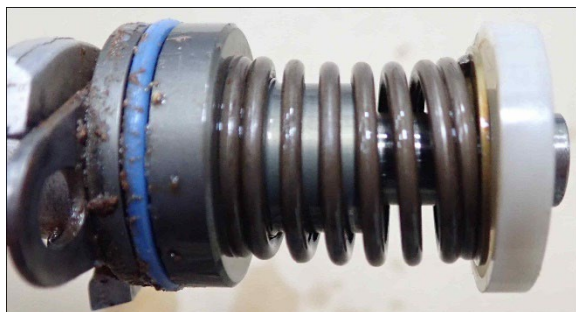
**Figure 3 - Control Lever Assy Spring - NTSB**

The mixture control assembly was removed. The lever assembly intact and undamaged, The dowels were in place, mixture control valve was free of scoring, along with control plate. The O-rings were intact and undamaged. The mixture control lever assembly spring appeared to be bent

(Figure 3), and debris was noted on the mixture sliding plate (Figure 4). The possibility was discussed that the debris could have contributed to the higher than standard fuel flow values observed at idle shutoff.

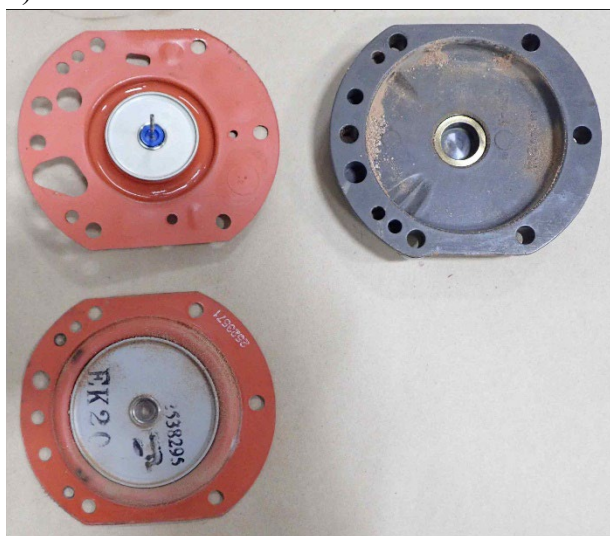
**Figure 5 - Dust on Diaphragms and Housing - NTSB**

The ambient air side of the large diaphragm was coated with fine brown dust, matching the color of the dust found on the outer body (figure 5). Similarly, when the venturi housing was removed, the same dust material was found coating the O-rings and inner sleeve and pressure slots (figure 6).
