## **NATIONAL TRANSPORTATION SAFETY BOARD**

# **AIRFRAME AND ENGINE EXAMINATION**

**WPR19LA222**

Location: Jamul, CA  
Date: August 19, 2019  
Aircraft: Zenith 601XLB, Registration N662WB, S/N 6-6056  
NTSB IIC: Elliott Simpson

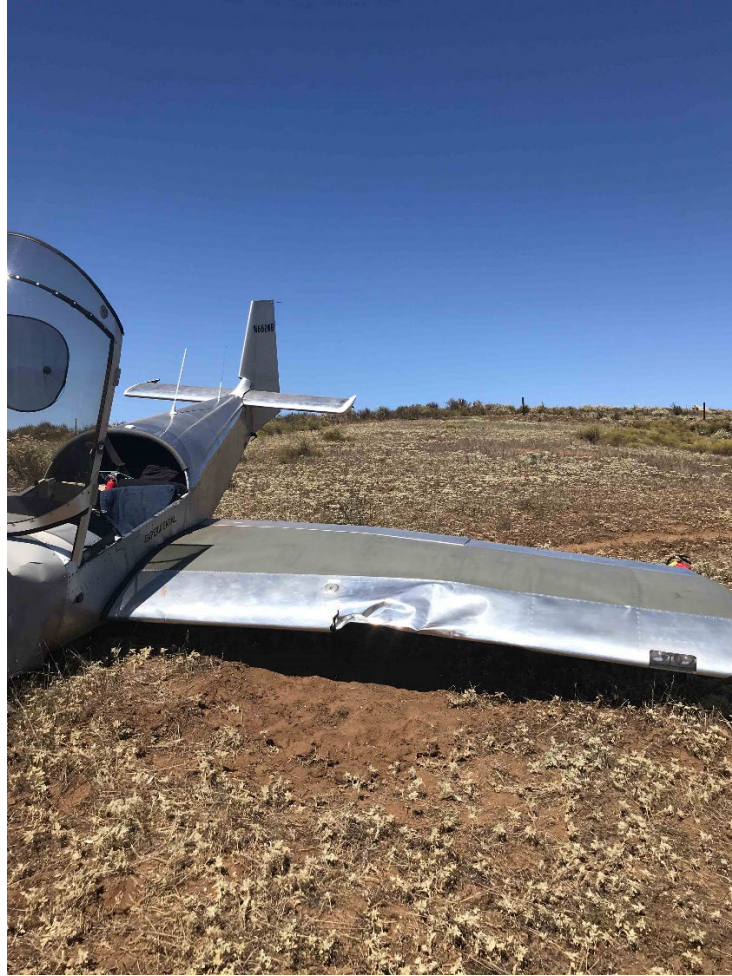
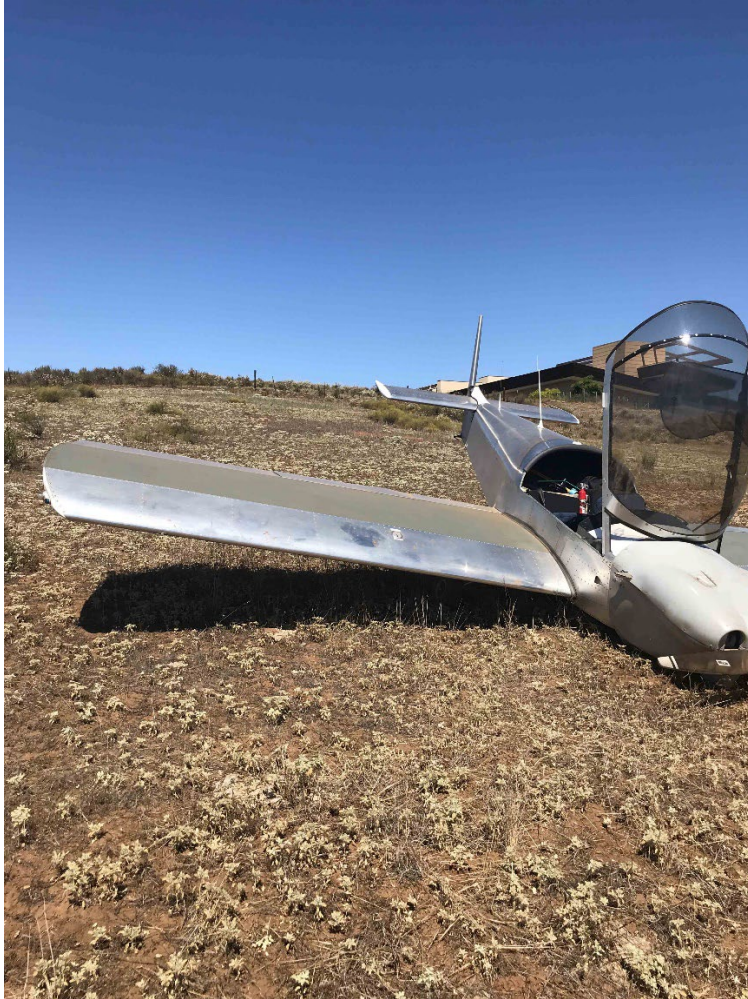
The airplane sustained substantial damage to the left wing, which had folded down midspan, and the forward fuselage (photo 1,2).

Photo 1 – Airplane at the accident site, photo courtesy of the FAA

Photo 2 - Airplane at the accident site, photo courtesy of the FAA

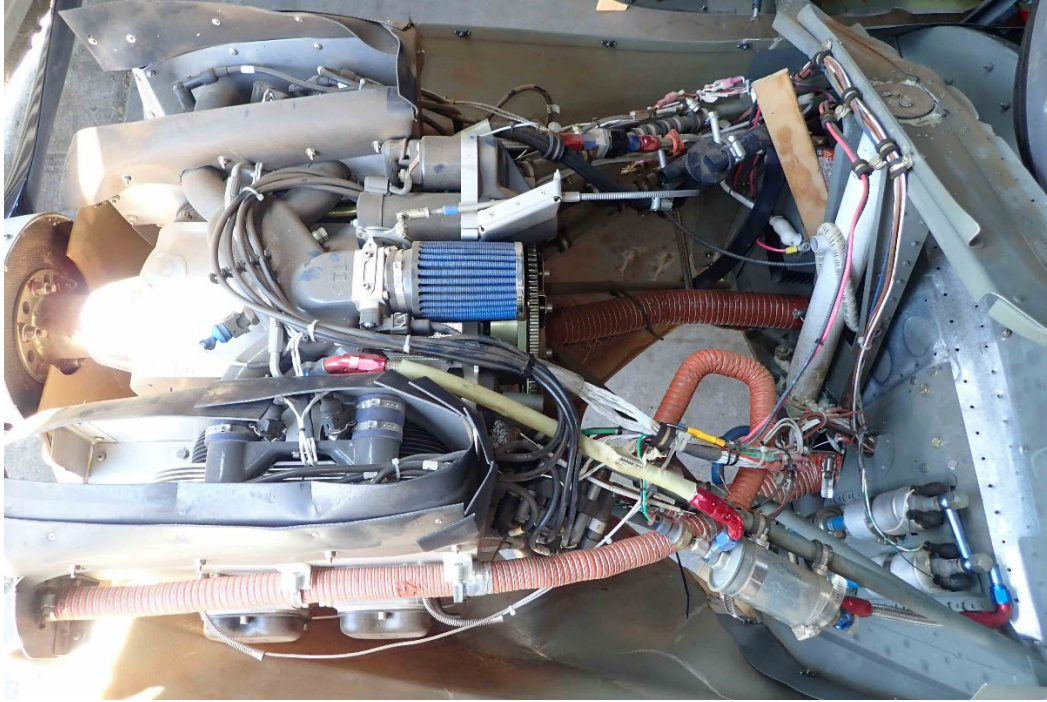
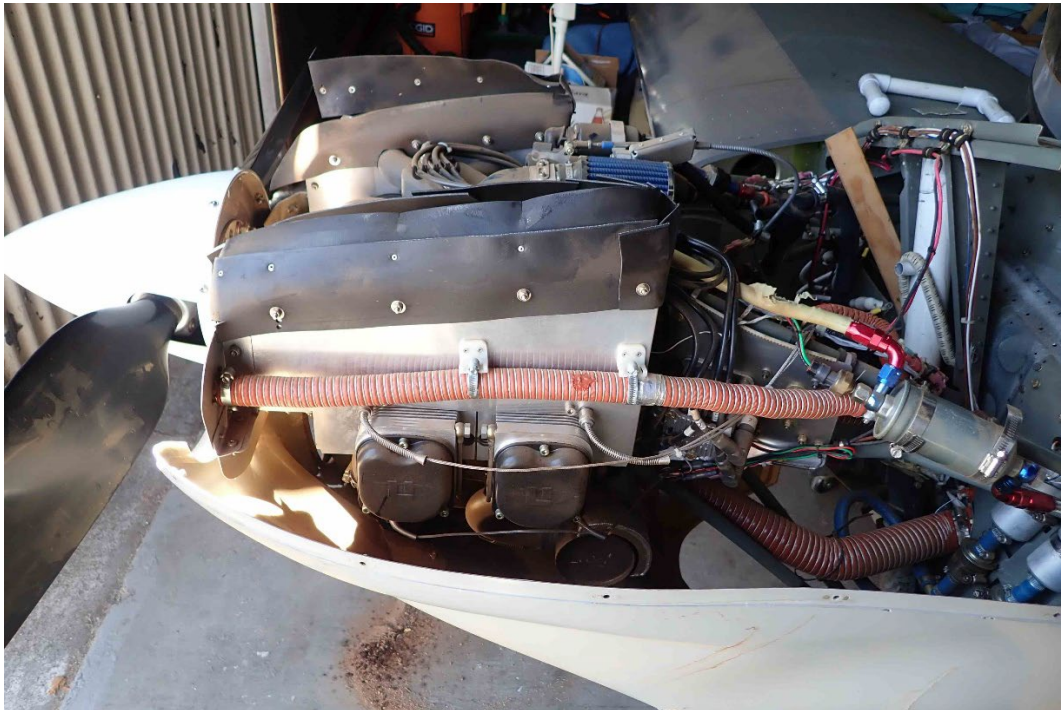
The engine remained attached to the firewall and appeared to have escaped significant damage (photo 3,4). The engine contained oil just short of the dipstick "max" limit. There was no evidence of catastrophic engine failure.

Photo 3 – Engine compartment

Photo 4 - Engine compartment

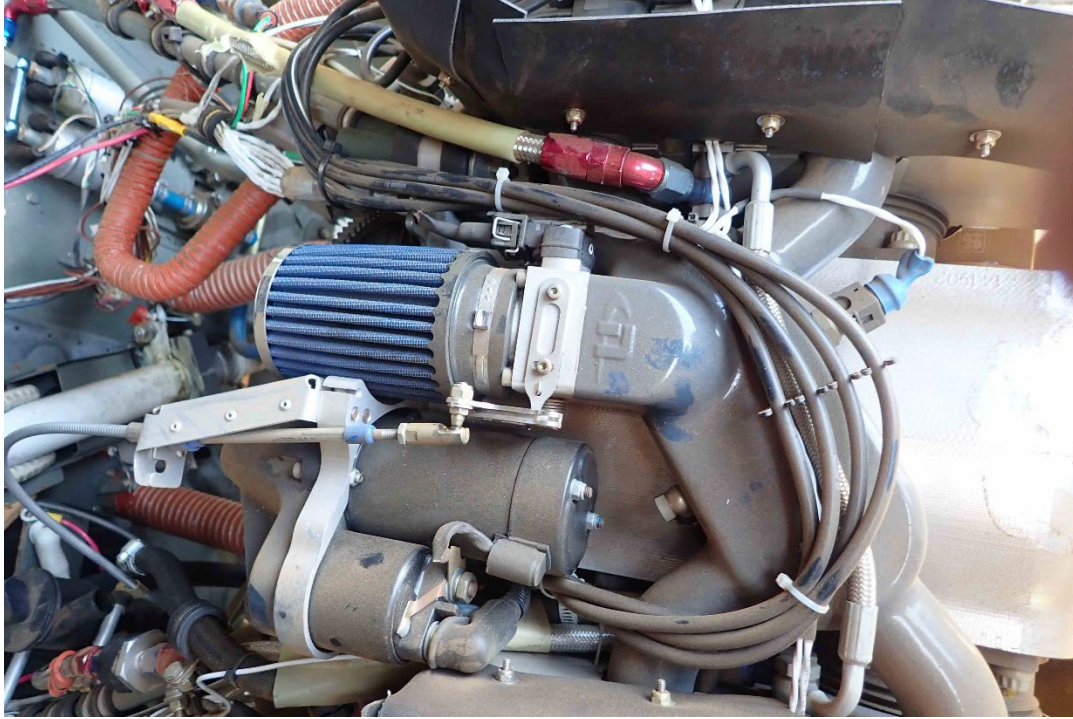
The throttle control was continuous from the throttle assembly (photo 5) to the cabin control. The air filter was free of debris. All fuel lines were intact (photo 6), and there was no evidence of fuel leak.

Photo 5 – Throttle control and induction air filter

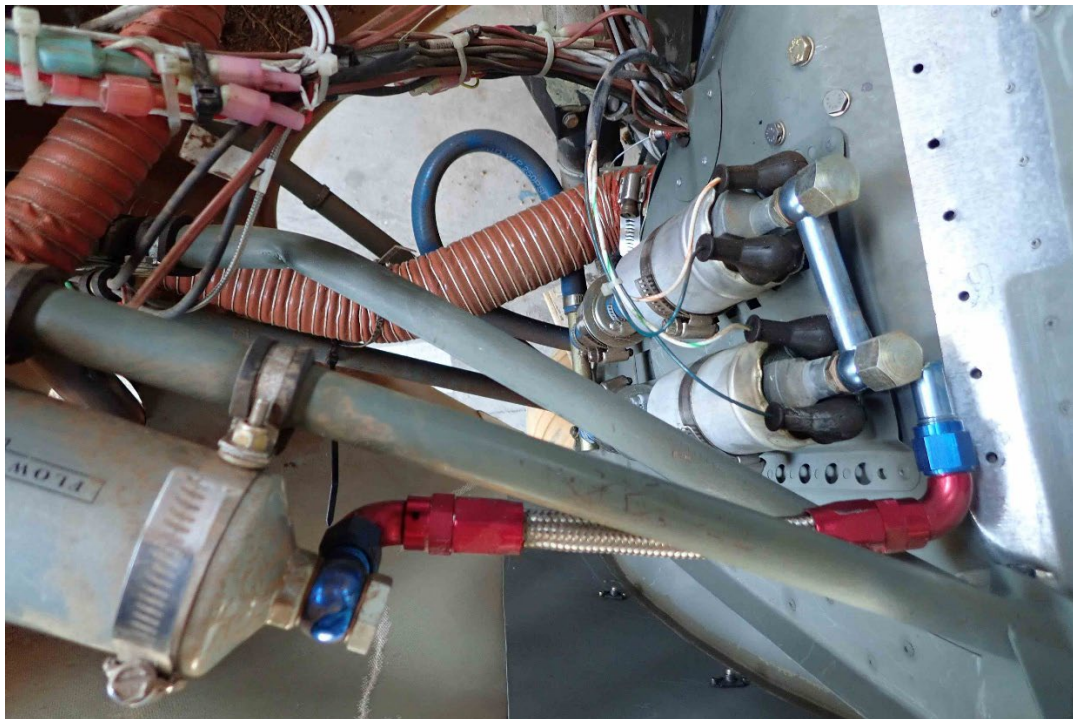
Photo 6 – Fuel pumps sand filter

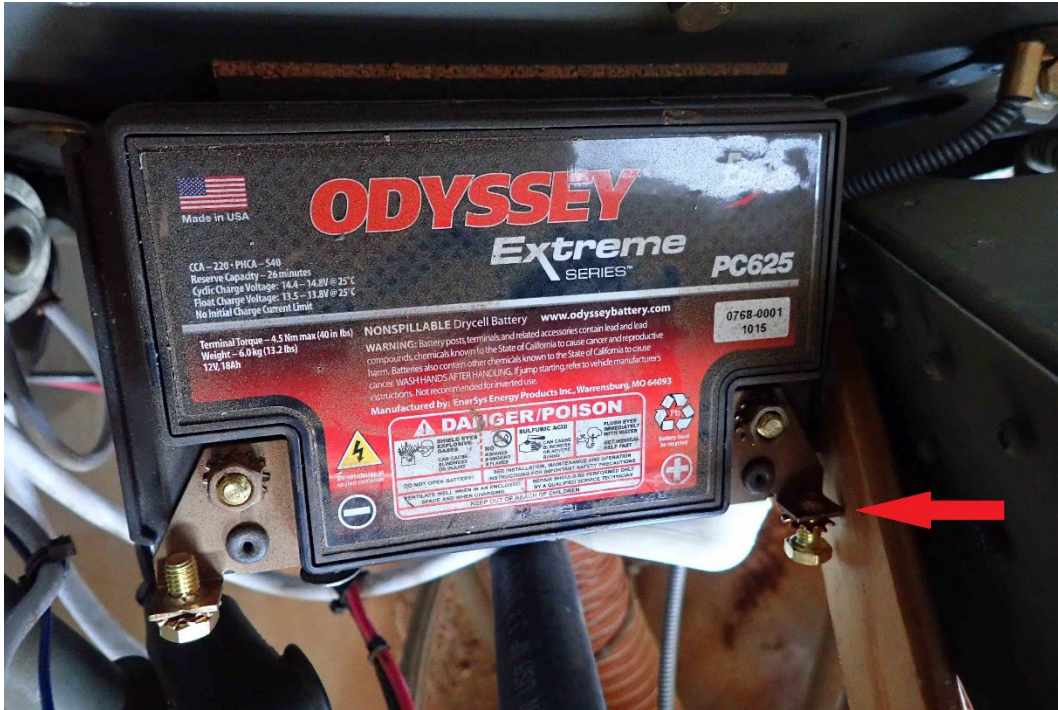
The firewall was bent, and the nose landing gear strut attachment bracket had detached and rotated to the left, such that it had come into contact with the positive terminal of the battery (photo 7). Arcing damage was noted at the contact point, and the battery indicated 5.21 volts when tested with a voltmeter.

Photo 7 – Battery, red arrow indicates contact with airframe (wood block installed post-accident to prevent further damage)
