# NATIONAL TRANSPORTATION SAFETY BOARD

## Onboard Image Recorder

**Specialist's Factual Report**  
**By Kyle Garner**

Location: Ruidoso, New Mexico  
Date: August 17, 2019  
Aircraft: Beech H35  
Registration: N5410D  
Operator: Private  
NTSB Number: WPR19LA223

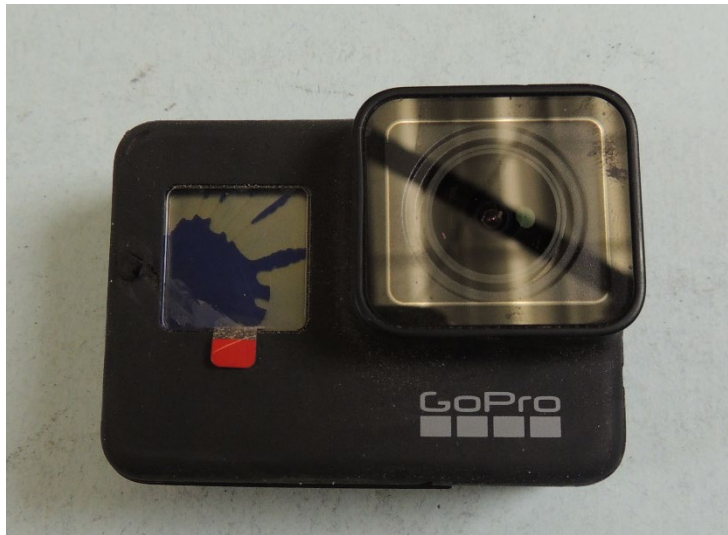
The GoPro HERO7 arrived at the Vehicle Recorder Division laboratory intact, however, the status screen on the front of the device was damaged as shown in Figures 1 and 2.

**Figure 1. Condition of GoPro HERO7 – Front**

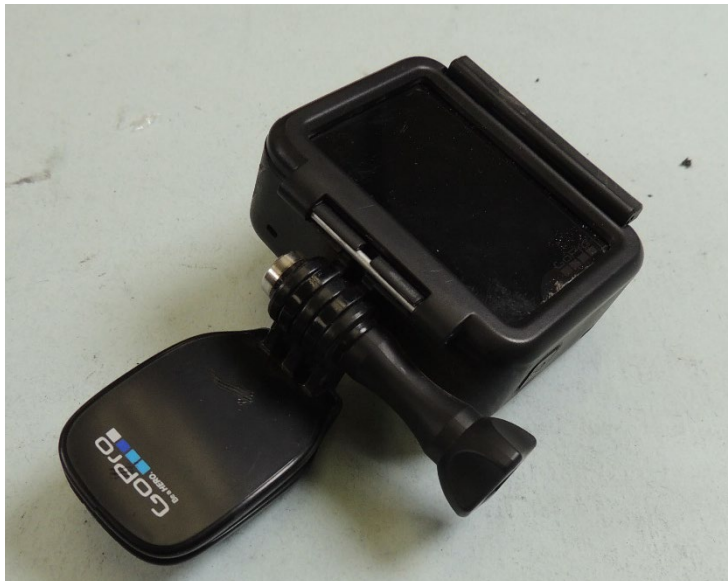
**Figure 2. Condition of GoPro HERO7 – Back**

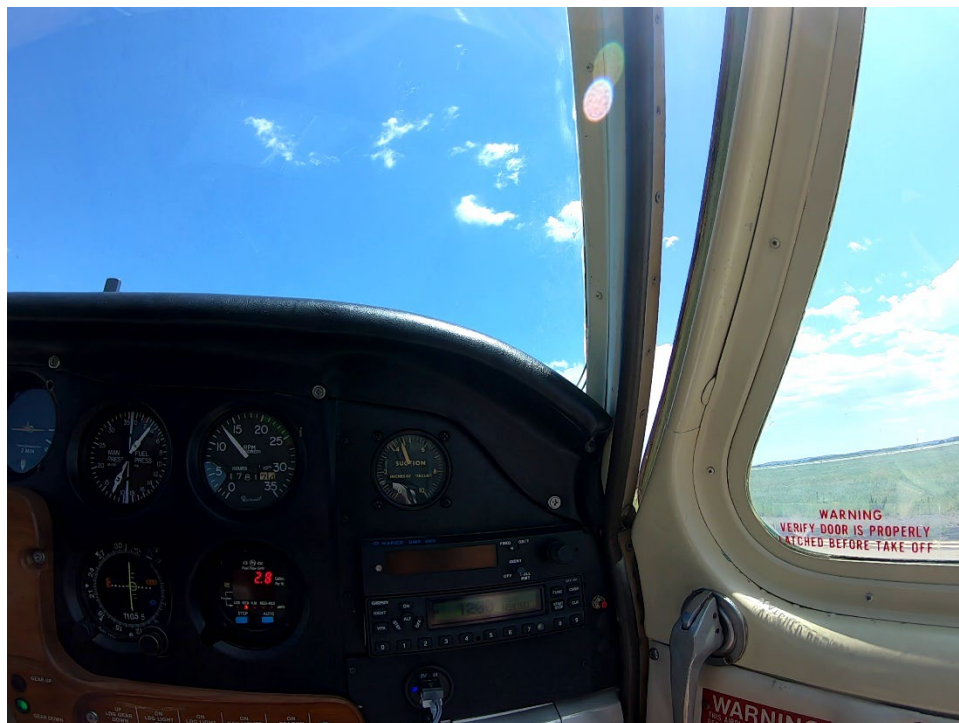
| <b>Video Elapsed Time (mm:ss)</b> | <b>Observations</b> | <b>Figure</b> |
|---|---|---|
| 00:50 | The camera view changed to forward-facing and the passenger side instrument panel was visible. The aircraft was still taxiing to the departure runway. The tachometer read 1300 rpm and showed a total engine time of 1781.74 hours. The fuel pressure indicator read 3 psi. The manifold pressure indicator read 13 inHg. The suction gauge read 4.75 inHg. | 3 |

**Figure 3. View of aircraft taxiing and passenger-side instrument panel.**

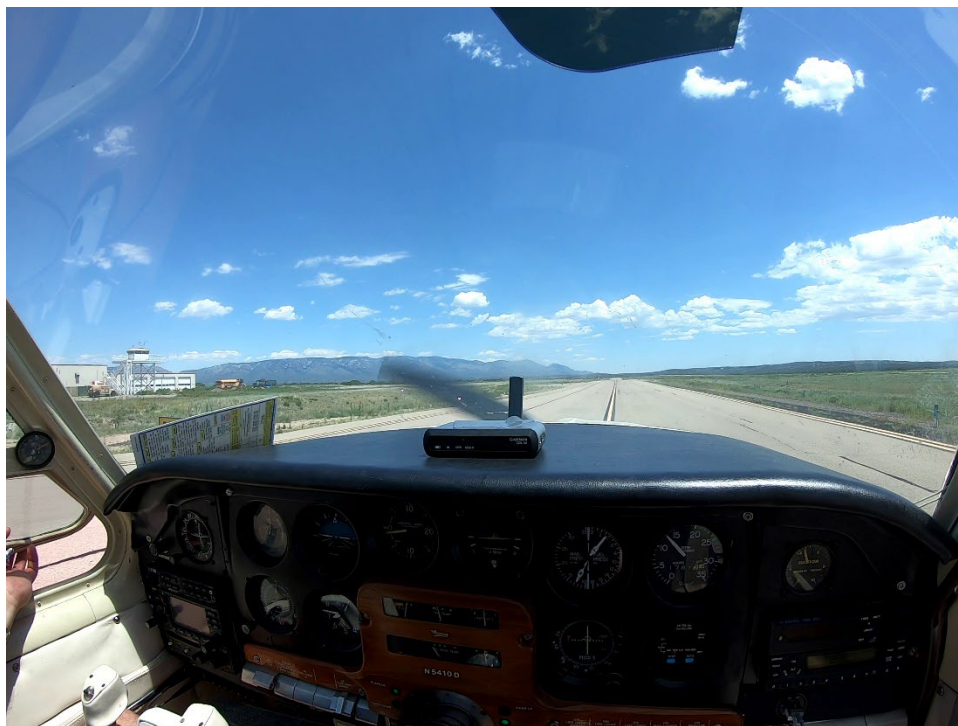
| Video Elapsed Time (mm:ss) | Observations | Figure |
|---|---|---|
| 00:59 | A larger portion of the instrument panel was visible. The aircraft was still taxiing to the departure runway. The altimeter read approximately 6750 feet. The fuel quantity gauge indicated 51.6 gallons of fuel remaining. | 4 |

**Figure 4. View of aircraft taxiing and instrument panel.**

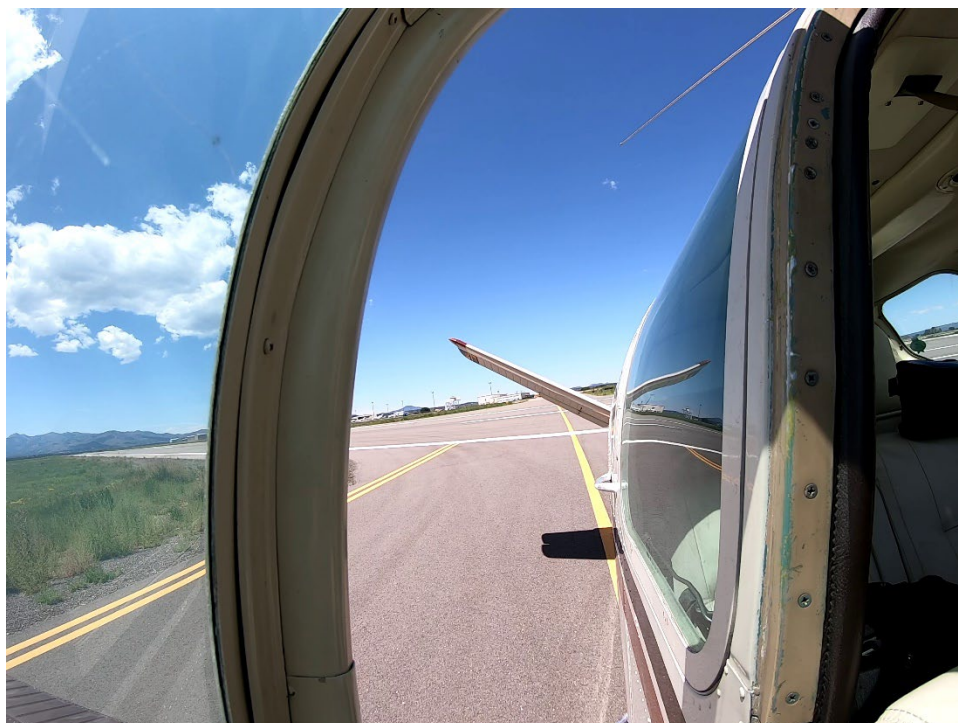
| Video Elapsed Time (mm:ss) | Observations | Figure |
|---|---|---|
| 01:53 | The camera was positioned outside the open passenger door and the right empennage of the aircraft was visible. No damage or inconsistencies were noted. | 5 |

**Figure 5. View of right empennage.**

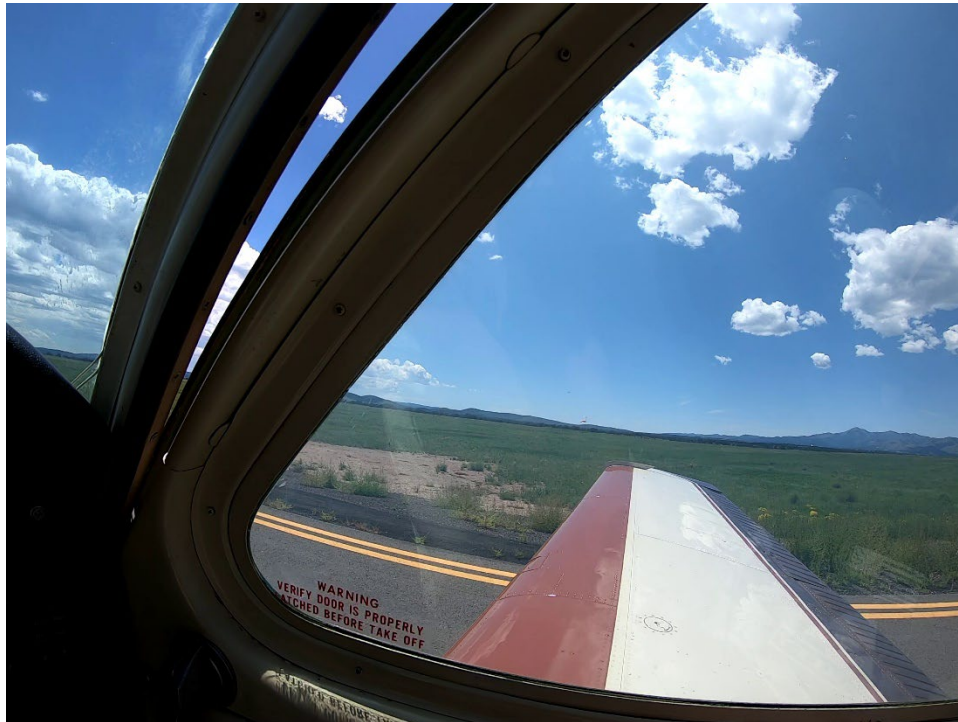
| Video Elapsed Time (mm:ss) | Observations | Figure |
|---|---|---|
| 02:00 | The camera was moved to show outside the passenger door including the right wing, aileron, and flap. The right flap was in the up position. No damage or inconsistencies were noted. | 6 |

**Figure 6. View of right wing.**

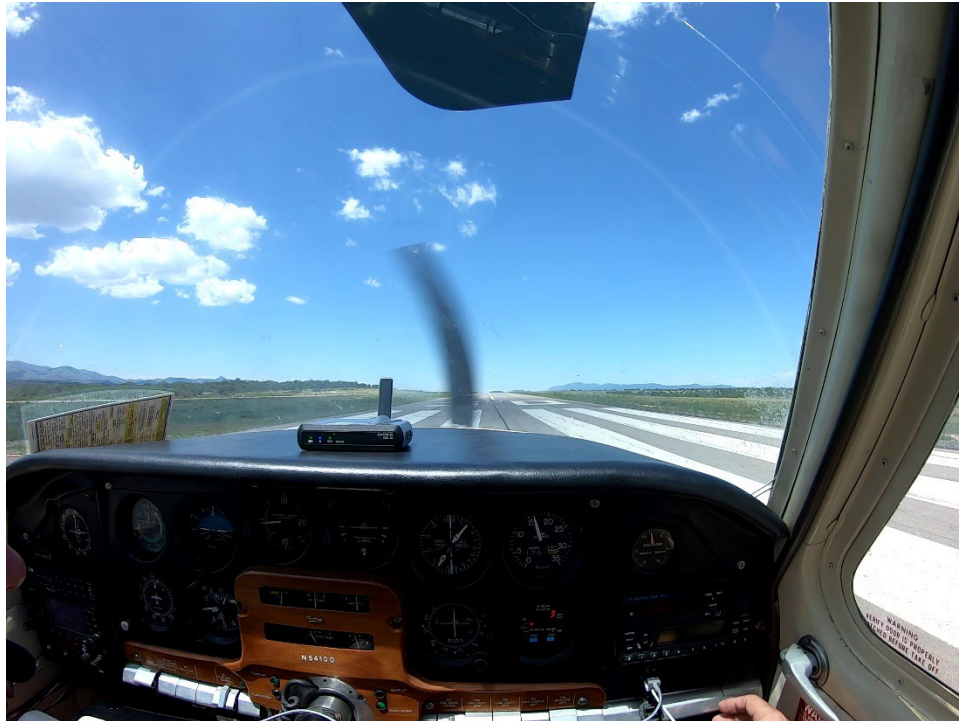
| <b>Video Elapsed Time (mm:ss)</b> | <b>Observations</b> | <b>Figure</b> |
|---|---|---|
| 00:01 | The video began with the aircraft holding at the end of runway 30 at KSRR. The camera was positioned with a forward-facing view and most of the instrument panel was visible. The flaps indicator indicated flaps up. The altimeter read 6700 feet. The view out the windshield was unobstructed. The weather was partly cloudy. | 7 |

**Figure 7. View before takeoff, holding on runway 30.**

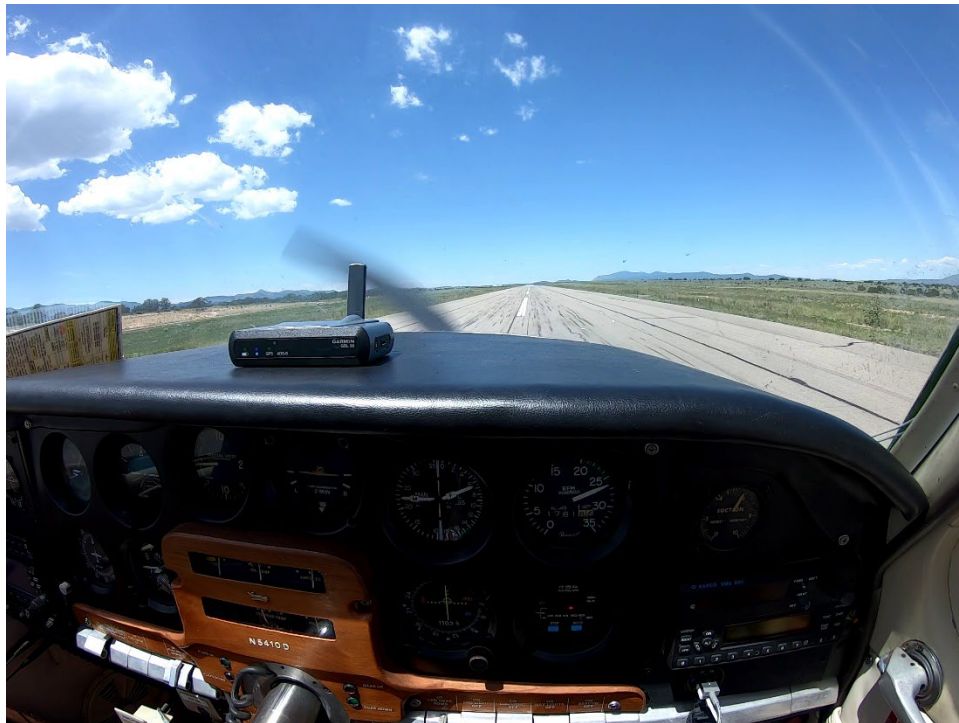
| <b>Video Elapsed Time (mm:ss)</b> | <b>Observations</b> | <b>Figure</b> |
|---|---|---|
| 00:25 | The pilot applied power and the aircraft began to move down the runway. The tachometer indicated 2600 rpm. The fuel pressure indicator read 6.5 psi. The manifold pressure indicator read 22.5 inHg. The suction gauge read approximately 6 inHg. | 8 |

**Figure 8. View after power was applied, aircraft began moving down the runway.**

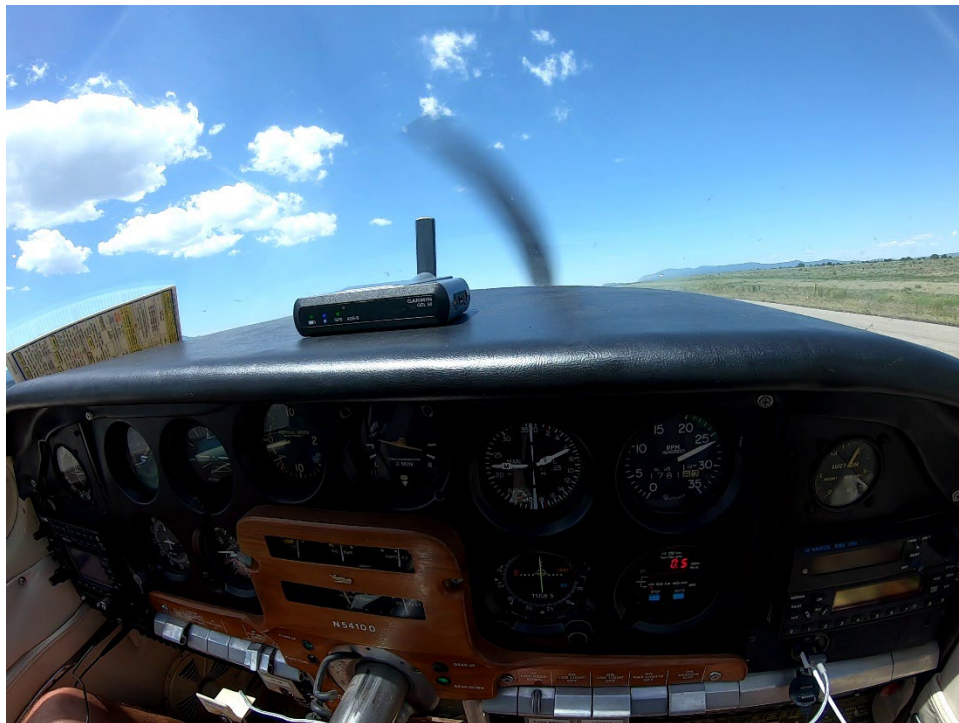
| <b>Video Elapsed Time (mm:ss)</b> | <b>Observations</b> | <b>Figure</b> |
|---|---|---|
| 00:59 | The aircraft began to pitch up. | 9 |

**Figure 9. Aircraft began to pitch up.**

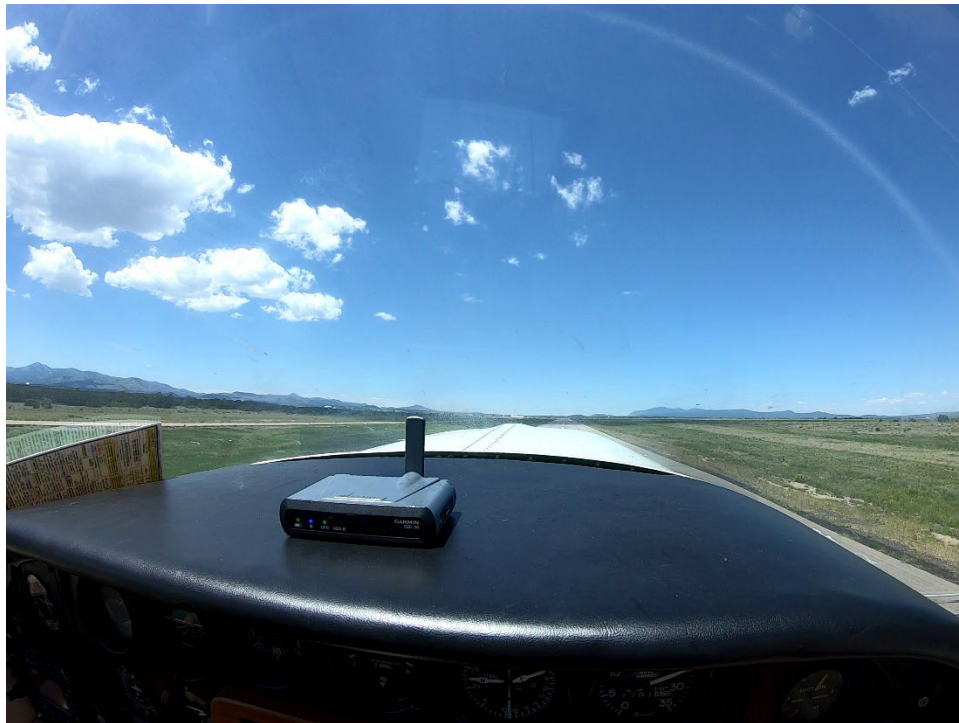
| <b>Video Elapsed Time (mm:ss)</b> | <b>Observations</b> | <b>Figure</b> |
|---|---|---|
| 01:05 | The aircraft lifted off the runway. | 10 |

**Figure 10. Aircraft lifted off the runway.**

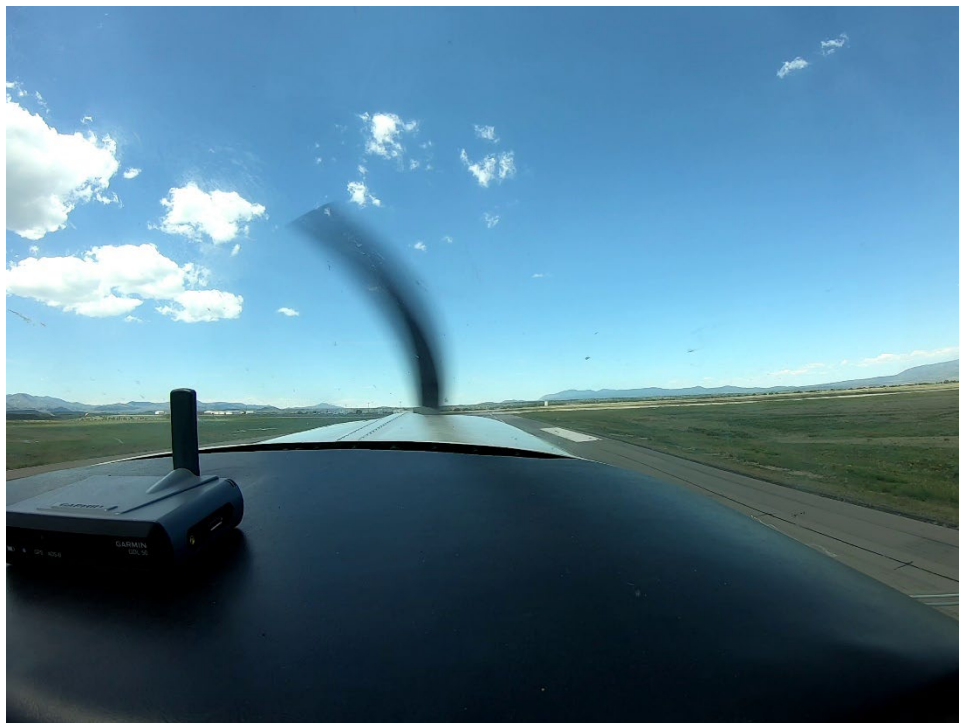
| <b>Video Elapsed Time (mm:ss)</b> | <b>Observations</b> | <b>Figure</b> |
|---|---|---|
| 01:19 | The aircraft was a few feet off the ground, but still over the runway surface. The aiming point marking for runway 12 was visible ahead. The instrument panel was no longer visible. | 11 |

**Figure 11. View after takeoff. The aiming point marking for runway 12 was visible ahead.**

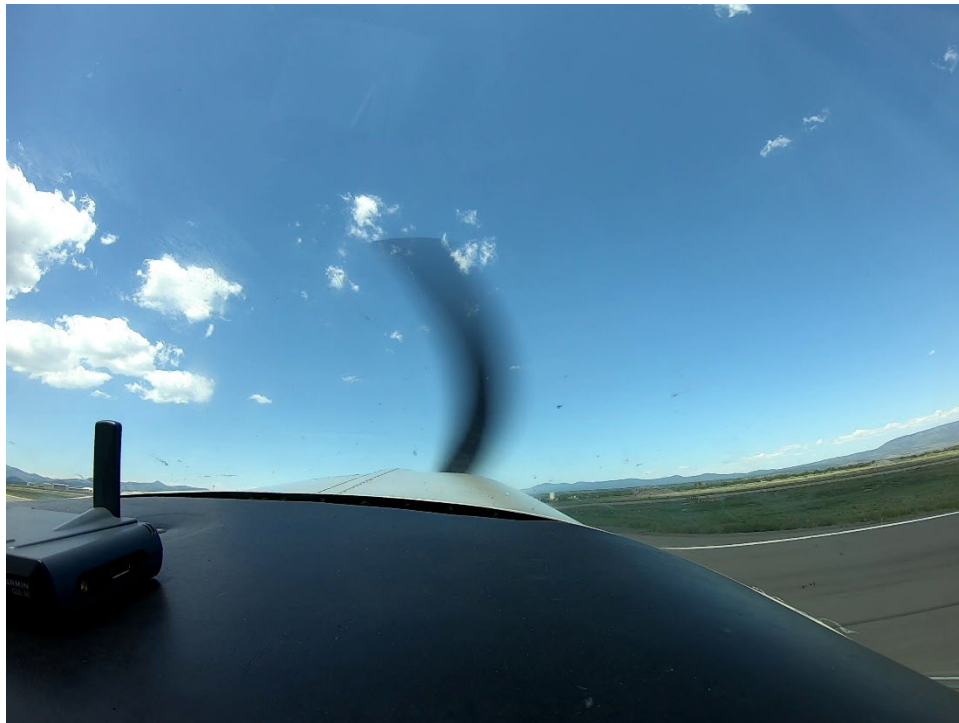
| <b>Video Elapsed Time (mm:ss)</b> | <b>Observations</b> | <b>Figure</b> |
|---|---|---|
| 01:30 | The aircraft was a few feet off the ground. The intersecting runway 6/24 was visible passing below. | 12 |

**Figure 12. View with intersecting runway 6/24 passing below.**

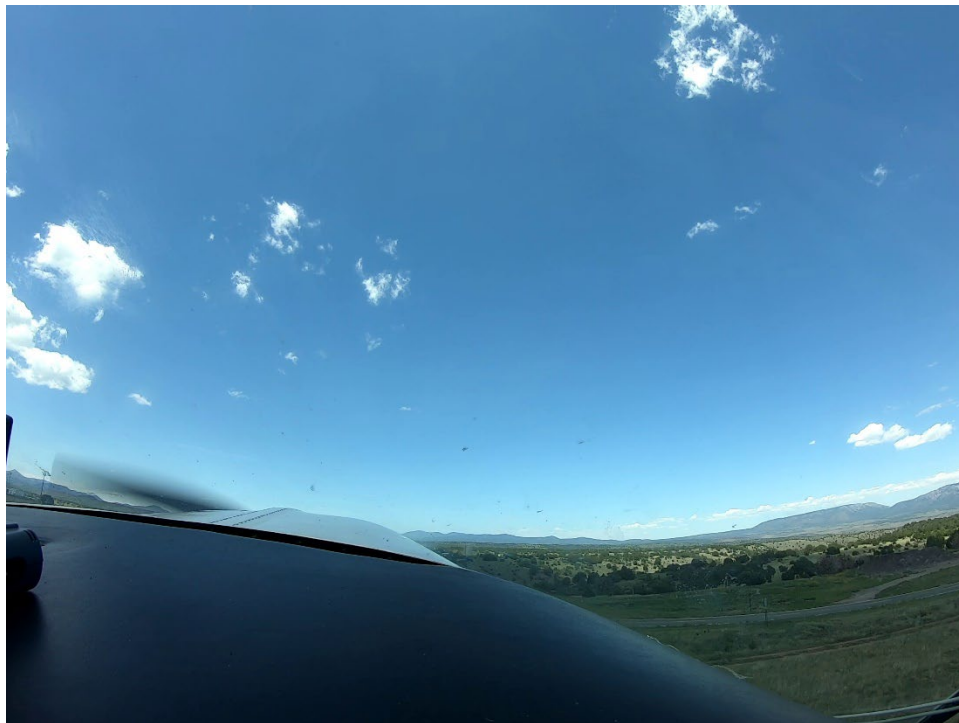
| <b>Video Elapsed Time (mm:ss)</b> | <b>Observations</b> | <b>Figure</b> |
|---|---|---|
| 01:35 | The paved runway surface was no longer visible. | 13 |

**Figure 13. View with paved runway surface no longer visible.**

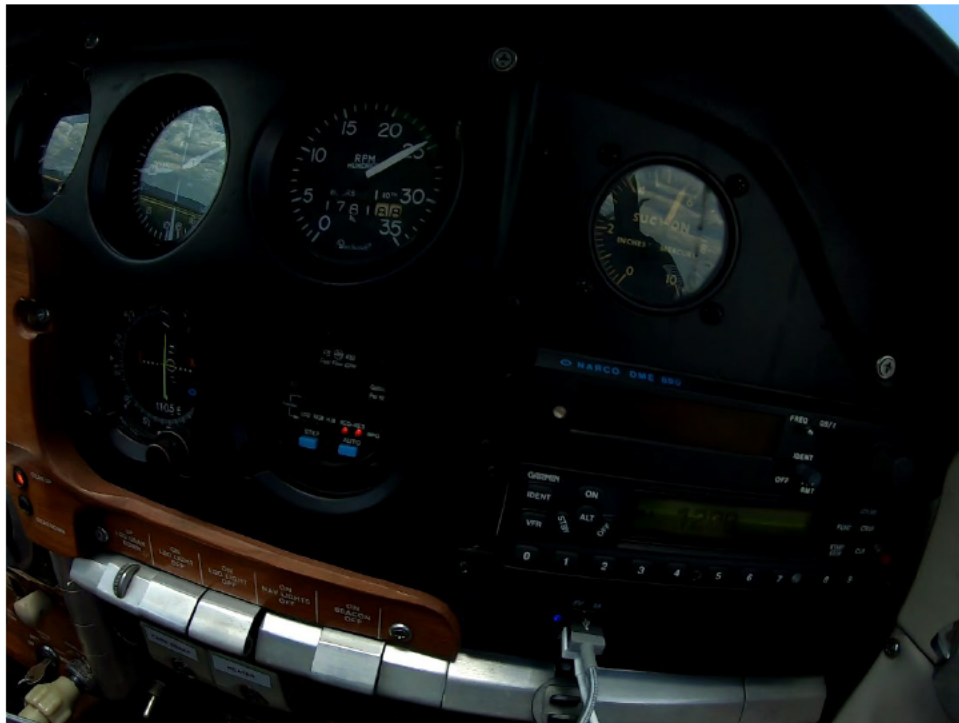
| <b>Video Elapsed Time (mm:ss)</b> | <b>Observations</b> | <b>Figure</b> |
|---|---|---|
| 01:43.0 | The camera view moved down and a portion of the instrument panel in front of the passenger was visible. The tachometer indicated 2400 rpm. The landing gear indication indicated gear up. The propeller control lever was in the full forward position. The manifold pressure indicator read 23 inHg. The suction gauge read approximately 5.8 inHg. | 14 |

Figure 14. View of passenger-side instrument panel before impact.

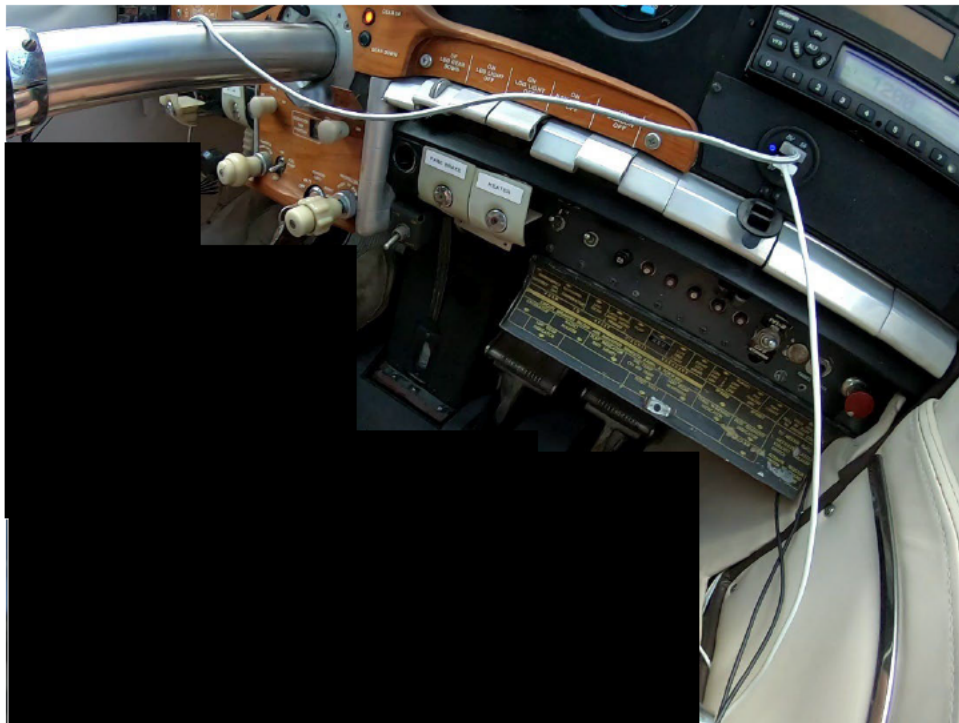
| <b>Video Elapsed Time (mm:ss)</b> | <b>Observations</b> | <b>Figure</b> |
|---|---|---|
| 01:43.5 | The camera view moved down and to the left and the lower portion of the instrument panel on the passenger's and pilot's side was visible. The throttle lever was in the full forward position. The mixture control lever appeared to be in-line with the throttle lever and in the full forward (full rich) position. The yoke was being pulled aft. | 15 |

Figure 15. View of the lower portion of the instrument panel before impact.
