## **NATIONAL TRANSPORTATION SAFETY BOARD**

# **AIRFRAME AND ENGINE EXAMINATION SUMMARY**

**WPR19LA226**

Location: Fall City, WA  
Date: July 26, 2019  
Aircraft: Cessna 177: N1828Q  
NTSB IIC: Albert Nixon

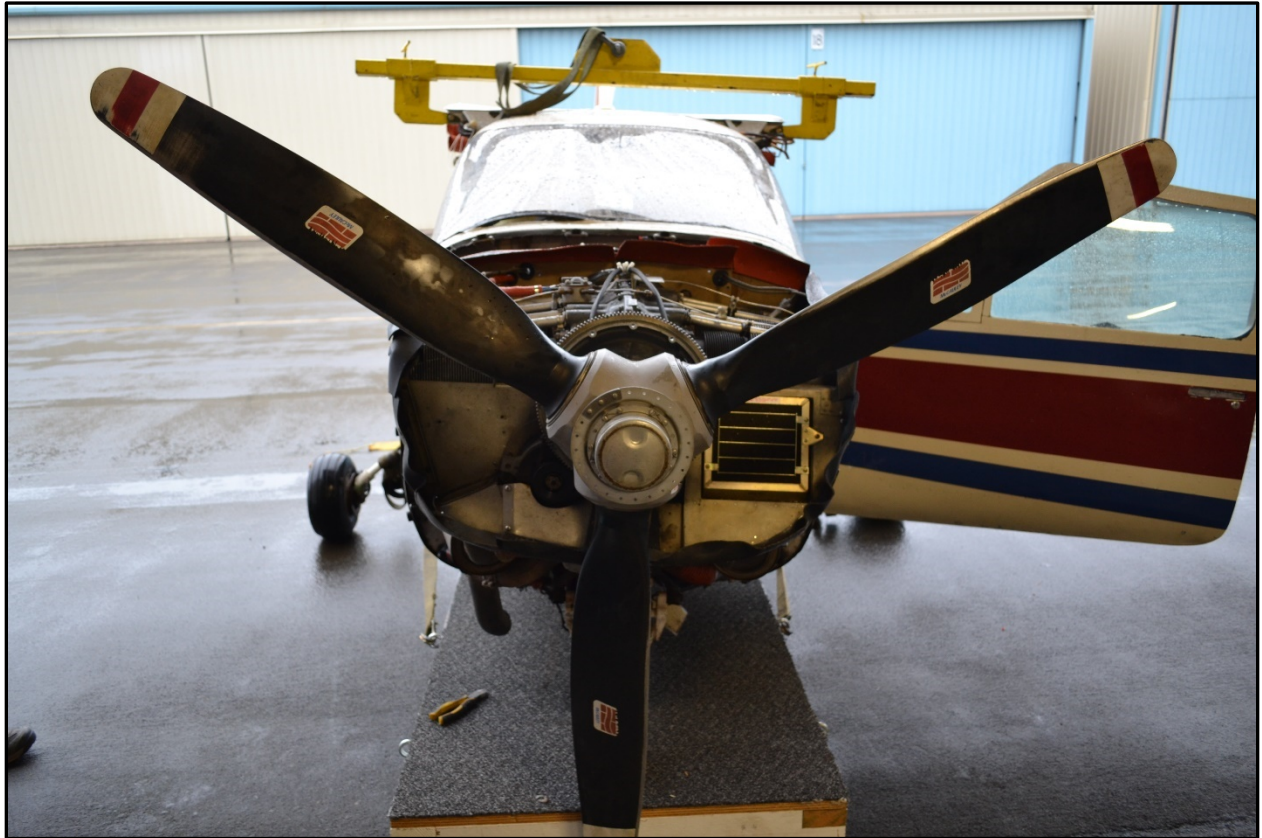
Examination of the airplane revealed that the wings were removed for recovery.

Figure 1: Airplane as viewed from the front.

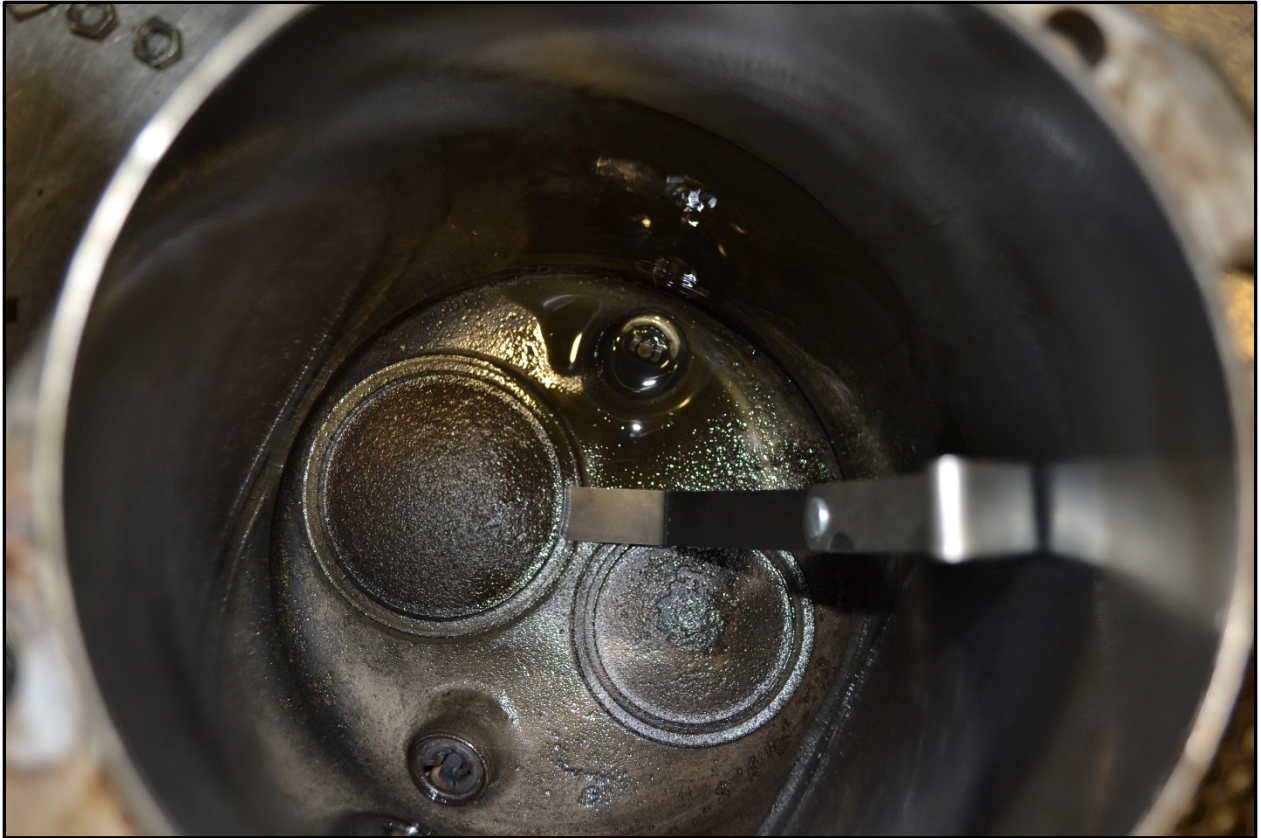
A fuel source and new battery were secured for an engine run. An engine run was accomplished and the engine was noted to run rough. After the engine run, the No. 3 cylinder was noted to be cold to the touch that was consistent with it not being operational. Therefore, the No.3 cylinder was removed and examined. During the cylinder examination, the intake valve was observed not to seat properly, and a feeler gauge was able to be inserted between the cylinder top and the

valve. The intake valve was noted to have stretched to exhibit a cup shape consistent with a “tulip” like shape.

**Figure 2: Interior of the No. 3 cylinder, intake valve with gap measured by the feeler gauge tool.**

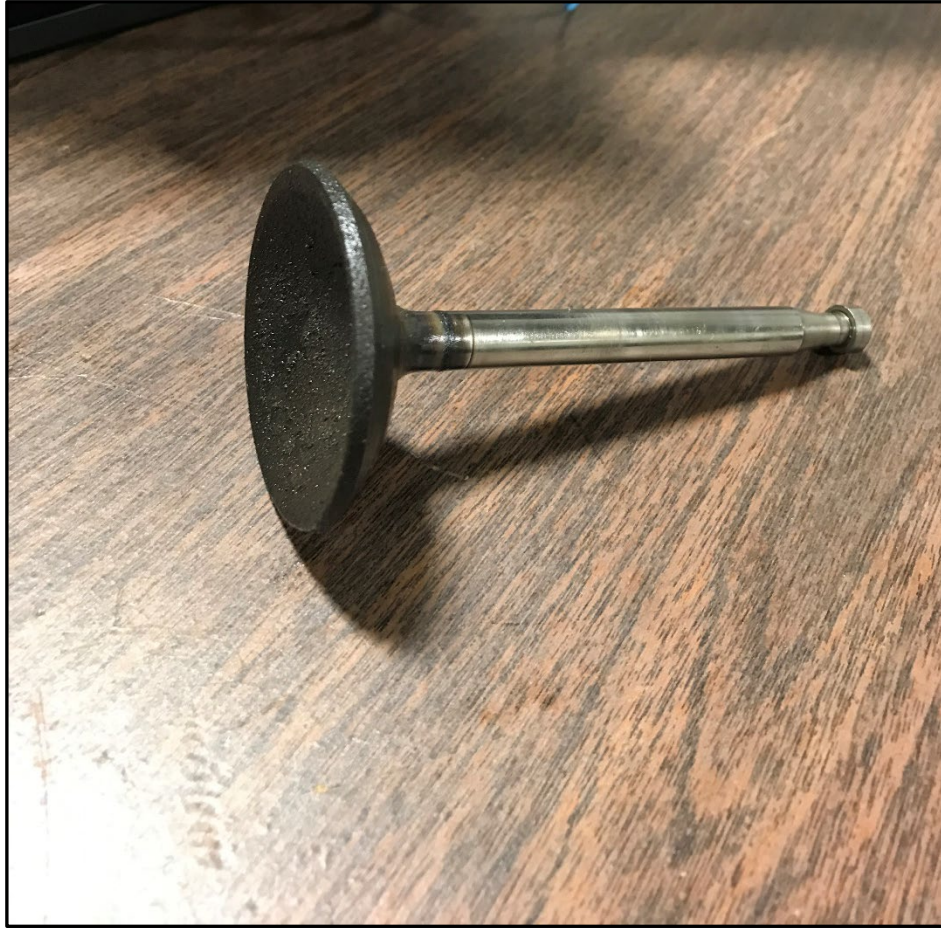
**Figure 3: Cylinder No. 3 intake valve.**
