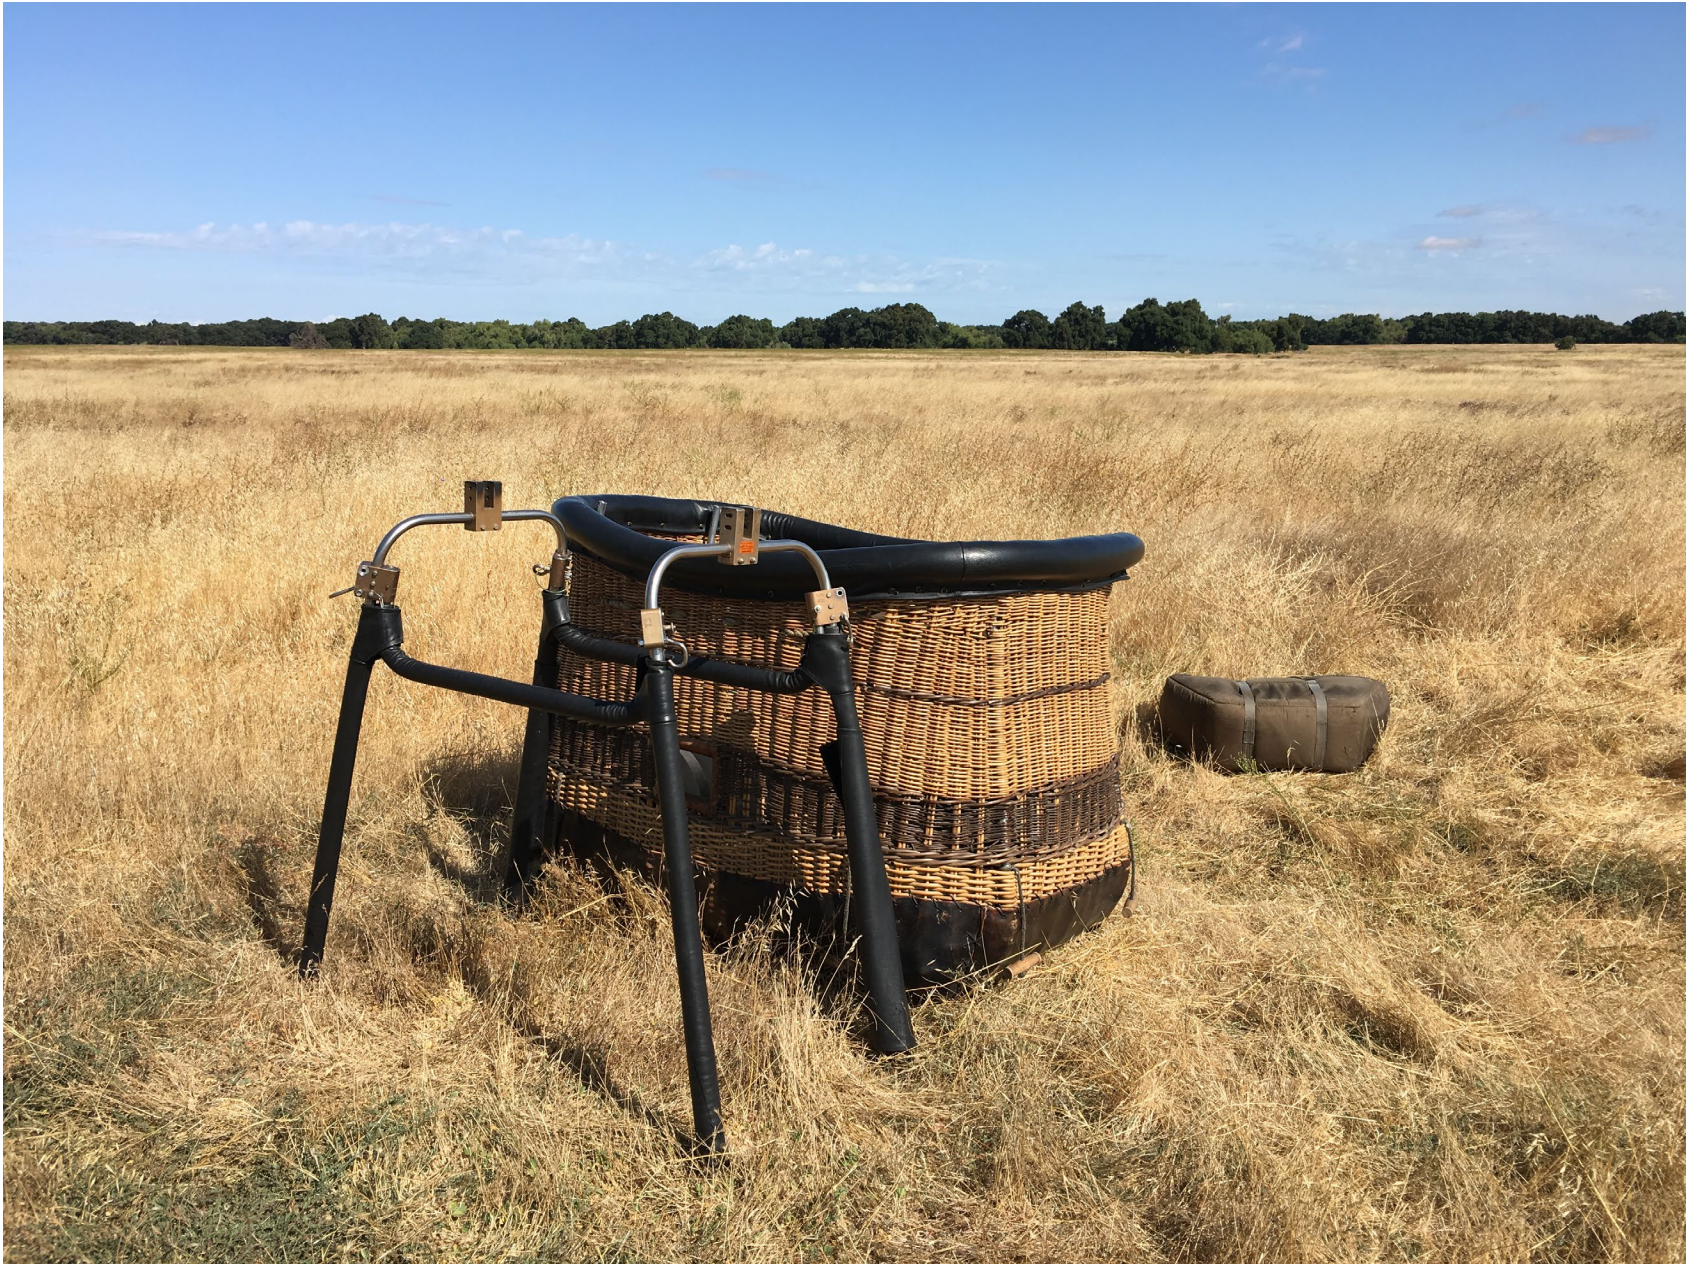
**Photo 1 – Basket and Rigid Frame at Accident Site (Photo Courtesy of Fire Department)**

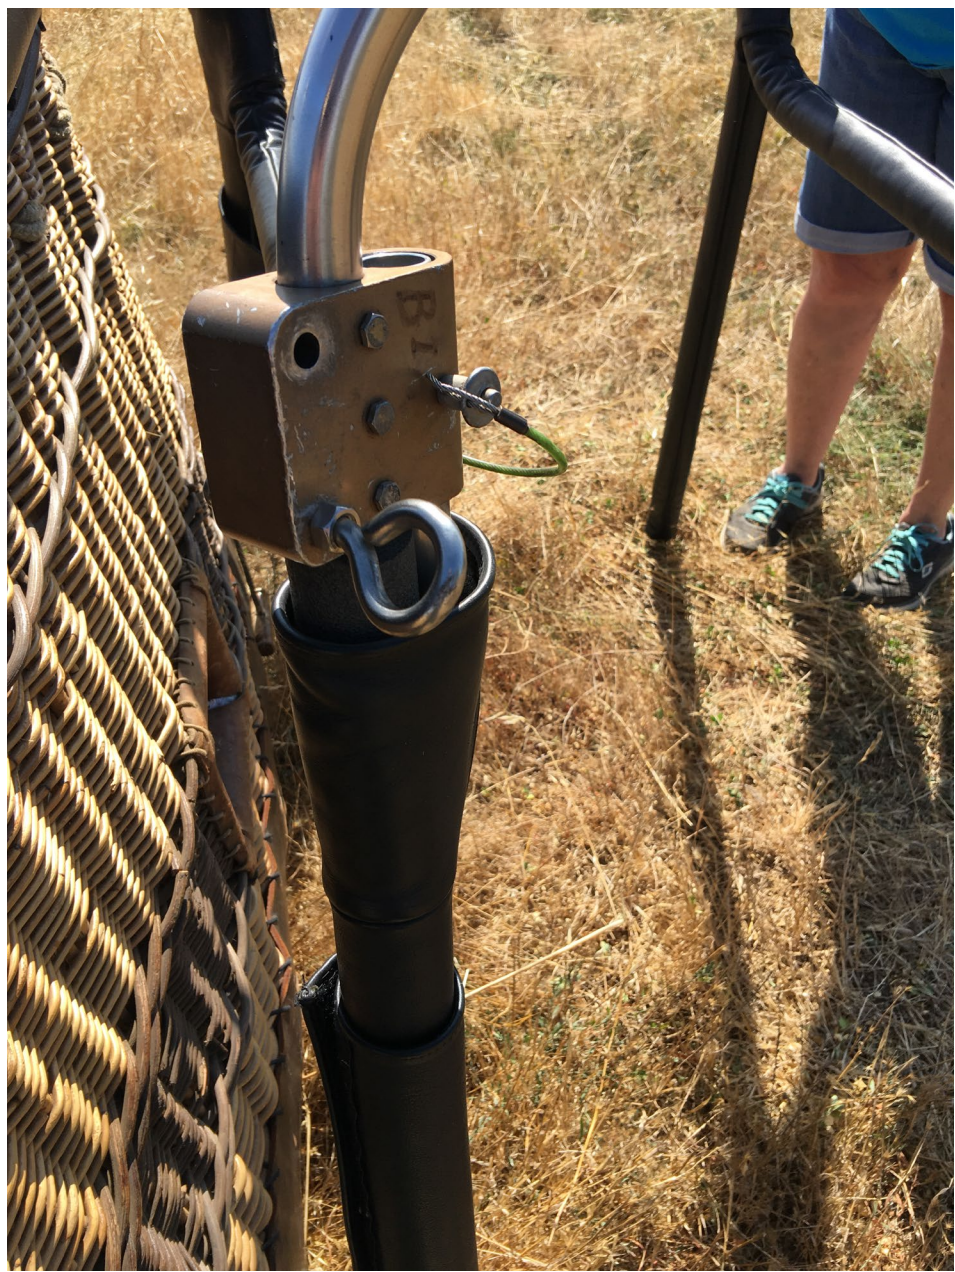
**Photo 2 – Corner Plate with intact Eyelet at Accident Site (Photo Courtesy of Fire Department)**

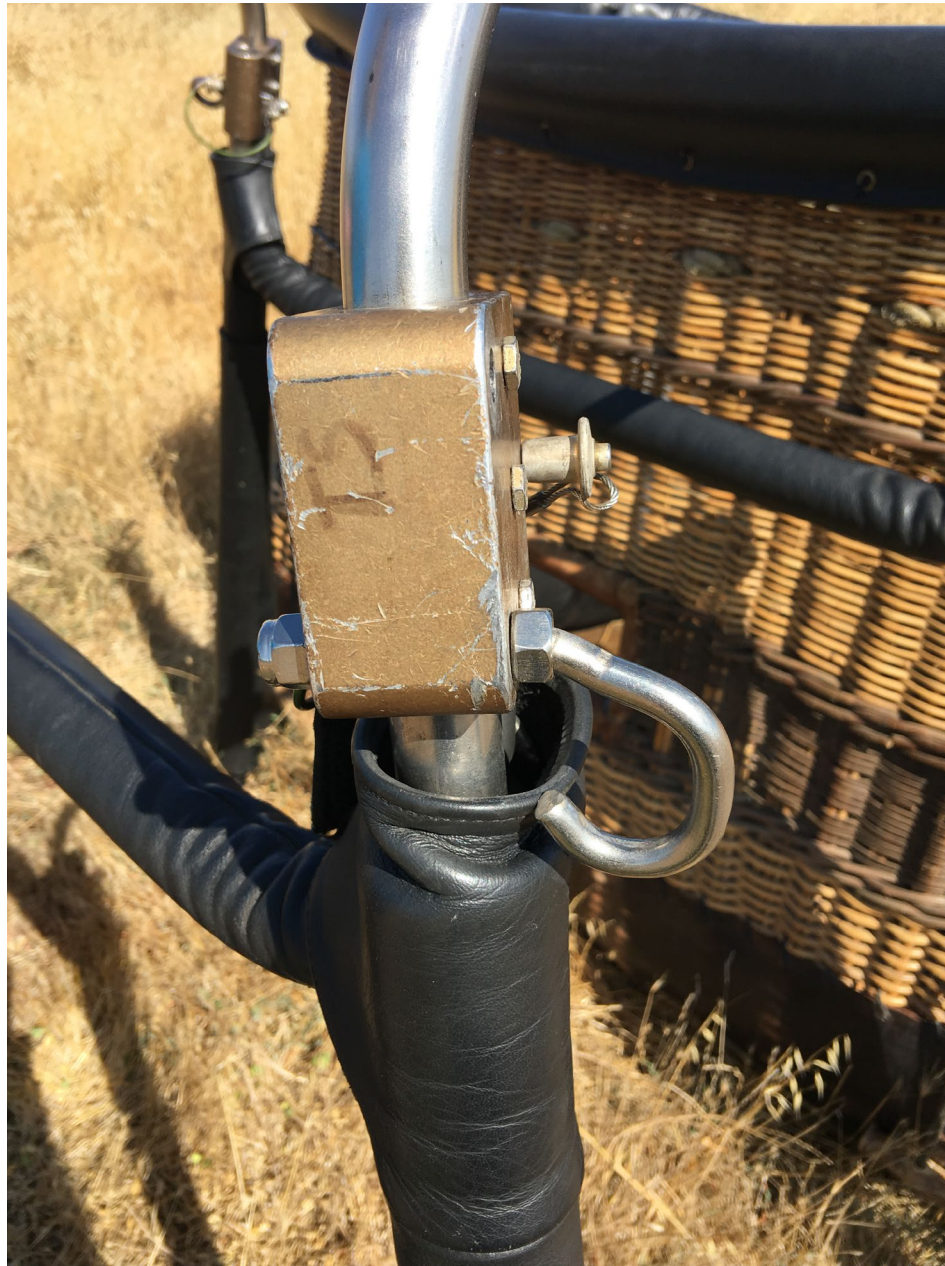
**Photo 3 – Corner Plate with Elongated Eyelet at Accident Site (Photo Courtesy of Fire Department)**

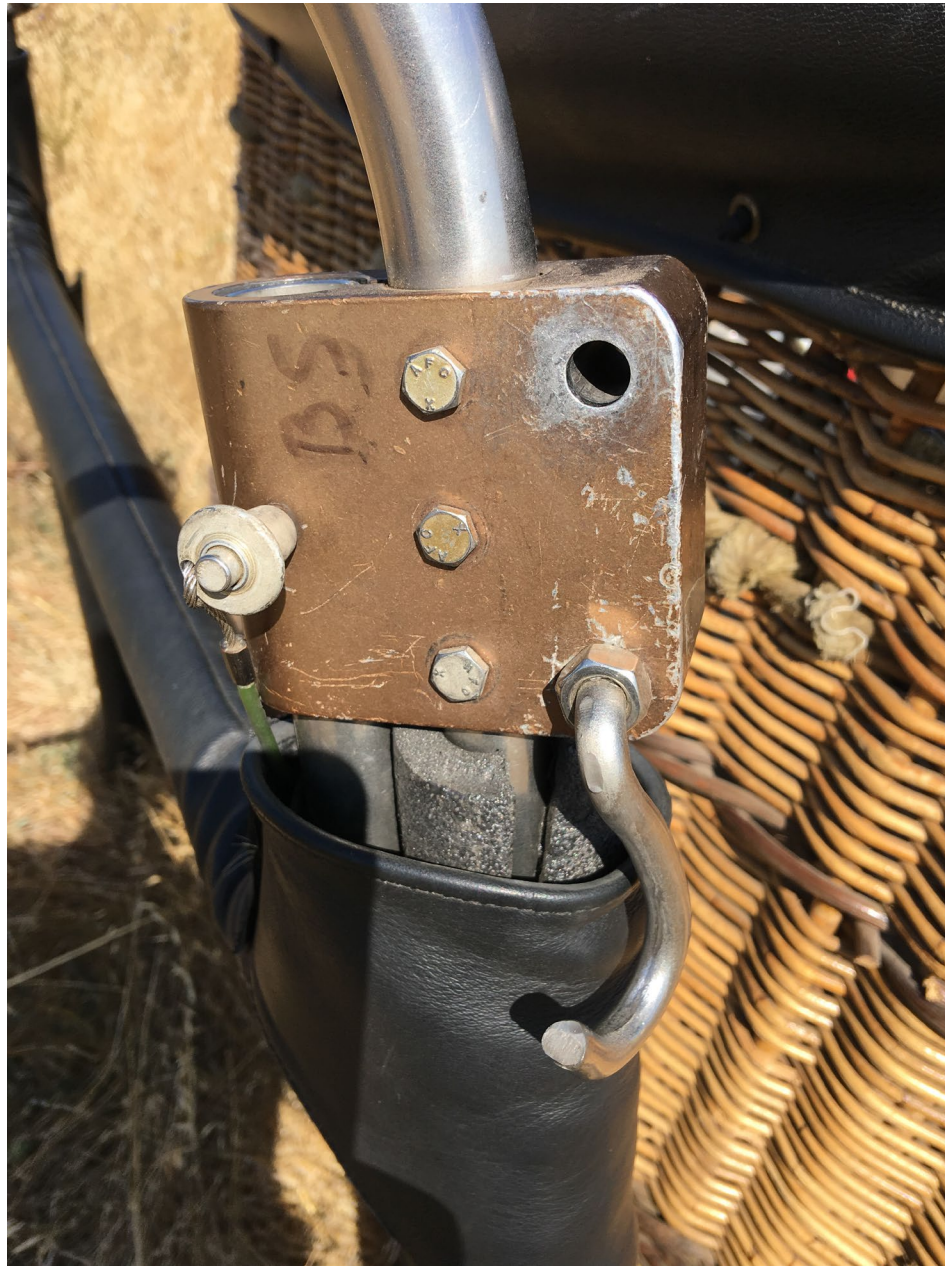
**Photo 4 – Corner Plate with Elongated Eyelet Screw at Accident Site (Photo Courtesy of Fire Department)**

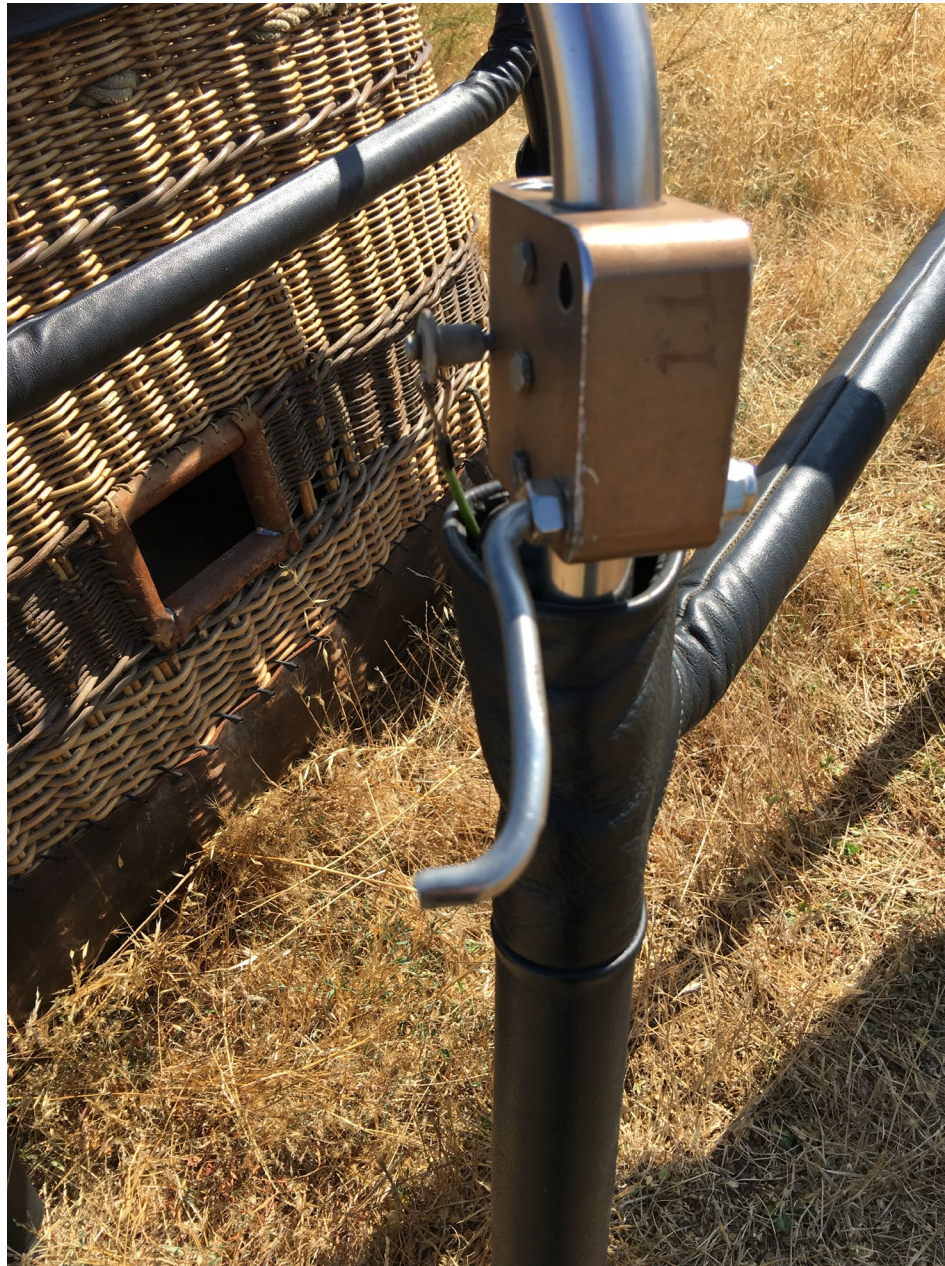
**Photo 5 – Corner Plate with Elongated Eyelet Screw at Accident Site (Photo Courtesy of Fire Department)**

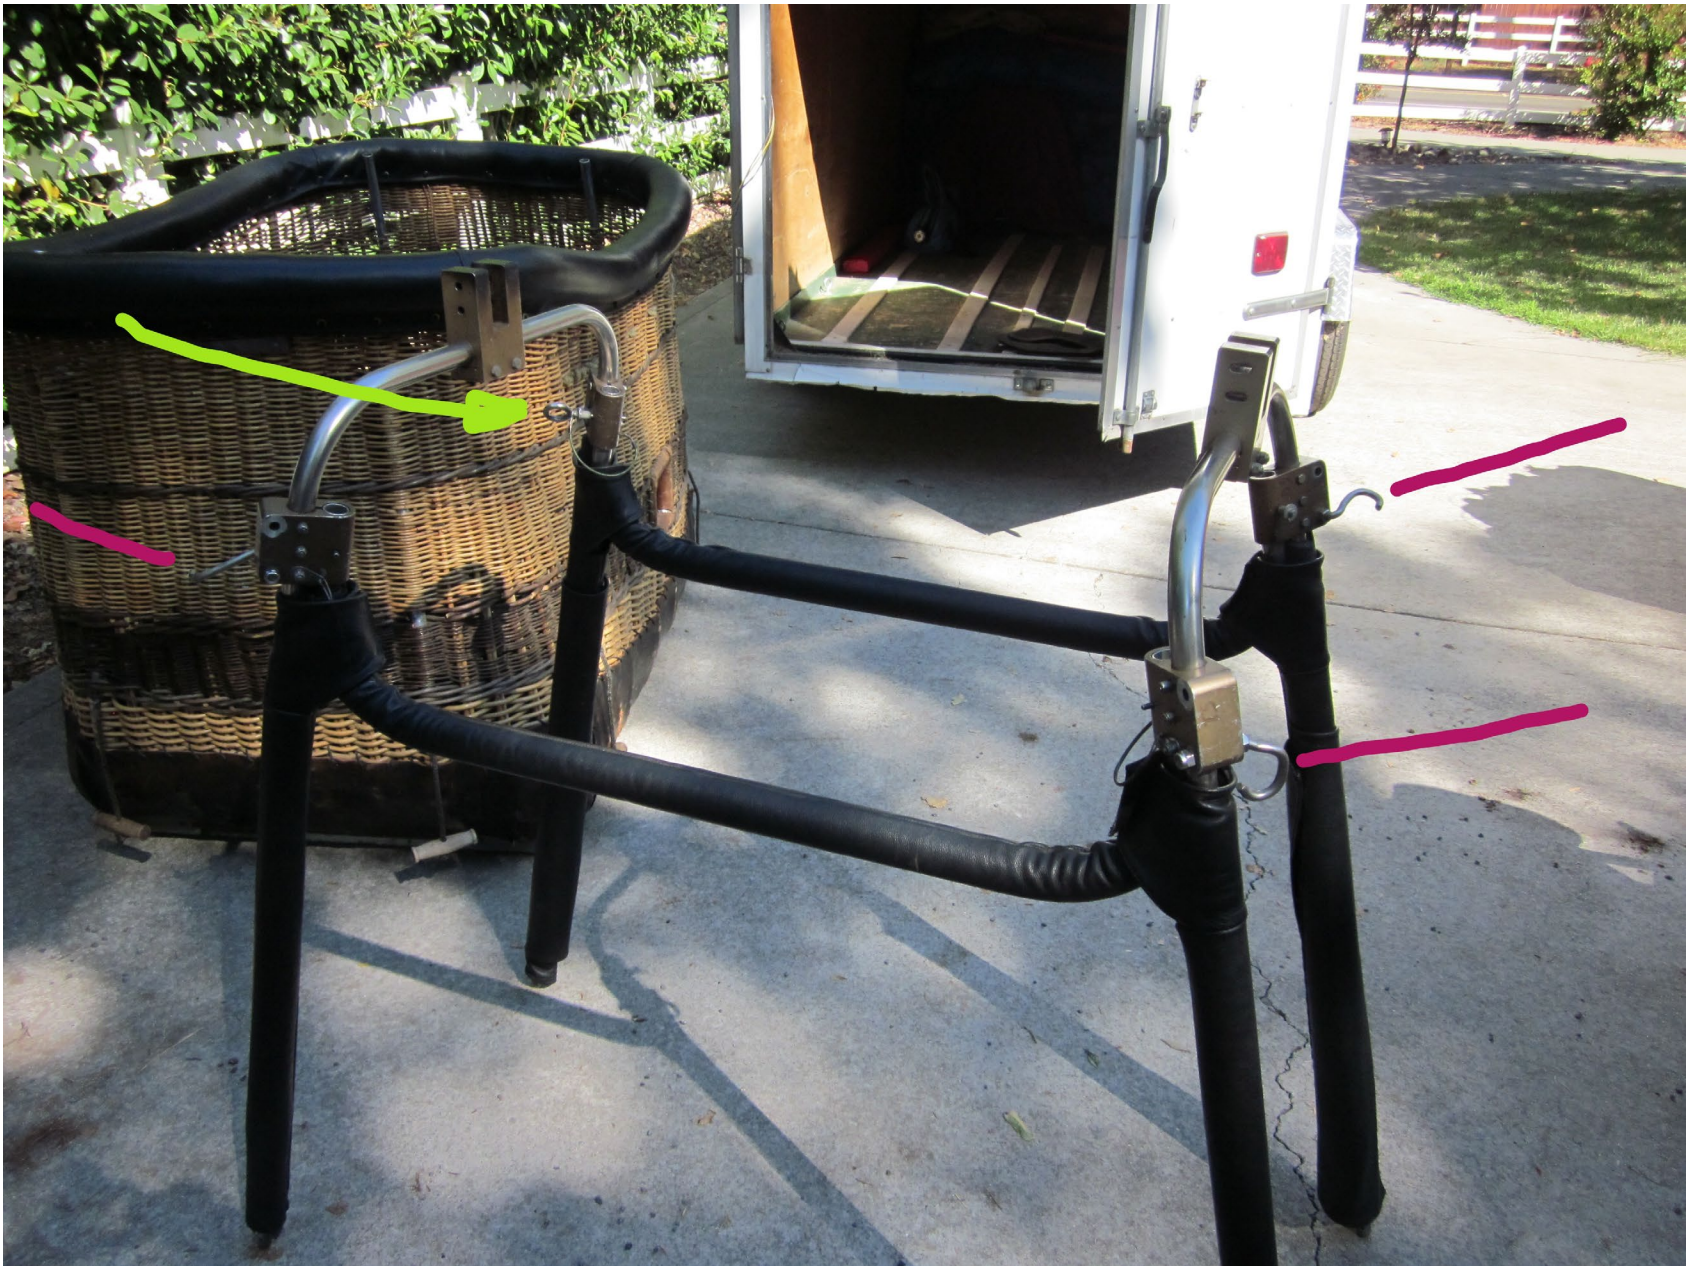
**Photo 6 – Overview of Rigid Frame (Photo Courtesy of FAA)**

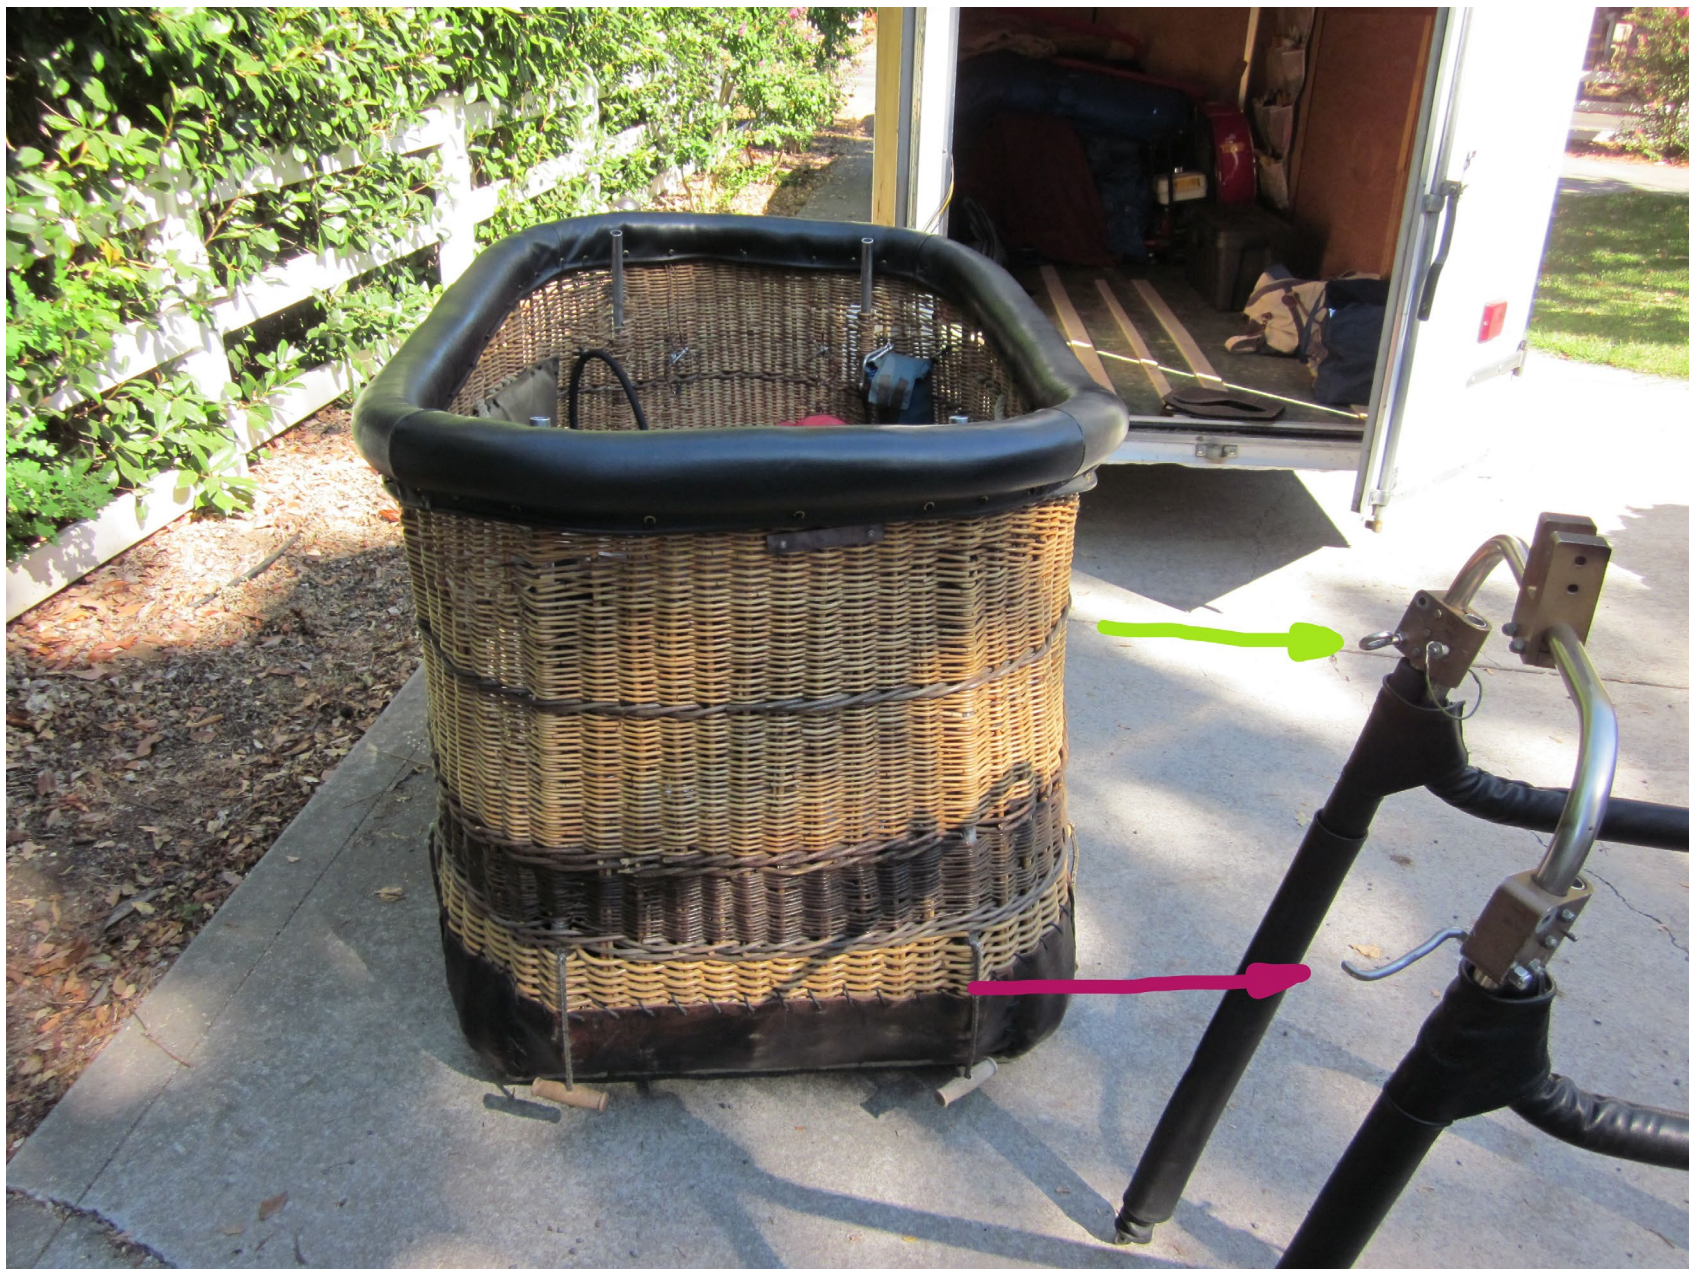
**Photo 7 – View of Rigid Frame (Photo Courtesy of FAA)**

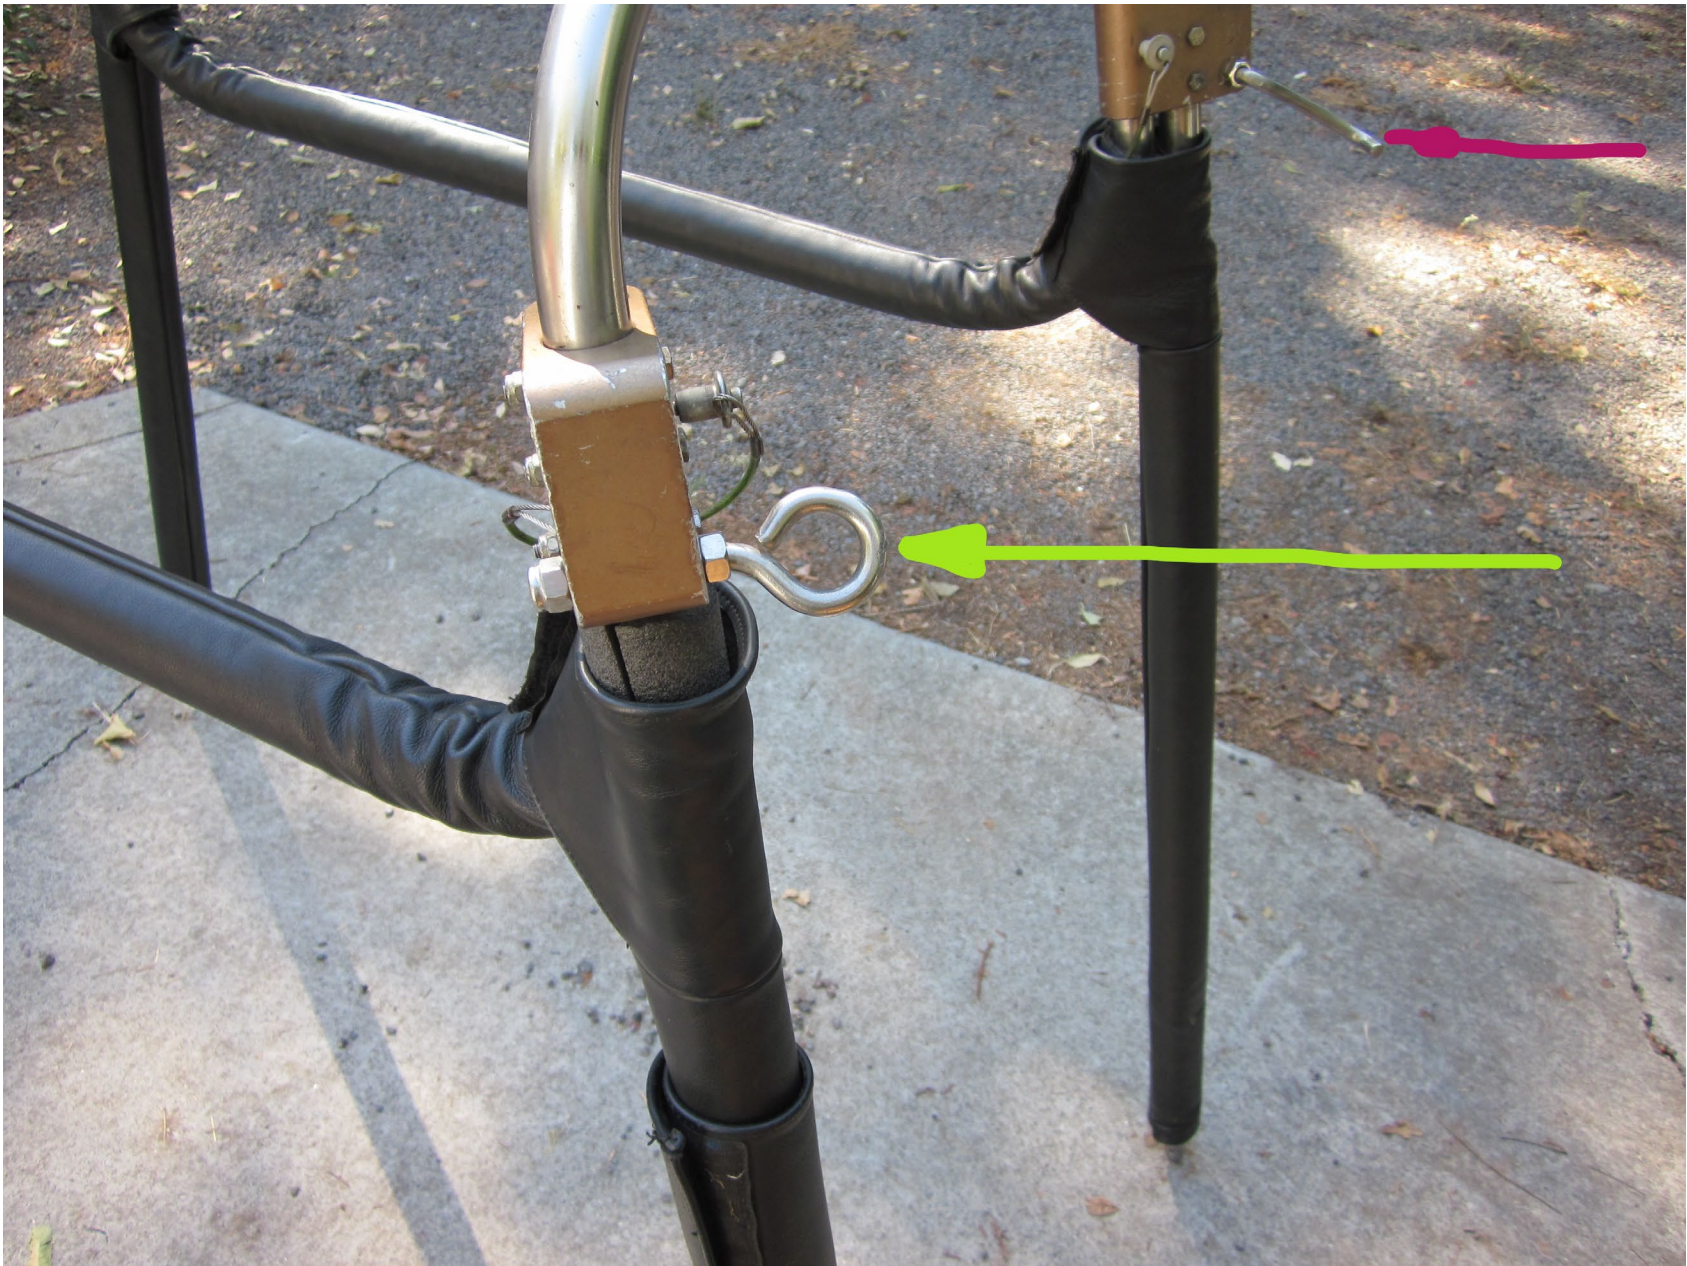
**Photo 8 – Close-up View of Eyelet Screws (Photo Courtesy of FAA)**

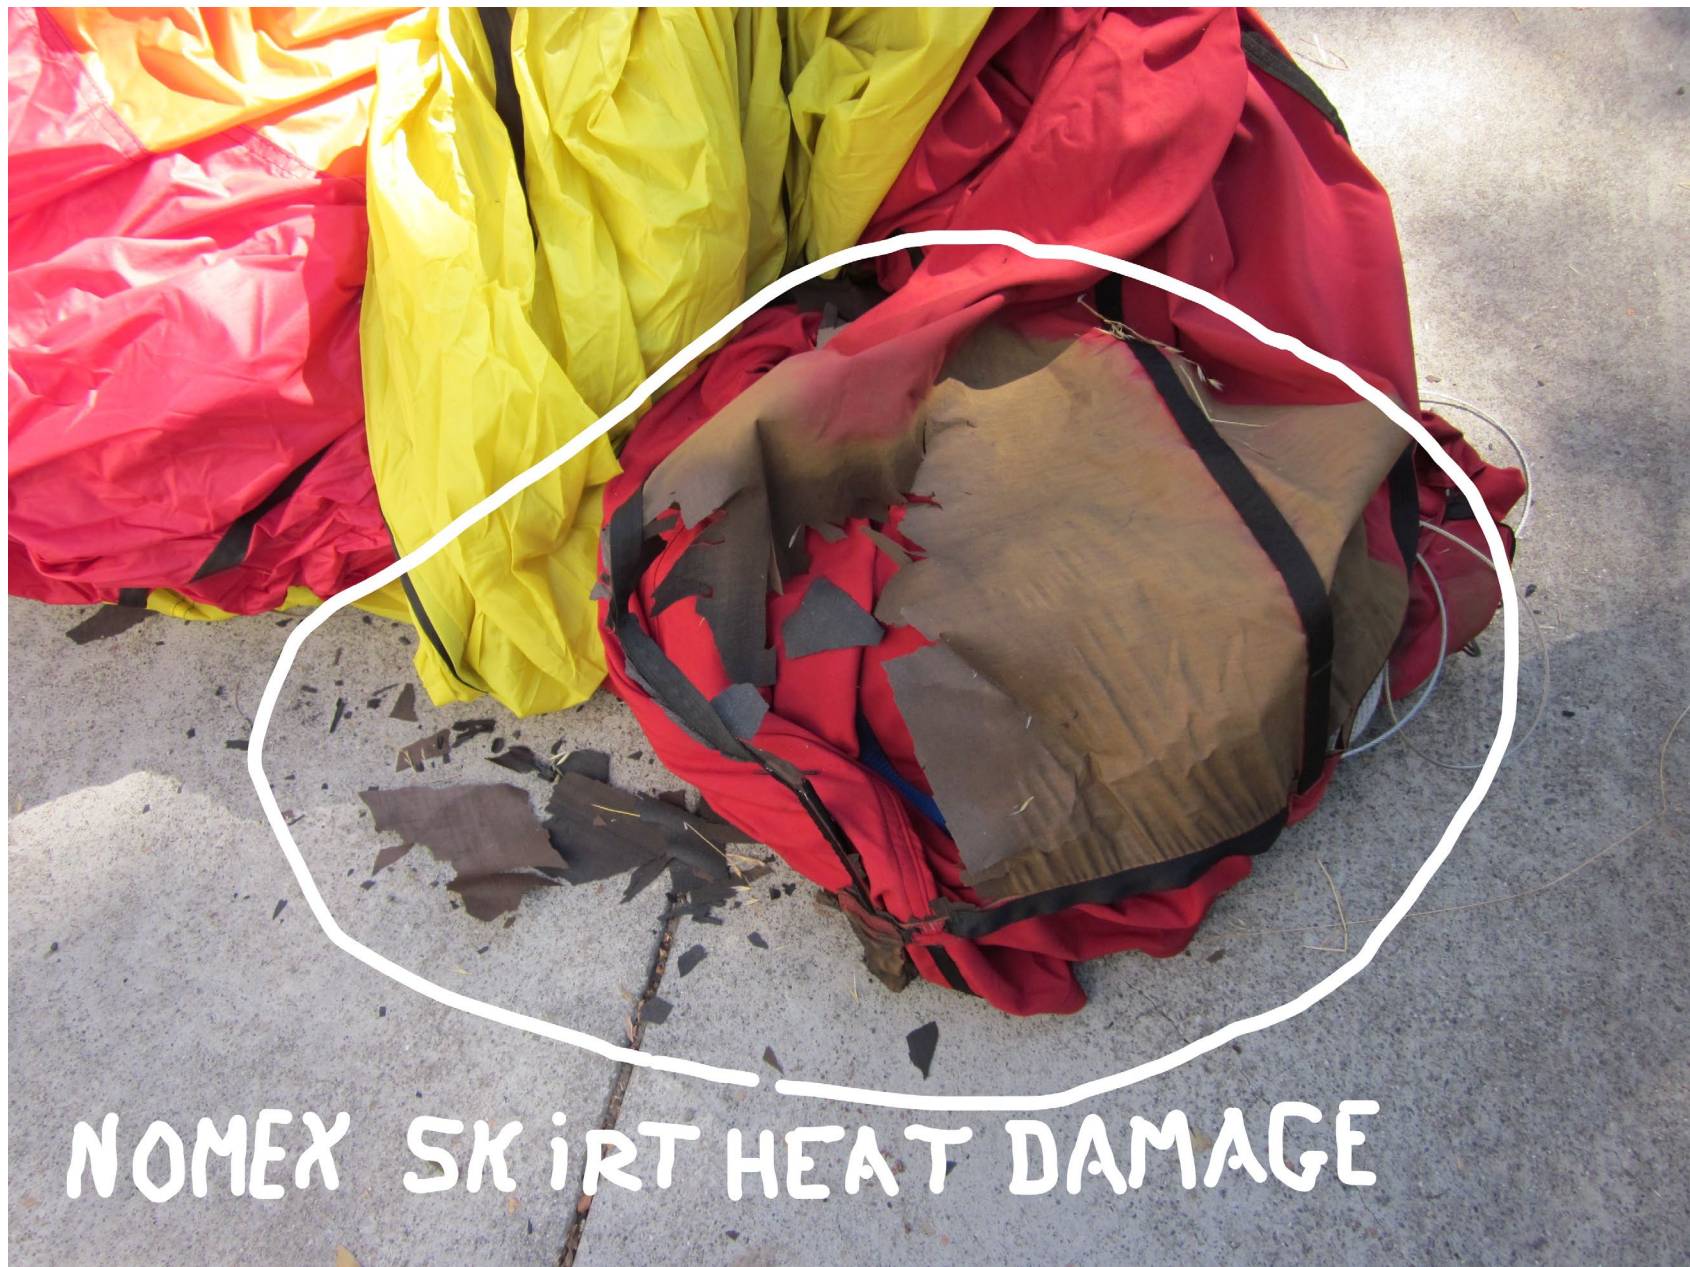
**Photo 9 – Nomex Skirt Heat Damage (Photo Courtesy of FAA)**
