## RECORD OF MEMORANDUM

**Date: June 10, 2021**  
**Person Contacted: Mr. Justin Louw (Federal Aviation Administration)**  
**NTSB Accident Number: WPR19LA233**

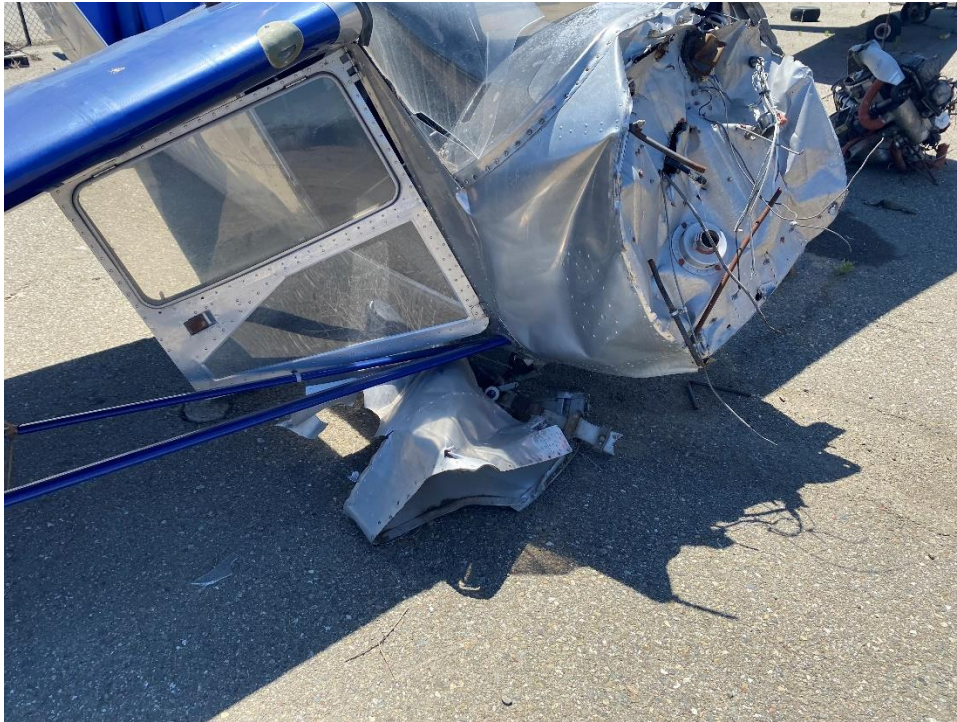
*Figure 1: Damage to the Firewall and Forward Fuselage of the Airplane*

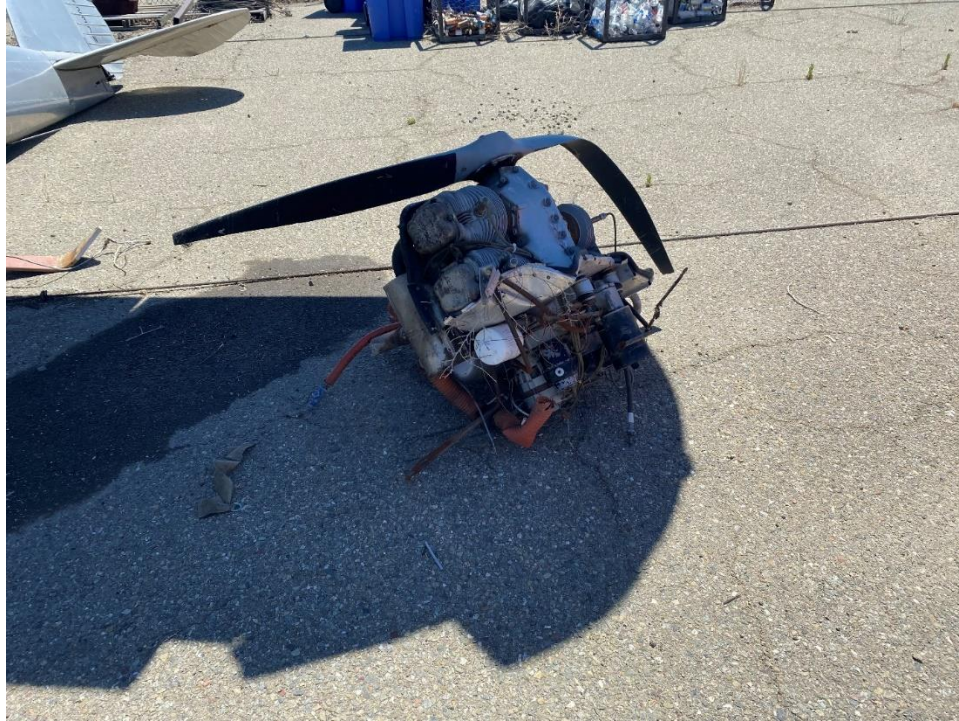
- Since the accident, the airplane had been stored outside and uncovered. The engine was positioned on the ground underneath the left wing.
  - The engine was pointed upward about 45-degrees and leaned toward the right about 30-degrees.

*Figure 2: Engine at the Start of the Examination*

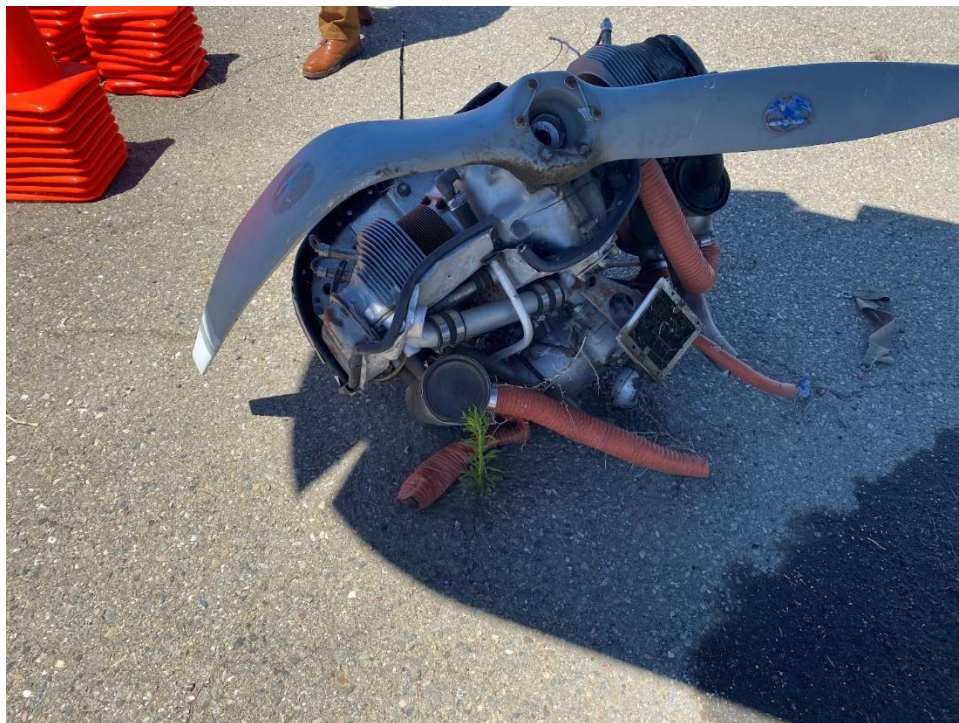
- One blade was bent aft near the root and the other was mostly straight.
  - The propeller was removed from the engine.
- The valve covers were removed from the engine.

*Figure 3: Front of Engine and Propeller*

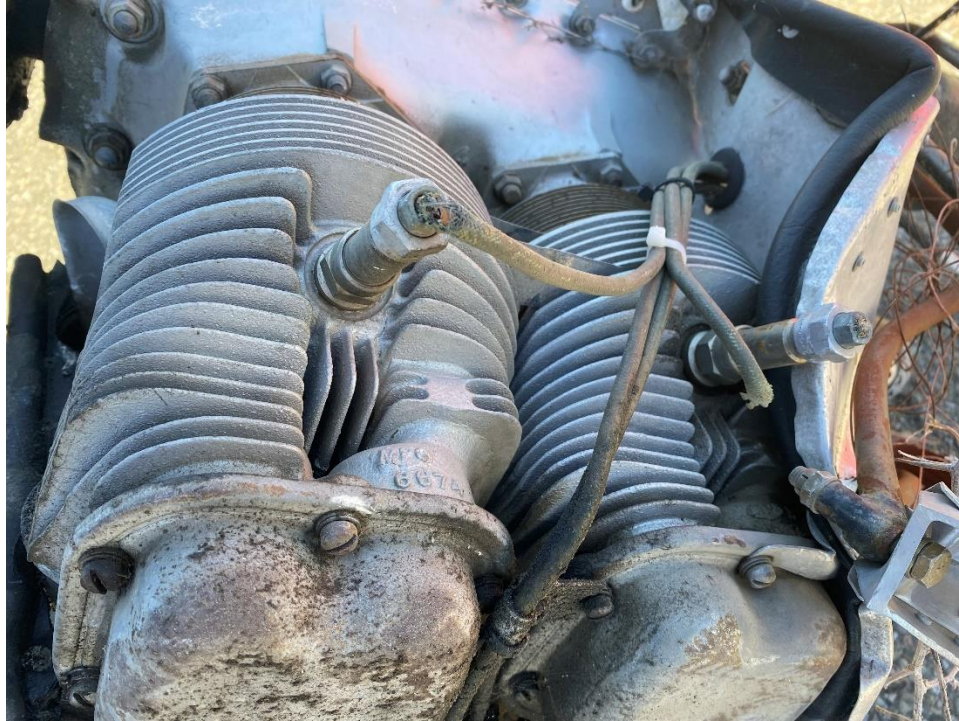
- The ignition harness exhibited damage consistent with impact and was unable to be tested.
- The magnetos were removed and disassembled.
  - The points and overall condition of the magnetos were unremarkable.

*Figure 4: Damage to Ignition Harness*

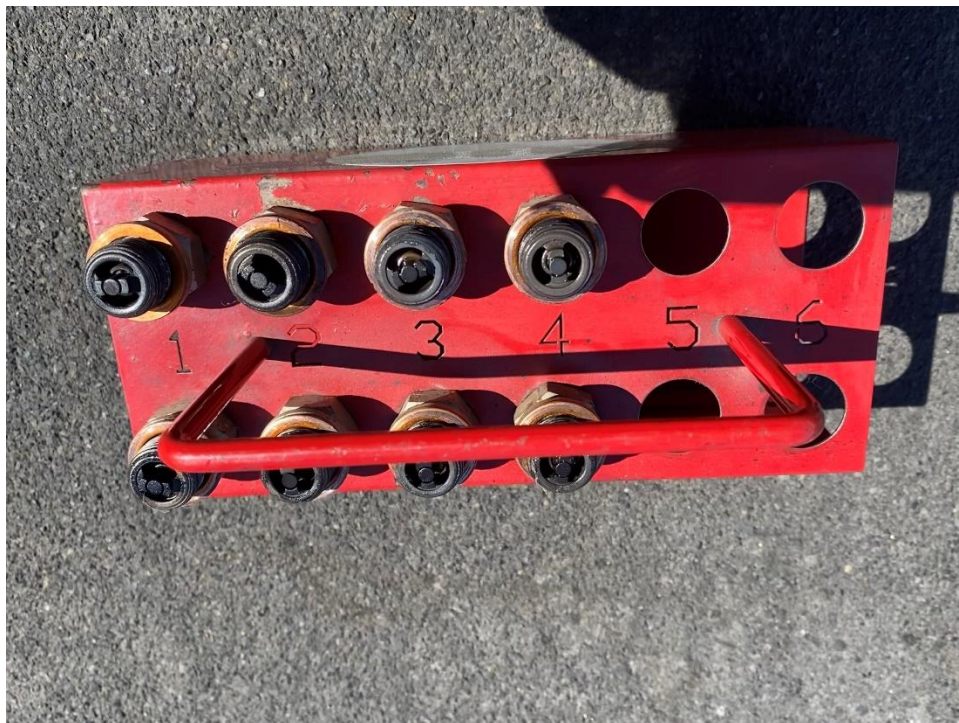
- The spark plugs were removed from the engine.
  - Both the upper and lower spark plugs from the #4 cylinder, and the lower spark plug from the #3 cylinder exhibited oil and soot bridging the gap between the electrodes.

- All other spark plugs exhibited black soot build-up on the electrodes and insulator.
- Engine timing was tested and found to be at the required 24 degrees before top center.

*Figure 5: Overview of Spark Plugs*

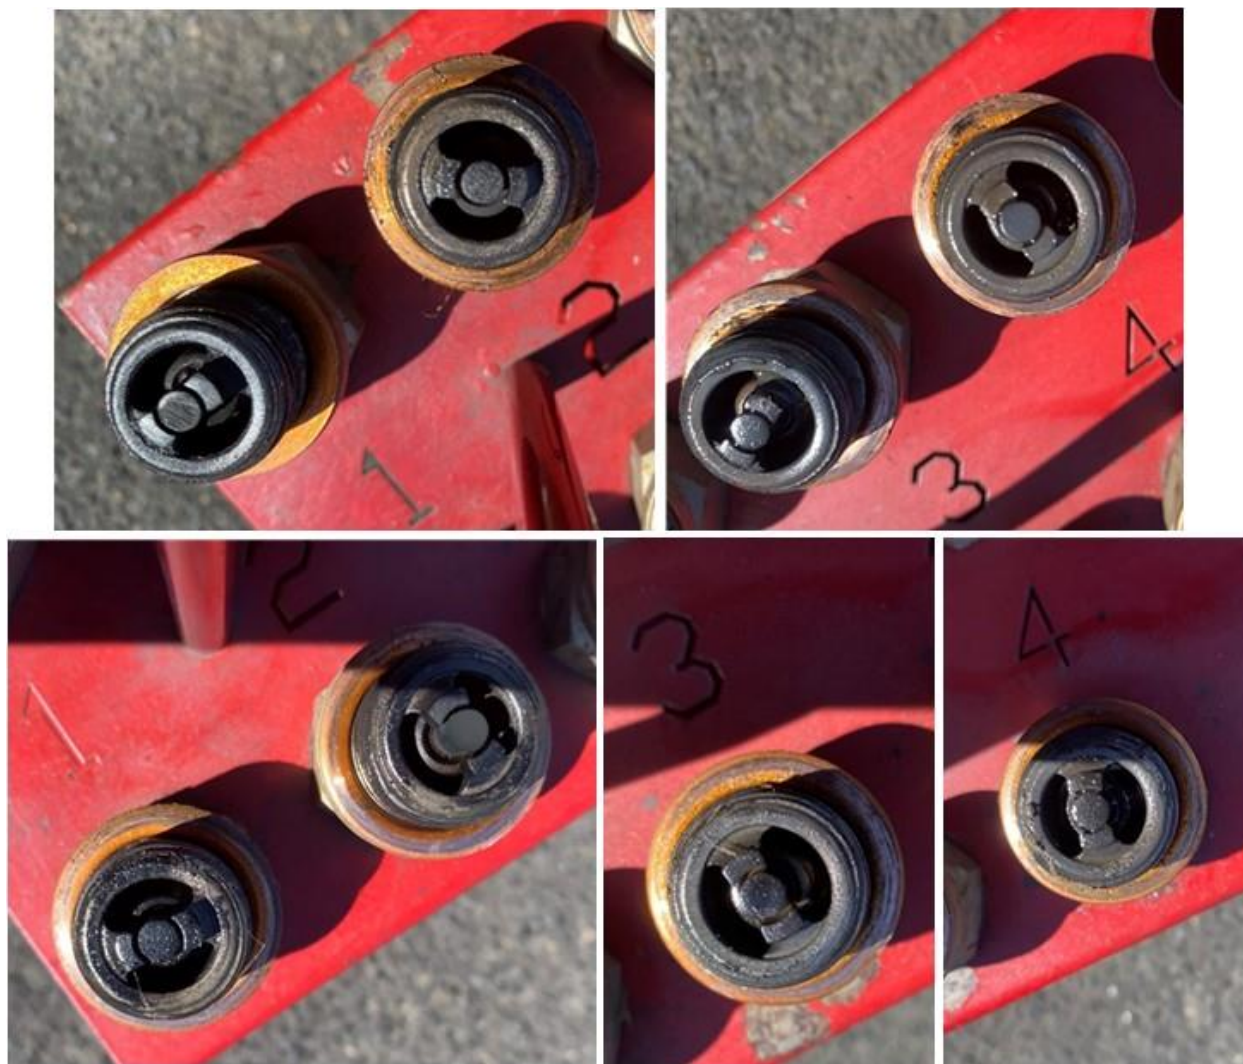
*Figure 6: Up Close view of Spark Plugs*
