## **NATIONAL TRANSPORTATION SAFETY BOARD**

# **WRECKAGE EXAMINATION SUMMARY**

**WPR19LA239**

Location: Wendover, Nevada  
Date: August 24, 2019 at 1315 MDT  
Aircraft: PA-224-250, N6696P  
NTSB IIC: Andrew Swick

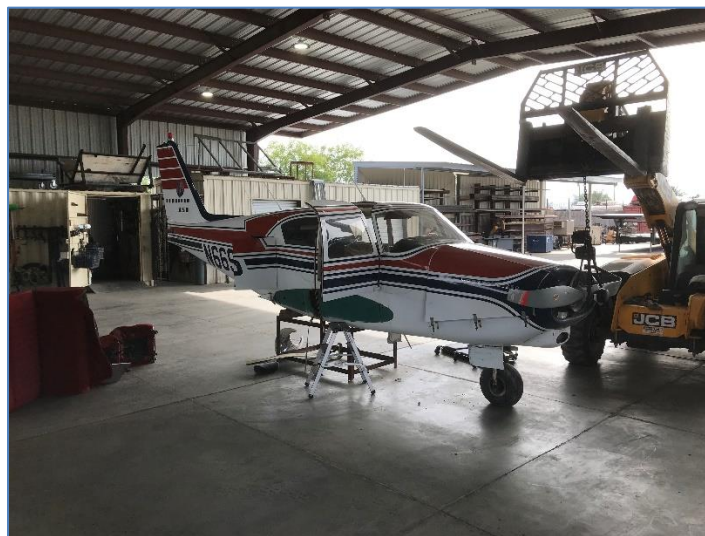
**Figure 1-Main Wreckage**

The wings and horizontal stabilators were removed from the airplane prior to the examination. The airplane belly had impact damage revealing the landing gear motor, jack screw and emergency extension linkage. No damage was noted to the landing gear system or its electrical wires. The landing gear motor circuit breaker was found in the open position. The airplane's fuselage was supported off the ground, where the nose landing gear was free to swing.

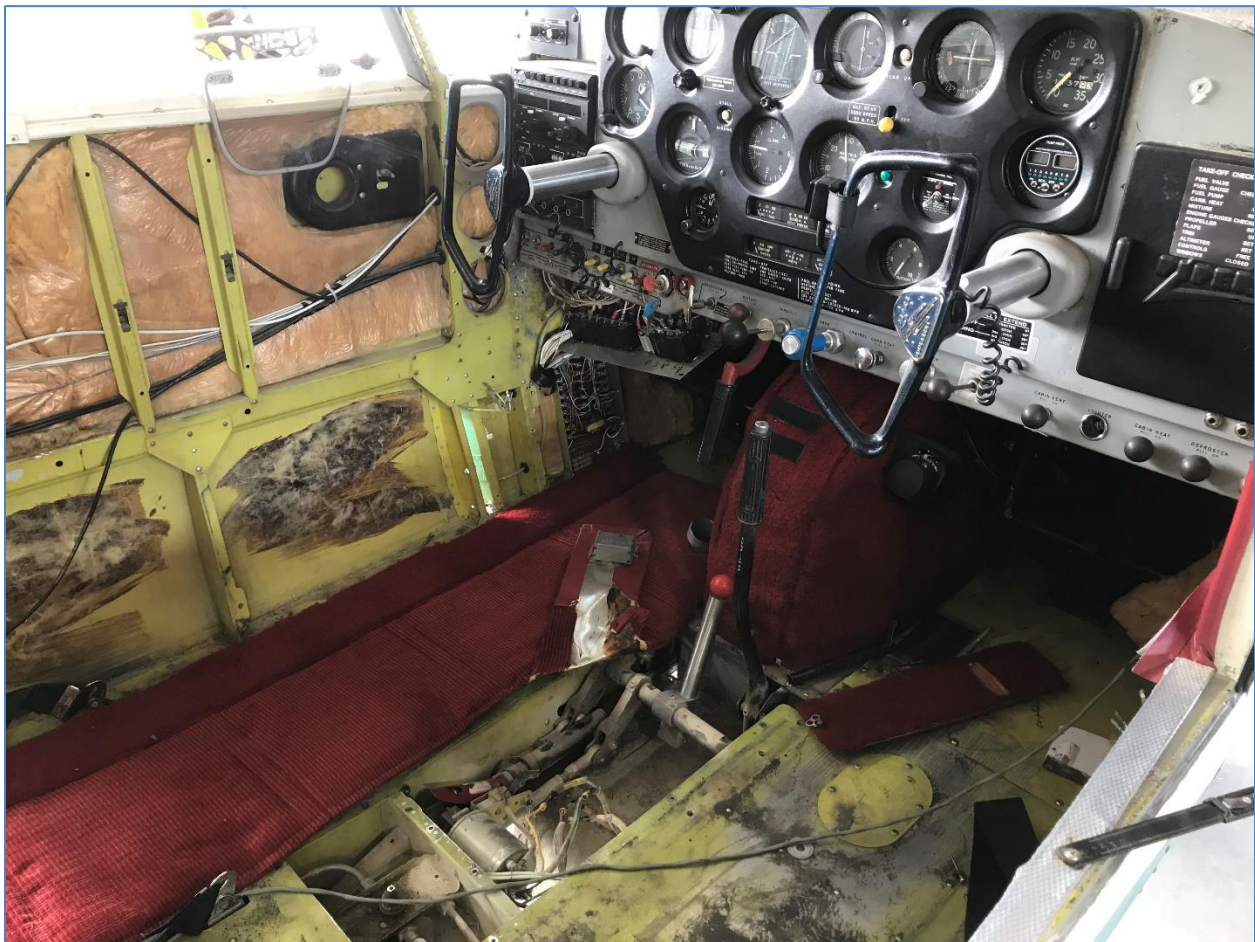
Figure 2-Main Wreckage-Cabin Area

The landing gear selector switch was positioned to the center 'OFF' position. The emergency landing gear motor-raise motor release arm was positioned to the forward position and the gear freely swung to a transient position, between the retracted position and down-and-locked position. The landing gear emergency gear handle was extended to full length and the handle was positioned to the full forward position, locking the nose landing gear in place. The main landing gear control cables operated normally during the emergency extension of the landing gear. The nose landing gear was retracted by use of the emergency gear handle. The main landing gear control cables operated normally during the retraction of the landing gear.

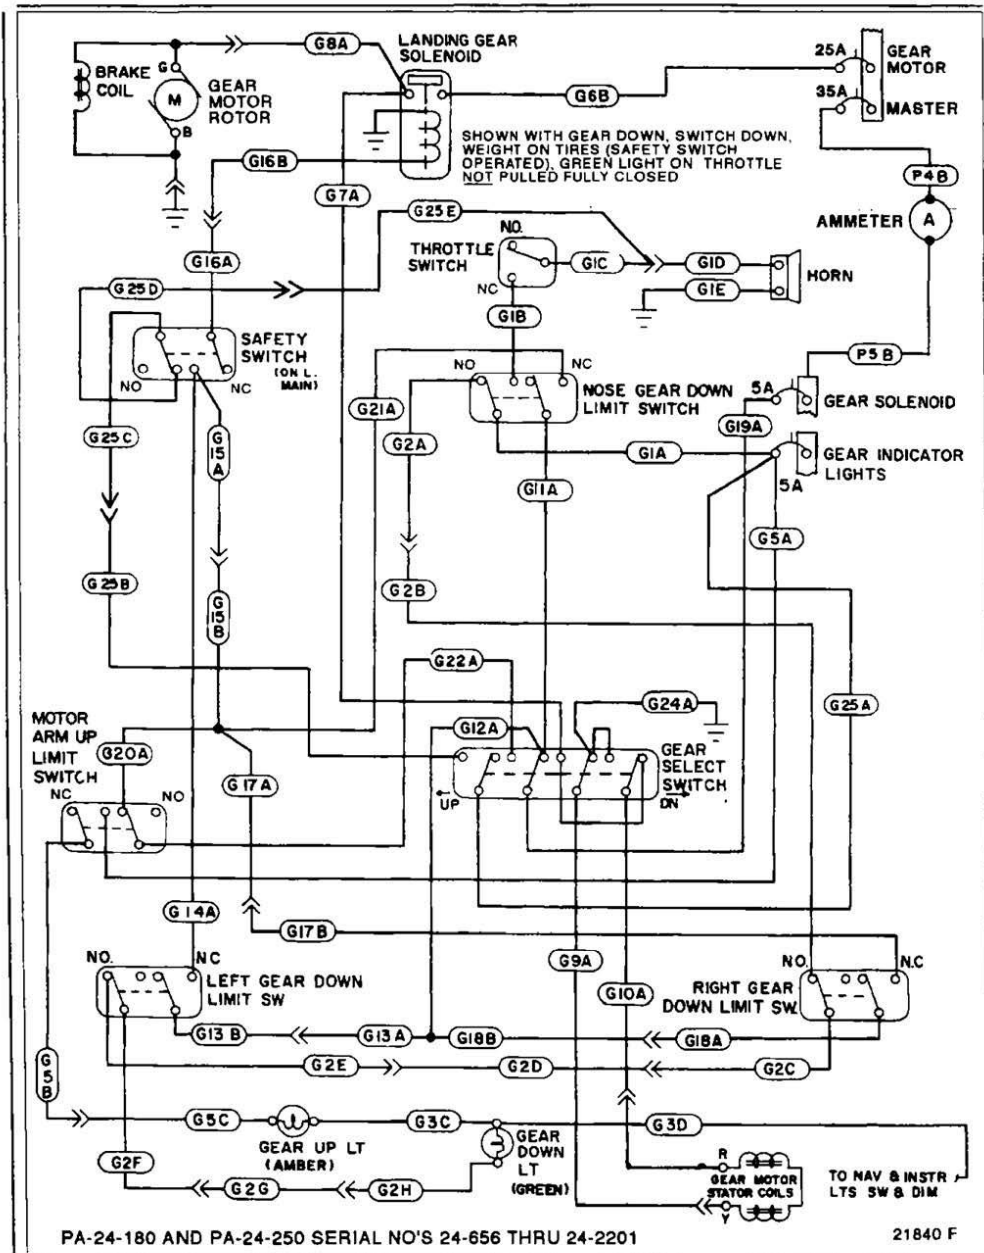
Figure 4-Landing Gear Electrical Schematic

An electrical source was attached to the airplane's battery and the landing gear motor circuit breaker was closed. The master switch was turned to the 'ON' position and the landing gear switch was positioned in both 'UP' and 'DOWN' positions. The landing gear motor did not operate during the positioning of the switch. The landing gear electrical wires were examined from the circuit breaker to the landing gear solenoid to the landing gear motor, and no damage or loose connections were found on any of the wires. A voltmeter was attached to the circuit breaker and electrical power was exiting from the breaker. The voltmeter was attached to the electrical wire into the landing gear motor and electricity was not indicated at the motor. An electrical jumper was attached from the circuit breaker to the motor, and the landing gear motor

worked normally from the landing gear switch in both positions. The landing gear solenoid was not removed from the airplane and the electrical connections were tight at the solenoid terminals.
