## **NATIONAL TRANSPORTATION SAFETY BOARD**

# **ENGINE EXAMINATION**

**WPR19LA240**

Location: Lancaster, CA  
Date: August 25, 2019  
Aircraft: Super Petrel, Registration Number: N632MM  
NTSB IIC: Albert Nixon

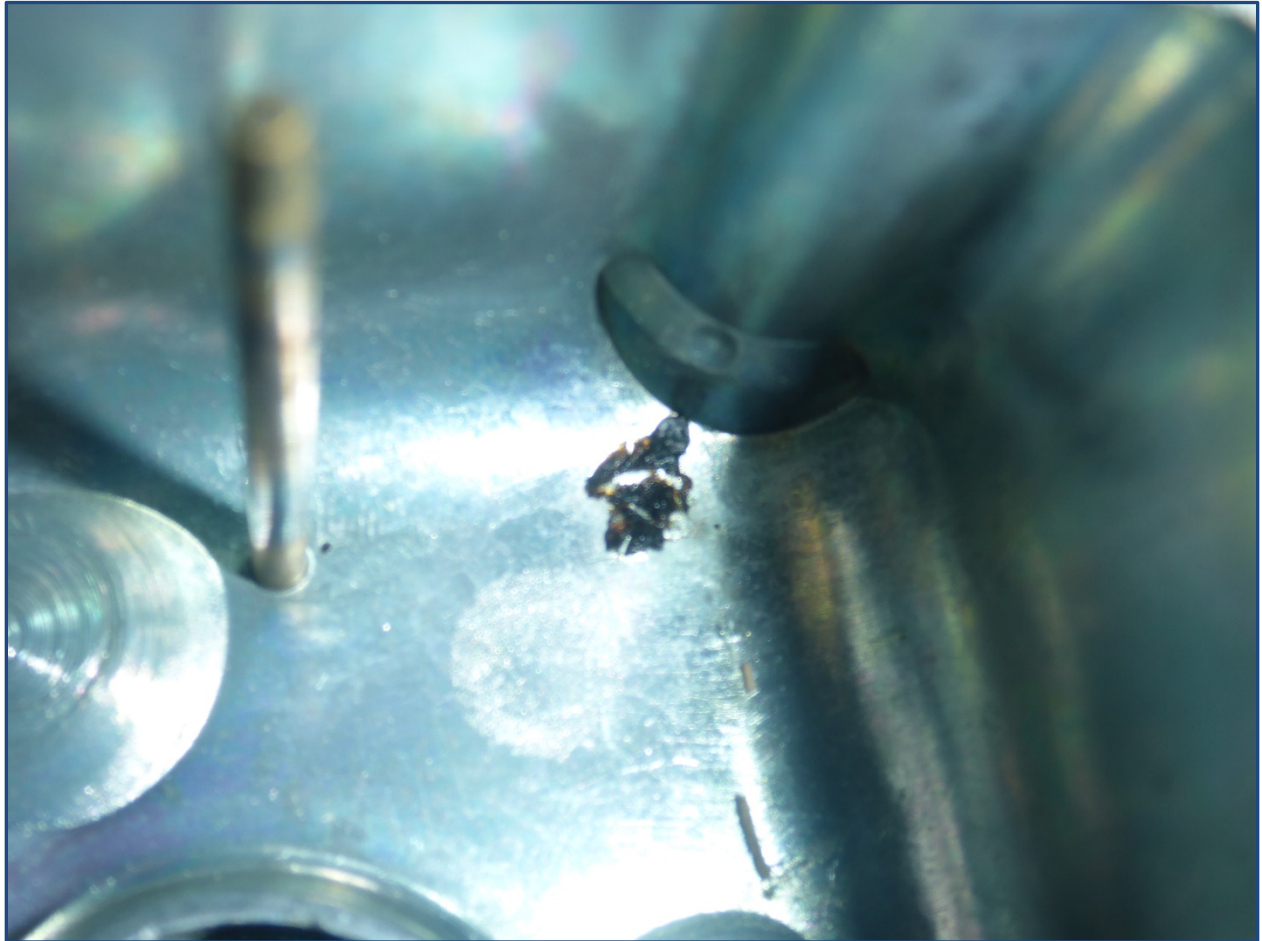
The two carburetor float bowls were removed and examined. The cylinder Nos. 1 and 3 carburetor float bowl had contamination located beneath one float. The cylinder Nos. 2 and 4 carburetor float bowl had contamination located below the main jet. The contamination was consistent with grease that was used on the float bowl's gaskets. The fuel pumps tested good. Additionally, the lubrication system, engine cylinders and internal engine components, cooling system, ignition, and exhaust system, were examined with no anomalies noted. The examination of the engine determined that it could be safely run.

**Figure 1: Contamination carburetor float bowl for cylinder nos, 1 and 3.**

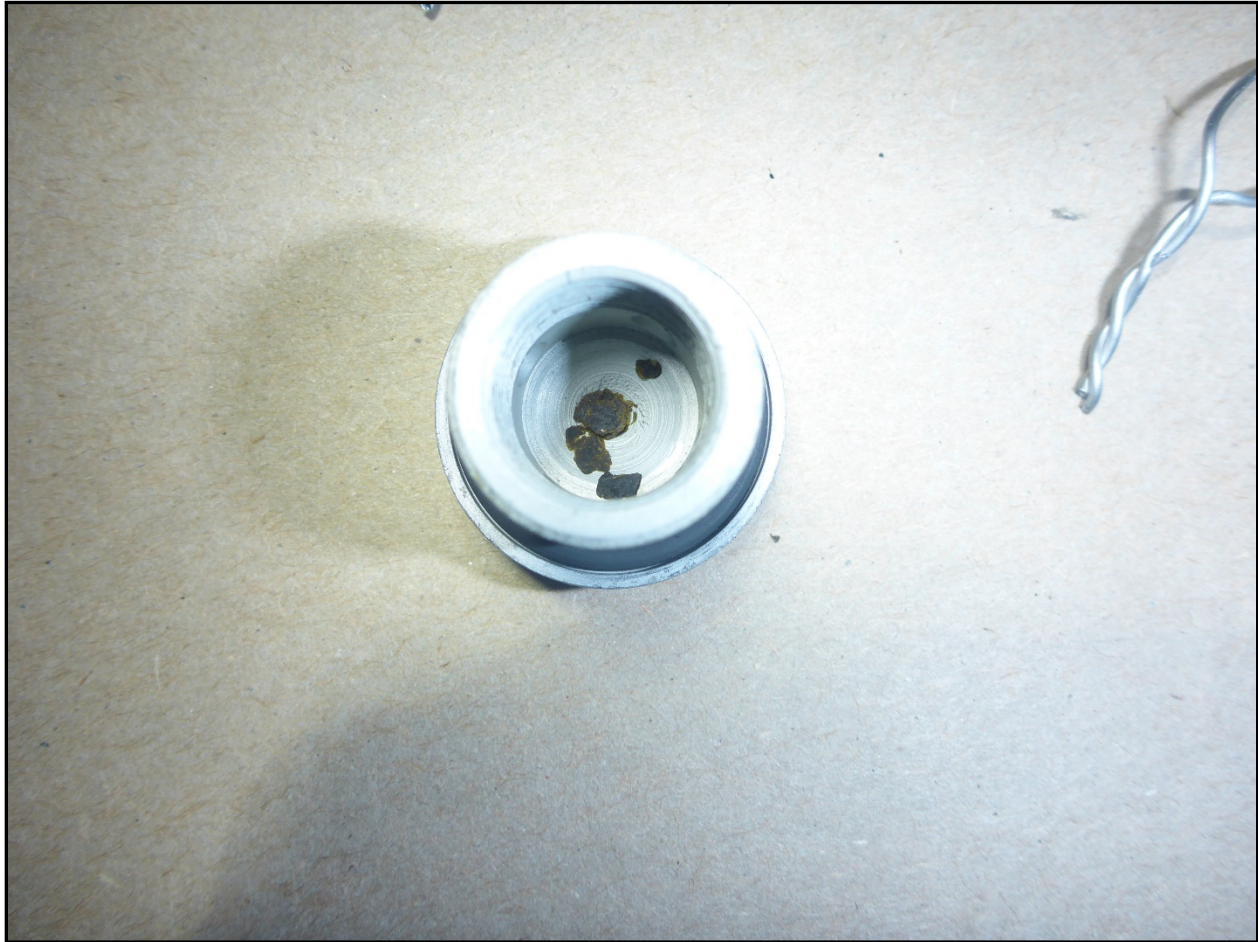
**Figure 2: Contamination in carburetor float bowl for cylinder nos. 2 and 4.**
