# NATIONAL TRANSPORTATION SAFETY BOARD

## MATERIALS LABORATORY FACTUAL REPORT

Report No. 20-036

Place : Santa Barbara, California  
Date : September 25, 2019  
Vehicle : Lockheed C-130A, N119TG  
NTSB No. : WPR19LA242  
Investigator : Tealeye Cornejo, AS-WPR

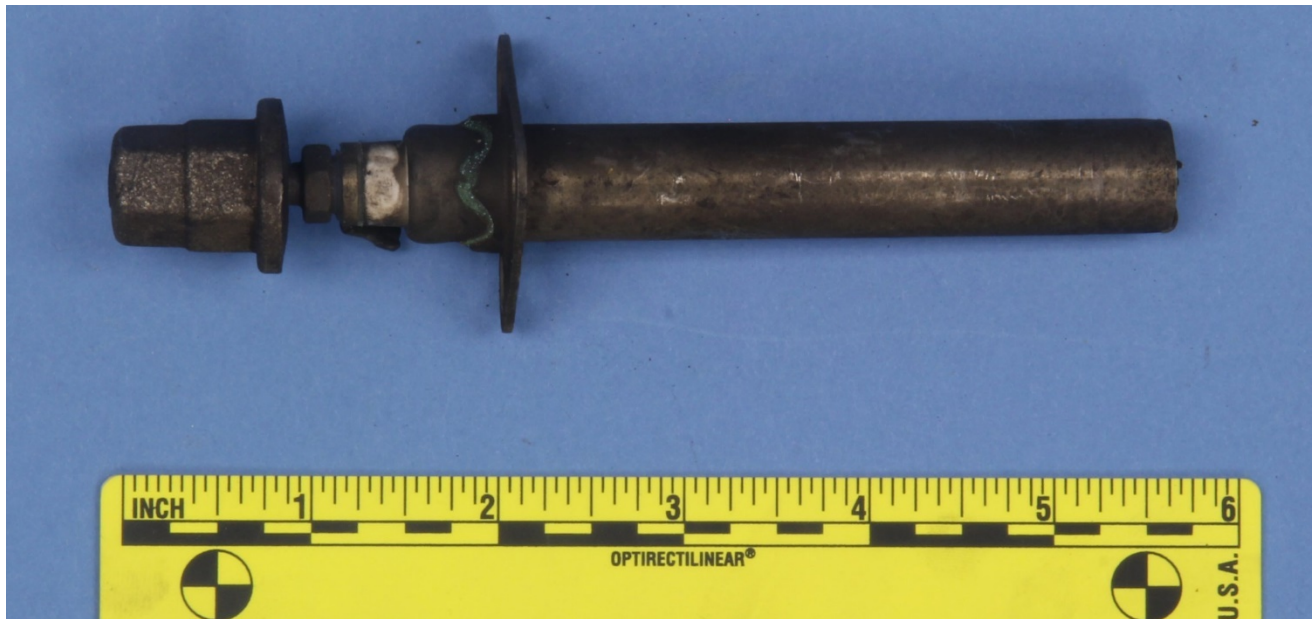
Figure 1 shows the temperature sensor from the bleed air duct assembly, as received. This sensor exhibited some darker carbon deposits, consistent with its proximity to the high temperature bleed air gasses. There were no indications of deformation, cracking, or wear on the outside of the sensor. No rattling or oscillating sounds were made when moving or shaking the part.

Figure 1 – The temperature sensor, as received.

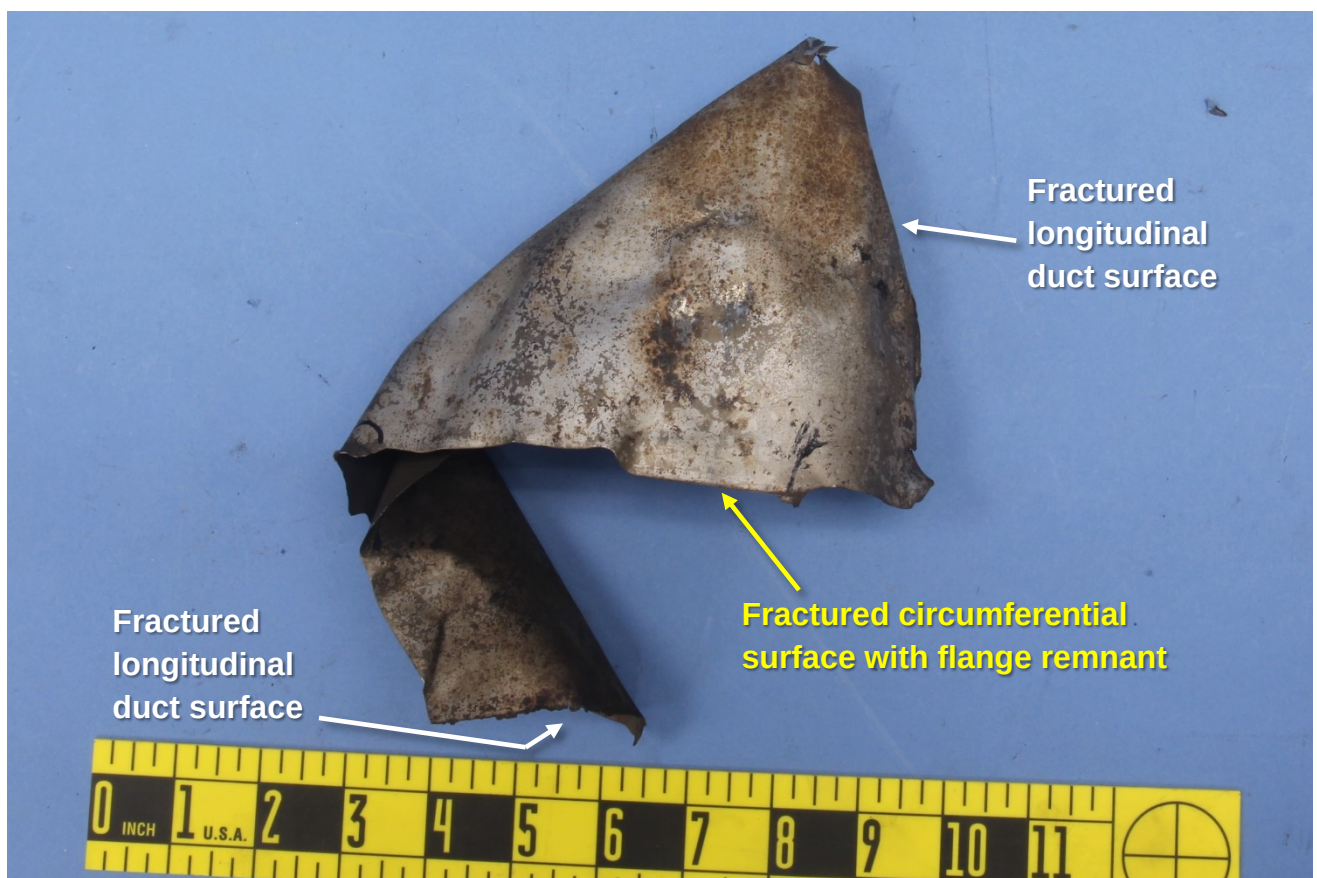
Figure 2 and 3 show the bleed air duct remnant, as received. The duct remnant had separated from the flange remnant in the V-band clamp, and had been folded over itself, as shown in the figures. The remnant exhibited dark and brownish-orange discolorations on the outer surface, with dark-colored soot present on the inner surface—this soot was easily removed with contact by touch (Figure 3).

The duct was normally cylindrical, but had fractured both circumferentially and longitudinally, as illustrated in Figure 2. In order to examine the duct remnant, it was bent and flattened out, then cleaned using acetone and ethanol. Figure 4 shows the flattened duct remnant from the external surface. The upper circumferential and longitudinal fractures were generally jagged and randomly oriented. The lower circumferential fracture was relatively flat in orientation, with the exception of three downward protruding areas. These areas were consistent with having mated with mirrored areas in the duct flange remnant, shown as received in the V-band clamp in Figure 5.

Figure 2 – View of the outer surface of the bleed air duct remnant, as received. The remnant is oriented such that the mating flange remnant would mate on the bottom, with the mating longitudinal fractures on the right and bottom.

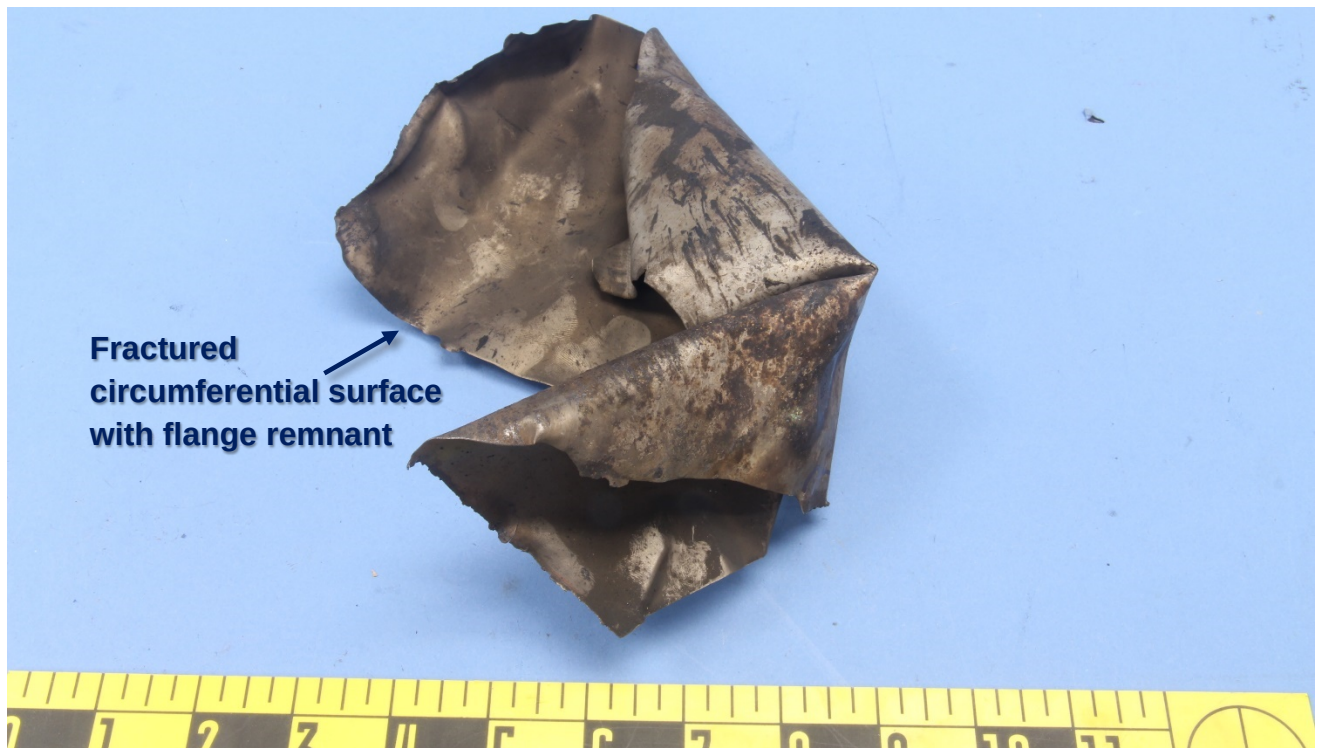
Figure 3 – View of the internal surfaces of the bleed air duct remnant.

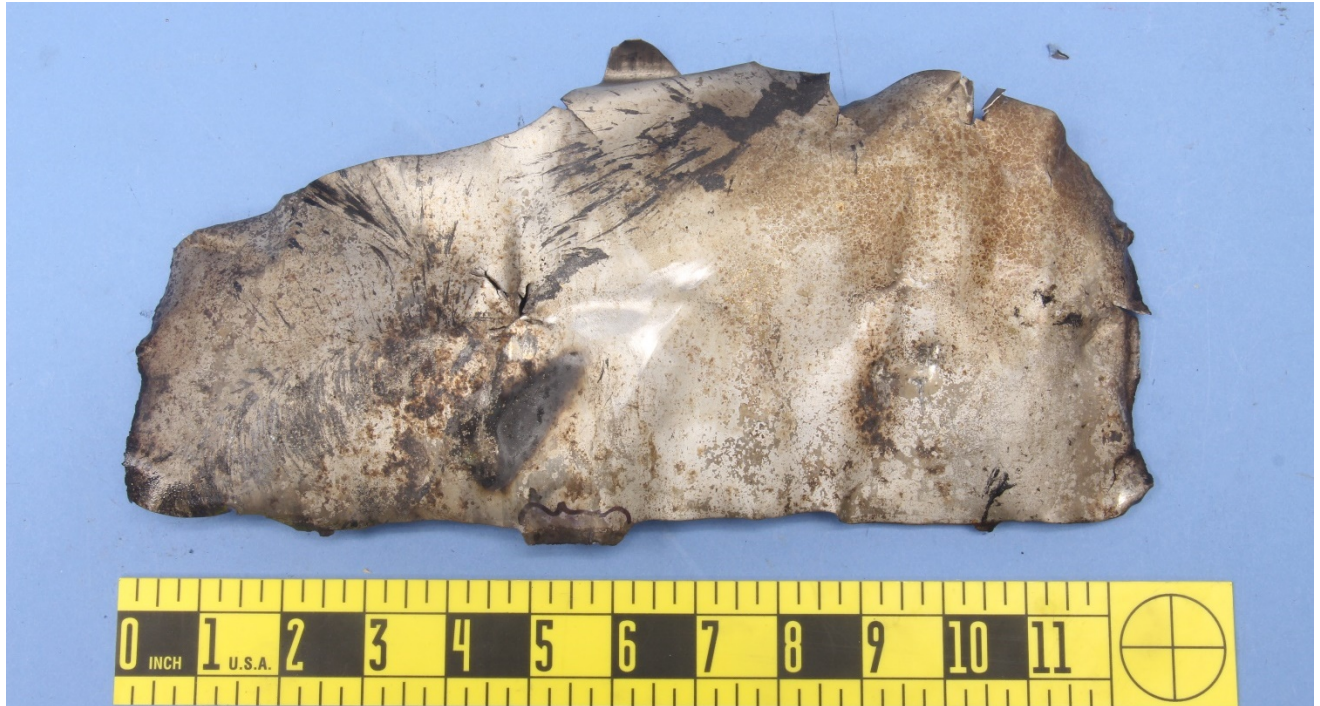
The portions of the flange remnant fracture surface that corresponded to the downward protrusions in Figure 4 did not manifest as upward protrusions themselves. Rather, these regions were recessed in location, and appeared flatter, more faceted, and darker in appearance. Figure 8 shows a transition of the flange remnant between a flatter portion of the fracture surface, and the fracture surface on the thin, reflective protrusions.

Figure 4 – View of the bleed air duct remnant, after flattening. The fracture surface that mates with the flange remnant on the bottom, with the mating longitudinal fractures on the sides.

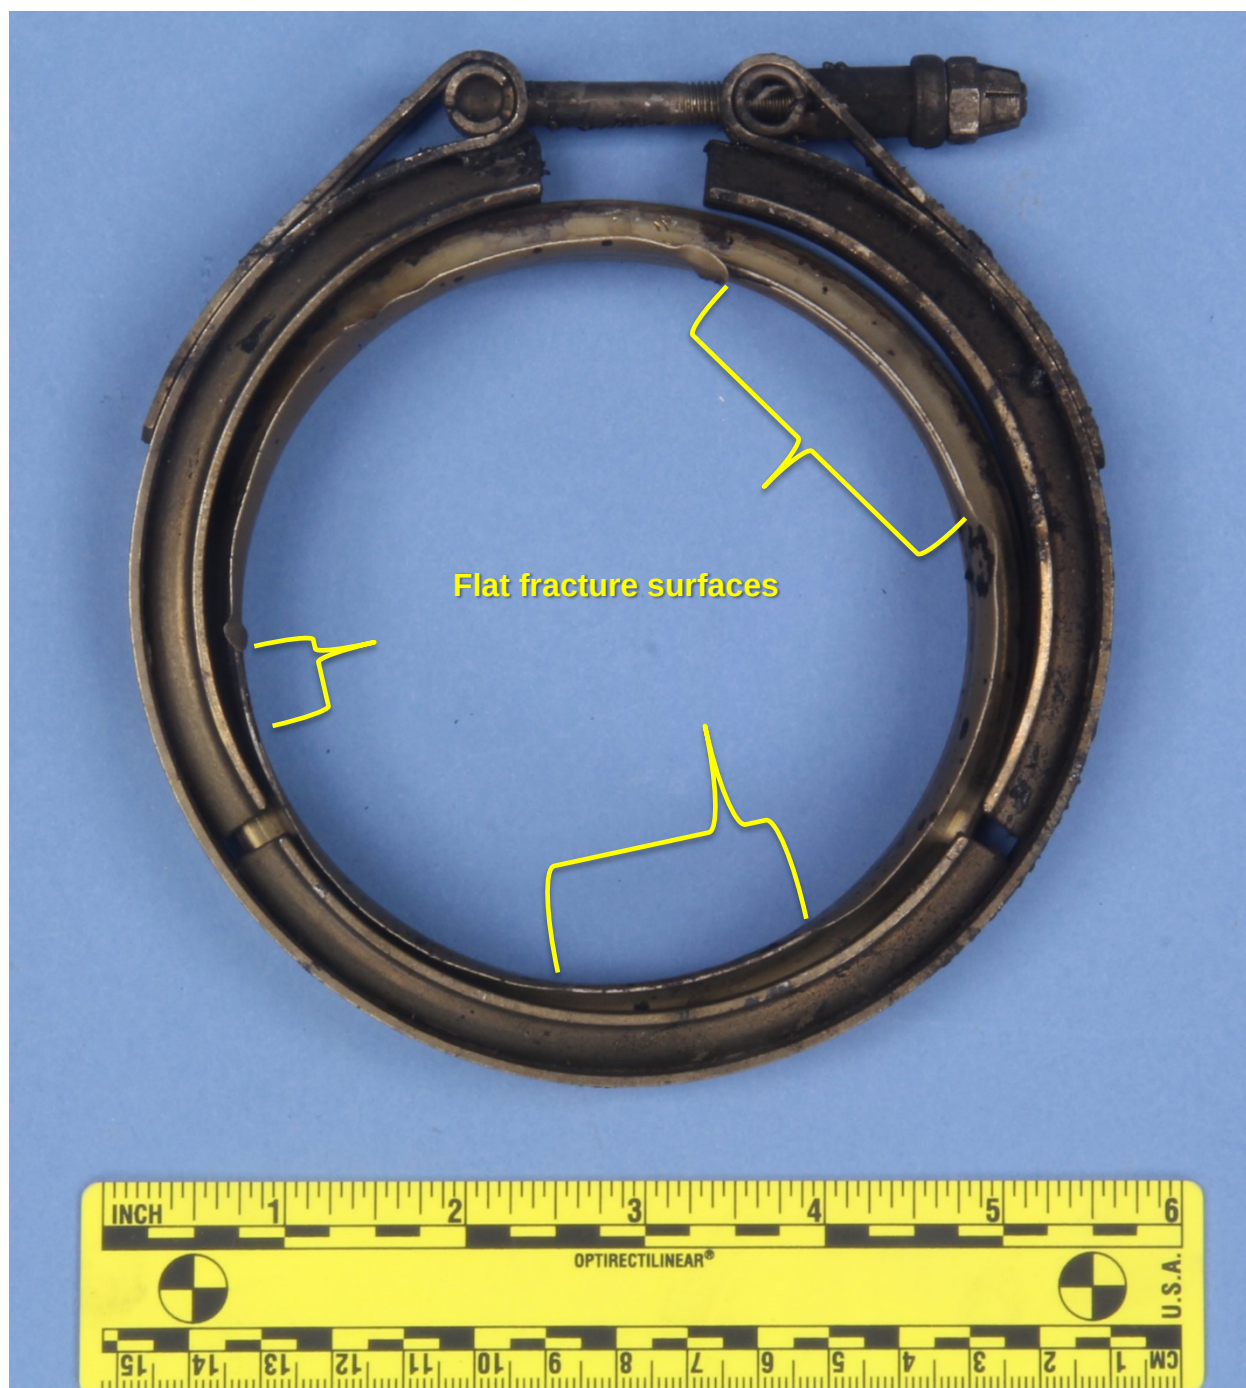
Figure 5 – View of the bleed air duct flange remnant, in the V-clamp, as received. The areas with flat fracture surfaces adjacent to the weld are annotated.

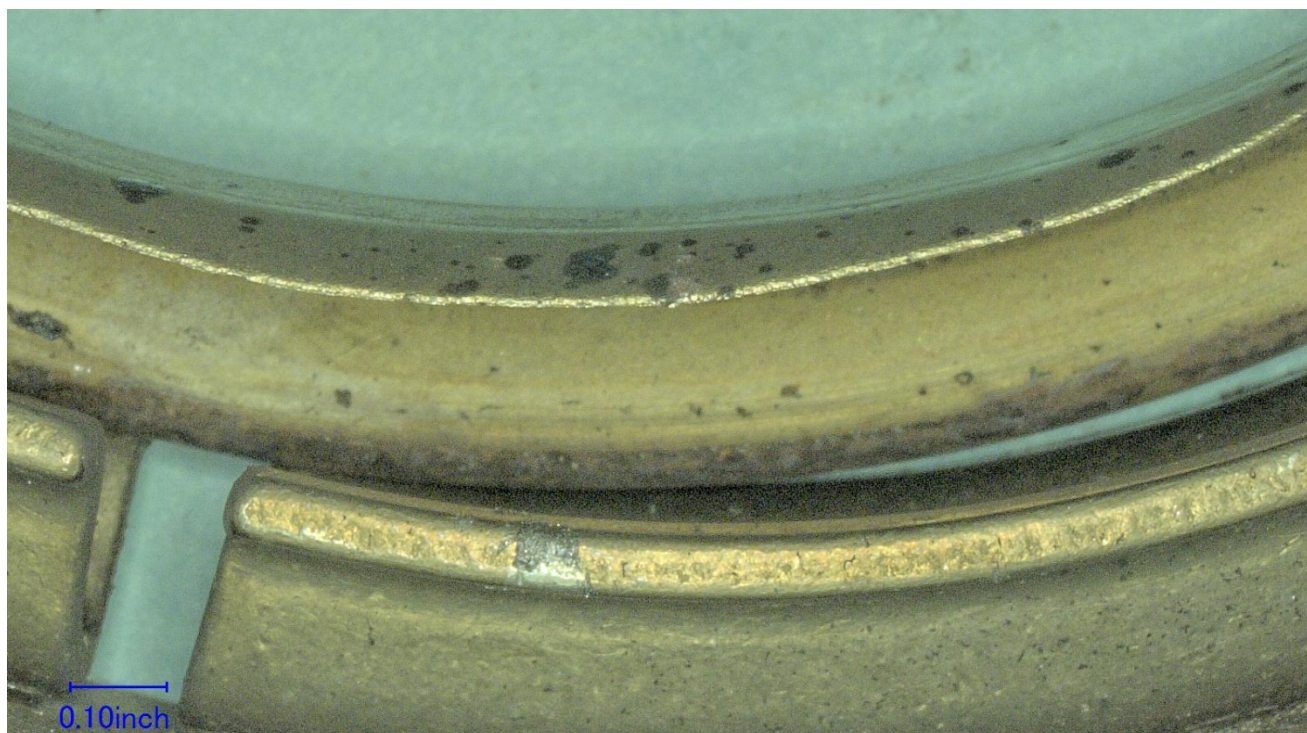
Most of the flange remnant exhibited protruding portions that were the circumferential fracture surface of the duct. As typified in Figure 6 and Figure 7, these areas exhibited localized necking or thinning deformation adjacent to the fracture surface. There were also indications of localized surface tears, parallel to the fracture surface. The fracture surface, shown in Figure 7, was oriented at approximately 45° towards the duct interior, with a generally rough but reflective surface texture.

Figure 6 – View of a typical area of the flange remnant fracture surface that was protruding outward.

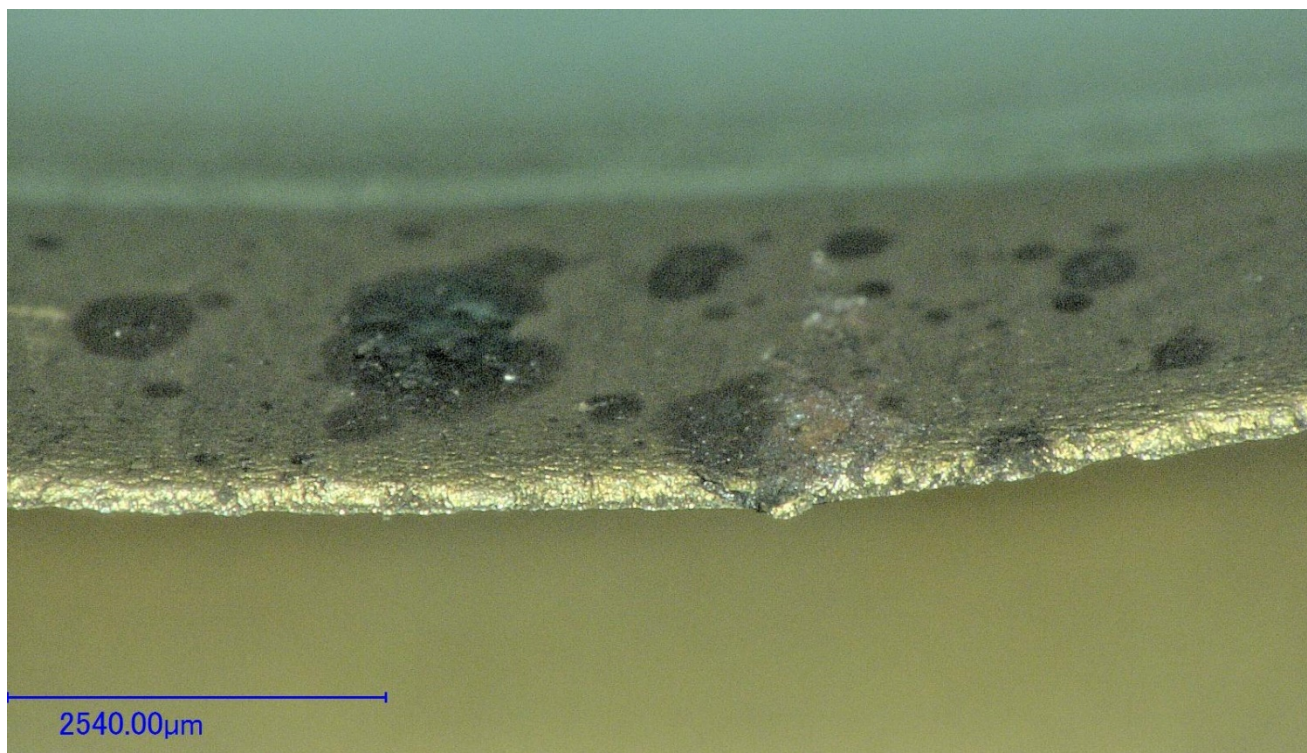
Figure 7 – Closer view of the fracture surface in Figure 6, showing localized thinning and plastic deformation.

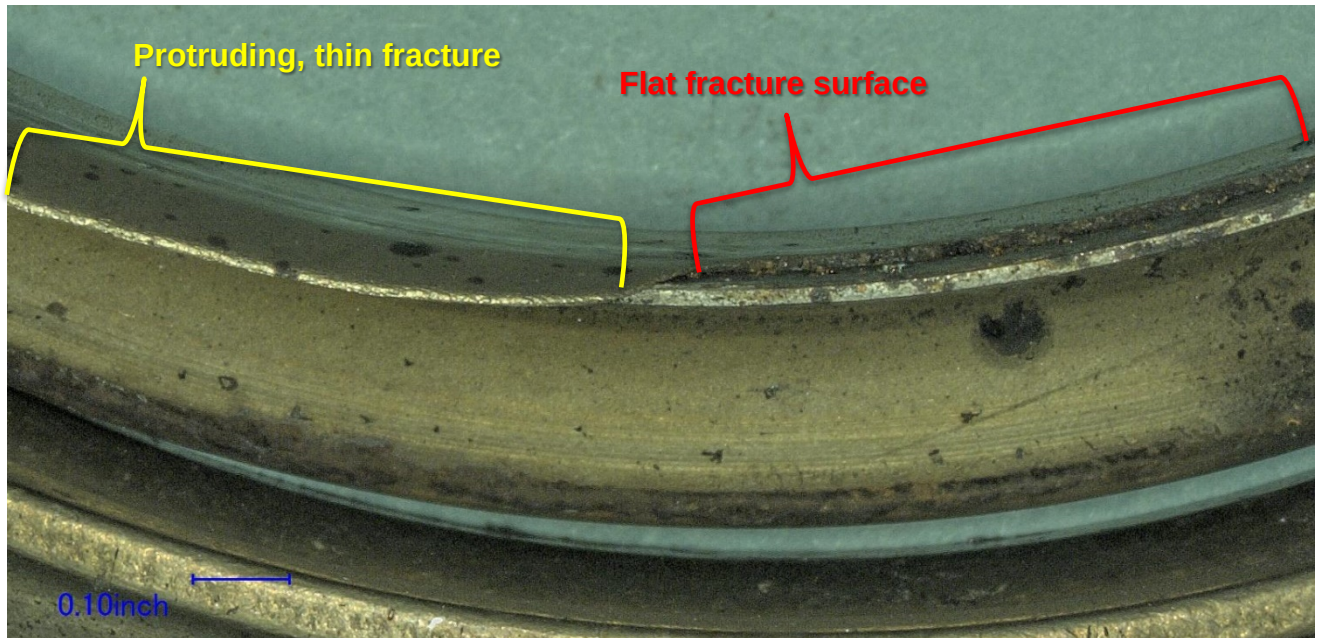
Figure 8 – Section of the flange fracture showing a difference between the protruding, thinned regions (left) and the flatter, rough near-weld fracture (right).

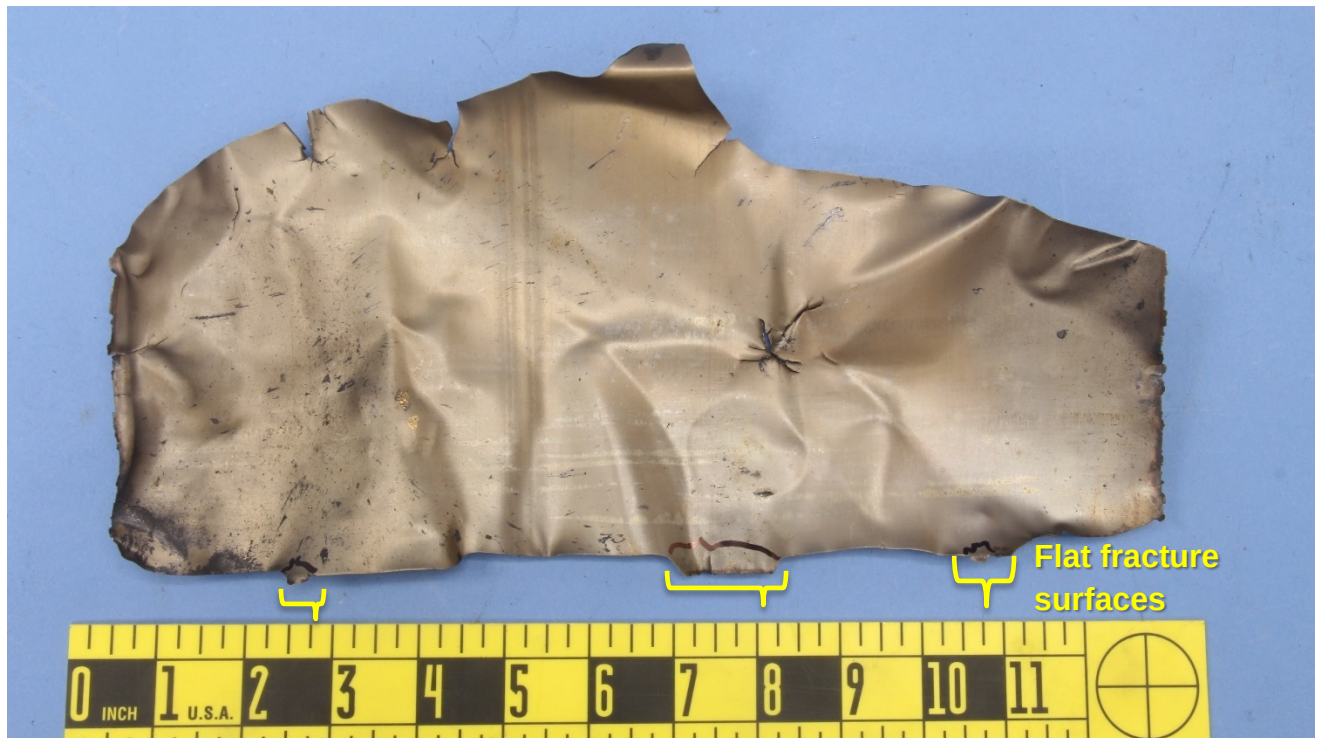
Figure 9 shows the interior surface of the flattened and cleaned duct remnant, with the three downward protruding portions of the circumferential fracture surface highlighted. The (circumferential) lengths of these areas were 1.149, 0.523, and 0.244 inches, from longest to shortest. The longest one is highlighted in Figure 10. This part of the circumferential fracture was generally flat and rough, exhibiting a darker brown color adjacent to the fracture surface, with vertical perpendicular cracks. This fracture region corresponded to the mating flat fracture area of the flange remnant, shown in Figure 11. Figure 12 and Figure 13 show the mating faces of the circumferential crack between the flattened duct remnant and sectioned flange remnant at the shorter protrusions.

Figure 9 – View of the inside surface of the flattened duct remnant, after cleaning. The fracture surface mating the flange remnants faces downward in the figure.

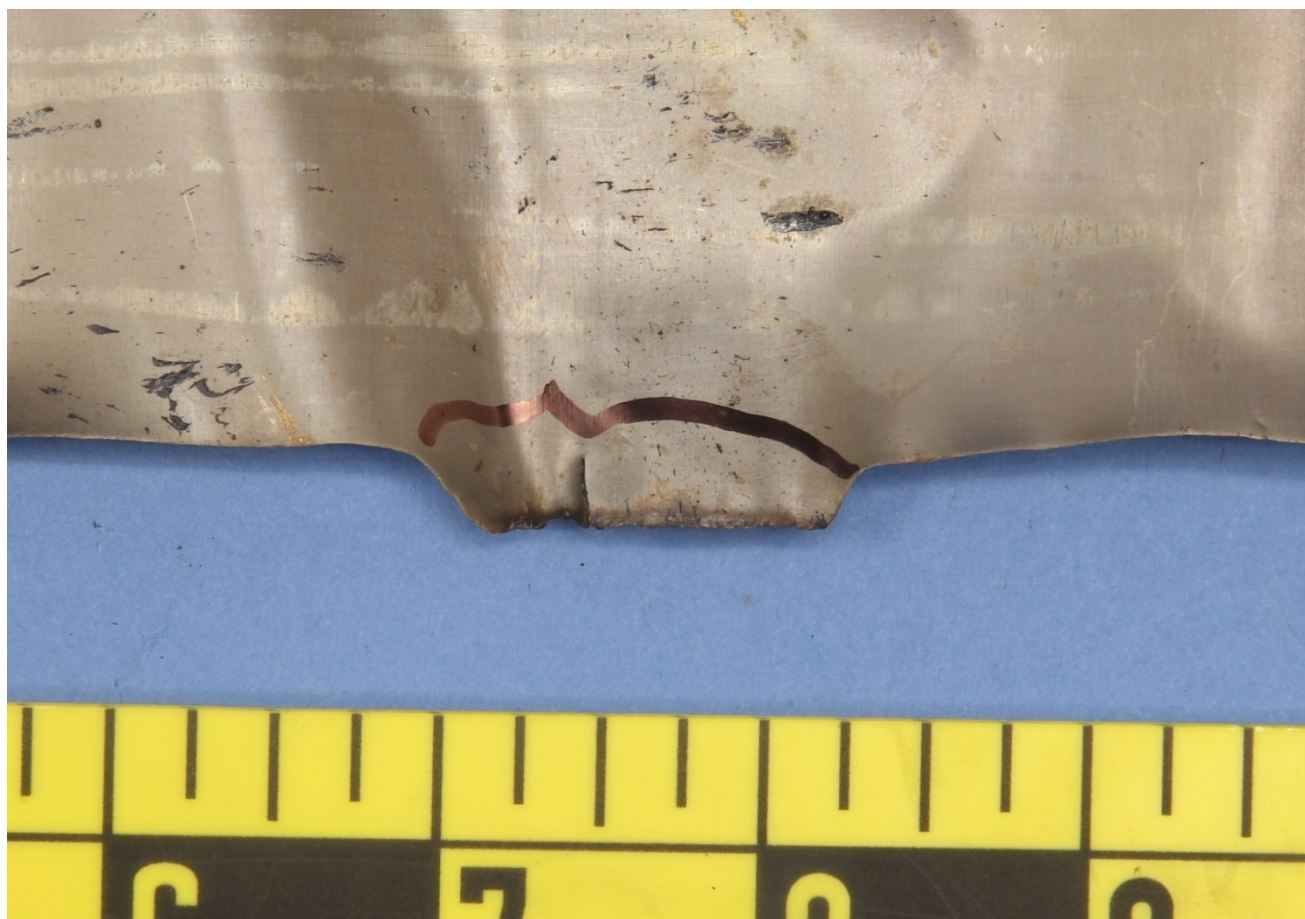
Figure 10 – The largest area of a downward-protruding portion of the bottom fracture surface of the duct remnant, which mates with the largest flat fracture area on the flange (Figure 11).

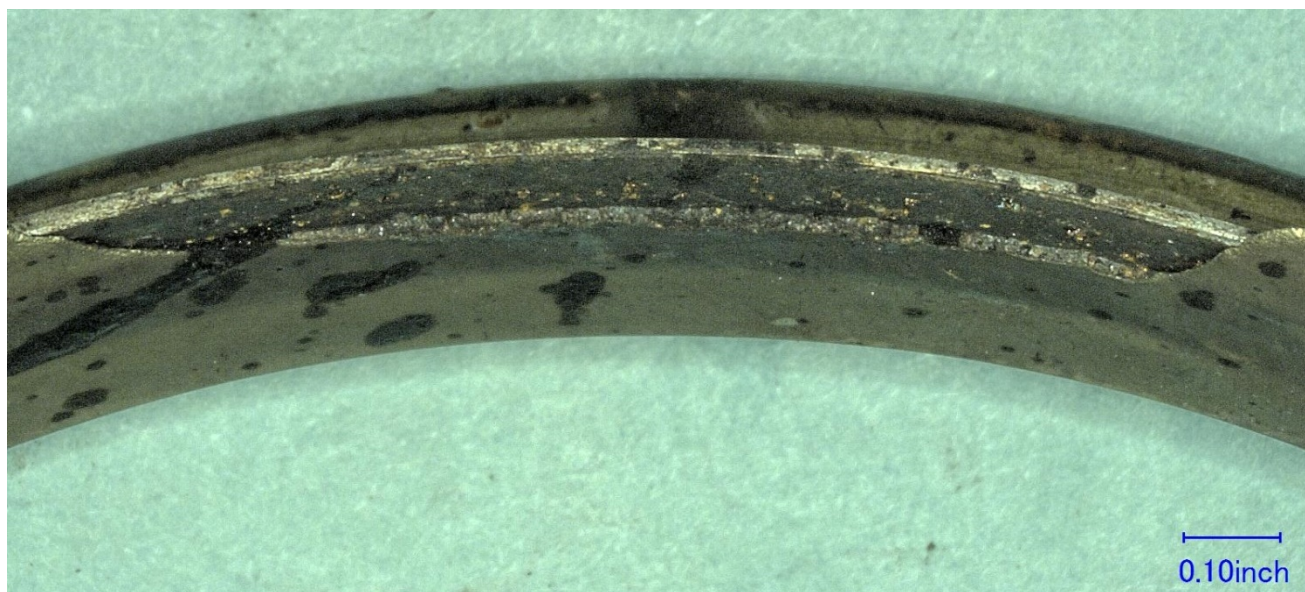
Figure 11 – The flat-fracture surface region near the weld on the duct flange remnant, which mates with the duct fracture section in Figure 10.

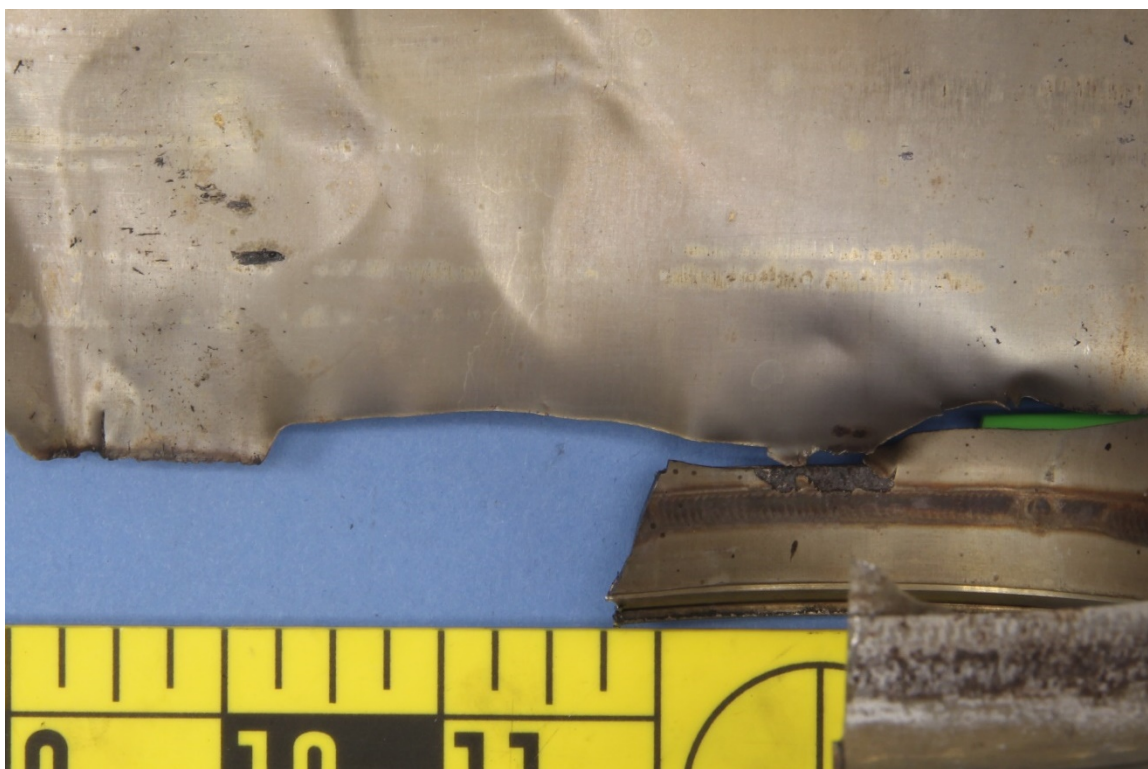
The flange assembly remnant consisted of a remnant of the duct tube (inner part) that was joined to the exterior-facing flange piece. The pieces were joined by a circumferential weld approximately 0.25 inch thick. This was visible as the dark brown ring on the flange fragment in Figures 12 and 13. The fracture surface was located above the circumferential weld in the figures.

Figure 12 – View of one of the other mating flat-fracture regions of the duct remnants.

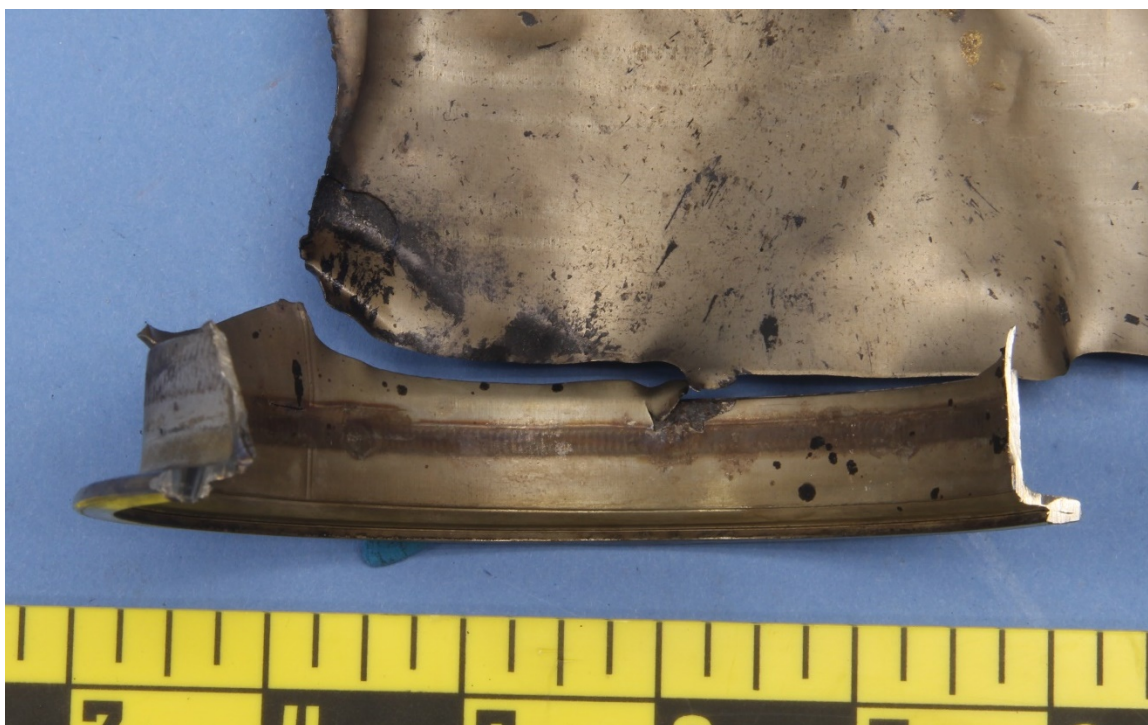
Figure 13 – View of one of the other mating flat-fracture regions of the duct remnants.

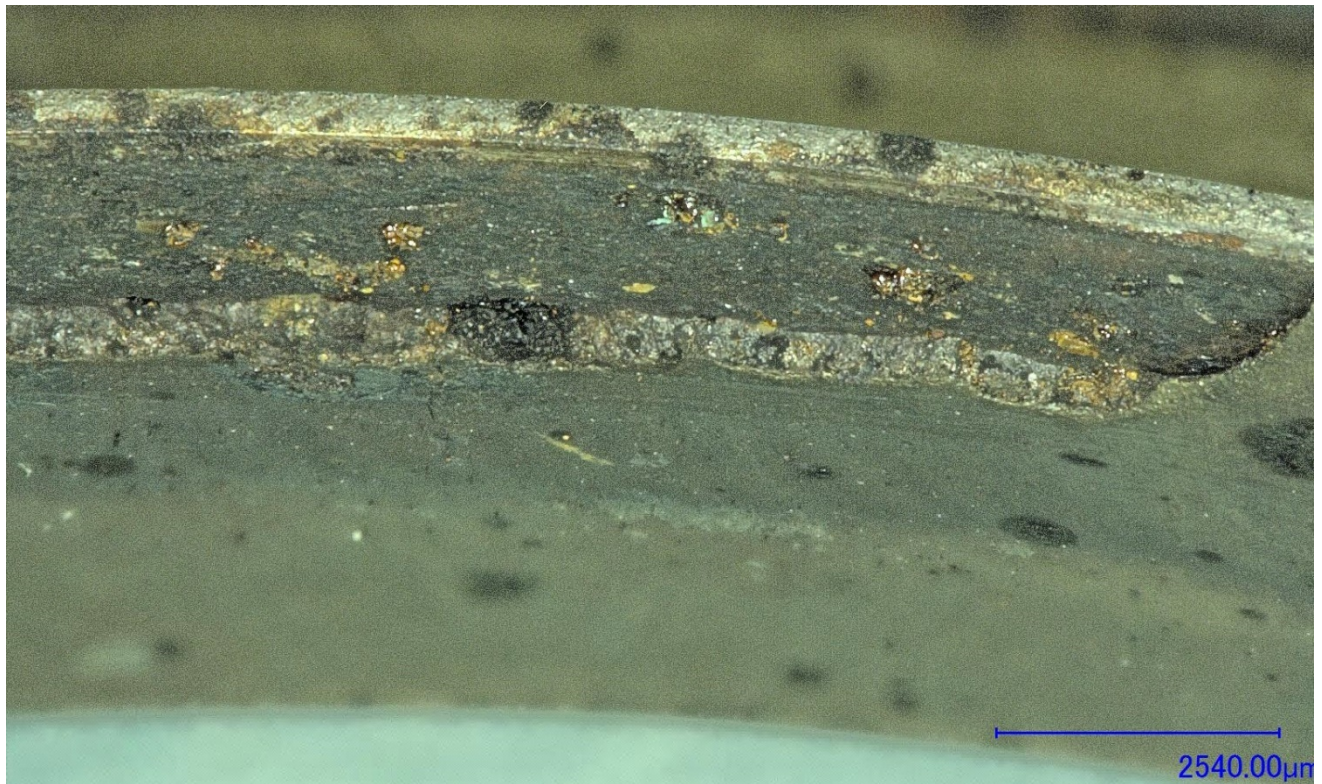
Figures 14 and 15 show closer views of the flat fracture regions from the flange remnant. While the thinned elongated fracture areas of the duct were located up to 0.5 inches above the weld boundary, these flatter fractures were located just above the circumferential weld, which joined the inner duct to the outer flange cap. Figure 16 shows the duct remnant region that mated with the flat fracture in Figure 14. This area also exhibited several vertical cracks, oriented perpendicular to the fracture surface. These cracks were consistent with having initiated on the fracture surface and progressing upward in the figure.

Figure 14 – Closer view of the edge of the flat fracture of the duct flange.

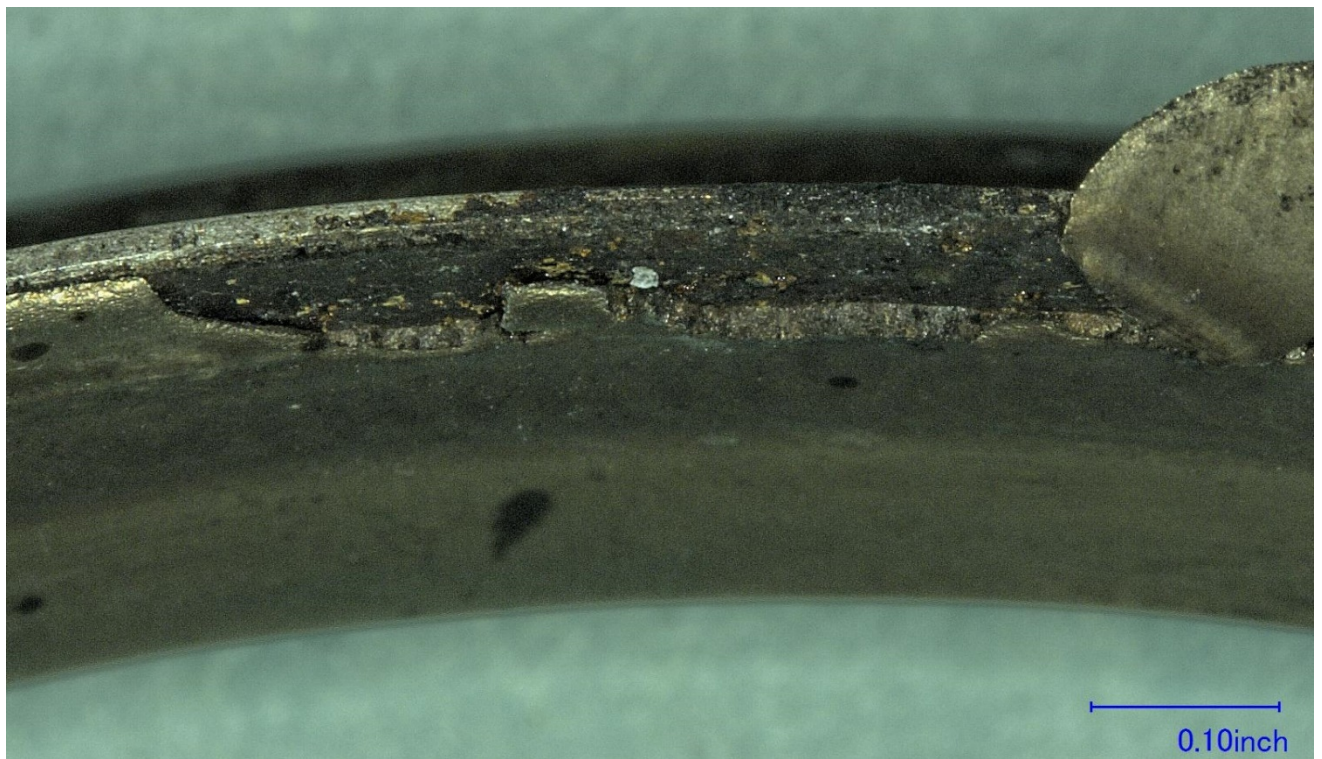
Figure 15 – Closer view of the flat fracture region shown in Figure 13.

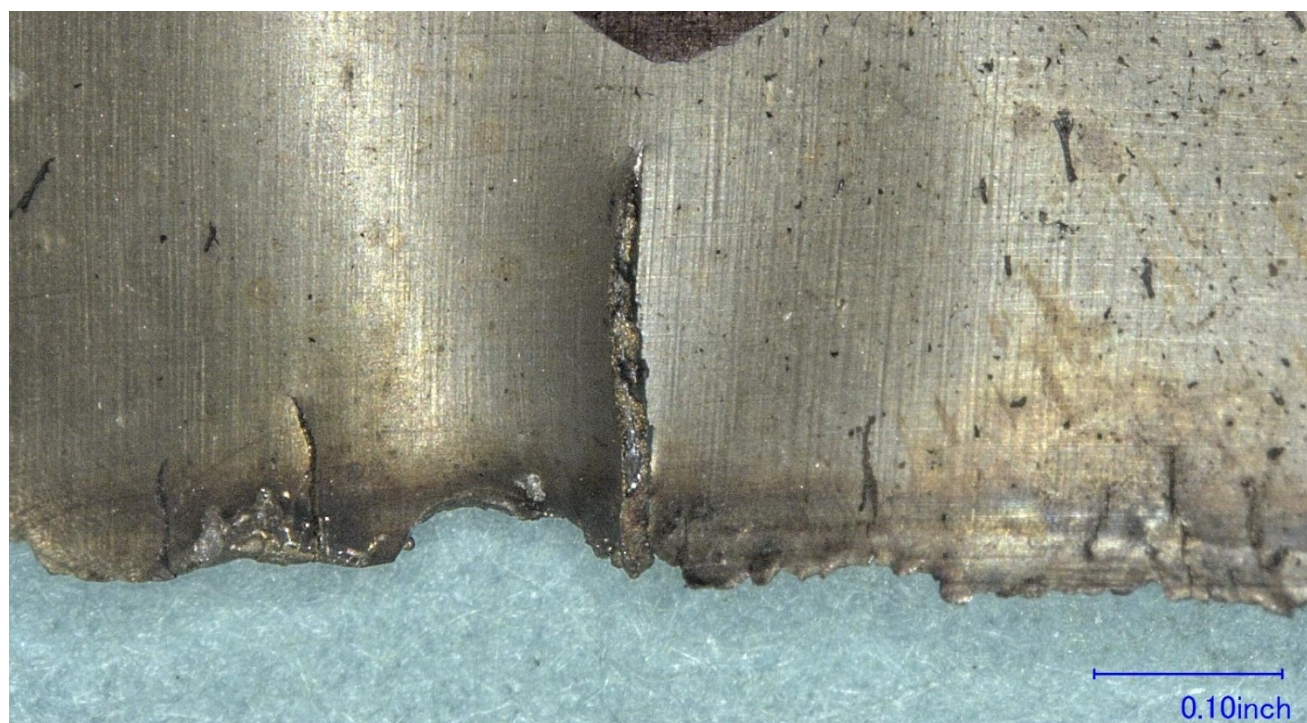
Figure 16 – Closer view of the larger flat fracture region of the duct from Figure 10.

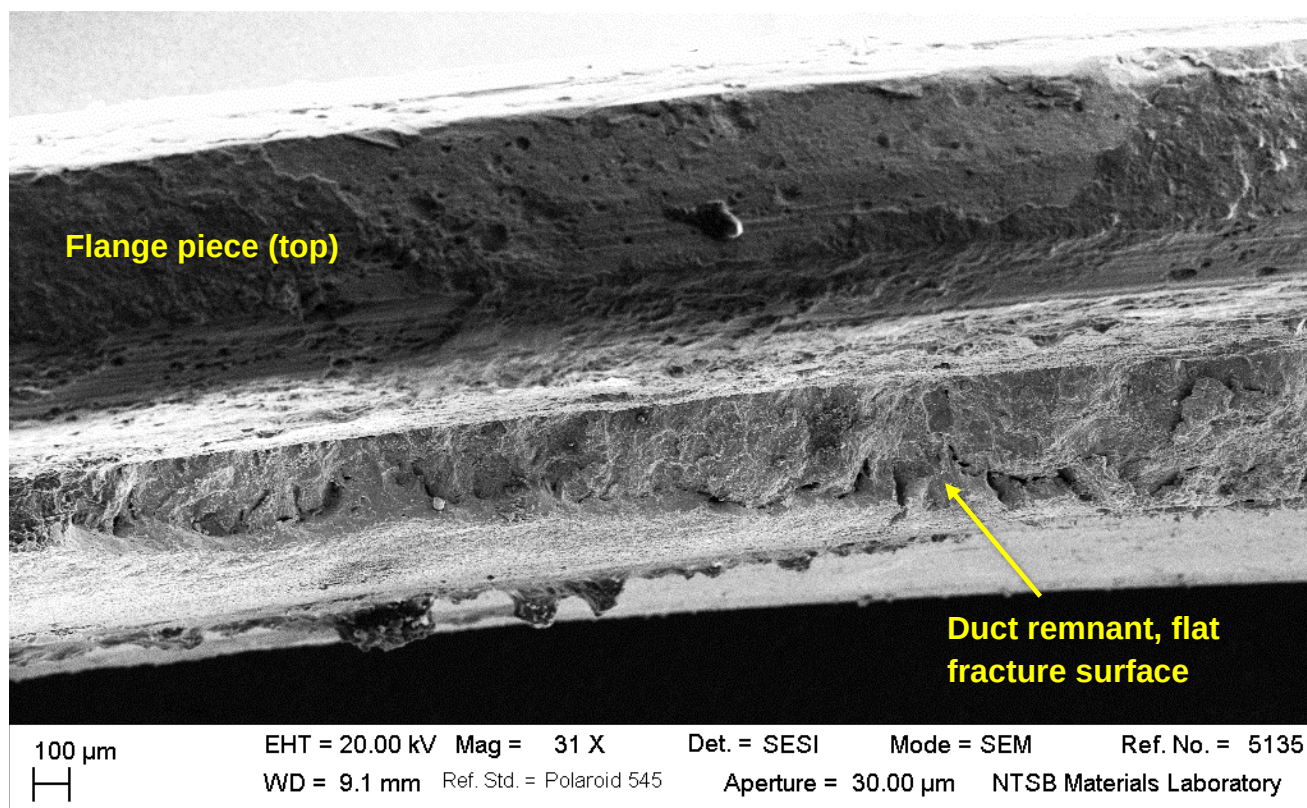
The flange remnant was sectioned in several places to allow for optical and electron microscopy examination of the fracture surface. Figure 17 shows a typical view of the largest flat fracture region on the flange remnant as imaged in a scanning electron microscope (SEM). As labeled in the figure, the fracture surface of the duct is located the bottom of the figure and is recessed in this view, while the flange portion on the upper area of the figure protrudes upward towards the reader. The fracture was oriented perpendicular to the duct and flange directions.

Figure 17 – Secondary electron (SE) micrograph of a typical region of the flat fracture region of the flange remnant shown in Figure 14.

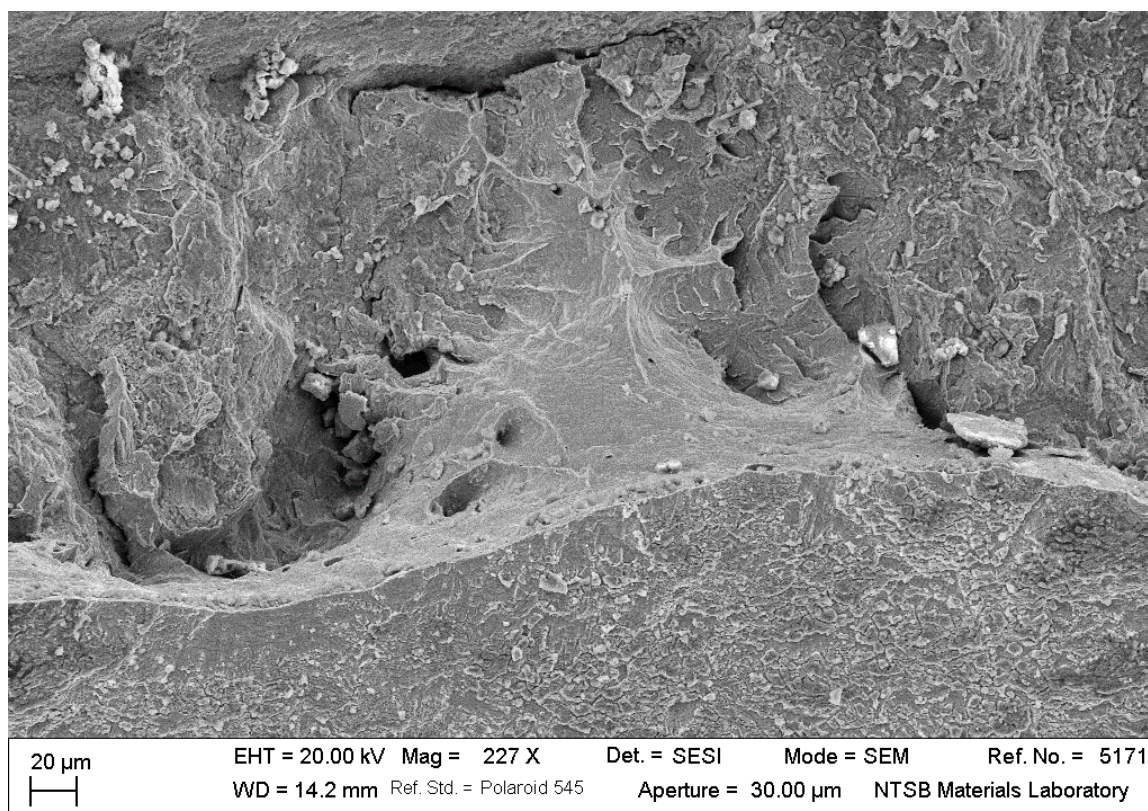
Figure 18 shows a typical area of the flat fracture surface. The fracture surface exhibited multiple features, including cleavage facets, porosity, and secondary cracking. In other areas, the features were predominantly dimpled rupture, as illustrated in Figure 19. The dimpled rupture on the flat fracture was primarily oriented in a parallel lamellar manner, consistent with fracture along the elongated grain direction of the rolled duct sheet. On the inside-facing surface of the duct remnant weld region below the fracture surface, the weld exterior exhibited a lenticular surface, as shown in Figure 20. These features were consistent with rumpling of the exterior metal oxide scale that formed during and after the welding process. The surface attains this surface morphology when the weld metal solidifies and cools, causing shrinkage. As these features were located on the exterior weld surface, they were inconsistent with typical progressive cracking features such as striations.

Figure 18 – SE micrograph of the flat fracture showing porosity, cleavage, and secondary cracking.

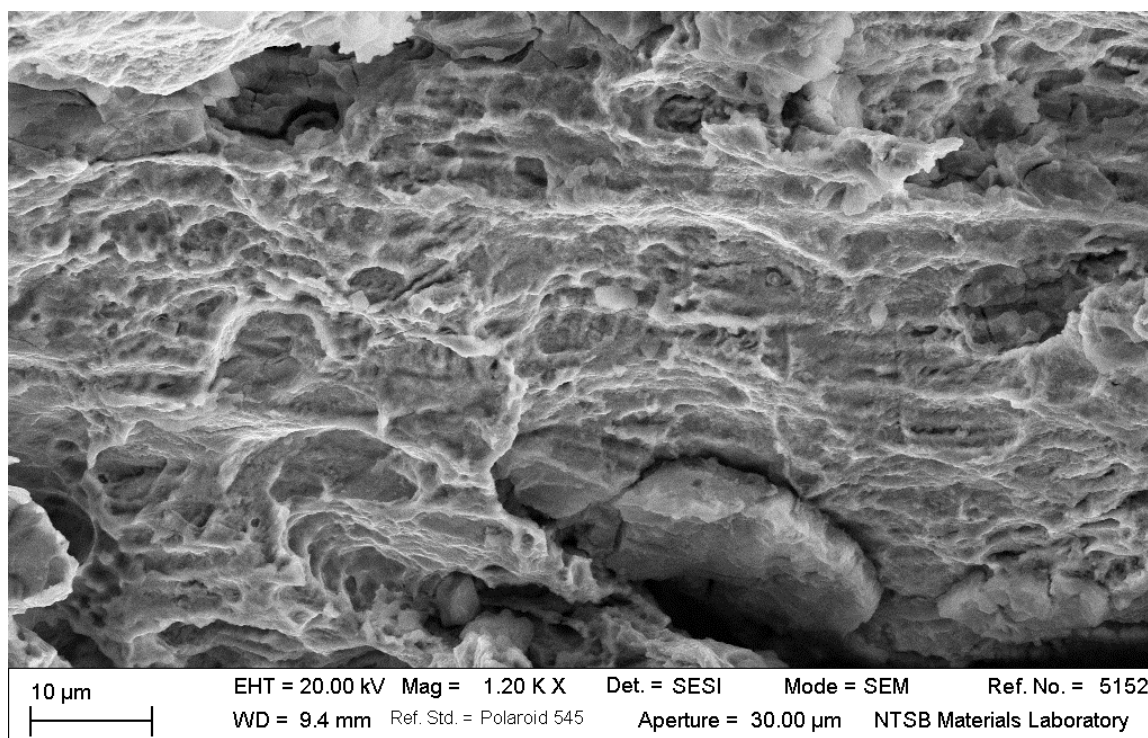
Figure 19 – SE micrograph of an area of the flat fracture showing dimpled rupture.

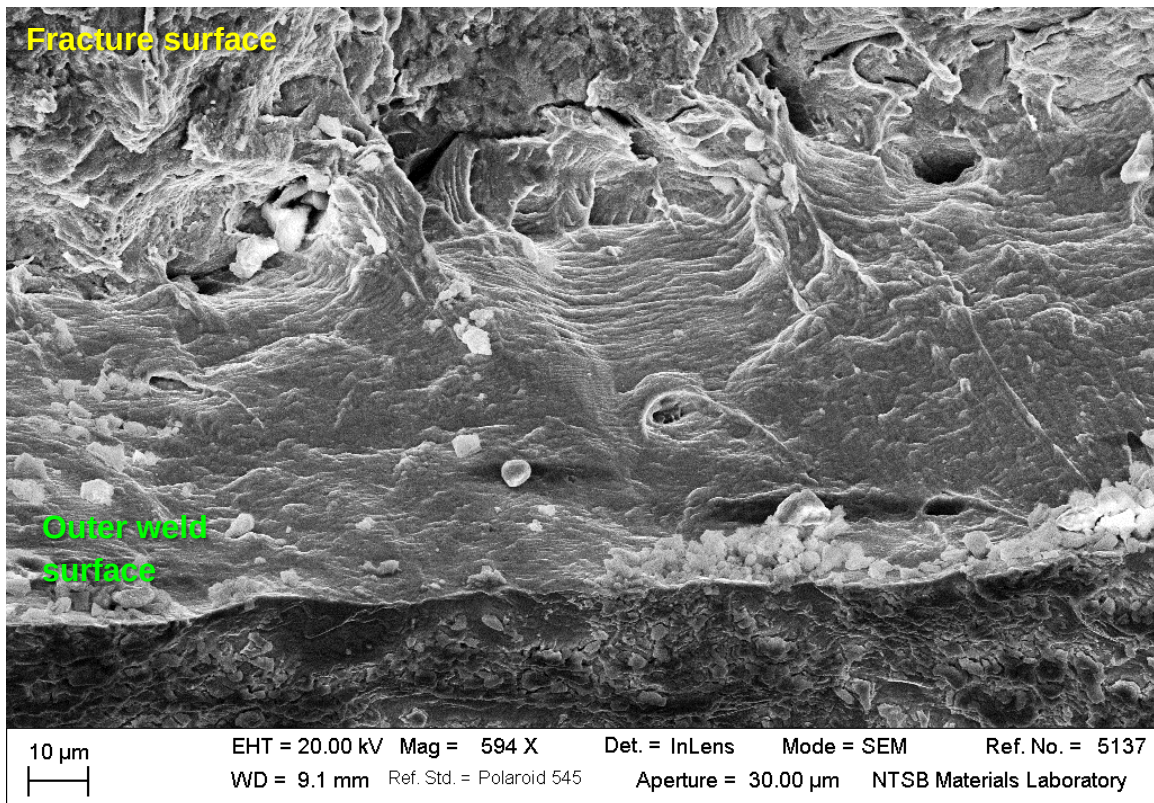
Figure 20 – SE micrograph of a portion of the lenticular weld surface (middle), adjacent the blocky fracture surface features (upper).
