# NATIONAL TRANSPORTATION SAFETY BOARD

## MATERIALS LABORATORY FACTUAL REPORT

Report No. 20-036

Place : Santa Barbara, California  
Date : September 25, 2019  
Vehicle : Lockheed C-130A, N119TG  
NTSB No. : WPR19LA242  
Investigator : Tealeye Cornejo, AS-WPR

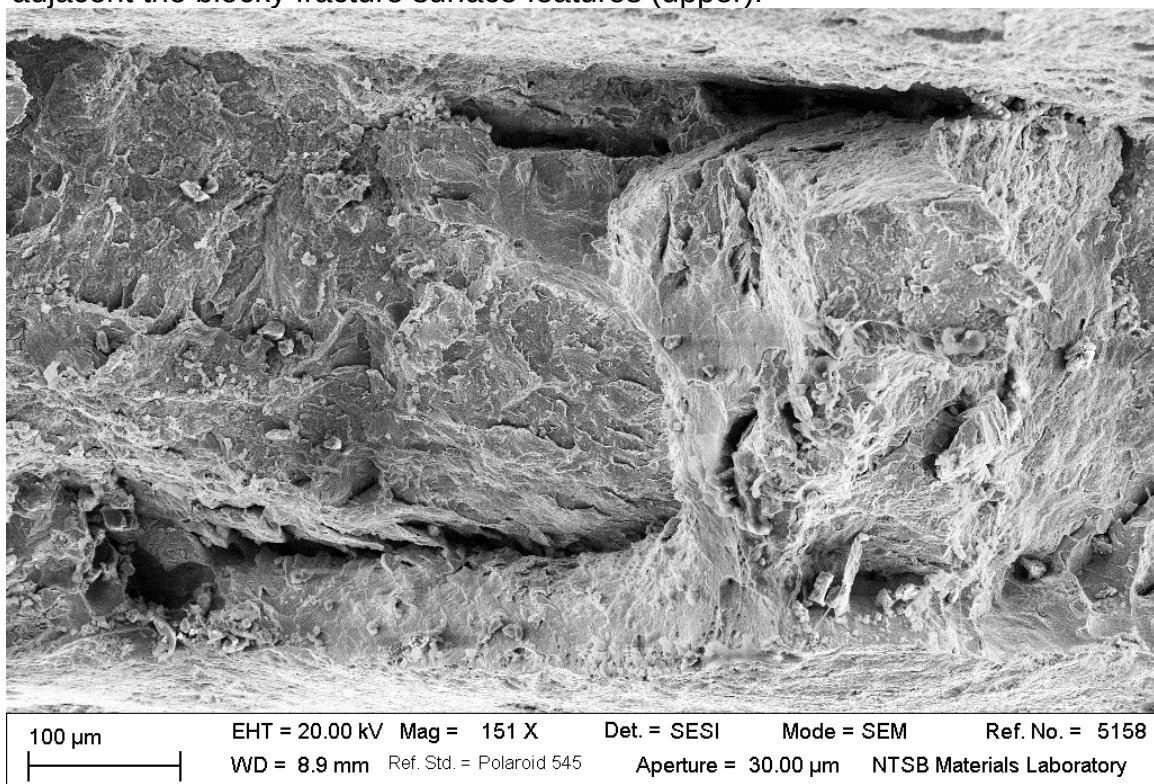
Figure 21 highlights some of the secondary cracking and cleavage features observed on the fracture surface. Secondary cracking means fractures or cracks oriented in directions perpendicular to the fracture surface. These features were consistent with branched cracking in multiple directions. This figure also showed porosity, with tearing near the pores. These features tended to be located toward the exterior surface of the duct remnant (facing downward in Figure 21) and adjacent to the weld location with the flange remnant. The cleavage features were widespread on the fracture surface, as exemplified in Figure 22. Cleavage is a preferential fracture mode along low-energy planes of the metal alloy, consistent with reduced ductility. Since dimpled rupture was observed sporadically

Figure 21 – SE micrograph showing perpendicular tearing in the weld fracture.

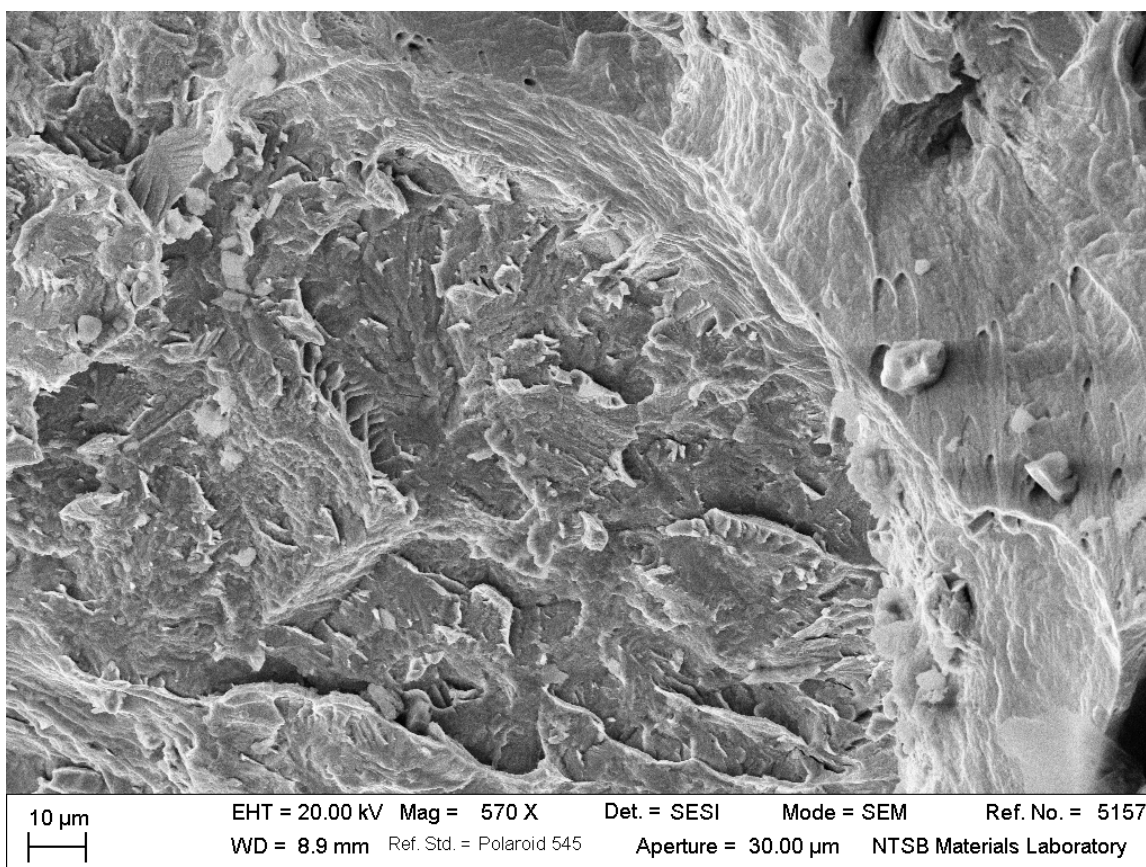
Figure 22 – SE micrograph of cleavage features on the flange flat fracture.

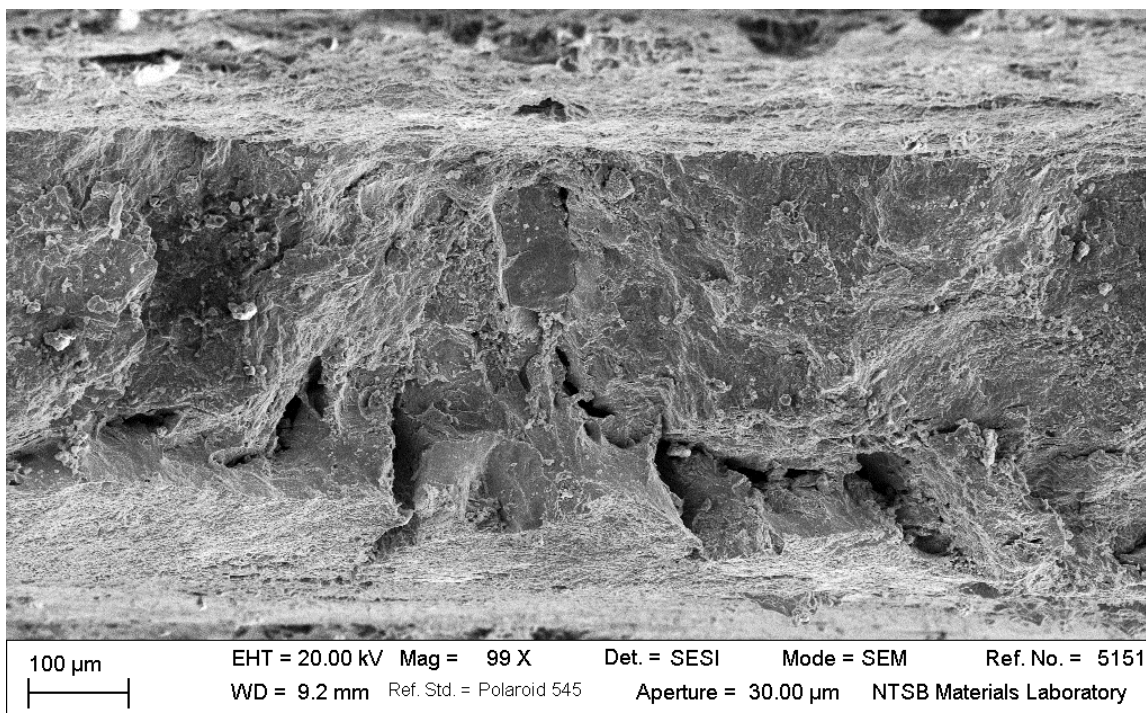
Figure 23 again shows an area of secondary cracking and cleavage fracture, along with more faceted features (center of the figure). Figure 24 highlights the faceted feature observed in the middle of Figure 23. This faceted feature was consistent with an isolated crystalline grain in this area, consistent with intergranular cracking. The sides of the grain facet show intergranular separation with the adjacent material, and some smearing on the right side—this smearing was consistent with movement of this grain along the adjacent material. Figure 25 shows another area of intergranular fracture. In this case, the faceted grains had partially separated from the surrounding material, leaving gaps along the intergranular fracture. Like in Figure 24, part of the separated grain had rubbed against the adjacent material.

Figure 23 – SE micrograph showing a flatter region of the fracture surface, with secondary cracking, and faceted surface features.

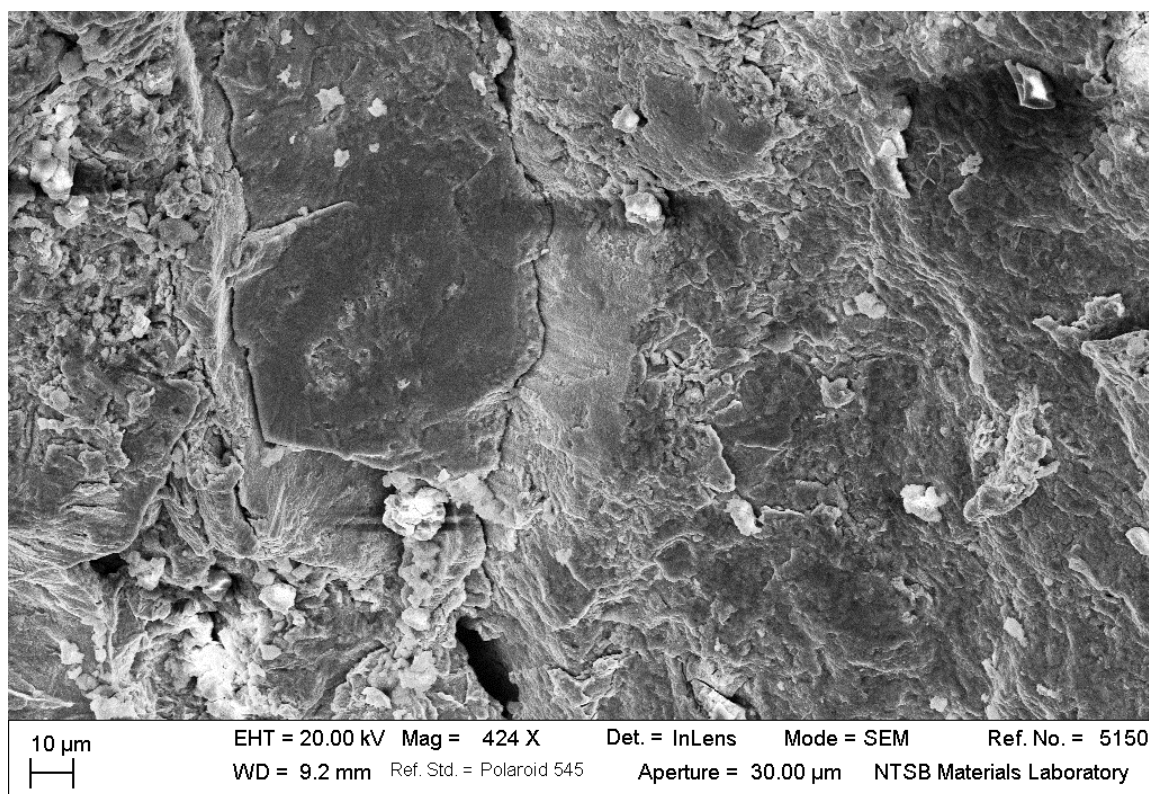
Figure 24 – SE micrograph showing one of the flatter faceted features.

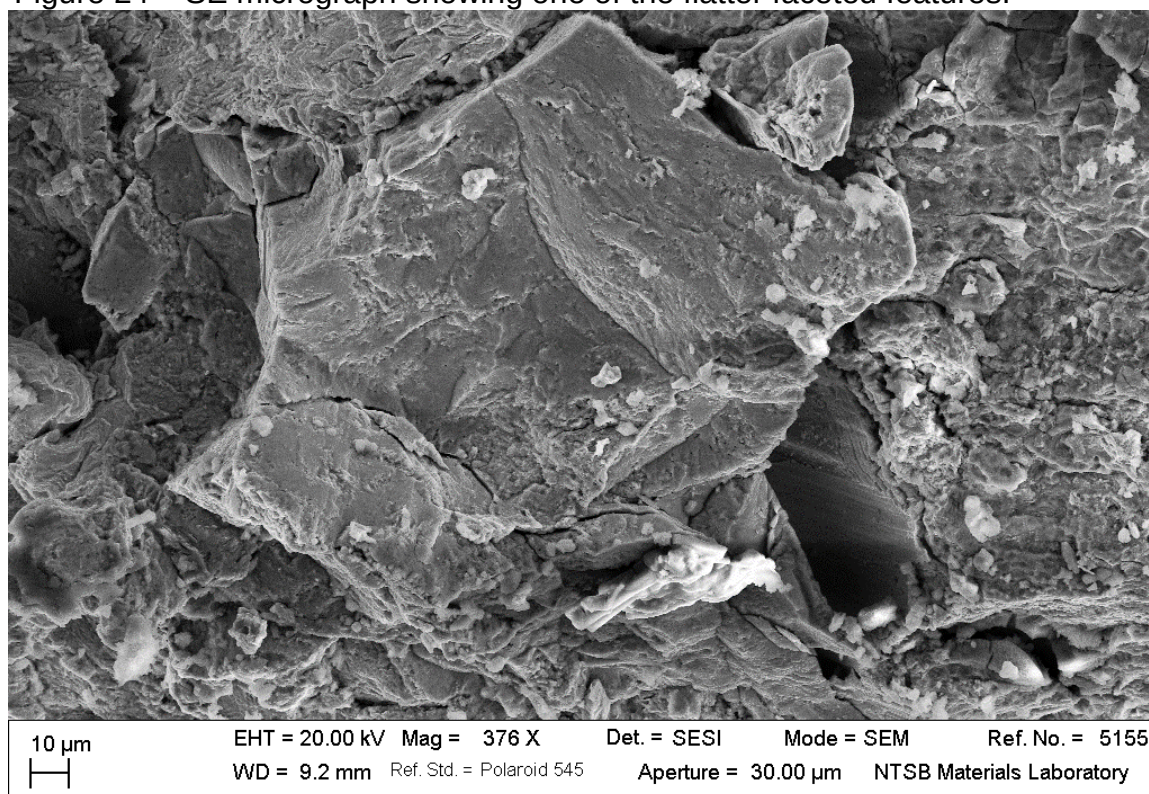
Figure 25 – SE micrograph showing a faceted area with intergranular fracture.

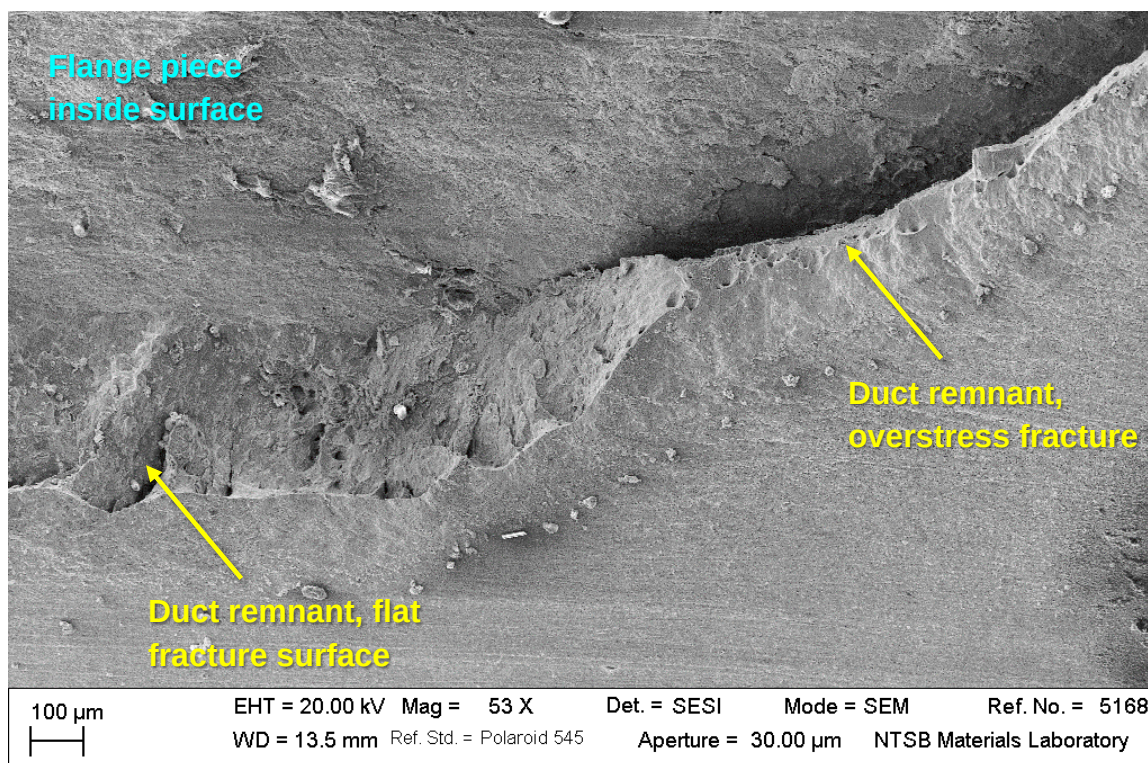
Towards the edges of the duct remnant flat fracture surface, localized thinning or necking became more prominent, as illustrated in Figure 26. At these ends of the flat fracture surface, rather than a perpendicular faceted surface, the fracture tapered. Along the right side of the fracture in Figure 26, the duct remnant had narrowed to an edge prior to fracture. Closer examination of these areas revealed equiaxed dimpled rupture, consistent with tensile overstress fracture in these areas.

Figure 26 – SE micrograph showing the transition from the flat to necked fracture.

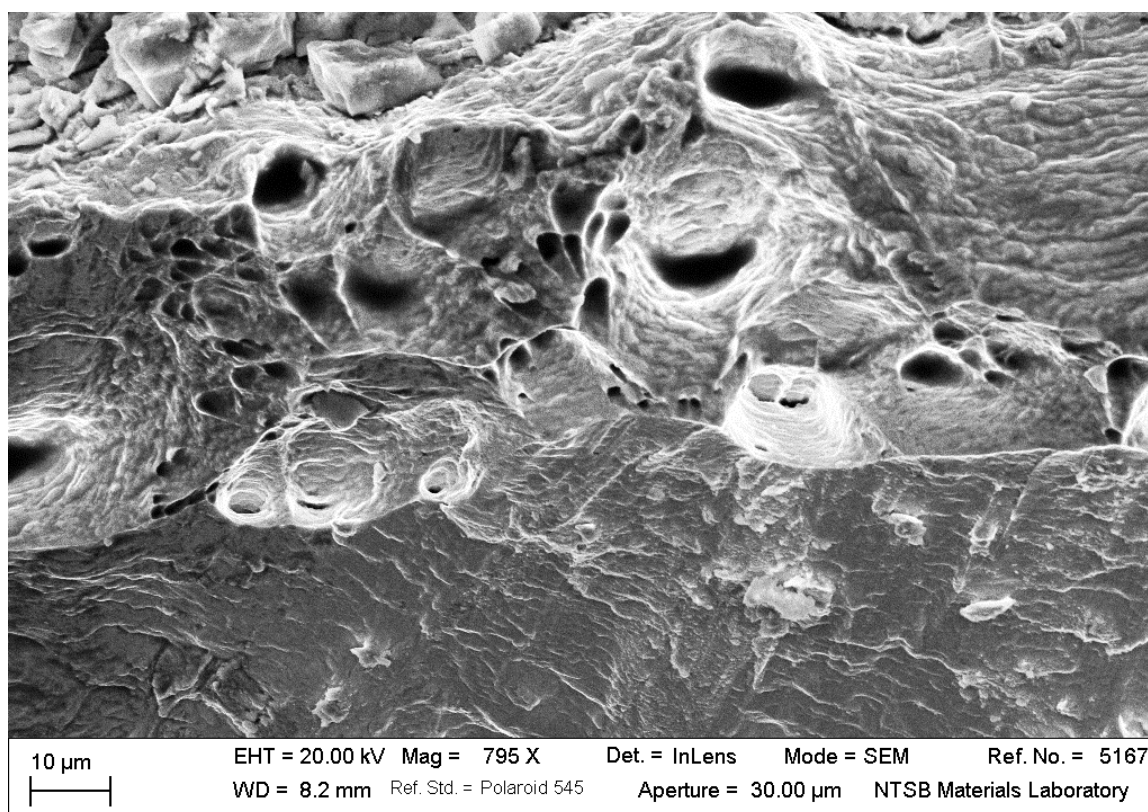
Figure 27 – SE micrograph showing dimpled rupture on the thinned fracture regions of the flange.

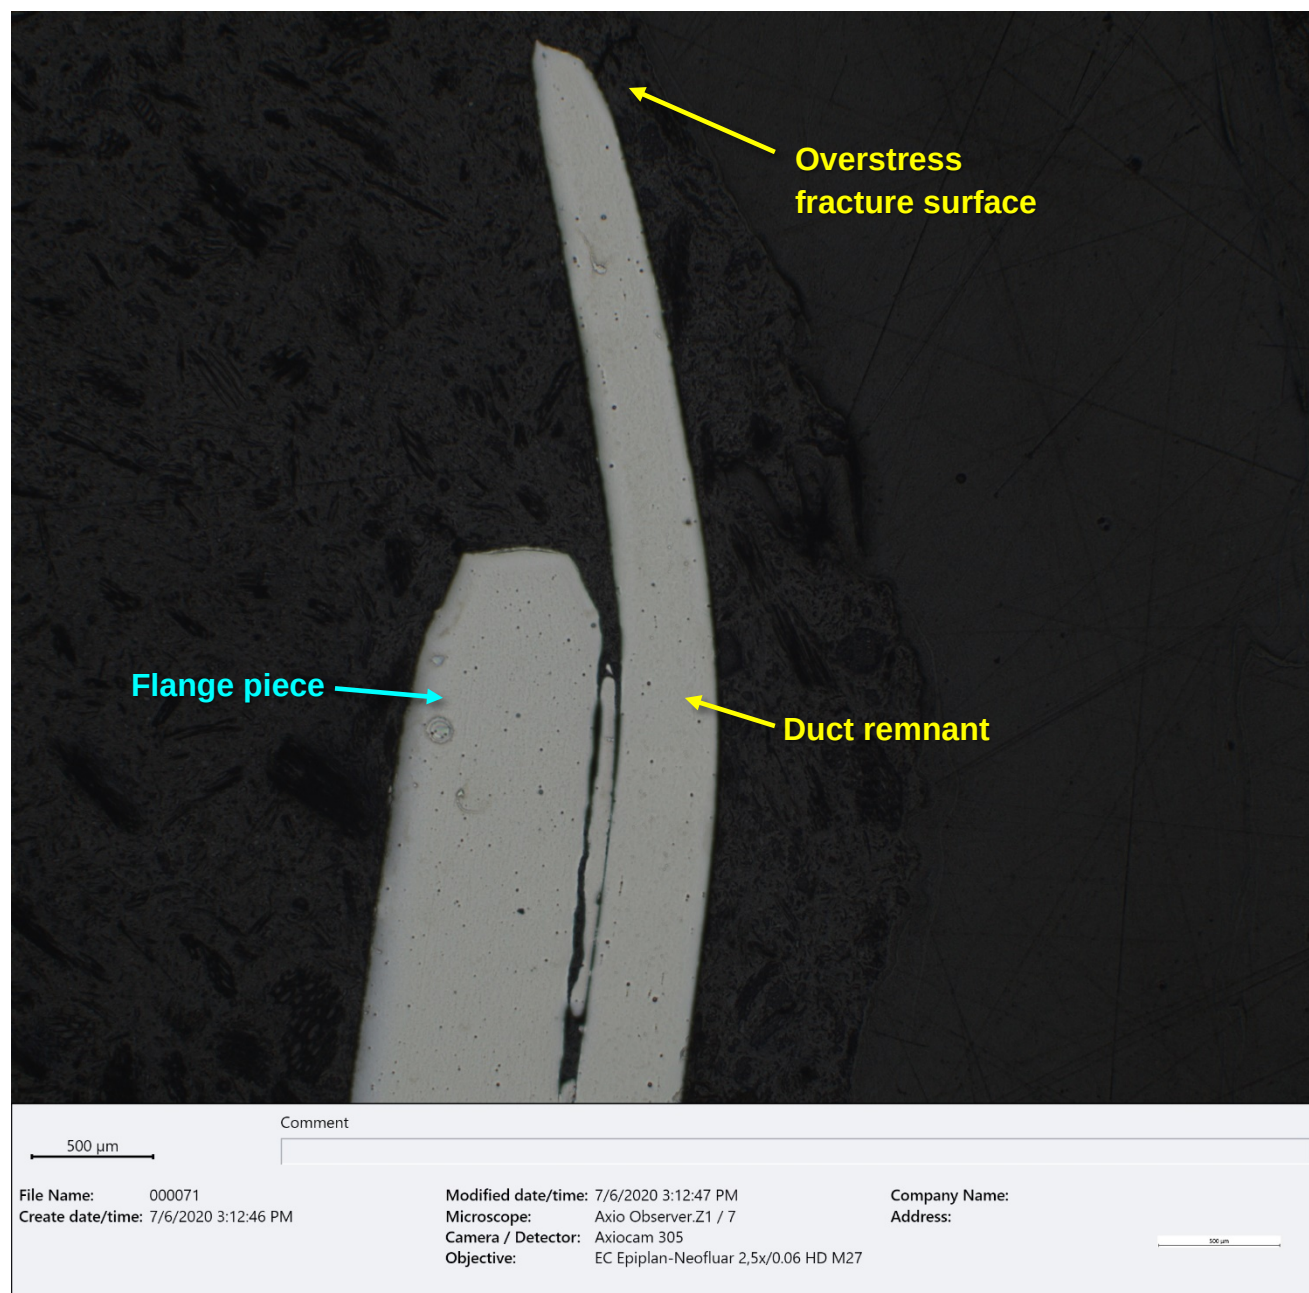
Cross sections were taken through the large flat fracture surface and an area with only overstress fracture. These cross sections were mounted, polished, and etched. Figure 28 shows a cross section of an area of overstress fracture. The left side shows the flange piece and the right side shows the fractured duct remnant, with the overstress fracture facing upward in the top portion of the figure. This area in the figure was above the welded region, and a gap was present between the flange piece and duct remnant. Figure 29 shows a cross-section of the overstress fracture of the duct away from the flange weld, showing grain elongation and localized necking consistent with plastic deformation near the fracture surface.

Figure 28 – Bright-field (BF) optical micrograph of a cross section of the flange weld fracture, showing a thin necked area (upper) (~25X, as-polished).

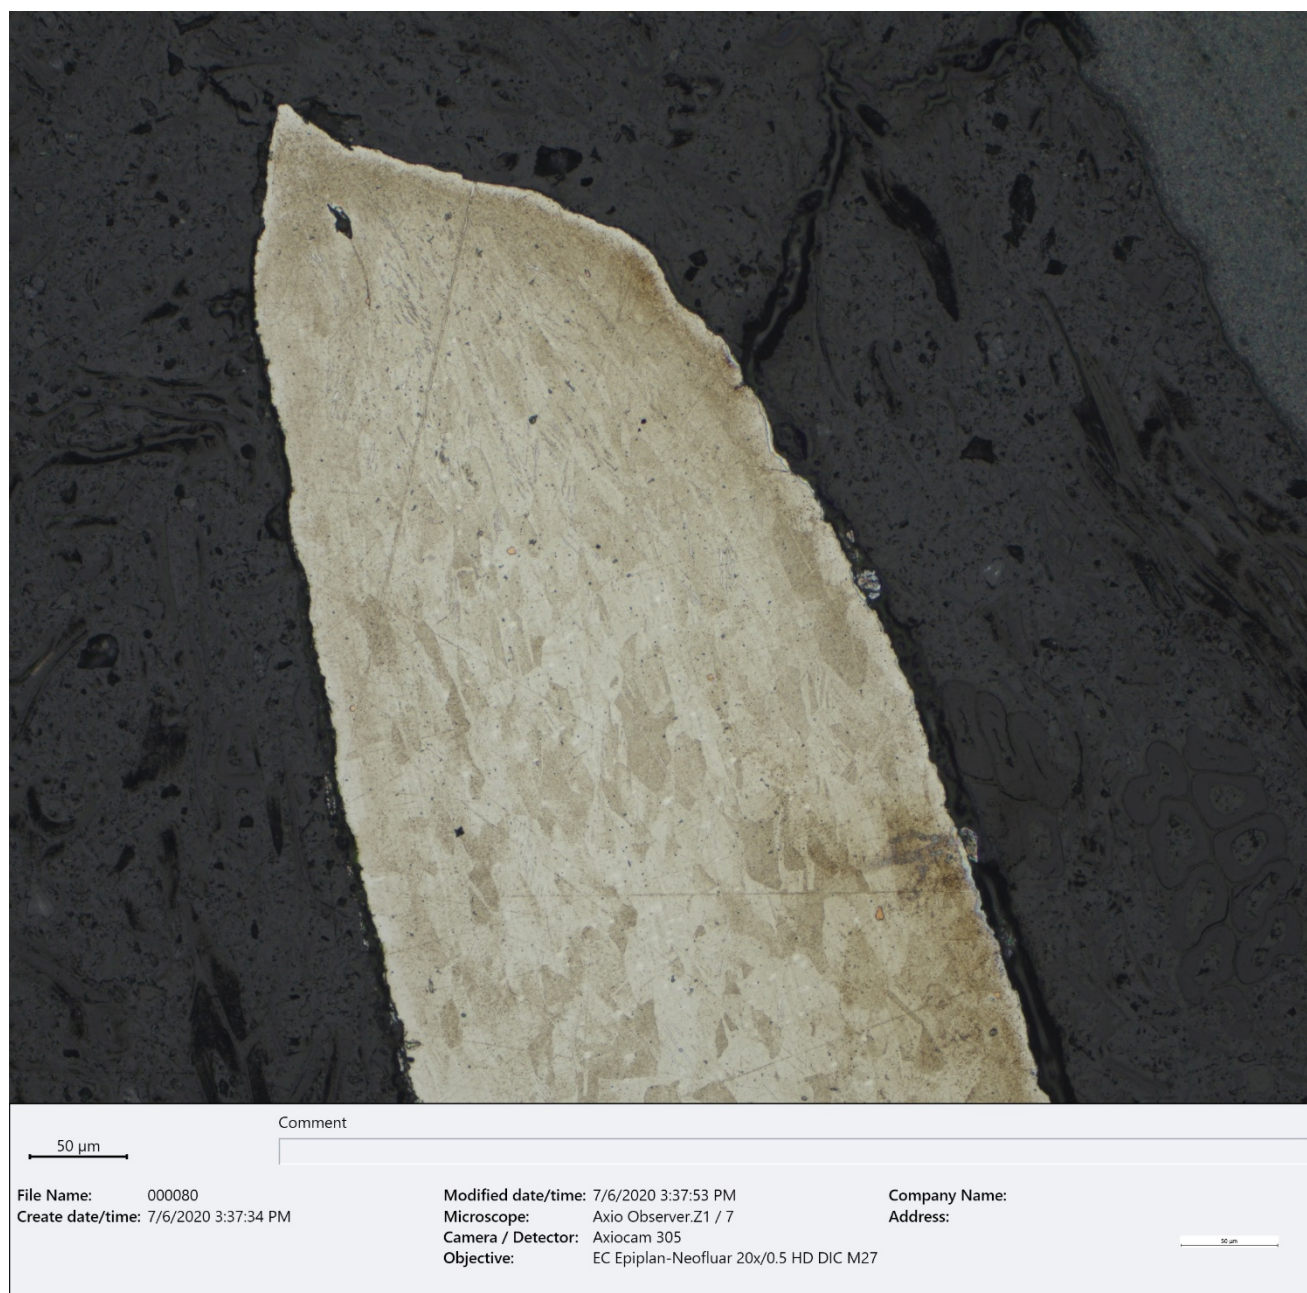
Figure 29 – BF optical micrograph of a cross-section of the thinned fracture of the duct away from the flange weld, showing grain elongation consistent with plastic deformation near the fracture surface (~200X, etched 2% Nital).

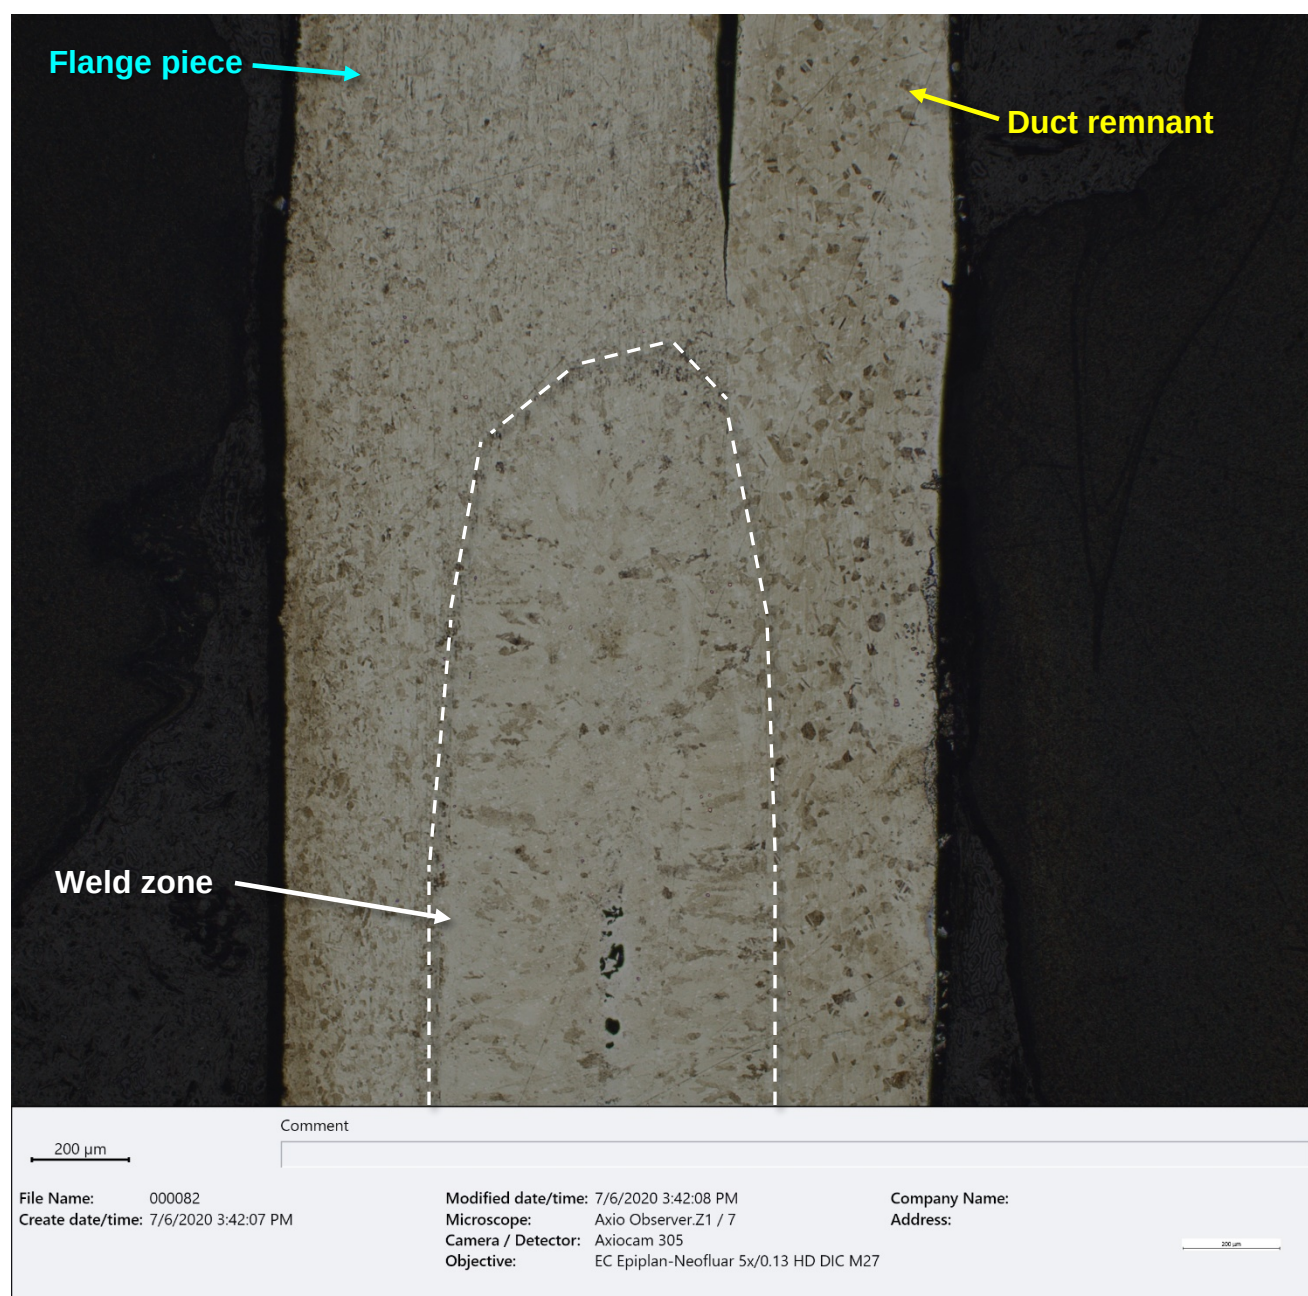
Figure 30 shows a cross section of the weld between the flange piece and duct remnant, located below Figure 29. The center exhibited columnar grains consistent with

solidification from the outer surfaces inward, typical of localized resolidification after the weld was performed. Some small porosity was present along the centerline, but no cracks were observed in this area.

Figure 30 – BF optical micrograph of an intact portion of the duct flange weld, showing horizontal columnar grains and some porosity along the centerline (~50X, etched 2% Nital).

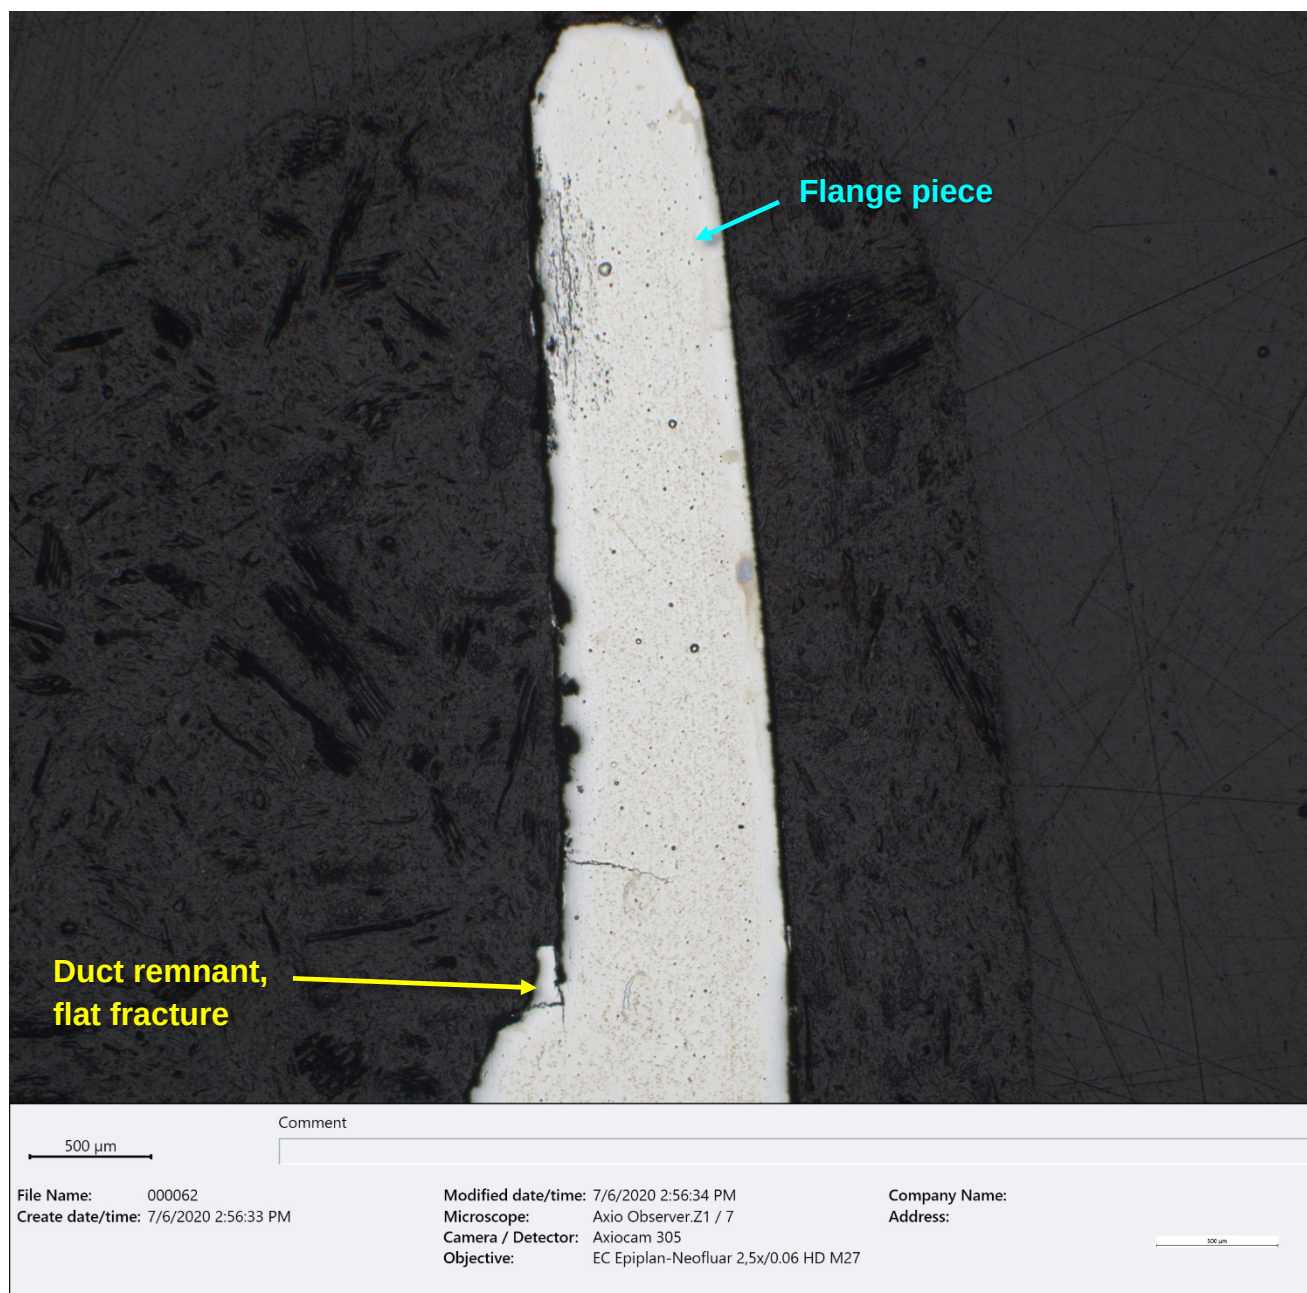
Figure 31 shows the cross section through the flat fracture region. In this figure, the duct remnant fracture is located in the lower left of the figure, and most of the figure shows the cross section of the flange piece. The flange piece exhibited a horizontal crack on the lower side of the figure, and vertical internal cracking in the upper portion of the figure.

Figure 31 – BF optical micrograph of a cross-section of the flat fracture portion of the flange remnant fracture surface (~25X, as-polished).

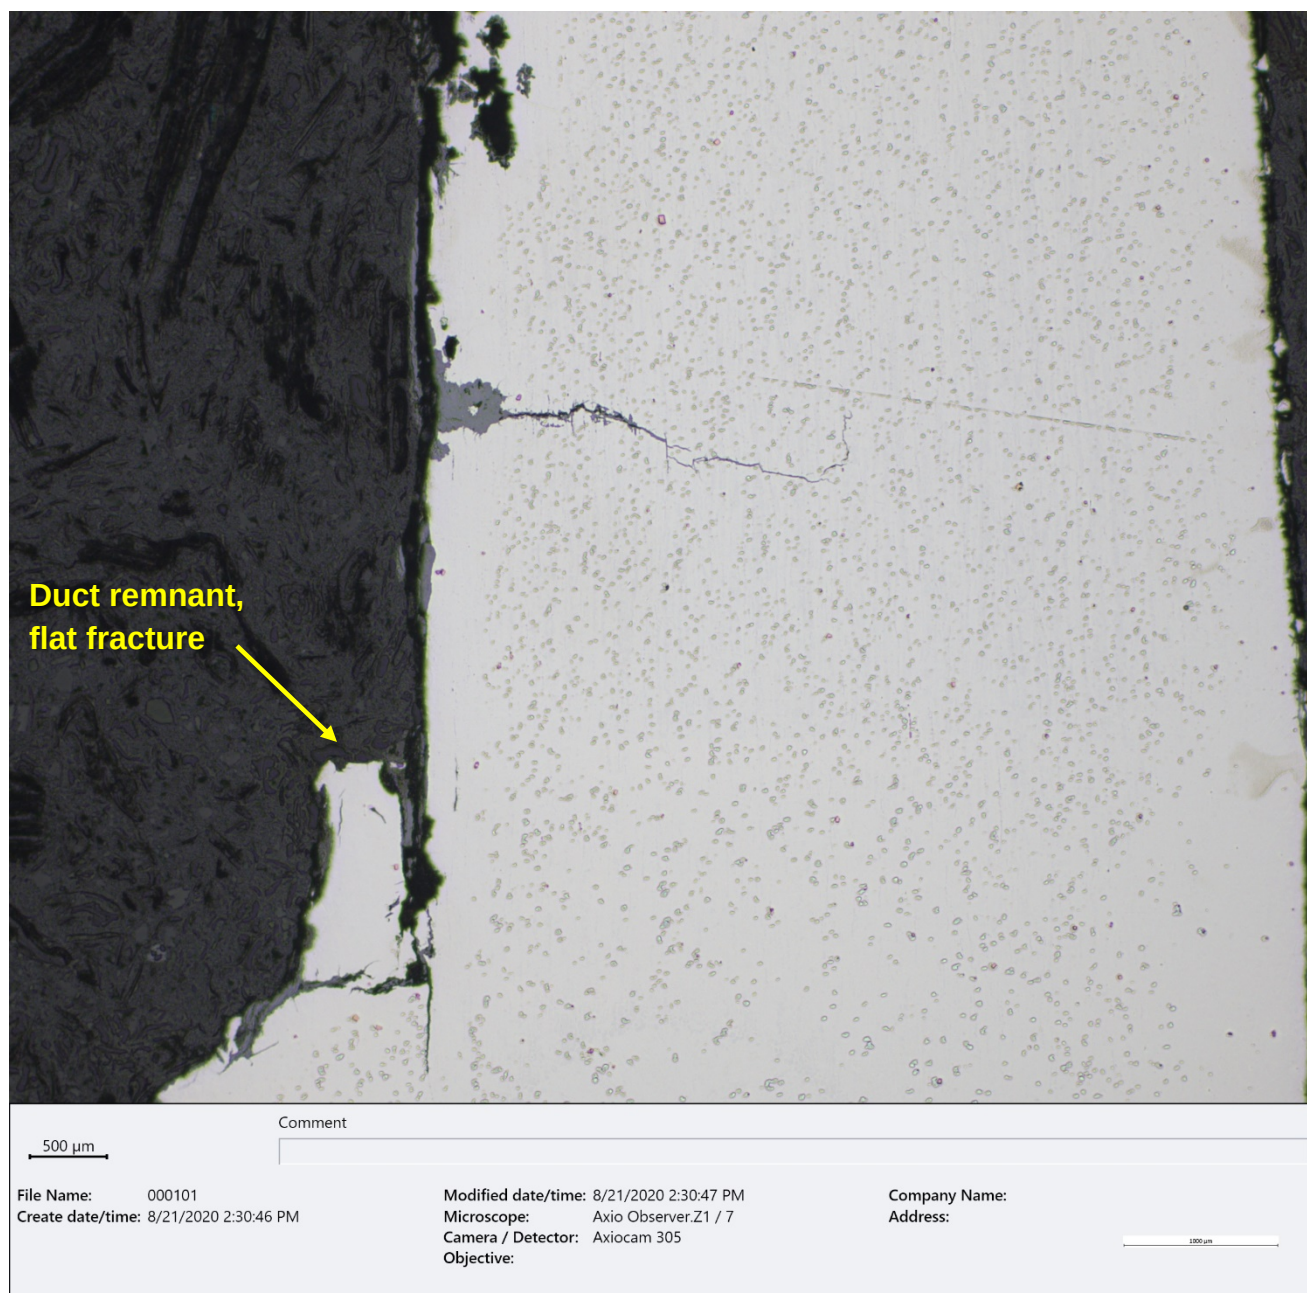
Figure 32 shows a closer view of the flat fracture surface, and the vertical crack in the flange piece. The interior (left-facing) surface of the flange and the duct exhibited pitting, with nonmetallic (gray-colored) compounds. Figure 33 shows a closer view of the horizontal crack. This crack had initiated at a series of surface pits, shown on the left in the figure. There were several smaller parallel cracks that had progressed from the left surface, also initiating at the surface pitting. The crack grew primarily left to right in the figure, but there were multiple vertically-oriented parallel cracks that had branched from the main crack. These branching vertical cracks were consistent with intergranular cracking along the elongated grain direction. The crack interior exhibited nonmetallic compounds along the entire crack interior.

Figure 32 – BF optical micrograph of the flat-fracture region, showing internal horizontal and vertical cracking (~50X, as-polished).

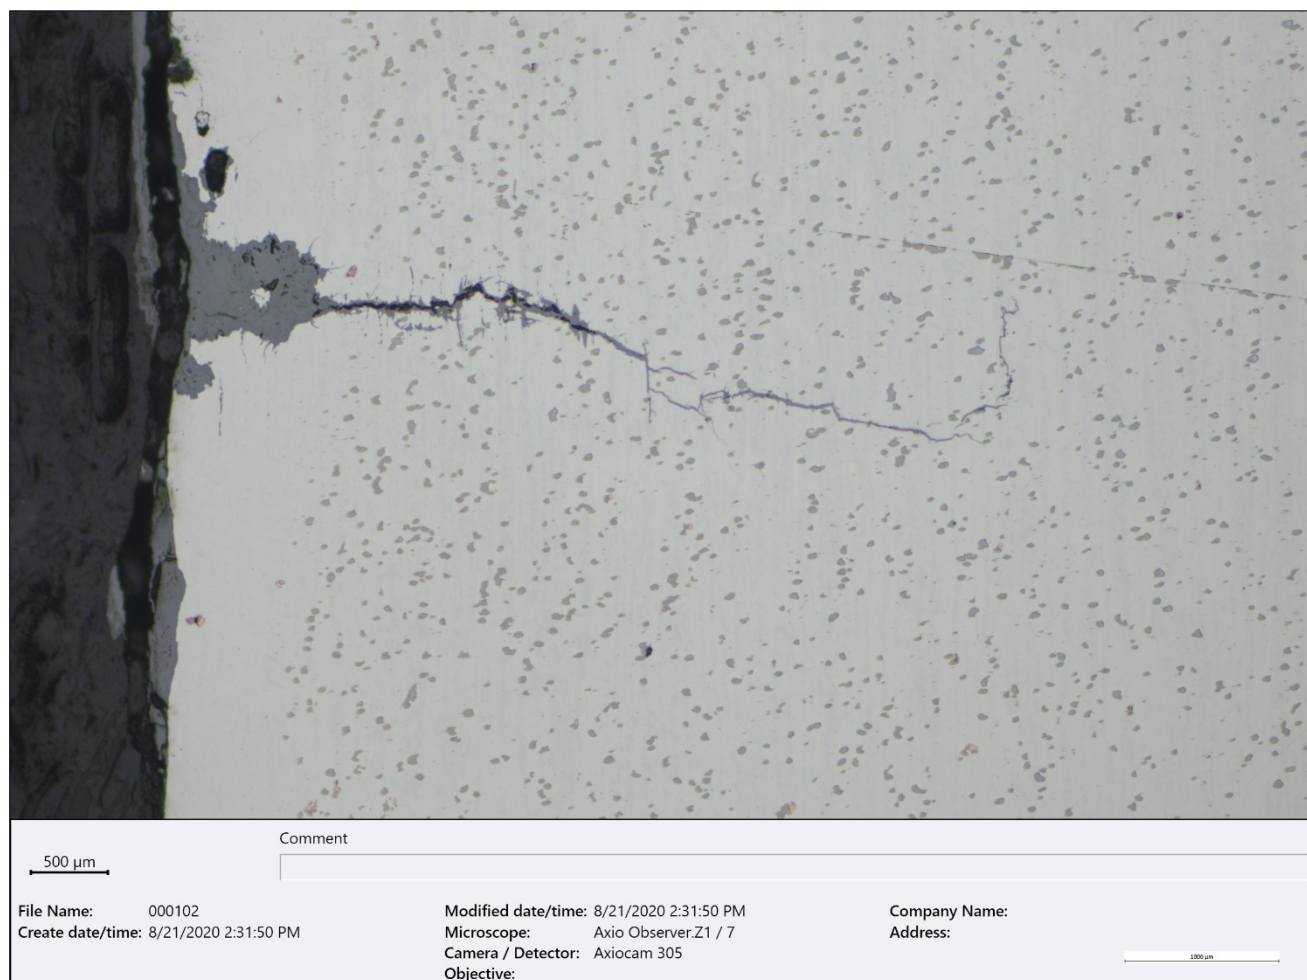
Figure 33 – BF micrograph of the horizontal crack in Figure 32, showing vertical intergranular branching (~500X, as-polished).

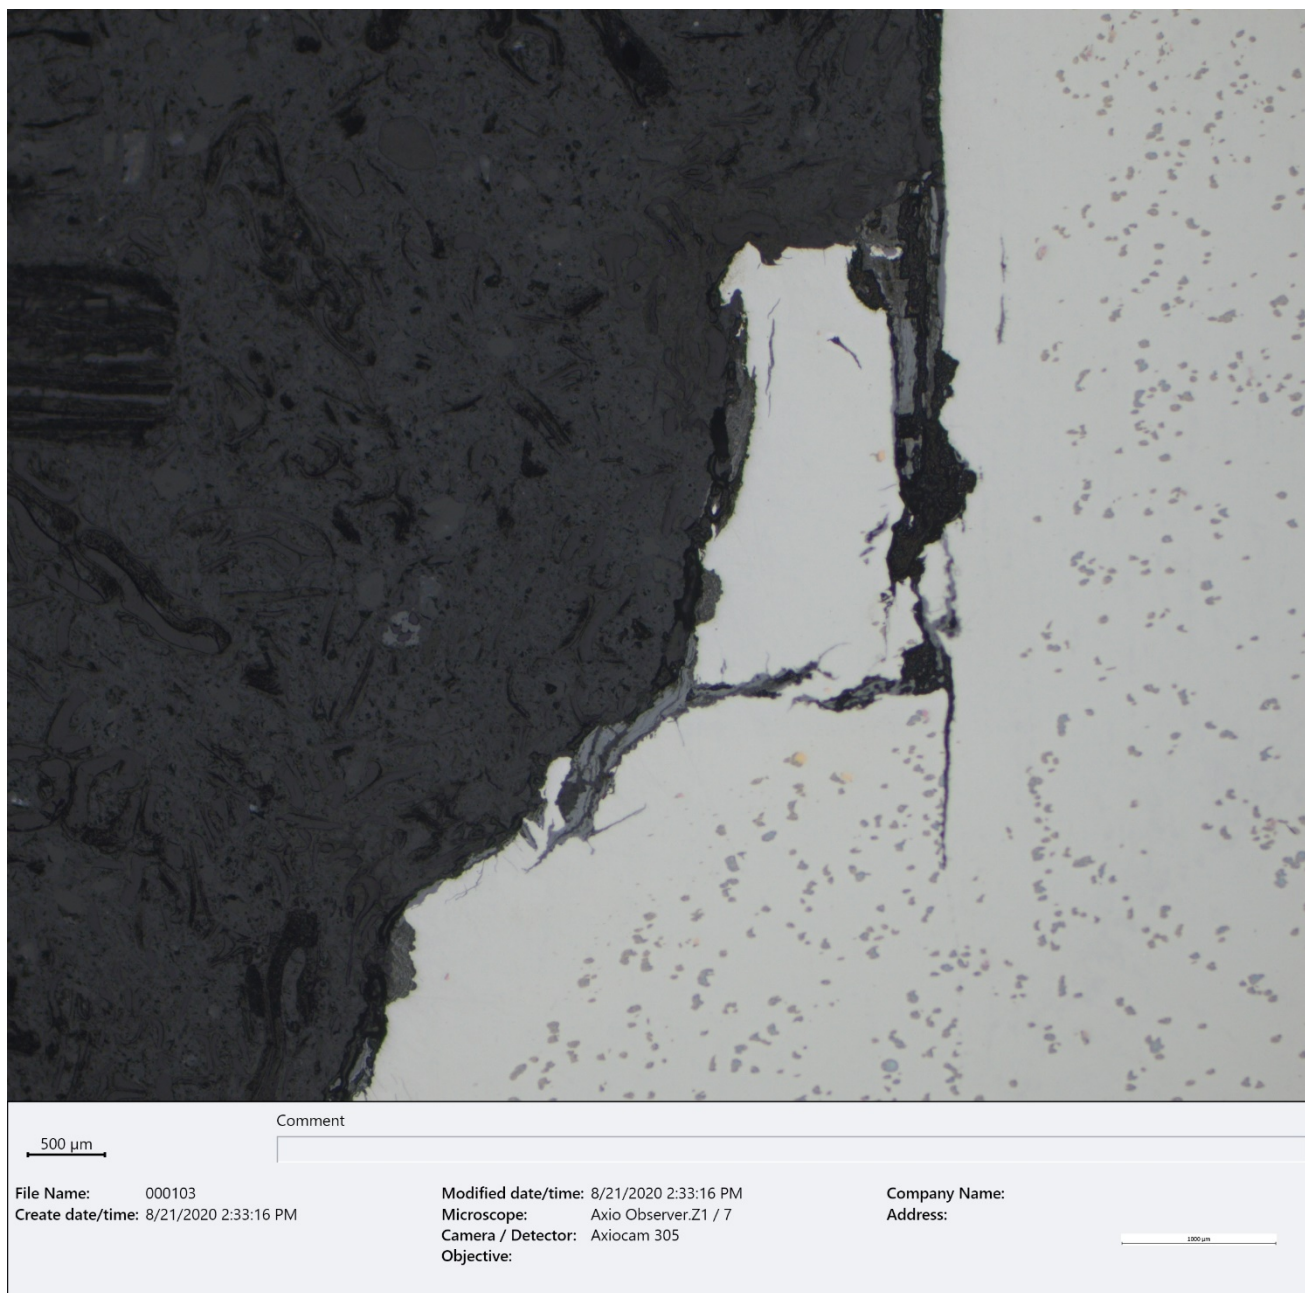
Figure 34 shows a closer view of the flat fracture cross section. In this location, multiple cracks were present, consistent with having developed on a surface and growing inward. There were vertical cracks growing downward in the figure, and horizontal cracks growing from the interior surface (left-facing) in the figure. In all cases, these cracks also contained non-metallic compounds, consistent with corrosion compounds. All these features illustrated were located just about the weld region, which are located at the very bottom of the figure. There were no indications of cracking or extensive porosity in the weld near the flat fracture cross sectioned.

Figure 34 – BF optical micrograph showing vertical and horizontal cracking at the flat fracture surface (~200X, as-polished).

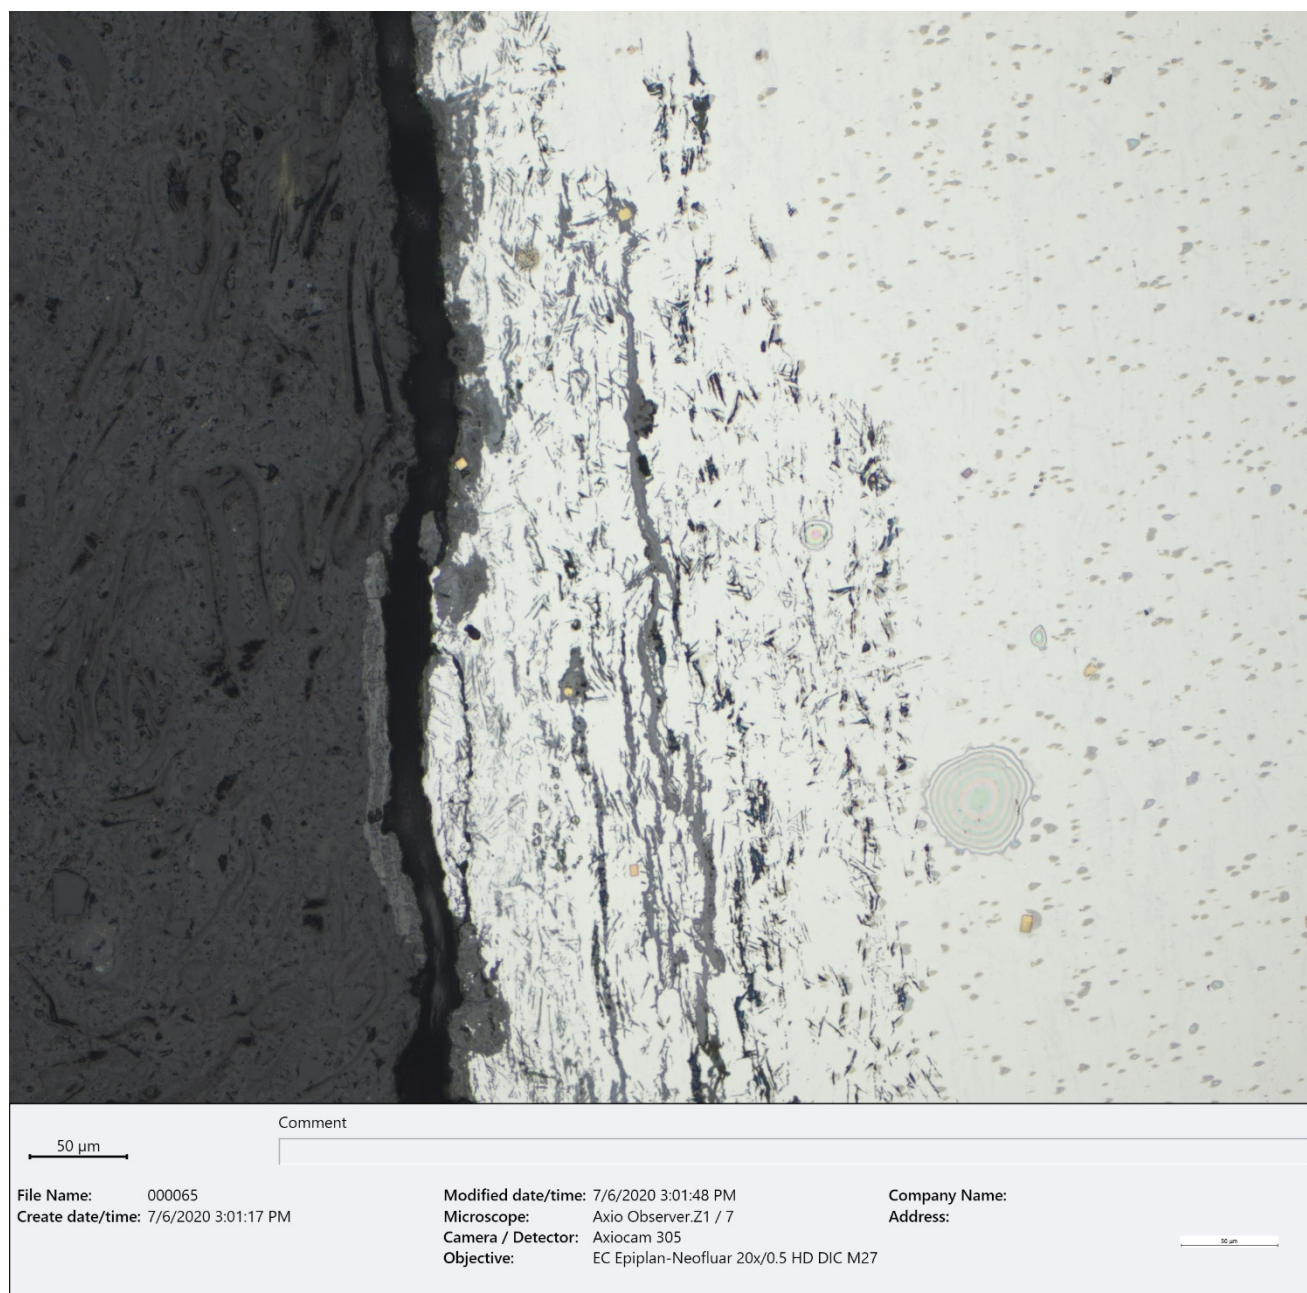
The vertical parallel interior cracking in the top part of the flange piece is highlighted in Figure 35 and 36. These cracks manifest as a layered series of cracks with non-metallic compounds, all parallel to the flange piece interior surface. As shown in Figure 36, many of the interior cracks exhibited needle-shaped morphologies, along with the gray nonmetallic compounds. Both the inward facing flange and duct remnant surfaces exhibited corrosion pitting containing nonmetallic compounds consistent with corrosion products (see Figure 37). In the cross section taken, these pits were located above and below the duct remnant fracture surface and horizontal cracks.

Figure 35 – BF optical micrograph of the layered, parallel internal corrosion compounds in the upper portions in Figure 31 (~200X, as polished).
