# NATIONAL TRANSPORTATION SAFETY BOARD

## MATERIALS LABORATORY FACTUAL REPORT

Report No. 20-036

Place : Santa Barbara, California  
Date : September 25, 2019  
Vehicle : Lockheed C-130A, N119TG  
NTSB No. : WPR19LA242  
Investigator : Tealeye Cornejo, AS-WPR

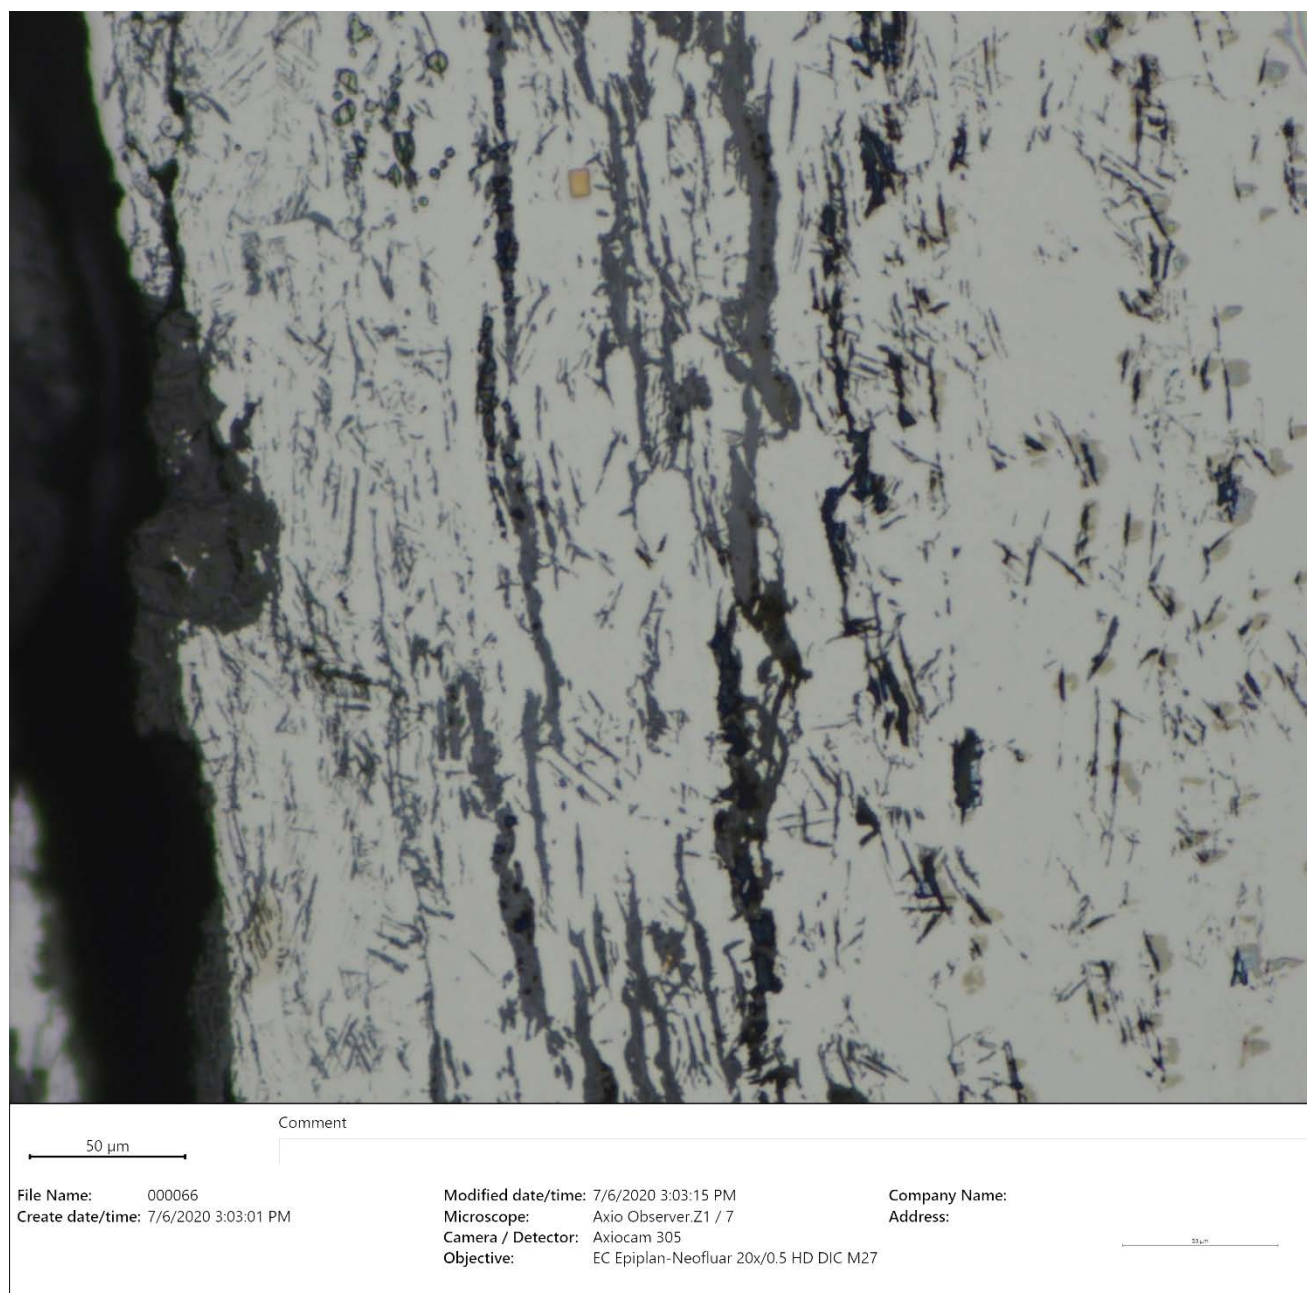
The vertical parallel interior cracking in the top part of the flange piece is highlighted in Figure 35 and 36. These cracks manifest as a layered series of cracks with non-metallic compounds, all parallel to the flange piece interior surface. As shown in Figure 36, many of the interior cracks exhibited needle-shaped morphologies, along with the gray nonmetallic compounds. Both the inward facing flange and duct remnant surfaces exhibited corrosion pitting containing nonmetallic compounds consistent with corrosion products (see Figure 37). In the cross section taken, these pits were located above and below the duct remnant fracture surface and horizontal cracks.

Figure 36 – BF optical micrograph of a closer look of the layered corrosion compounds in Figure 35 (~500X, as-polished).

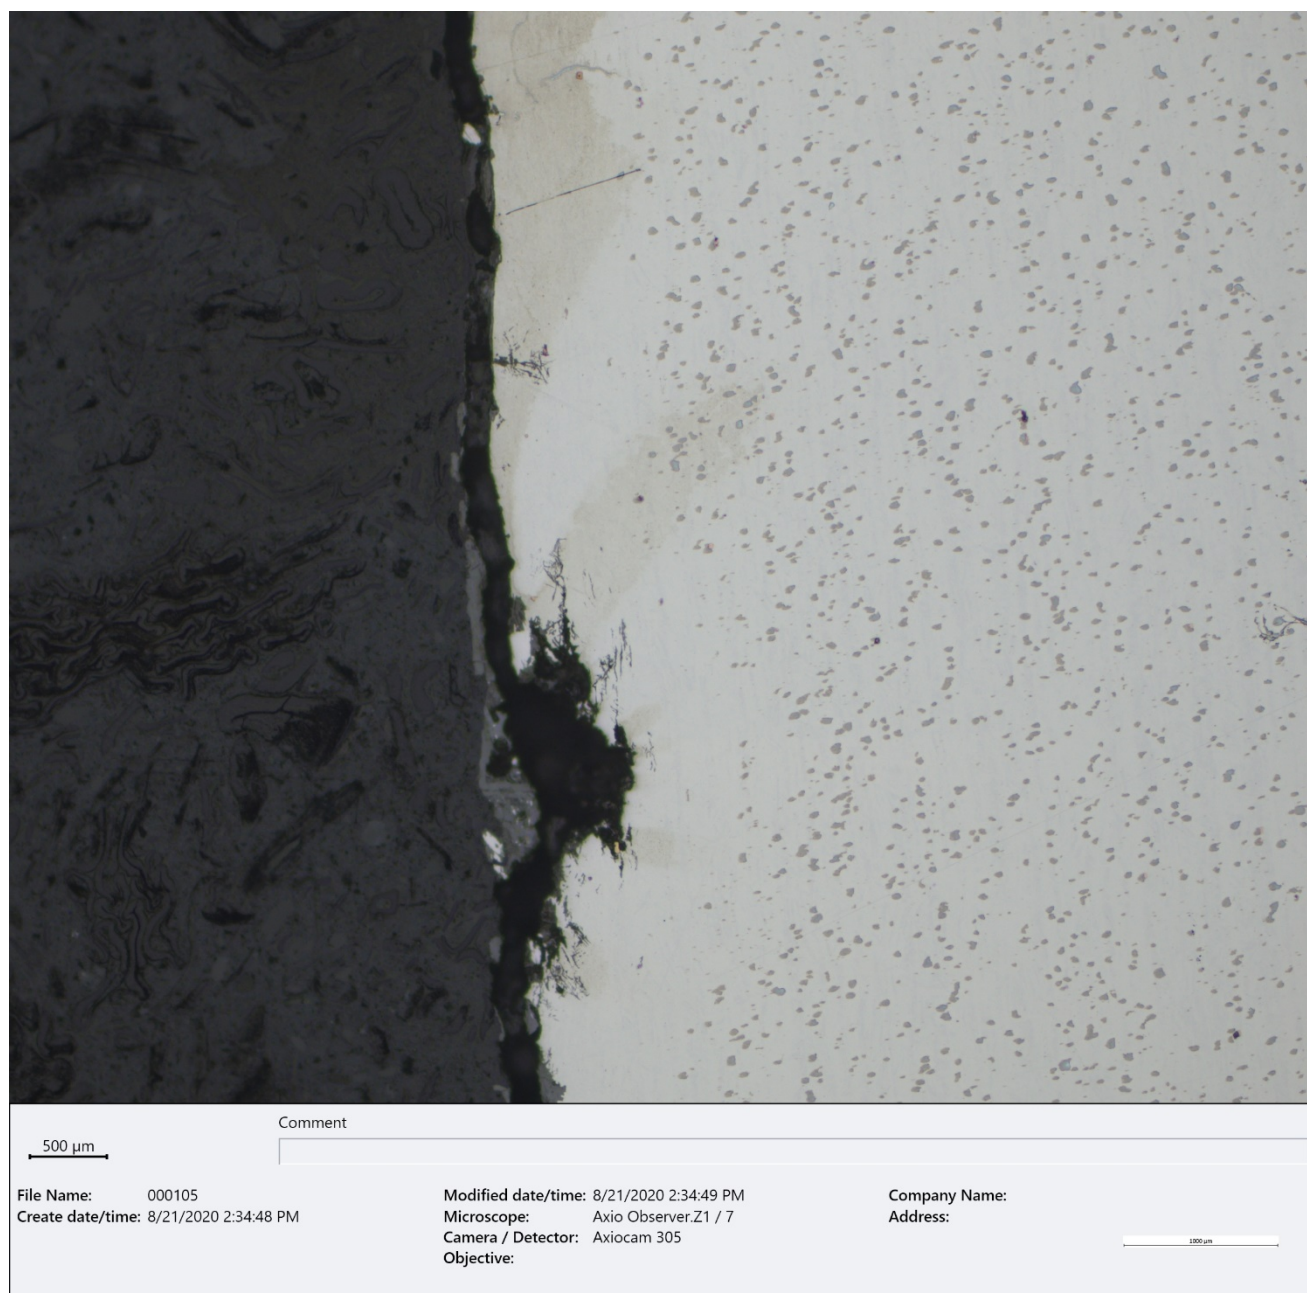
Figure 37 – BF micrograph of a surface corrosion pit on the flange piece, with branched cracking (~200X, as-polished).

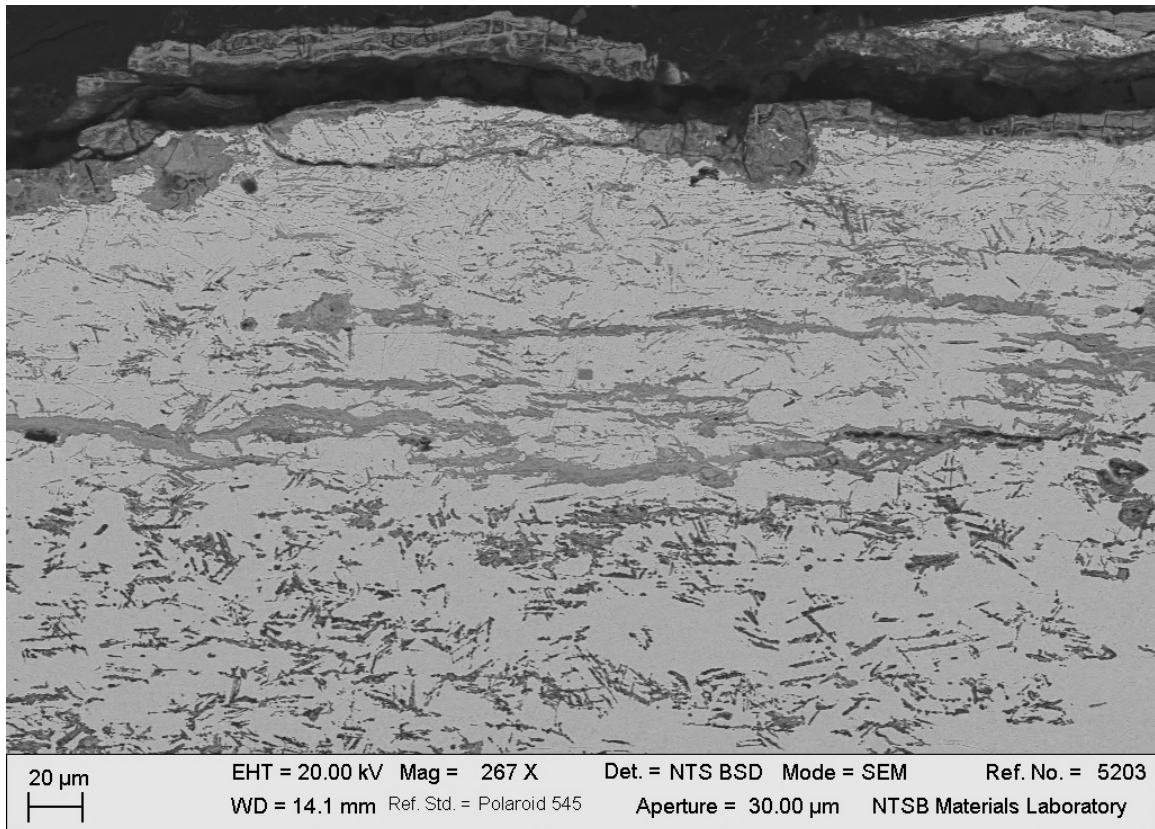
This cross section was examined using a SEM, as illustrated in Figure 38 and 39. The nonmetallic compounds show up as darker gray against the lighter-colored metal alloy in the figures due to the backscattered detector used.<sup>1</sup> EDS examination of the compounds

found them to be primarily consistent with iron- and chromium-based oxides, consistent with corrosion compounds typical of a stainless steel. The exterior compounds exhibited minor amounts of Na, Cl, Mg, and Si. The interior compounds also exhibited minor amounts of S and Cl.

Figure 38 – Backscattered electron (BE) micrograph of the layered internal corrosion (rotated 90° from Figure 35).

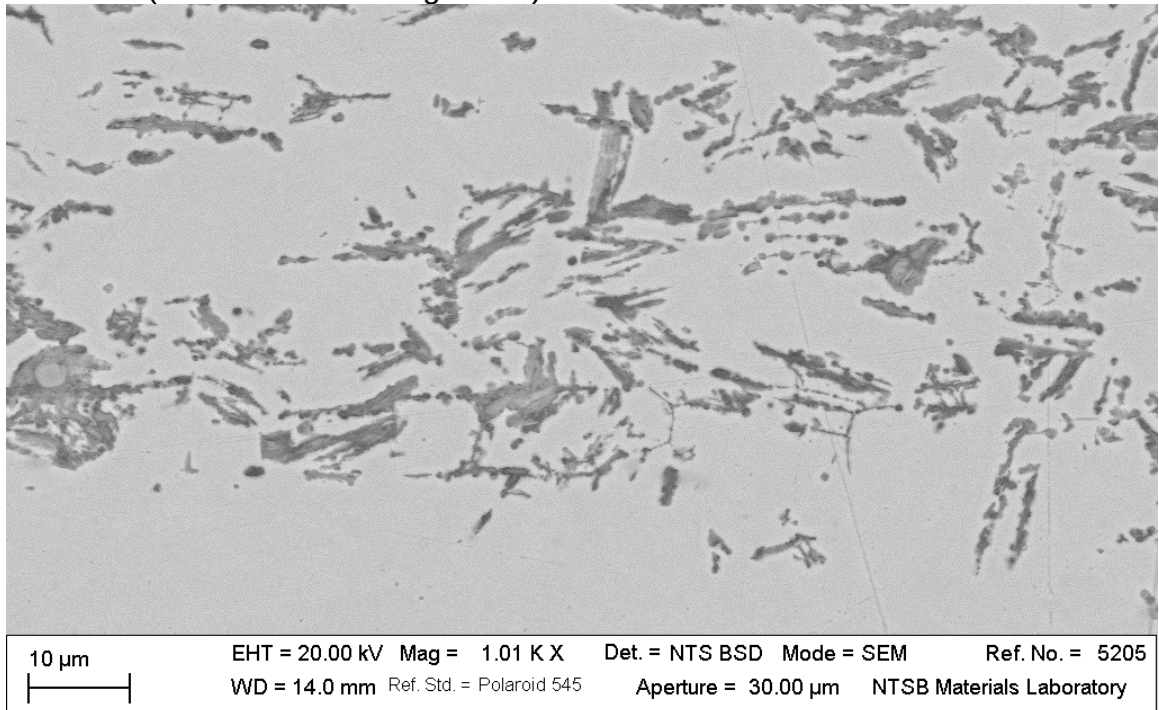
Figure 39 – BE micrograph highlighting the needle-like internal oxidation compounds, ~200 μm under the surface.
