**NATIONAL TRANSPORTATION SAFETY BOARD**

**AIRPLANE AND ENGINE EXAMINATION**

**WPR19LA243**

Aircraft: Mooney M20C

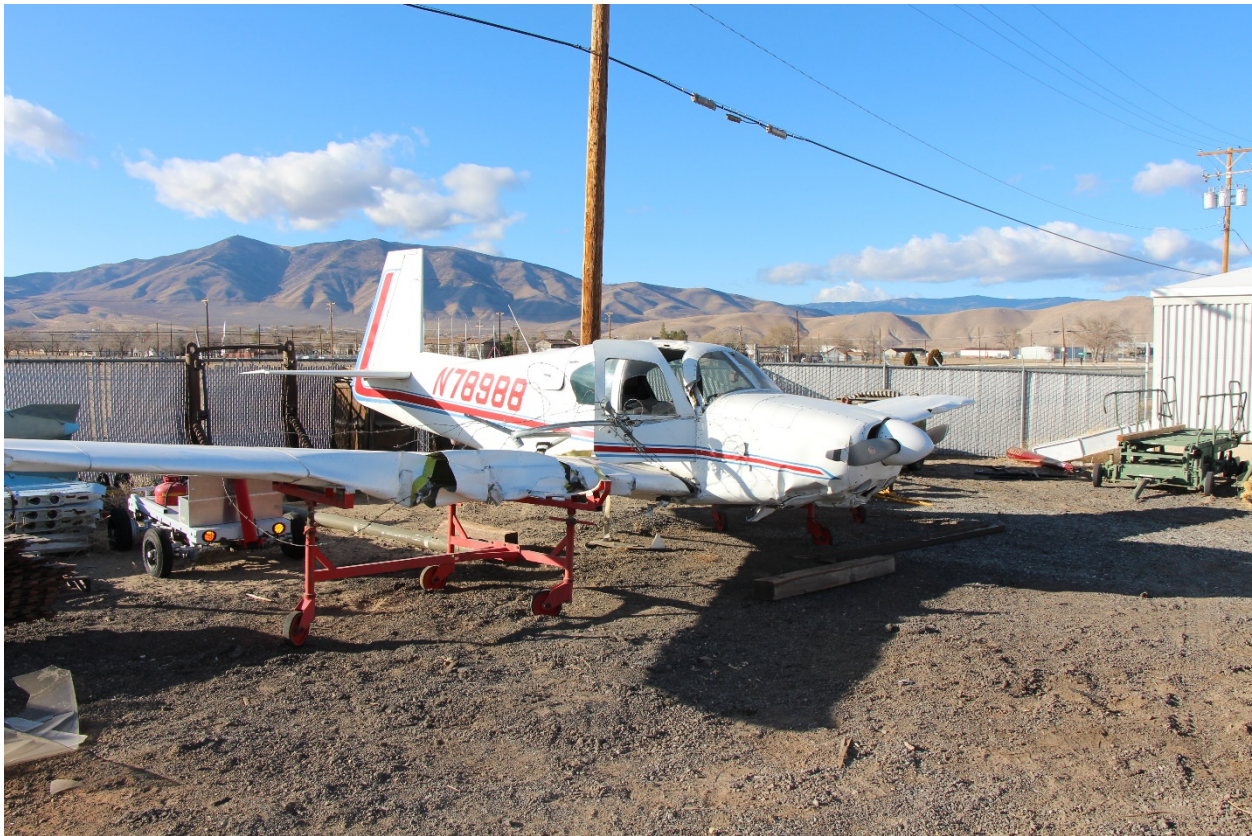
about midspan and outboard. Both the lower cowling and belly skin exhibited vertical crush deformation. Additionally, the right door had been penetrated by a fence post and barbed wire (photograph 1).

**Photograph 1: Right Quartering View of Accident Airplane Showing Fence Post and Barbed Wire at Door**

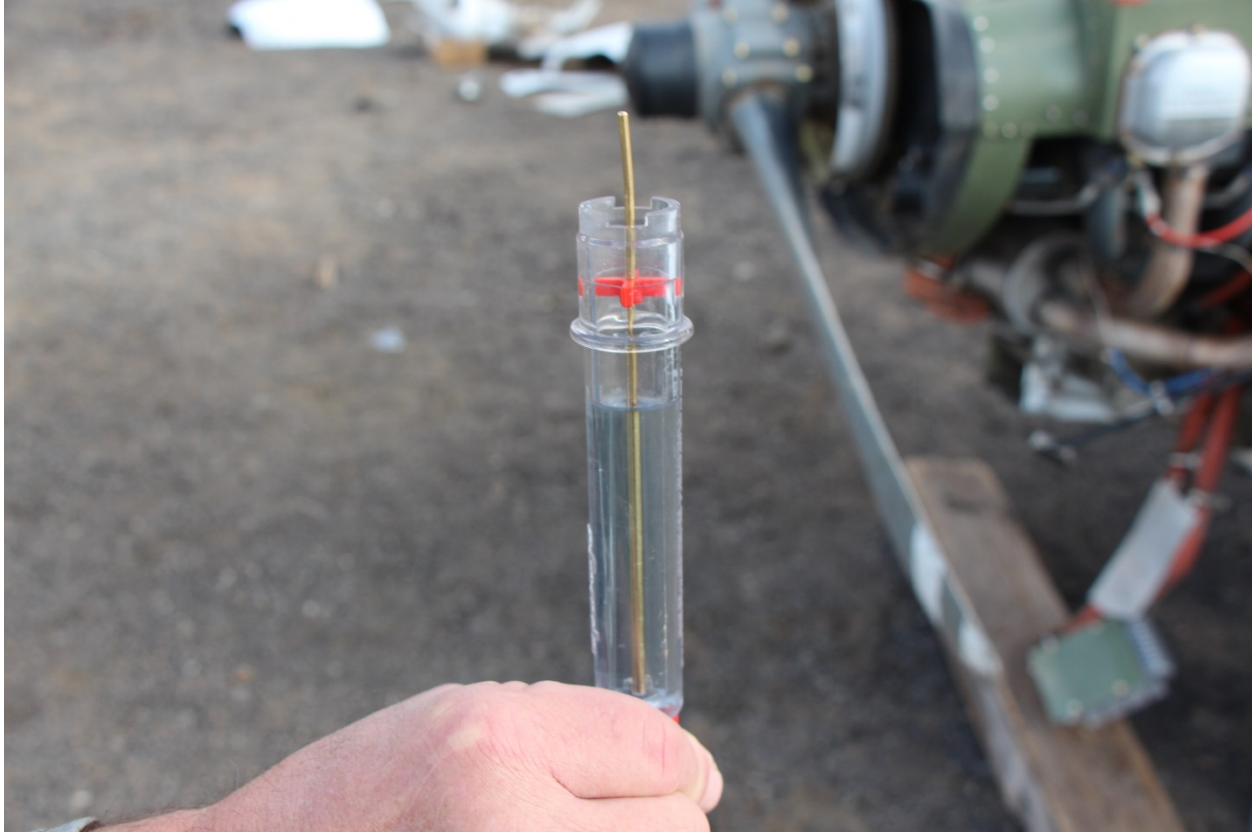
Fuel line continuity was confirmed from the right and left fuel tanks to the engine through the fuel selector, electric boost pump, and gascolator, and no breaches in the fuel lines were noted. The right wing fuel tank was breached and the left wing was presumed to have been intact based on initial reports. Approximately 3 gallons of 100 low lead aviation grade gasoline were placed in the left wing and the fuel was almost immediately expelled at the center belly and wing root due to an undiscovered rupture in the forward left fuel tank. The fuel selector rotated normally to the right tank, left tank and OFF position detents. Air was blown through the unit and no obstructions were observed. The gascolator fuel bowl contained several ounces of gasoline that did not appear to have been contaminated by debris or water (photograph 2). Additionally, the gascolator screen was free of debris.

Photograph 2: Fuel Drained from Gascolator

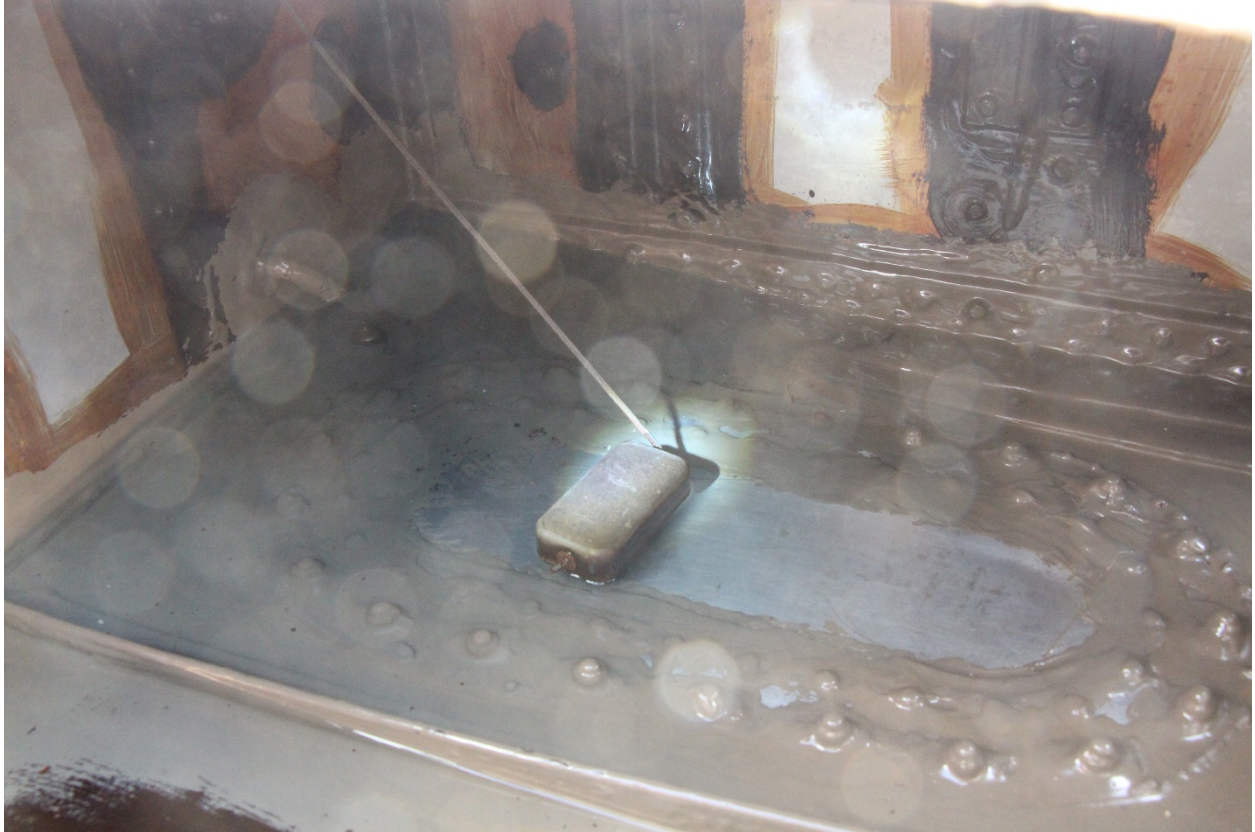
Both fuel tank gauges indicated erroneous fuel quantity indications with and without power applied to the airplane. The resting position of the left tank fuel sender was about 0.5 inches above the bottom of the tank and the resting position of the right tank sender was about 4 inches above the bottom of its respective fuel tank (photographs 3 and 4). The fuel gauges were tested manually with and without power applied to the airplane by manually placing each fuel sending unit in its low and high positions. The results of these tests are captured in the table below.

Photograph 3: Left Fuel Tank Sending Unit at Low Point In Fuel Tank

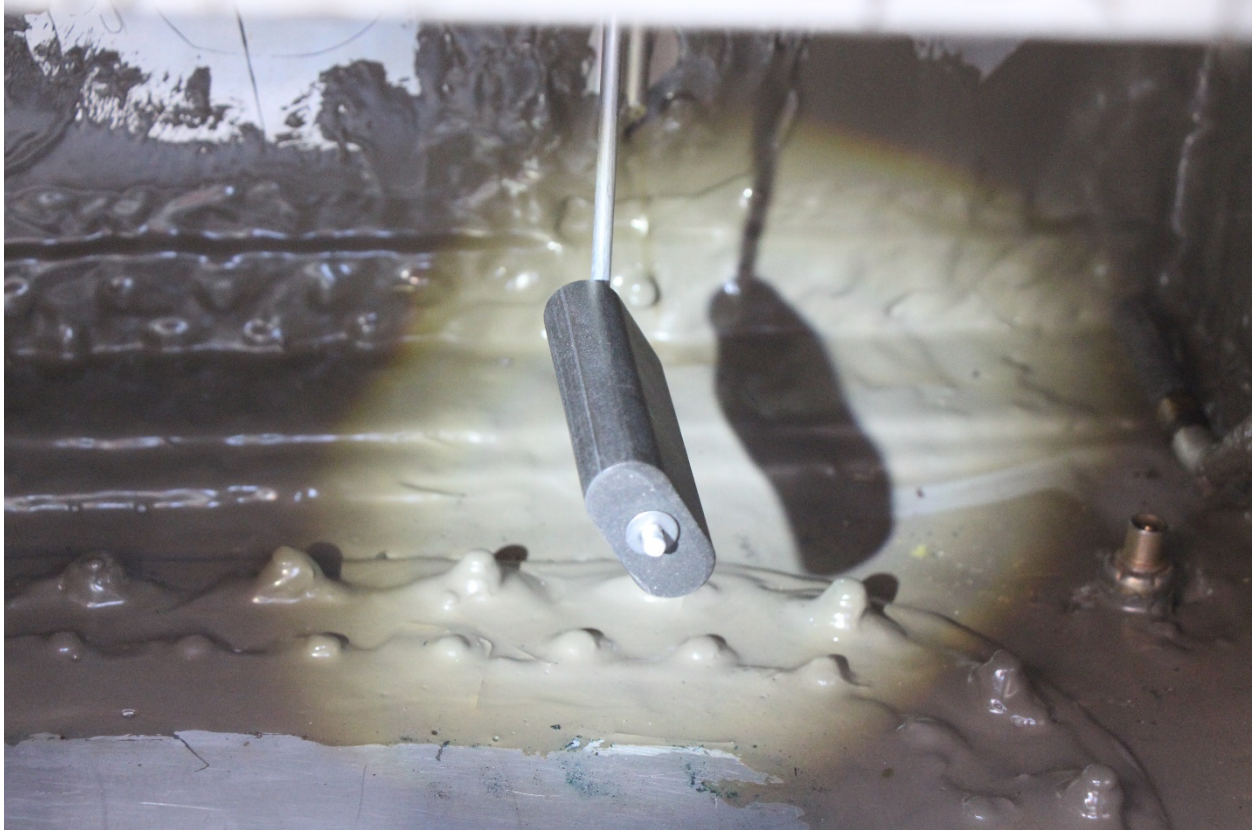
Photograph 4: Right Fuel Tank Sending Unit at Low Point In Fuel Tank

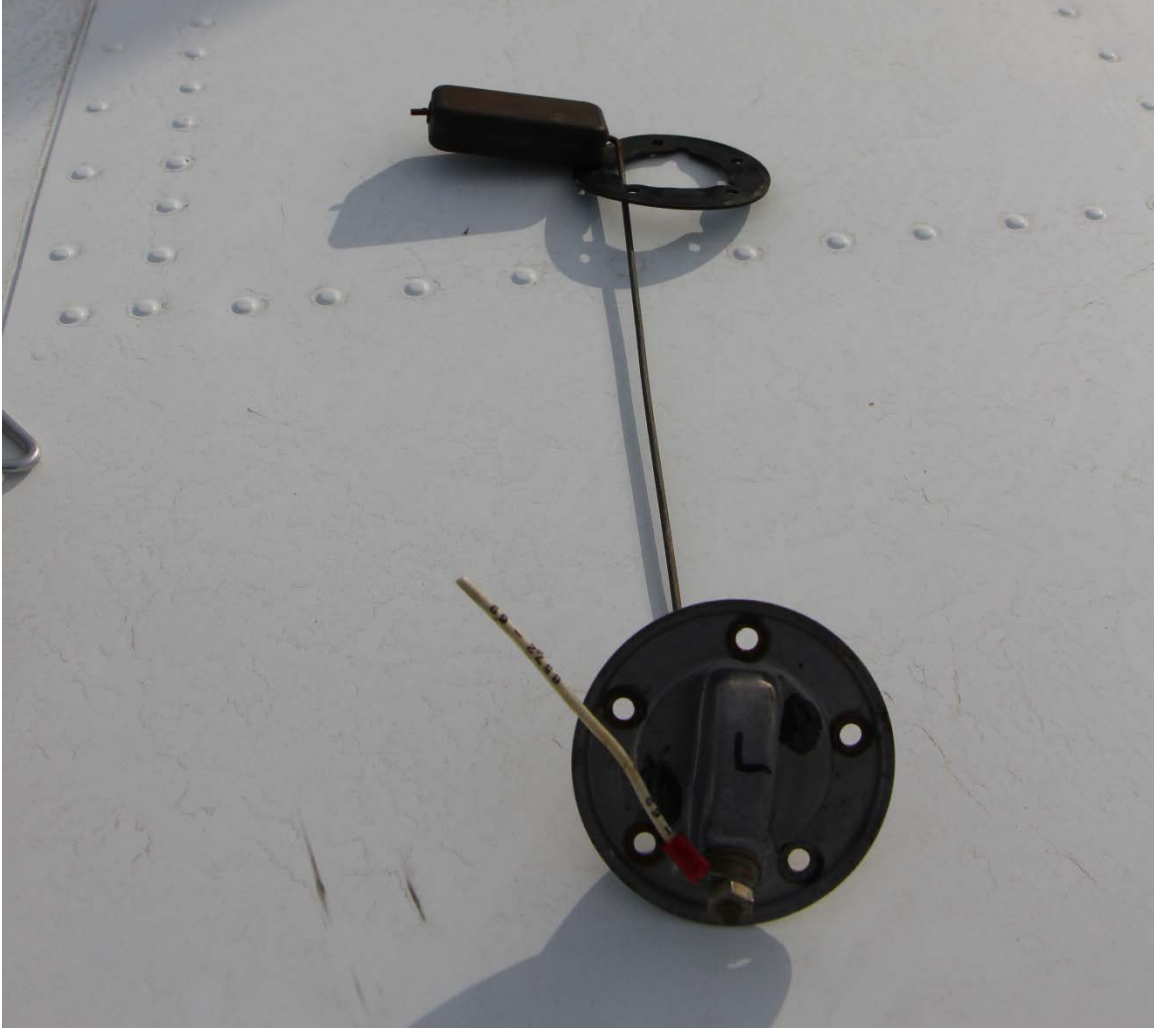
Examination of the fuel sending units revealed that separate models had been installed in the right and left fuel tanks (photographs 5 and 6). The fuel sending units and fuel gauges have been retained for further examination.

Photograph 5: Left Fuel Tank Sender

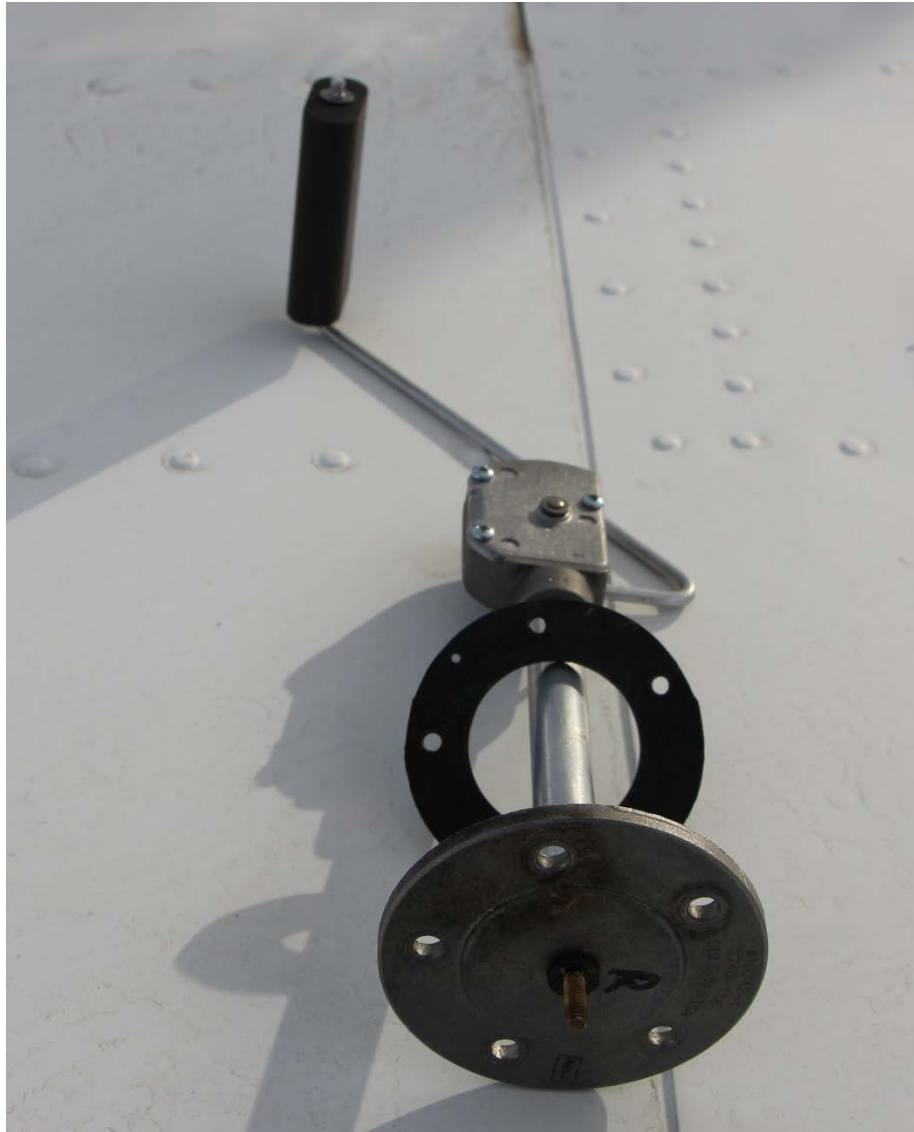
Photograph 6: Right Fuel Tank Sender

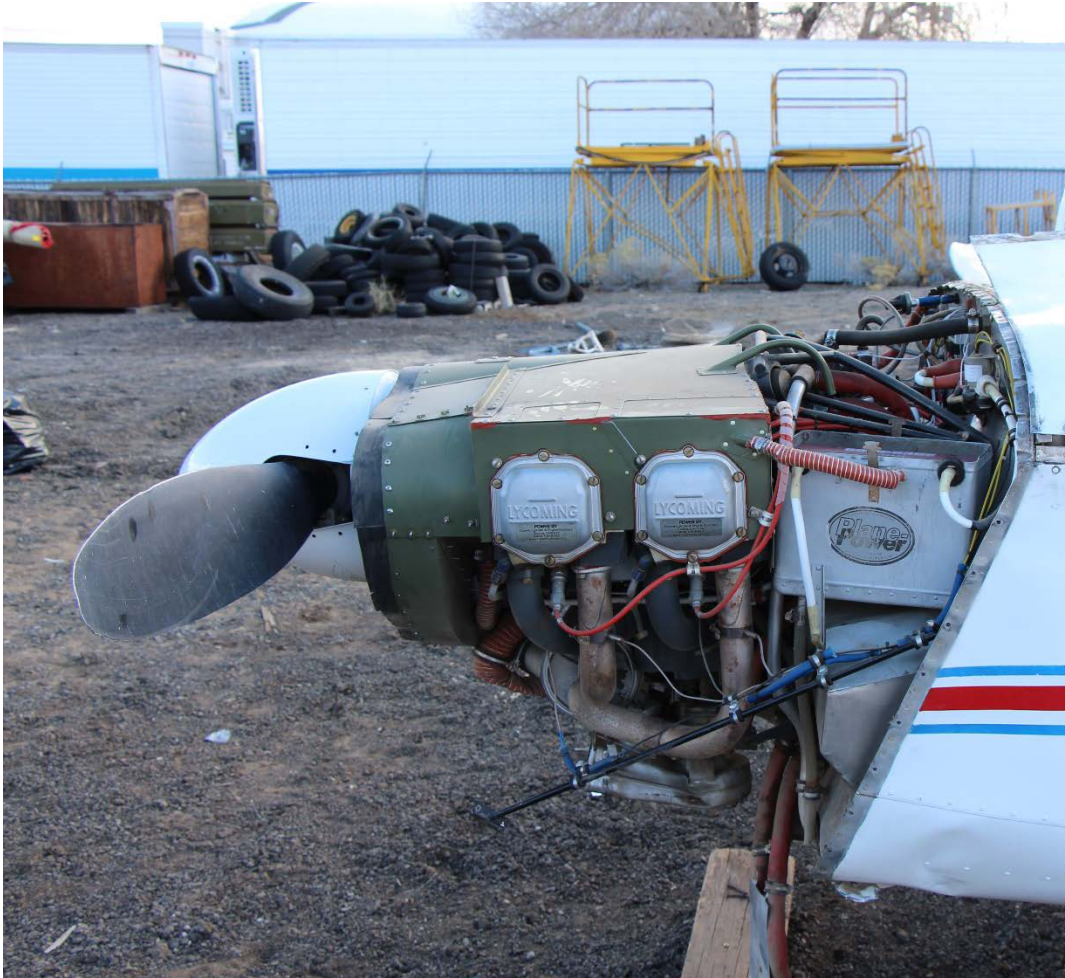
The engine was mostly intact with the exception of the airbox and exhaust, which exhibited minor damage (photograph 7). The engine contained approximately 6 quarts of oil. It was noted

that the hobbs connection at the oil pressure switch was separated and the oil filter had not been properly safety wired.

Photograph 7: Uncowled Engine
