## **Memorandum for Record**

**NTSB Accident Number: WPR19LA255**  
**Aircraft Registration & Make/Model: N1168U / S-58ET**  
**Accident Location: Azusa, California**  
**Accident Date: September 11, 2019**

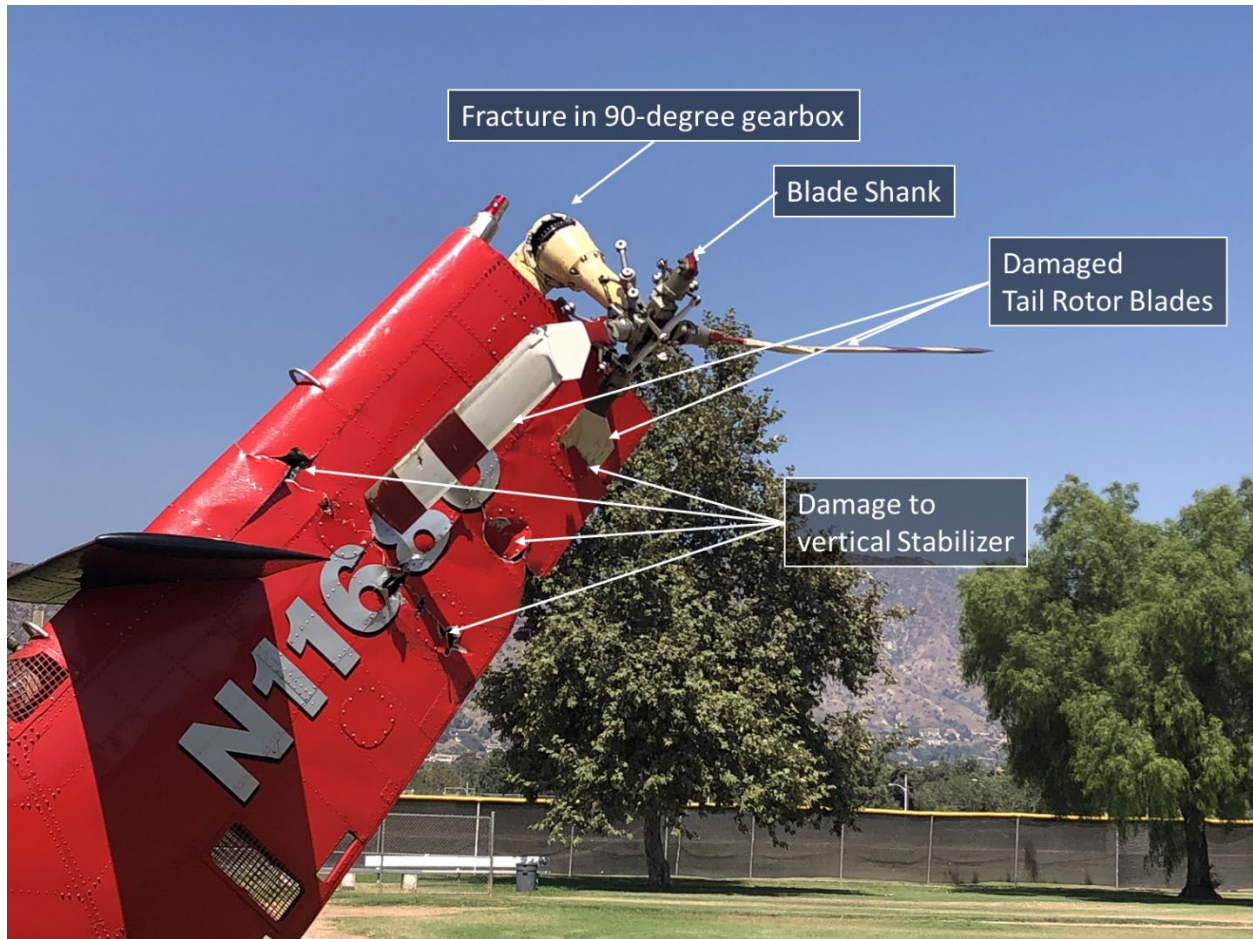
One tail rotor blade had separated from the tail rotor assembly. A section of the blade (shank) remained attached at the blade grip. The separated section was not recovered. The remaining three tail rotor blades exhibited dents and chord-wise bends. The 90-degree gear box fractured, exposing the internal gears. The tail rotor assembly moved downward. Two tail rotor blades lodged into the vertical stabilizer. The vertical stabilizer exhibited dents and holes in the sheet metal. See Figure 1.

Figure 1. Left-side view of N1168U, showing damage to the tail rotor assembly, the remaining blade shank, damage to the 90-degree gearbox, and damage to the vertical stabilizer.
