# NATIONAL TRANSPORTATION SAFETY BOARD

## MATERIALS LABORATORY FACTUAL REPORT

Report No. 20-035

Place : Azusa, CA  
Date : September 11, 2019  
Vehicle : Sikorsky S-58ET, N1168U  
NTSB No. : WPR19LA255  
Investigator : Fabian Salazar (AS-WPR)

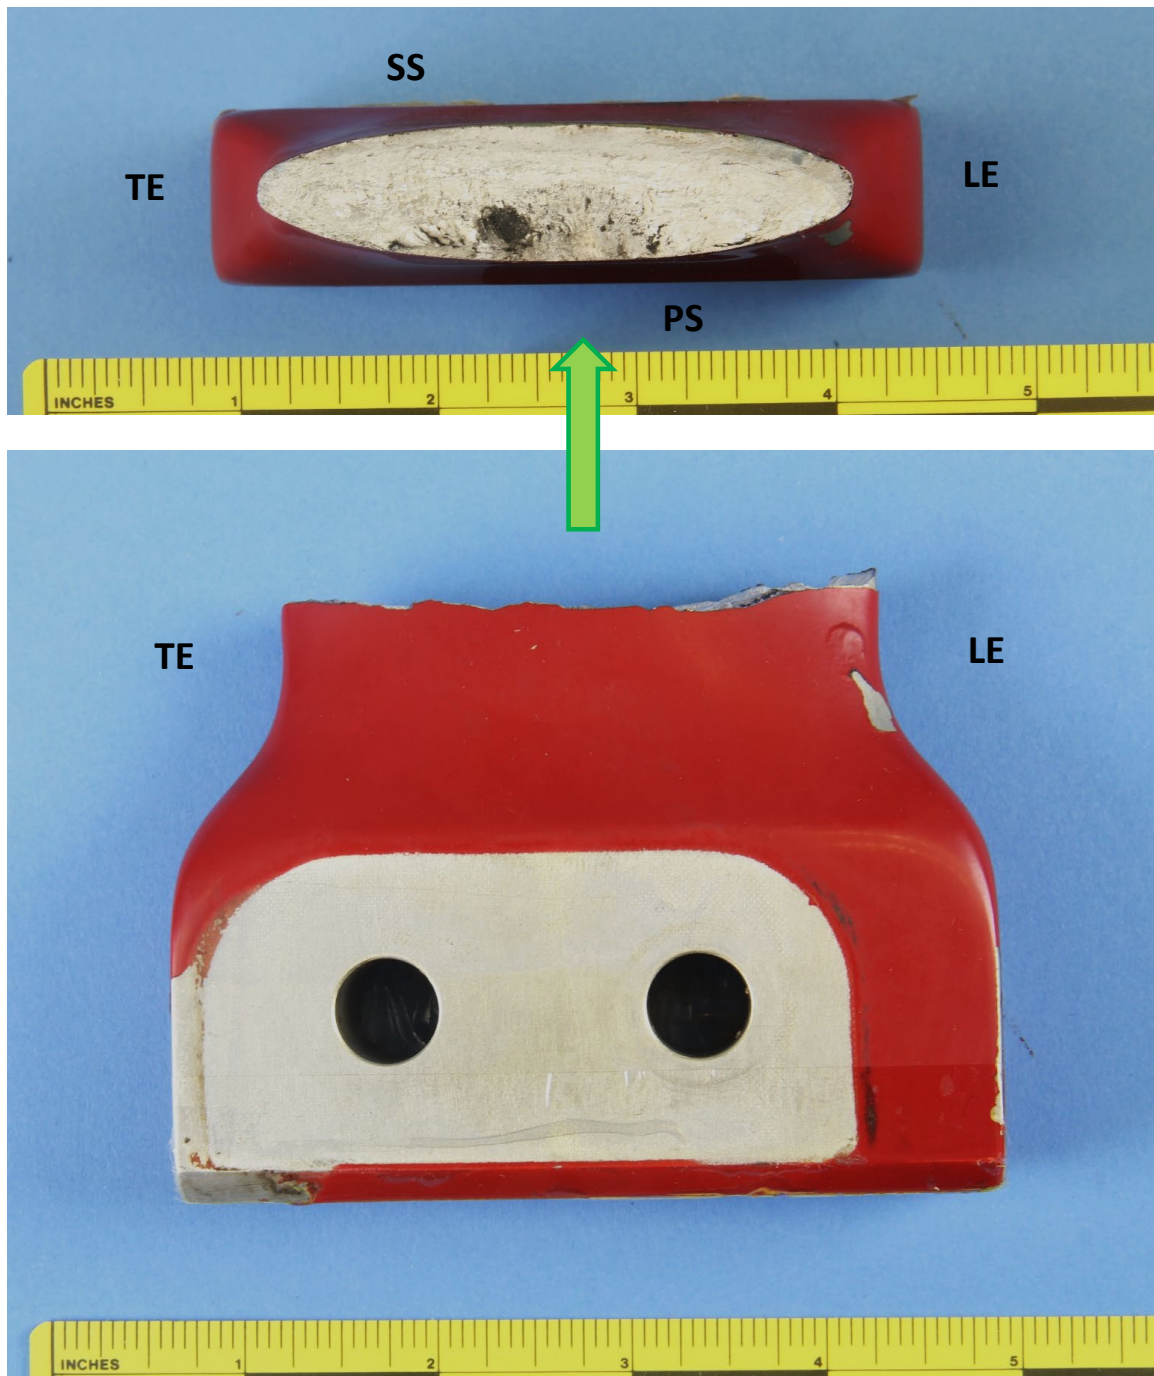
A piece of tail rotor blade containing the root end was submitted for evaluation, as shown in Figure 1. The blade had separated perpendicular to the blade length along a chord plane located approximately 3 inches from the bottom of the blade.

Figure 1: Overall macro photos of the submitted tail rotor blade piece. The leading edge (LE), trailing edge (TE), pressure side (PS), and suction side (SS) of the blade are labeled.

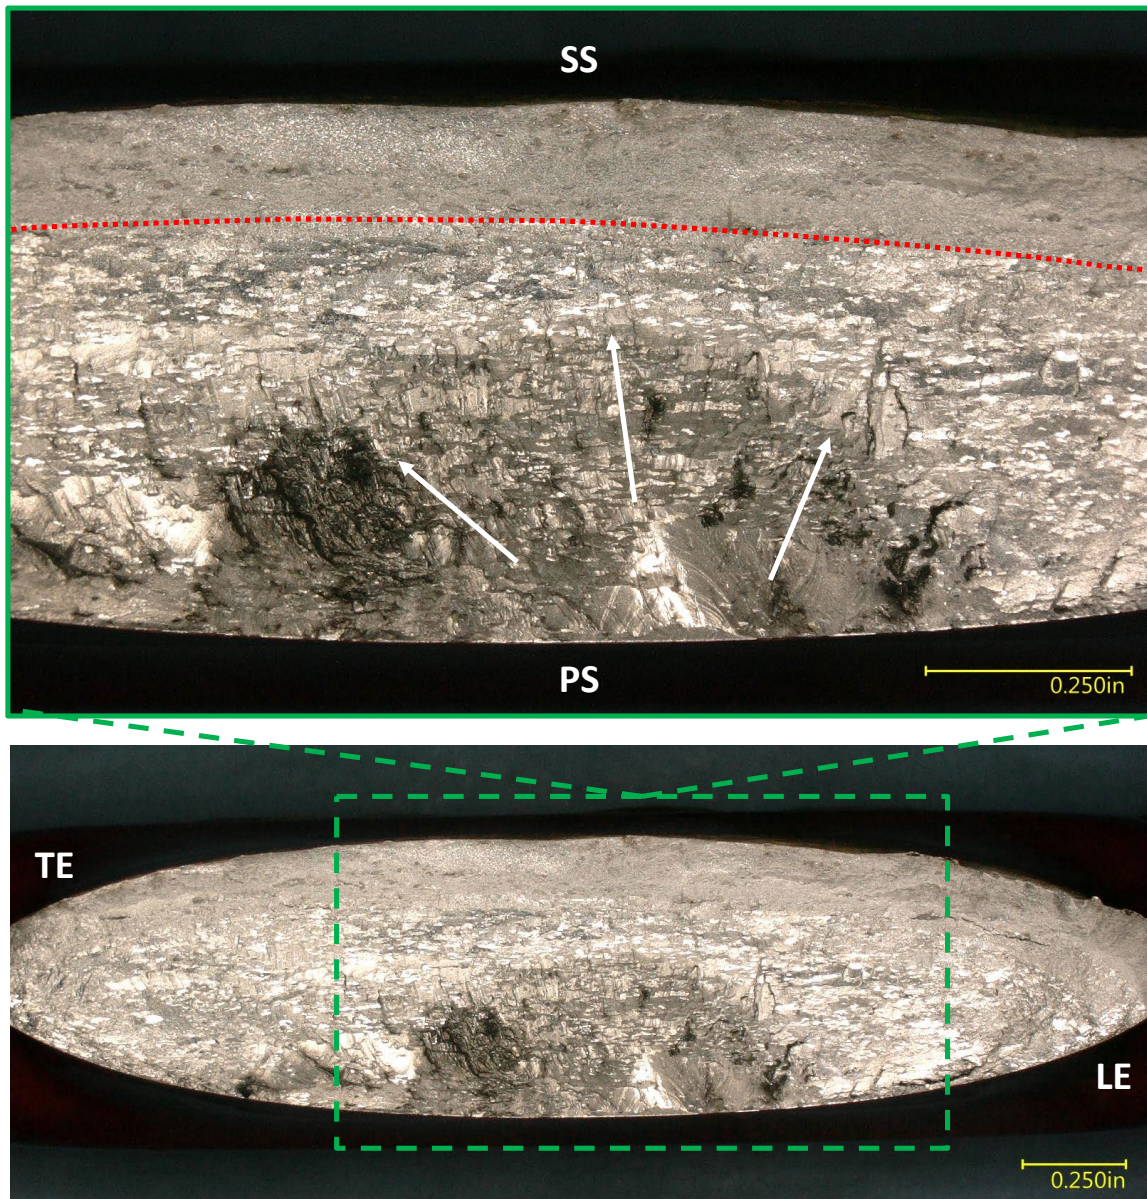
The fracture surface of the blade is shown in Figures 2 and 3. The fracture surface was relatively flat. A thumbnail-shaped pattern consistent with fatigue was observed emanating from the pressure side of the blade at approximately mid-chord. The edge of the thumbnail-shaped pattern (red dotted line, Figure 2) indicated the fatigue had propagated through roughly 77% of the blade width. The woody features within the thumbnail-shaped pattern were consistent with fatigue in aluminum with elongated grains.

Figure 2: Digital microscope images of the fracture surface on the separated blade as viewed perpendicularly. The red dotted line indicates the edge of the thumbnail-shaped pattern of fatigue. The white arrows indicate the direction of fatigue propagation.

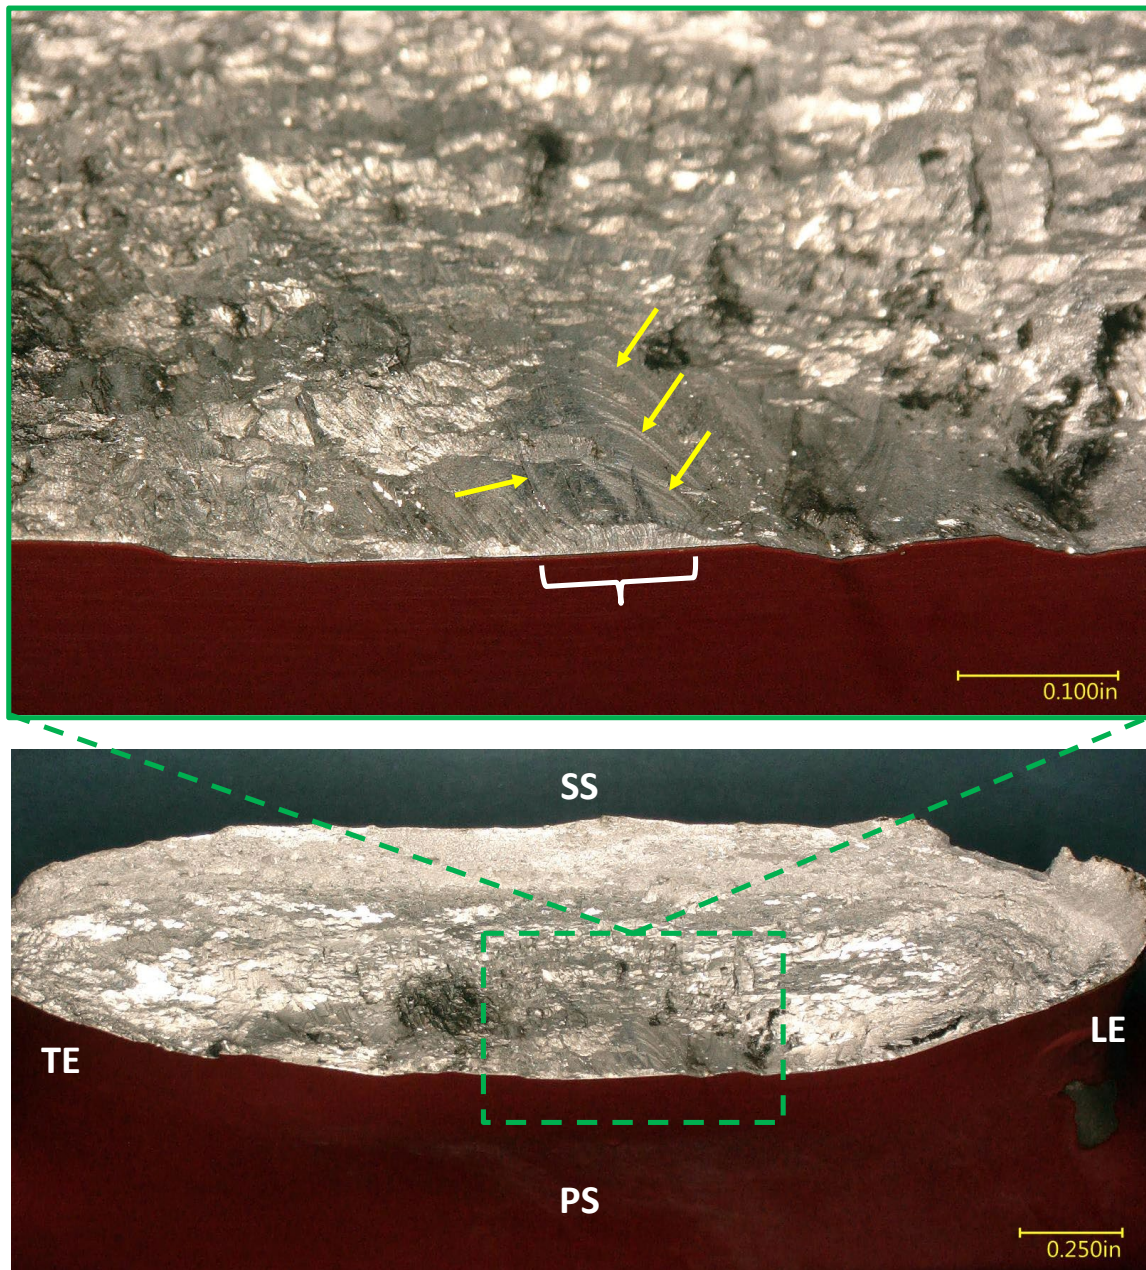
Crack arrest marks (yellow arrows, Figure 3) were visible on the fracture surface. The crack arrest marks emanated from a broad fatigue origin (white bracket, Figure 3). No external nicks or gouges were observed at the fatigue origin.

Figure 3: Digital microscope images of the fracture surface on the separated blade as viewed when tilted to show the pressure side (PS). The yellow arrows point to crack arrest marks. The white bracket indicates the fatigue origin area.

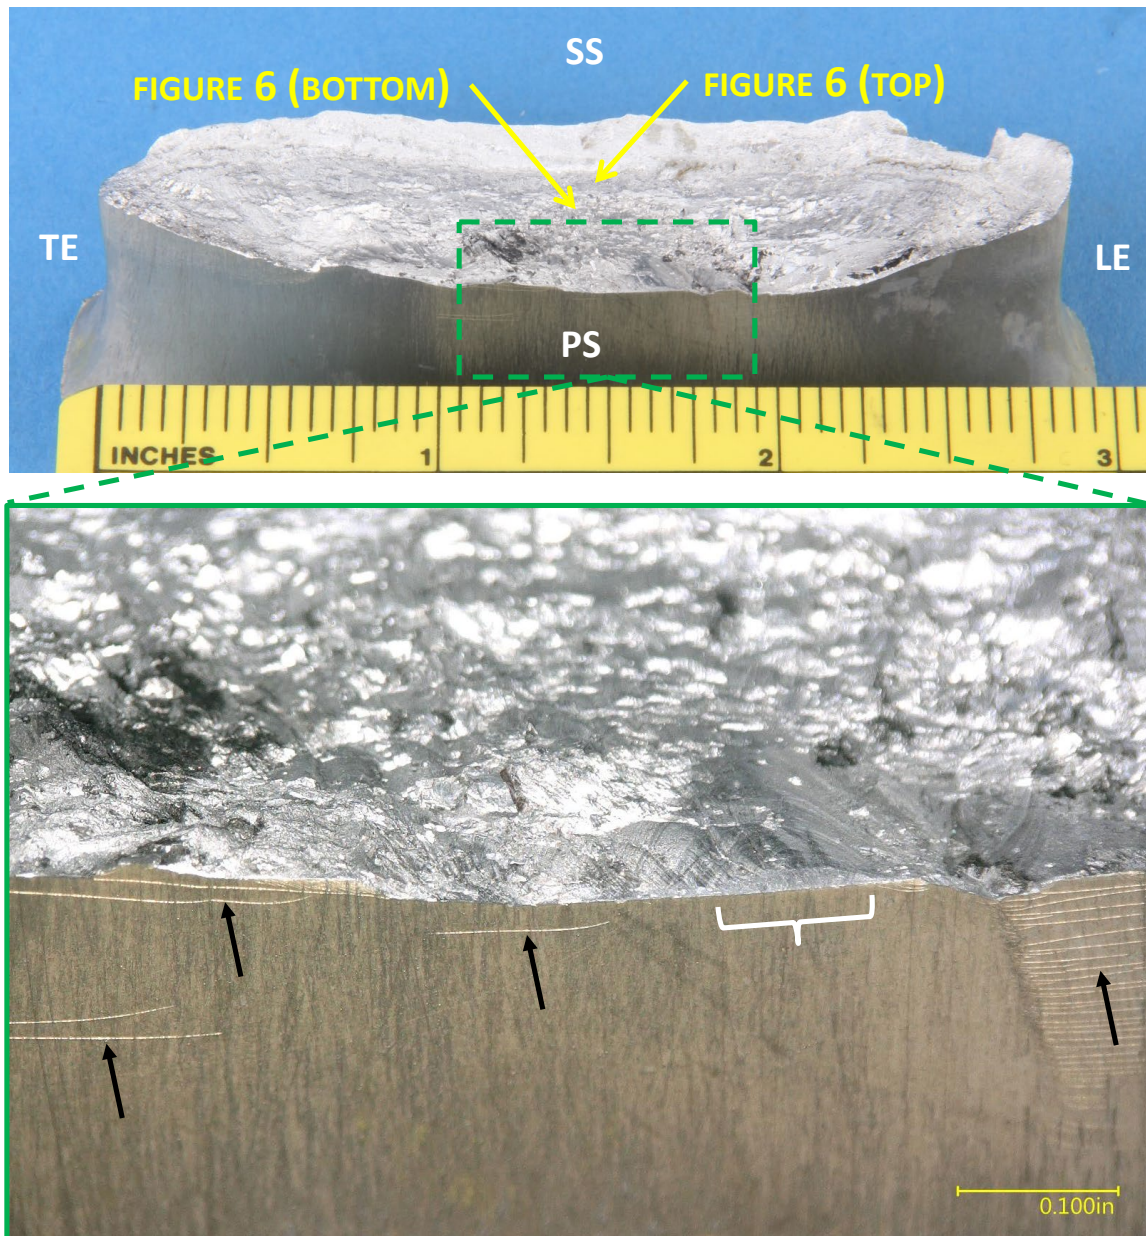
The fracture surface was sectioned from the blade bottom and the paint was removed from the blade surfaces using Cee Bee A-202 epoxy and polyurethane stripper manufactured by McGean-Rohco, Inc., Cleveland, Ohio. Craze cracking was observed in the anodized coating in several locations (black arrows, Figure 4). The anodized coating was present and intact along the edge of the fracture surface, including at the fatigue origin.

Figure 4: Digital microscope images of the fracture surface on the separated blade as viewed when tilted to show the pressure side (PS) after the paint was removed from the blade surface. The white bracket indicates the fatigue origin area. Craze cracking (black arrows) was observed in the anodized coating in several locations.

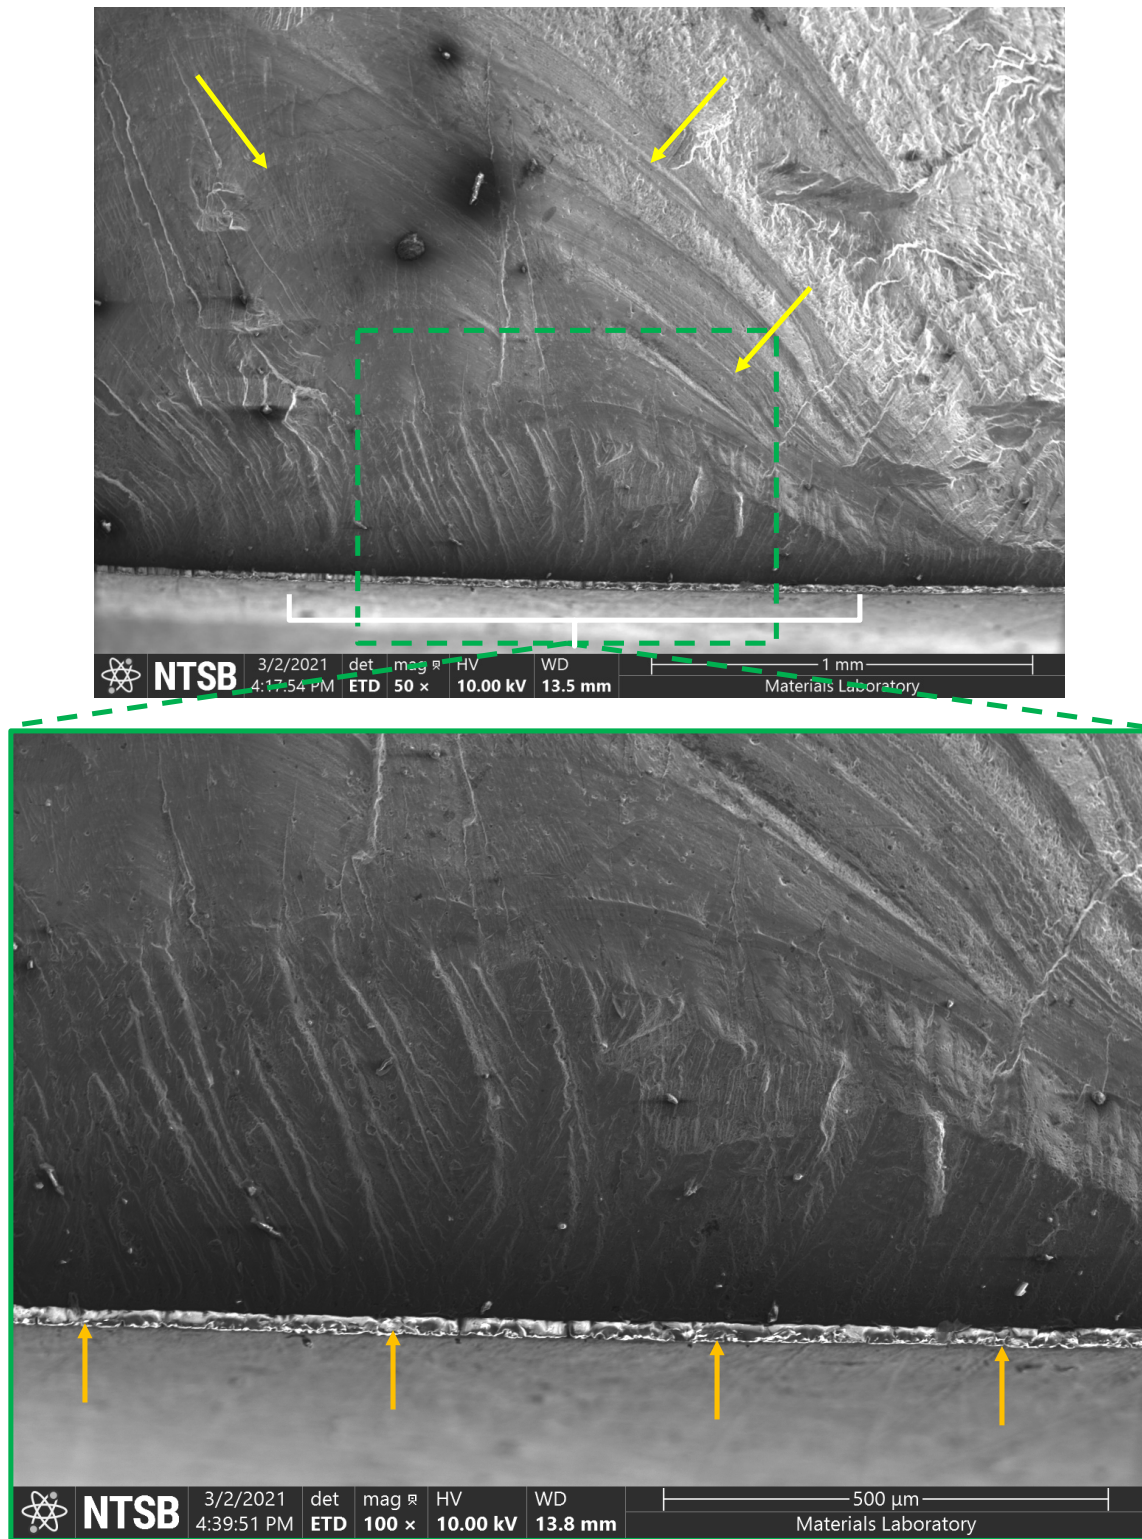
The fracture surface was examined using a Thermo Scientific Apreo 2 field emission scanning electron microscope (SEM). SEM images of the fracture surface shown in Figure 5 confirms the crack arrest marks (yellow arrows) emanating from a broad fatigue origin (white bracket) on the pressure side of the blade. The intact anodized coating (orange arrows) along the edge of the fracture surface is also visible. No damage or contamination was observed at the fatigue origin.

Figure 5: Secondary electron (SE) SEM images of the fatigue origin (white bracket) on the fracture surface. The yellow arrows in the top image point to crack arrest marks. The orange arrows in the bottom image point to intact anodized coating along the edge of the fracture surface.

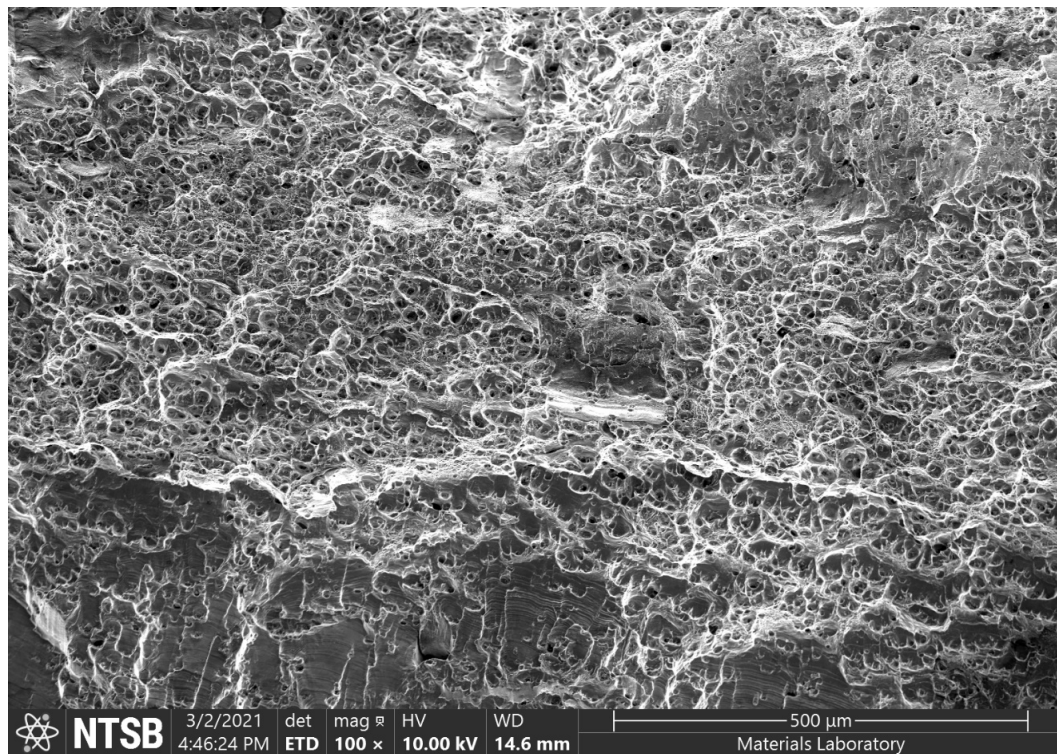
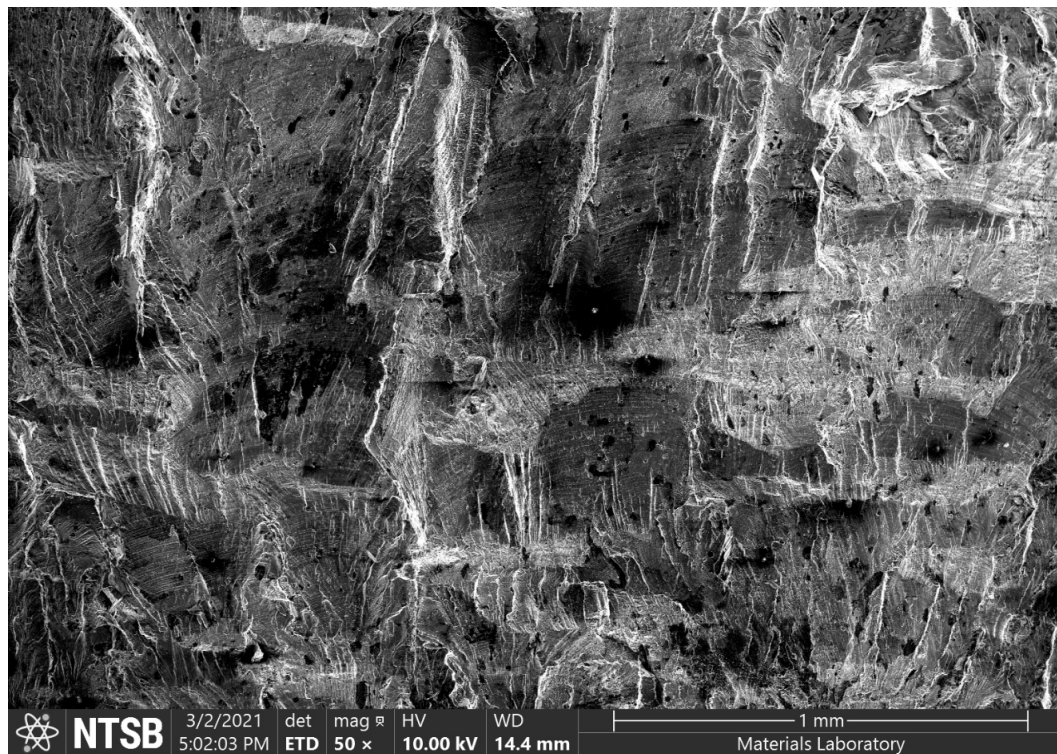
SEM images of the fracture surface approximately mid-thickness through the blade and at the edge of the shear lip along the suction side of the blade are shown in the bottom and top images, respectively, in Figure 6. The fracture surface features mid-thickness were consistent with mixed mode fracture. The fracture surface in the shear lip were dimpled rupture consistent with overstress.

Figure 6: SE SEM images fracture surface (bottom) approximately mid-thickness through the blade and (top) at the edge of the shear lip along the suction side of the blade.

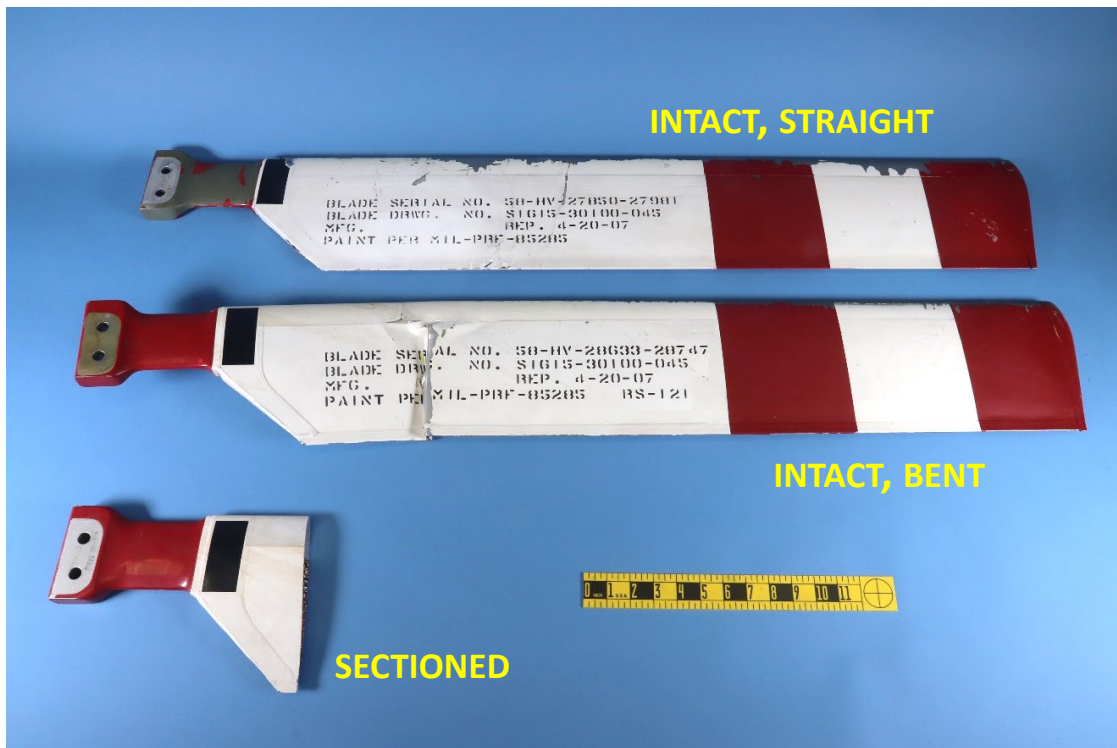
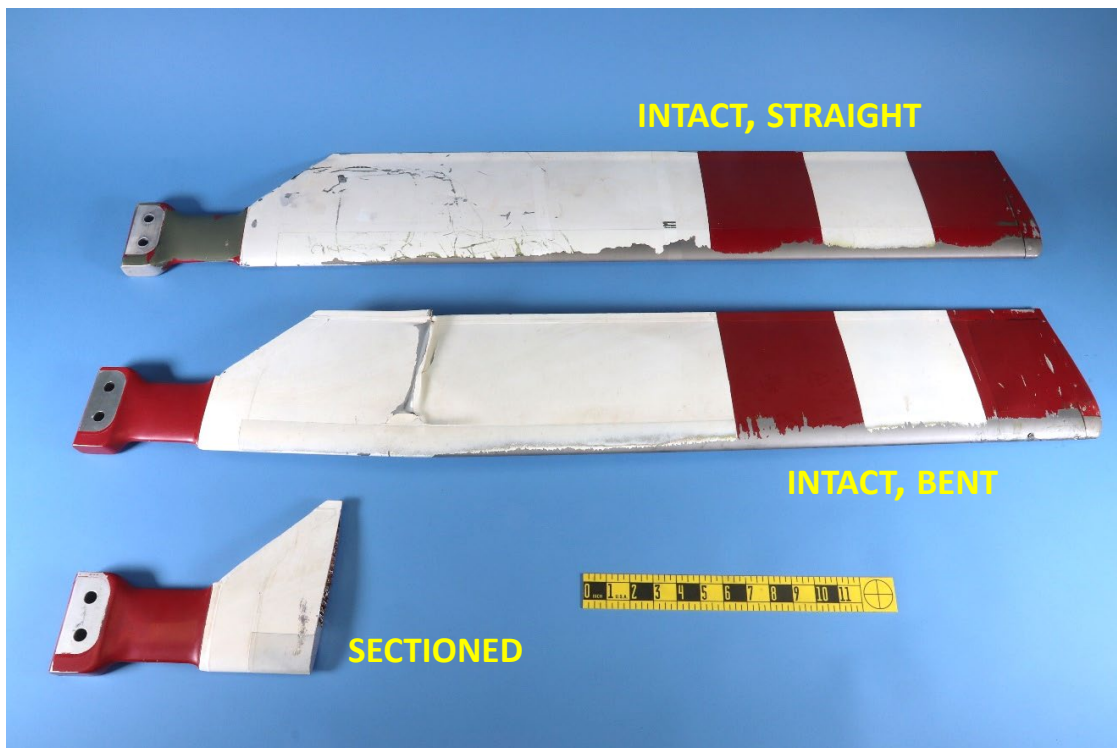
The other three tail rotor blades from the accident aircraft were submitted for evaluation. As shown in Figure 7, two of the blades were intact but damaged; one intact blade was bent and had a wrinkle in the bottom third of the airfoil. The third blade had been sectioned through the airfoil near the root end. Key overall dimensional measurements of each blade and the corresponding drawing specification are given in Table 1.

Figure 7: Overall macro photos of the other three tail rotor blades from the accident aircraft submitted for evaluation.
