## **NATIONAL TRANSPORTATION SAFETY BOARD**

### **ENGINE AND AIRFRAME EXAMINATION SUMMARY**

**WPR19LA259**

Location: Marana, Arizona  
Date: September 13, 2019  
Aircraft: Piper PA-28-181, N4403Z, Serial #: 2843726  
NTSB IIC: Andrew Swick

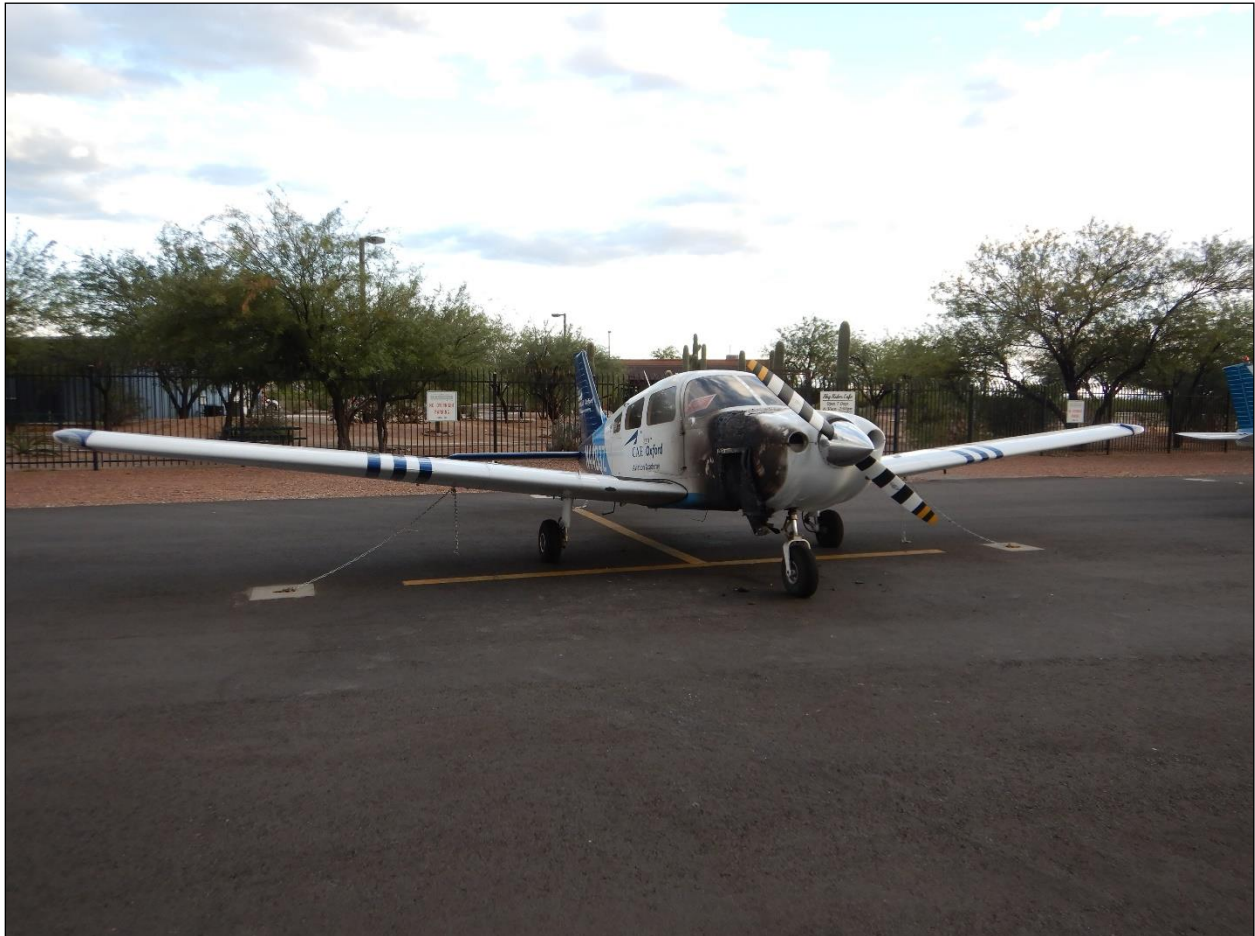
**Figure 1-Accident Airplane, Parked**

An examination of the airplane was conducted on September 14, 2019 at AVQ. The airplane was parked on the ramp at AVQ where the event occurred. The wreckage was located and secured on a parking space at AVQ. The right side of the upper and lower cowling and adjacent fuselage had thermal damage and sooting residue. A large section of the lower right side of the cowling was thermally damaged revealing the engine compartment. The right side of the cowling was opened by the responding fire department revealing the engine compartment. An axe was used to gain access for the purposes of fighting the fire. All flight control surfaces were in place and no damage was noted. The upper and lower cowlings were removed from the airplane. The lower cowling exterior surface had signs of settling fuel (blue colored fuel staining) near the area of the nose landing gear strut cutout.

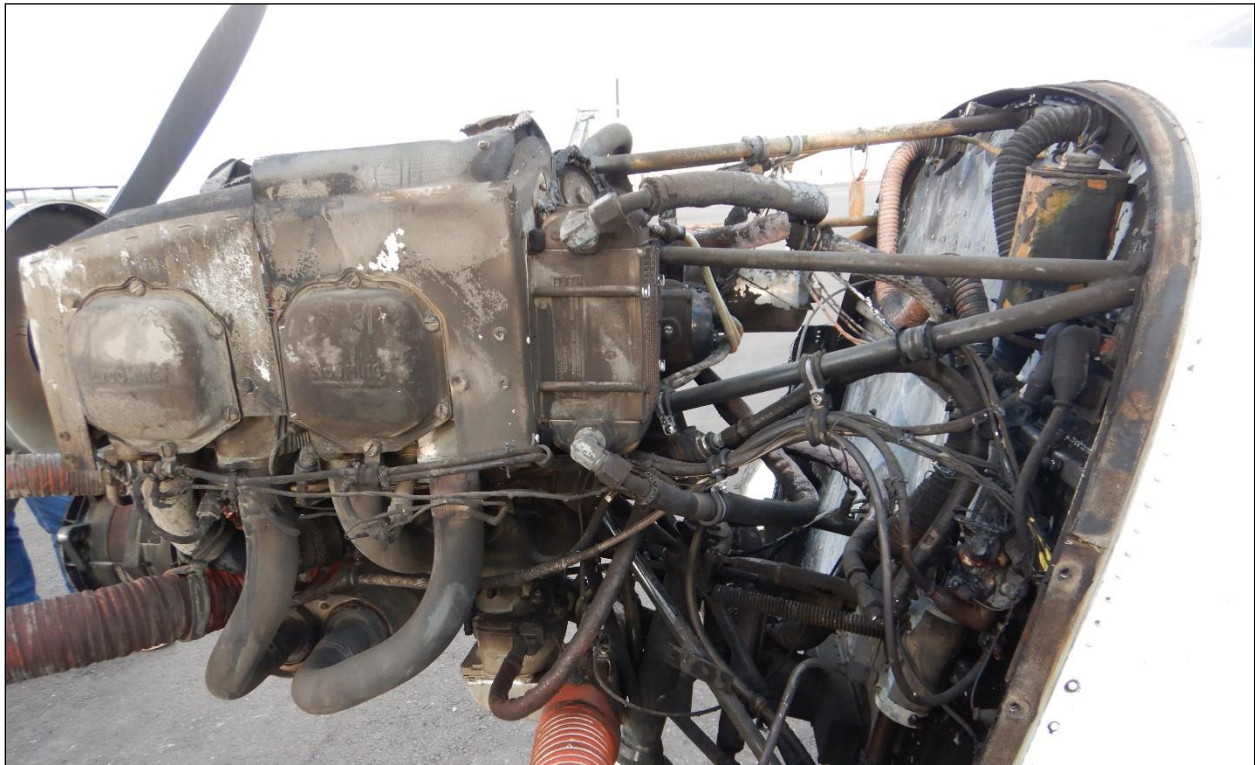
Figure 2-Engine-Left View

The engine accessory section and the lower side of the engine had thermal damage and discoloration. The left magneto distributor cap and both ignition leads had thermal damage. Fuel and oil lines had thermal damage to the heat shields. The engine mount rubber bushings had thermal damage. The engine mounting carriage had thermal discoloration. The engine firewall had thermal discoloration and bending of the firewall material. All fuel line B-nut fittings were tight when checked with a wrench. Most of the excessive fire damage was centralized in the accessory section. Three fuel lines were removed from the engine; boost pump to the mechanical pump, mechanical pump to the carburetor, and the boost pump to the primer solenoid. The fuel lines removed had thermal damage to the heat shielding and were obtained by the NTSB-IIC for further examination. The carburetor, induction air box and both magnetos were removed and obtained by the NTSB-IIC for further examination.

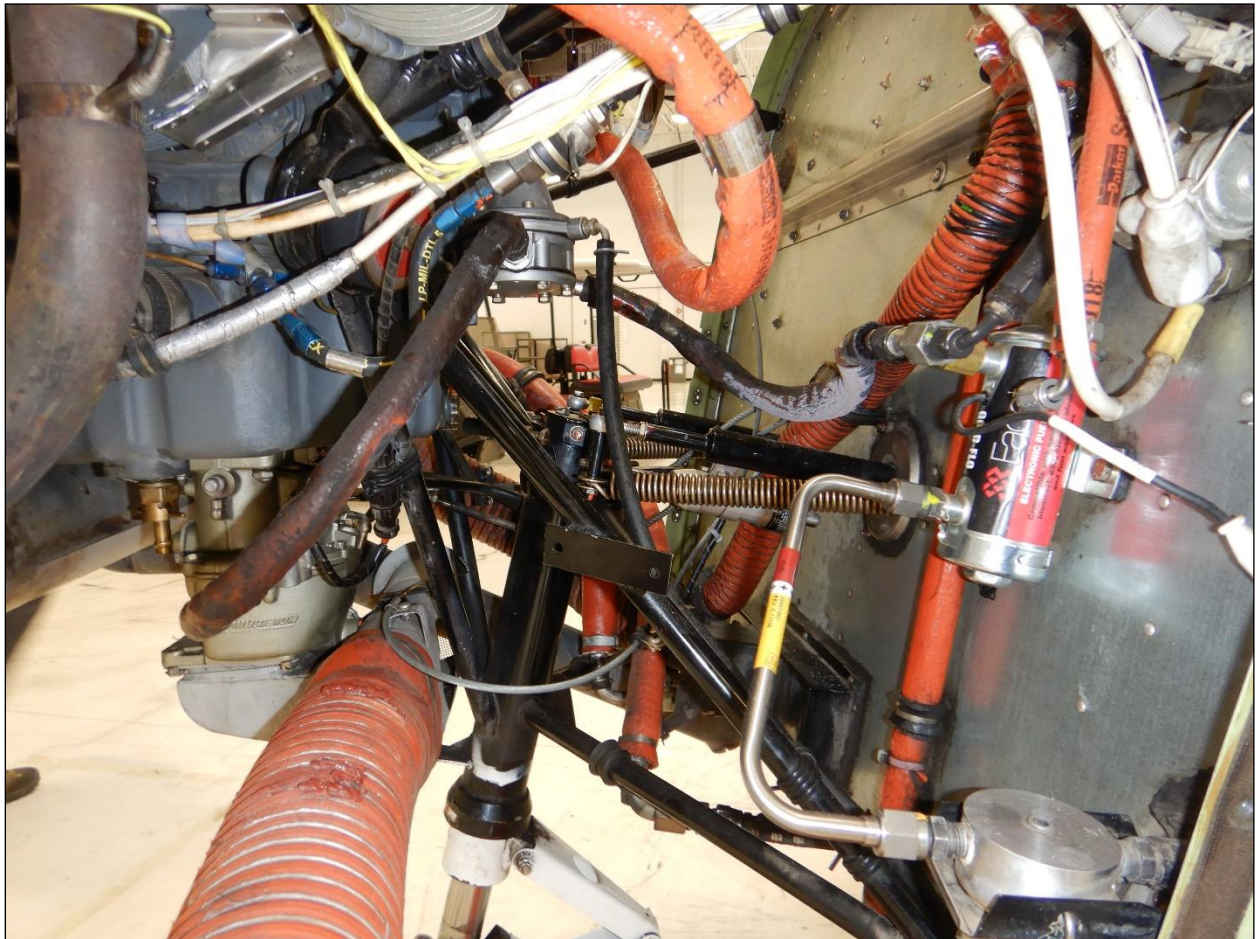
**Figure 4-Accident Airplane Fuel Lines (3) Installed on an Exemplar Airplane**

On September 15, 2019, the fuel lines obtained by the NTSB-IIC were installed on an exemplar airplane (N4403M, a 2013 Model) at the maintenance facilities of CAE. The cowling was not reinstalled, and the engine was started and operated at various settings. The accident airplane fuel lines installed did not leak any fuel during the test run. The engine was then setup and started as per the flight instructor's statement. No anomalies were noted and no fuel was leaking from the engine.

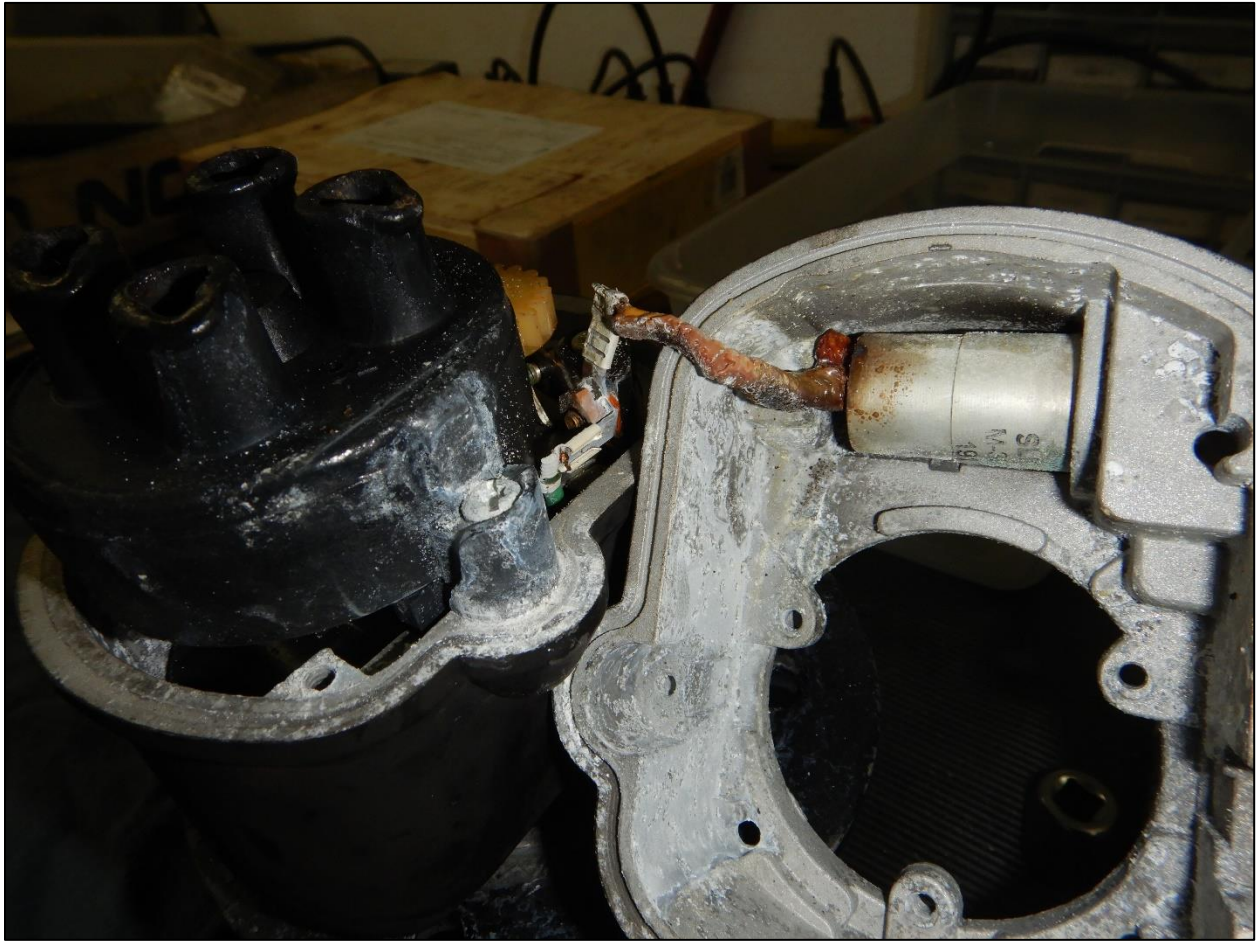
On September 17, 2019, the magnetos were sent to Aircraft Engine Specialists in Chandler, Arizona, for testing and teardown. The NTSB and a representative from CAE were present. The left magneto was positioned on a test bench and the drive rotated freely. No spark was produced during the test. The left magneto housing was opened and thermal damage was noted to the interior components. The internal timing was undetermined due to the points not closing. The impulse coupling and its associated components revealed no anomalies.

**Figure 5-Left Magneto Teardown, Internal Thermal Damage**

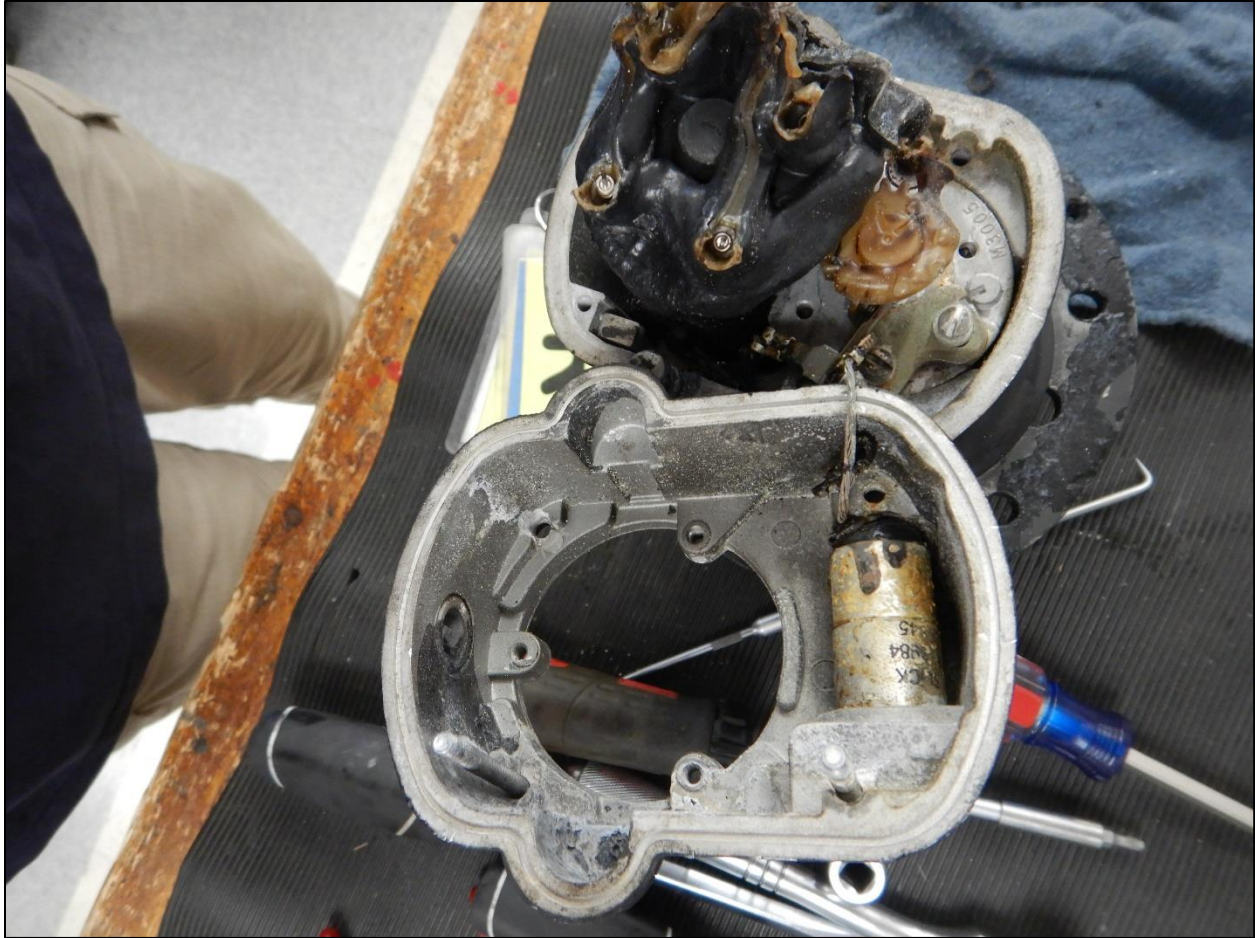
**Figure 6-Right Magneto Teardown**

The right magneto had more thermal damage to the distributor area and was not installed on the test bench. The housing was opened, and thermal damage was noted to the internal components. Internal timing was undetermined, and the points were found not to close.

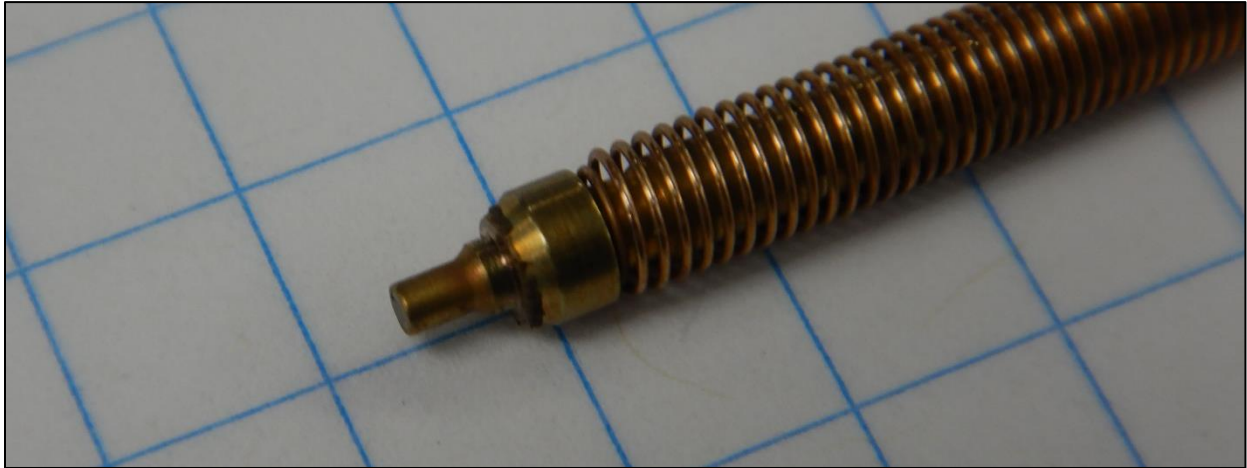
Figure 7-Accelerator Pump Valve Shaft

On September 19, 2019, the carburetor was examined and tested at Aircraft Engine Specialists in Chandler, Arizona. The carburetor was disassembled and no anomalies noted other than the accelerator pump needle valve wear. The accelerator pump needle valve wear was found near the valve contact area. The carburetor was reassembled and was installed on a pressure test bench. No anomalies were noted during the test.
