## **NATIONAL TRANSPORTATION SAFETY BOARD**

### **FUEL SYSTEM TEST – FIELD NOTES**

**WPR19LA259**

Location: Marana, Arizona  
Date: September 13, 2019  
Aircraft: Piper PA-28-181, N4403Z, Serial #: 2843726  
NTSB IIC: Andrew Swick

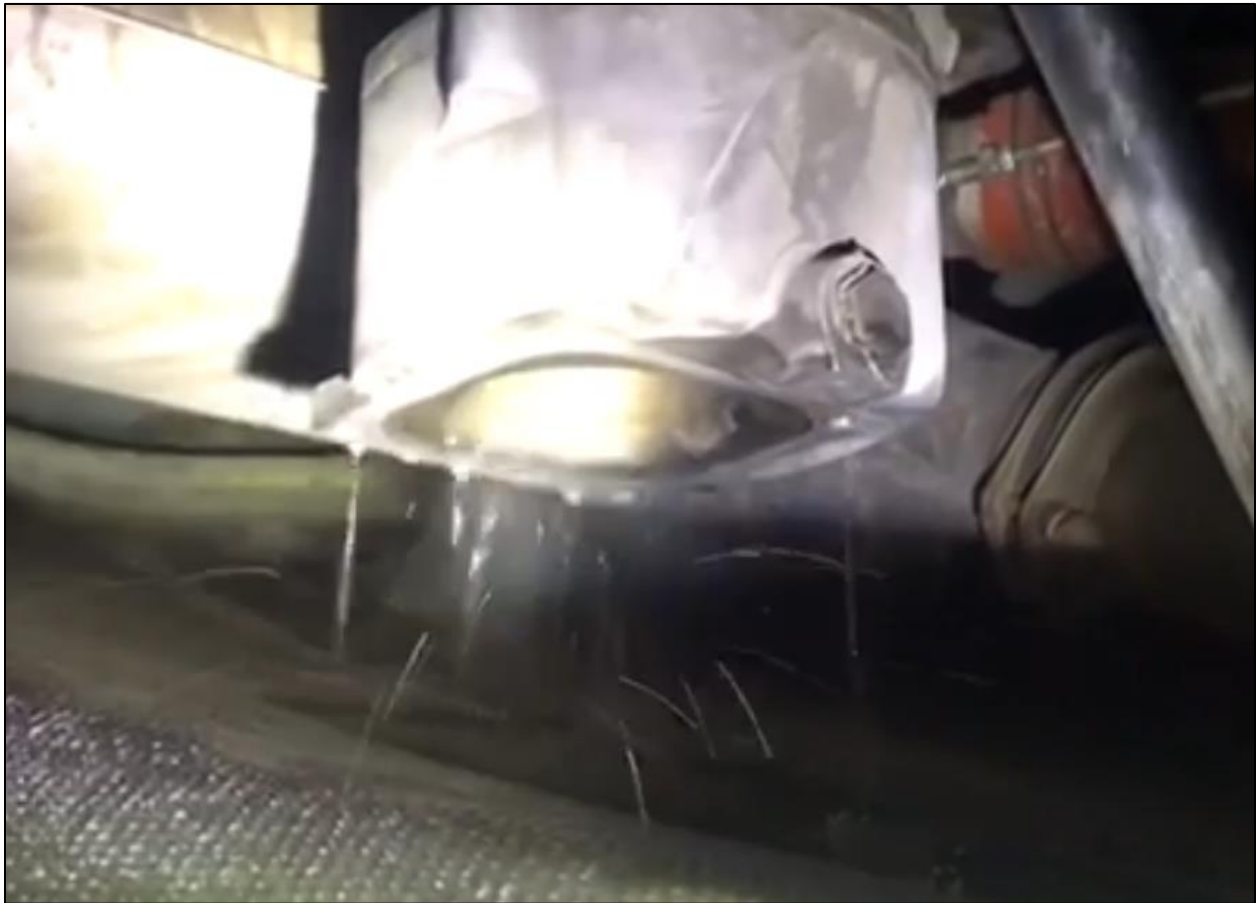
Figure 1-Test Run by CAE

On September 18, 2019, CAE was able to produce a large amount of fuel flowing from the carburetor during a test run and subsequent start attempts on two of their airplanes. A video confirmed that when the engine was operated to a certain oil temperature and then shut down, the accessory section including the carburetor and associated fuel lines were 'heat soaked' after a period of time, that during the subsequent engine start procedure, about 6-8 ounces of fuel 'showered' from the carburetor air intake.
