**NATIONAL TRANSPORTATION SAFETY BOARD**

**MATERIALS LABORATORY FACTUAL REPORT**

Report No. 20-054

Place : Tucumcari, NM  
Date : 9/14/19  
Vehicle : Smyth Sidewinder, N492AC  
NTSB No. : WPR19LA273  
Investigator : Joshua Cawthra

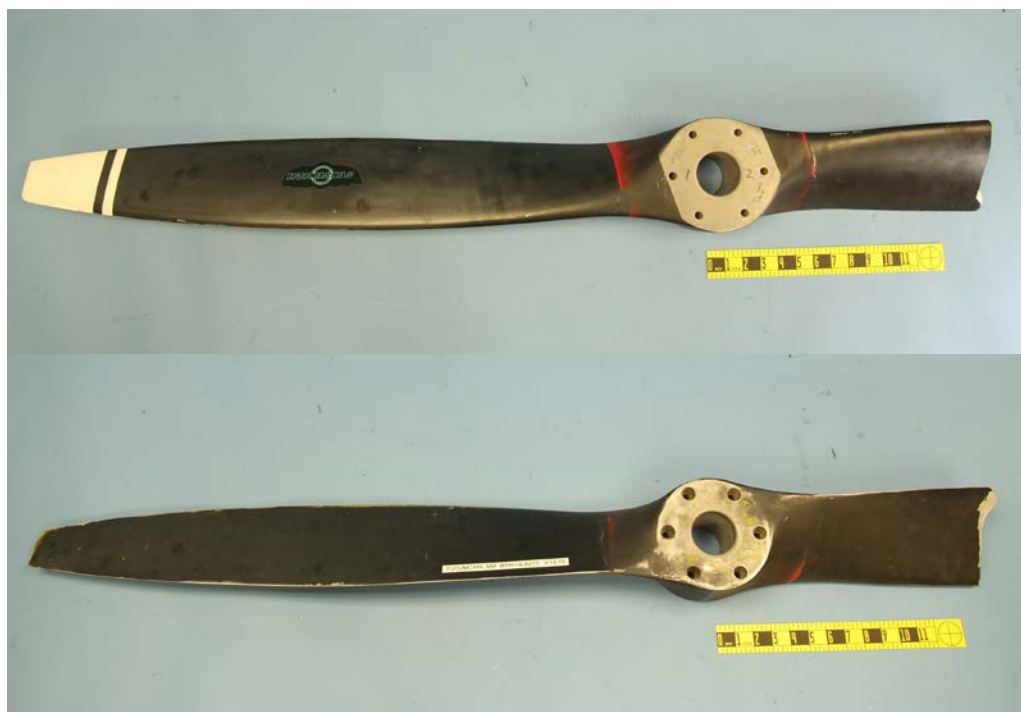
The portion of the Sensenich propeller exhibited a fracture chordwise across the propeller a little over 12 inches outboard of the center (Figure 1). A sectional cut was made to liberate the fracture surface from the main portion of the propeller for further examination (Figure 2). When exposed to oblique lighting the fracture surface exhibited two distinct regions, the larger one being relatively flat and terminating in a curved boundary and the other being on a slanted plain. The flat fracture area had a curved boundary with the center of curvature at a point on the face of the propeller blade identified as the origin in Figure 3. When examined with a 5X to 50X stereo-zoom microscope, the fracture origin area exhibited a small pit. Further examination with the scanning electron microscope (SEM) revealed fracture features consistent with progressive crack growth on the flat fracture surface in the area identified as the origin (Figures 4, 5). These fracture features are consistent with a fatigue fracture originating from the pit. Using a scanning electron microscope and orienting the fracture surface at a 45 degree incline an image of the pit at the origin area was taken as shown in Figure 6. Energy dispersive spectroscopy (EDS) of the origin area revealed chlorine containing salts consistent with a corrosion-initiated pit.

Figure 1: Portion of Sensenich propeller as received.

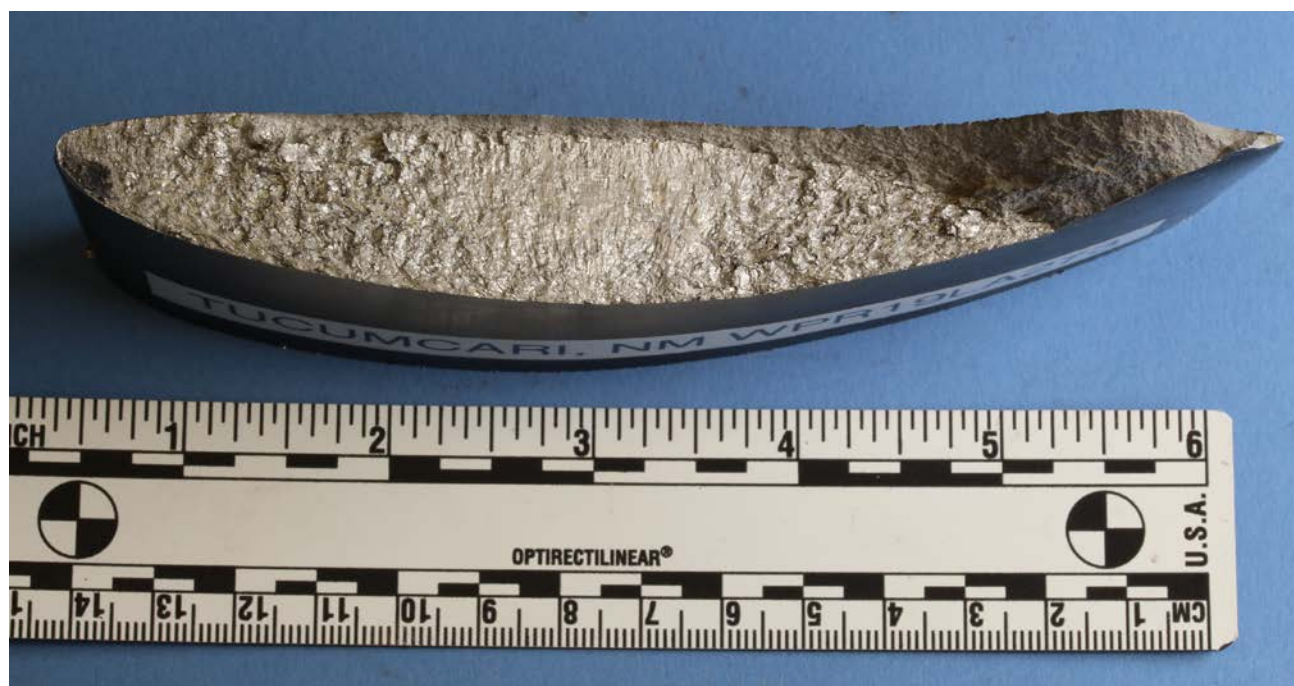
Figure 2: Section of the propeller containing the fracture surface.

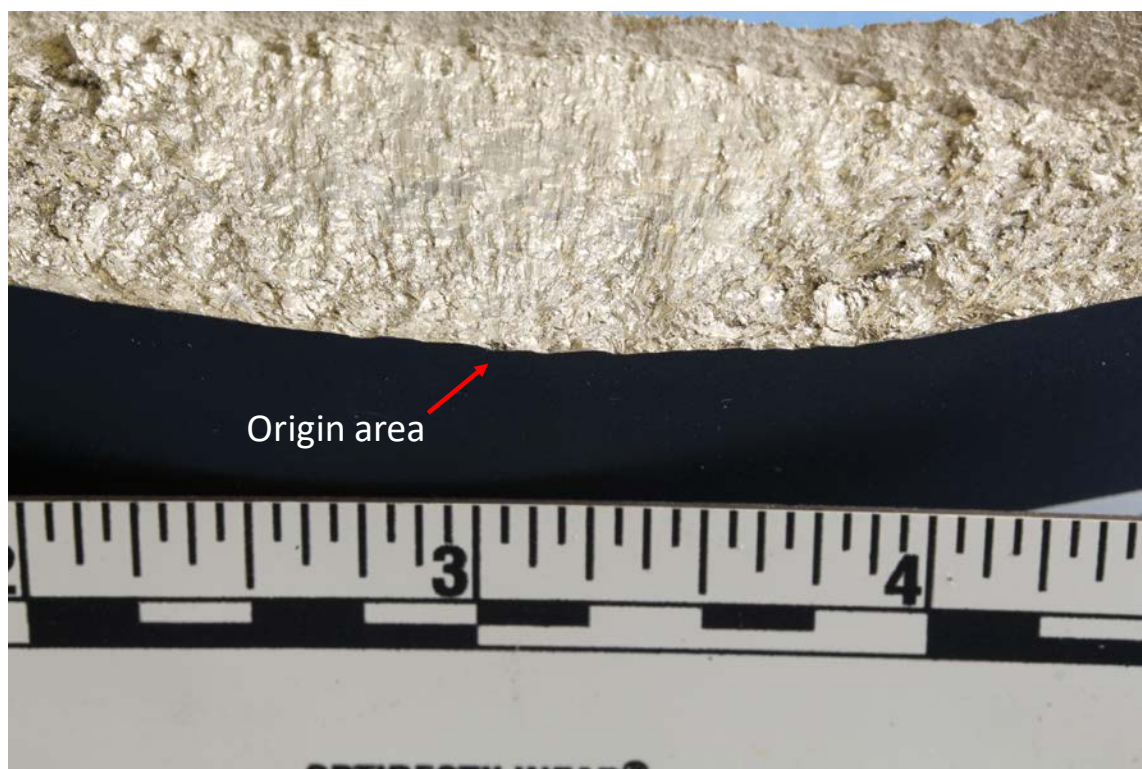
Figure 3: Origin area at the center of curvature of the flat fracture containing a small pit on the face of the propeller blade.

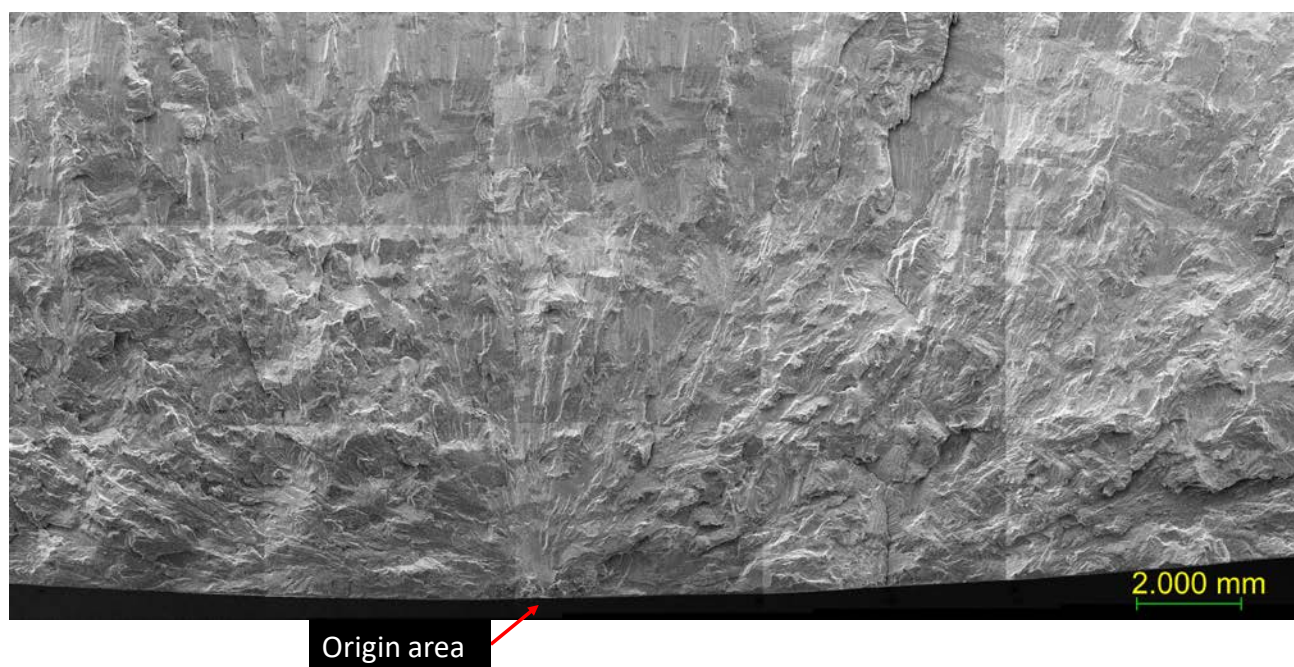
Figure 4: Secondary electron SEM montage image of the fracture surface including the origin area.

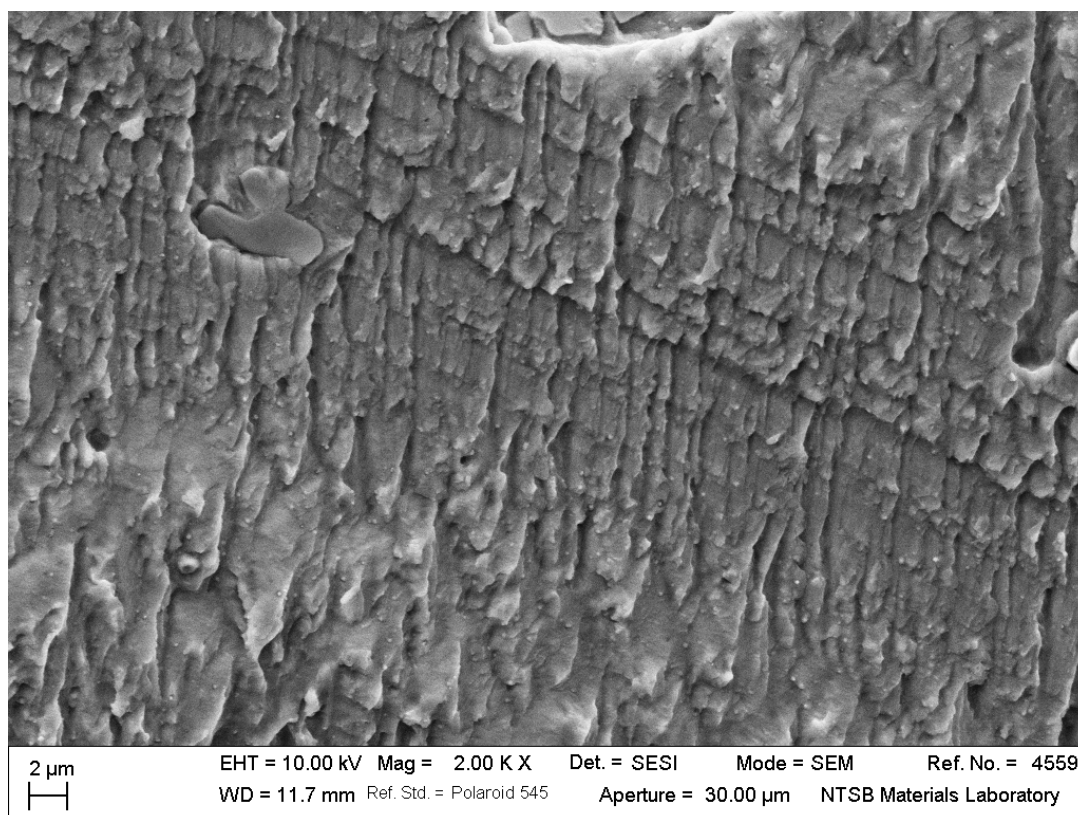
Figure 5: Secondary electron SEM image showing fracture features near the area of origin exhibiting progressive crack growth.

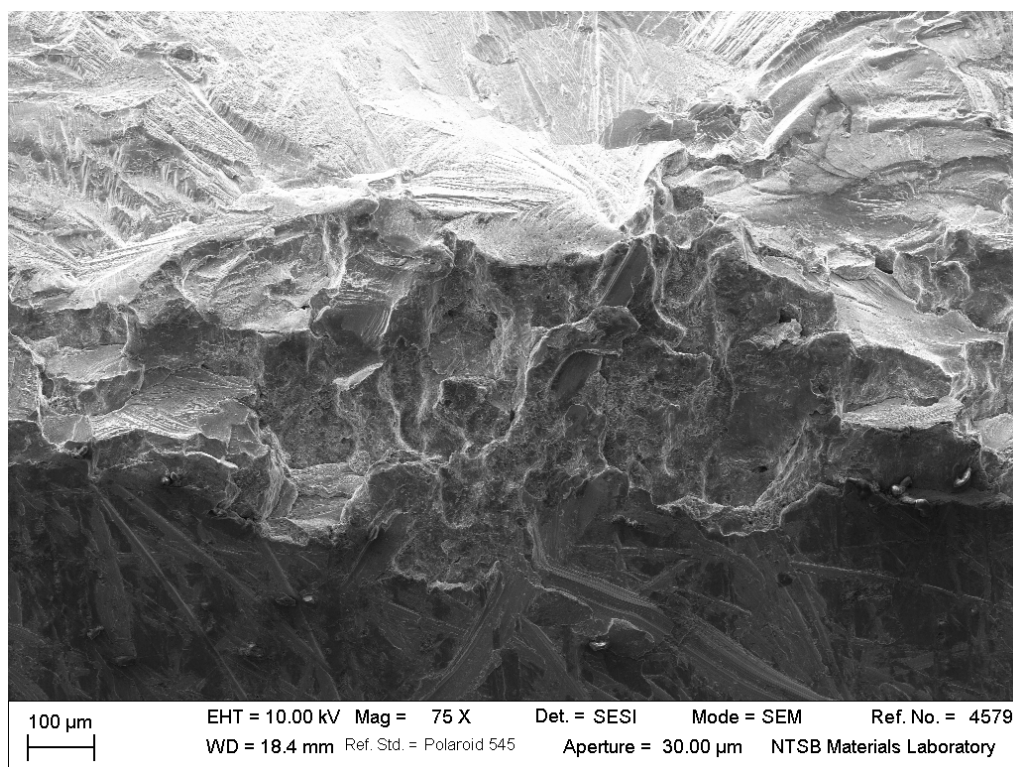
Figure 6: Secondary electron SEM image of the pit at the origin area viewed at a 45-degree angle to the face of the blade.

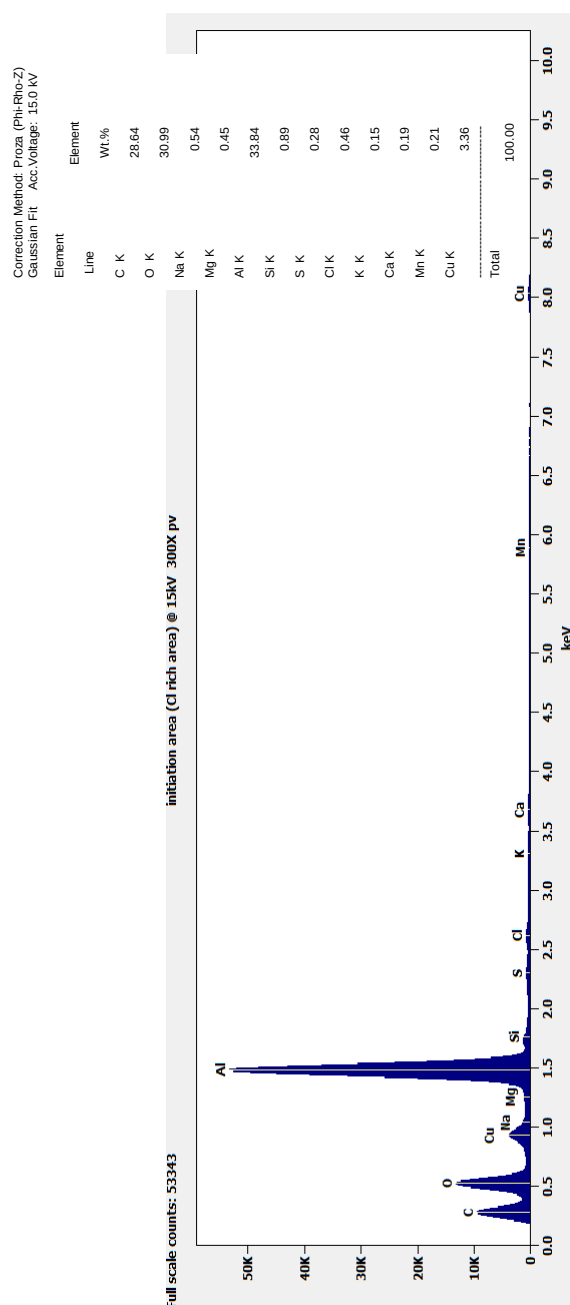
Figure 7: EDS spectra of the origin area.
