## **NATIONAL TRANSPORTATION SAFETY BOARD**

# **AIRFRAME AND ENGINE EXAMINATION**

**WPR19TA245**

Location: North Las Vegas, NV  
Date: August 27, 2019  
Aircraft: Bell 47G  
NTSB IIC: Fabian Salazar

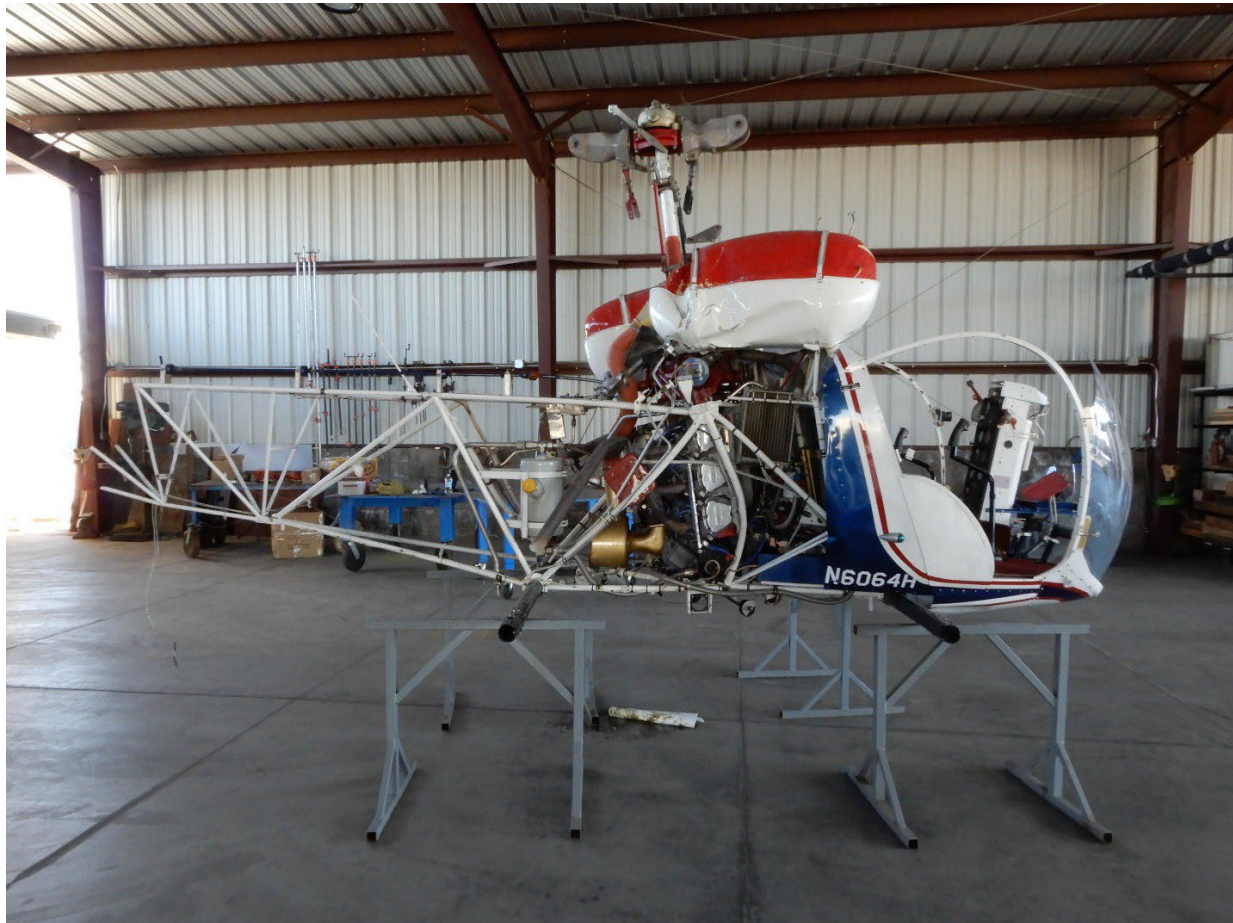
Fuselage. The fuselage was damaged consistent with ground impact. The acrylic dome windscreen was cracked but remained attached to the fuselage. The acrylic doors remained attached at their hinges. The truss tail boom was damaged and distorted. The tail boom was cut into two halves for recovery.

**Figure 1. N6064H, right-side view.**

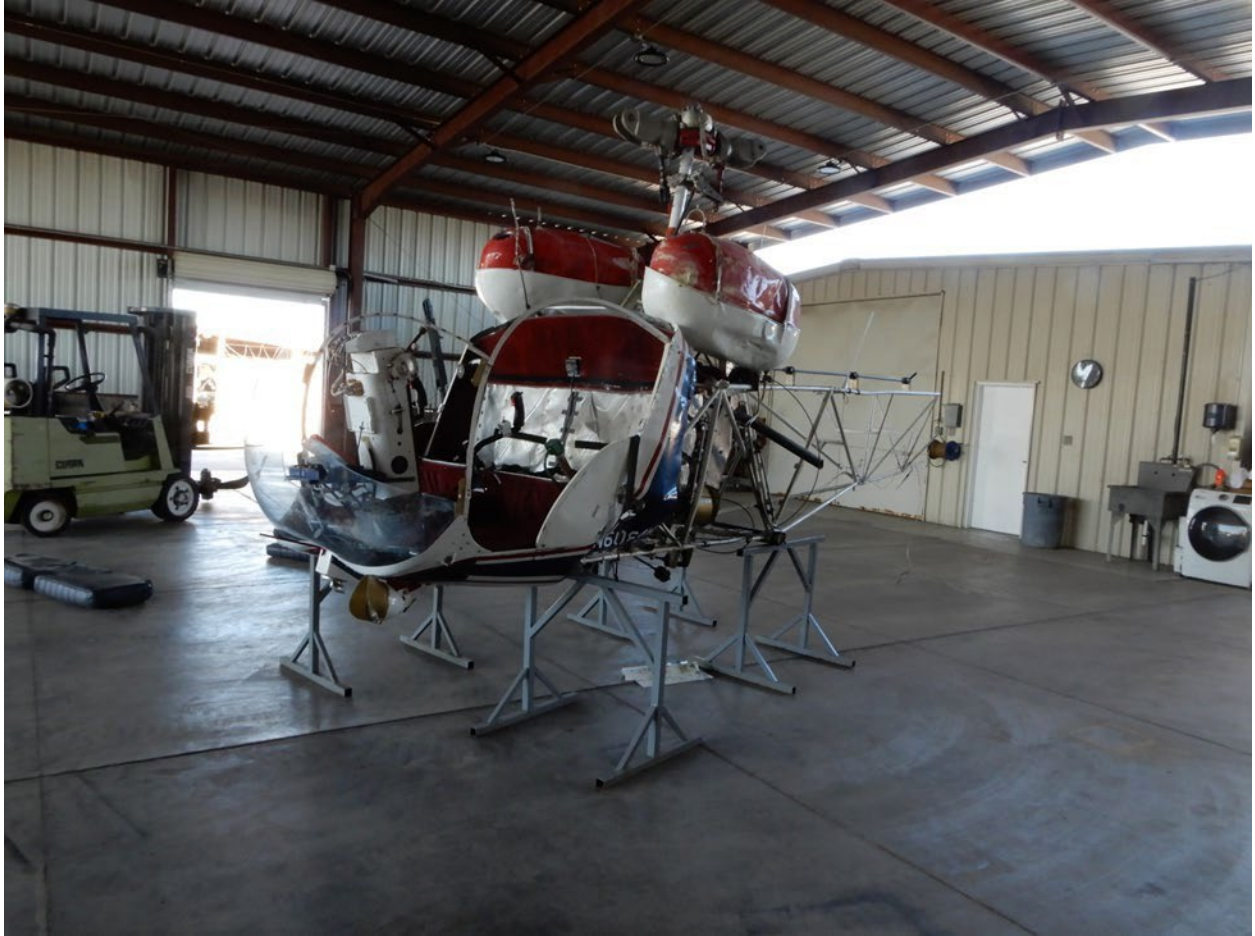
**Figure 2. N6064H, left-side view.**

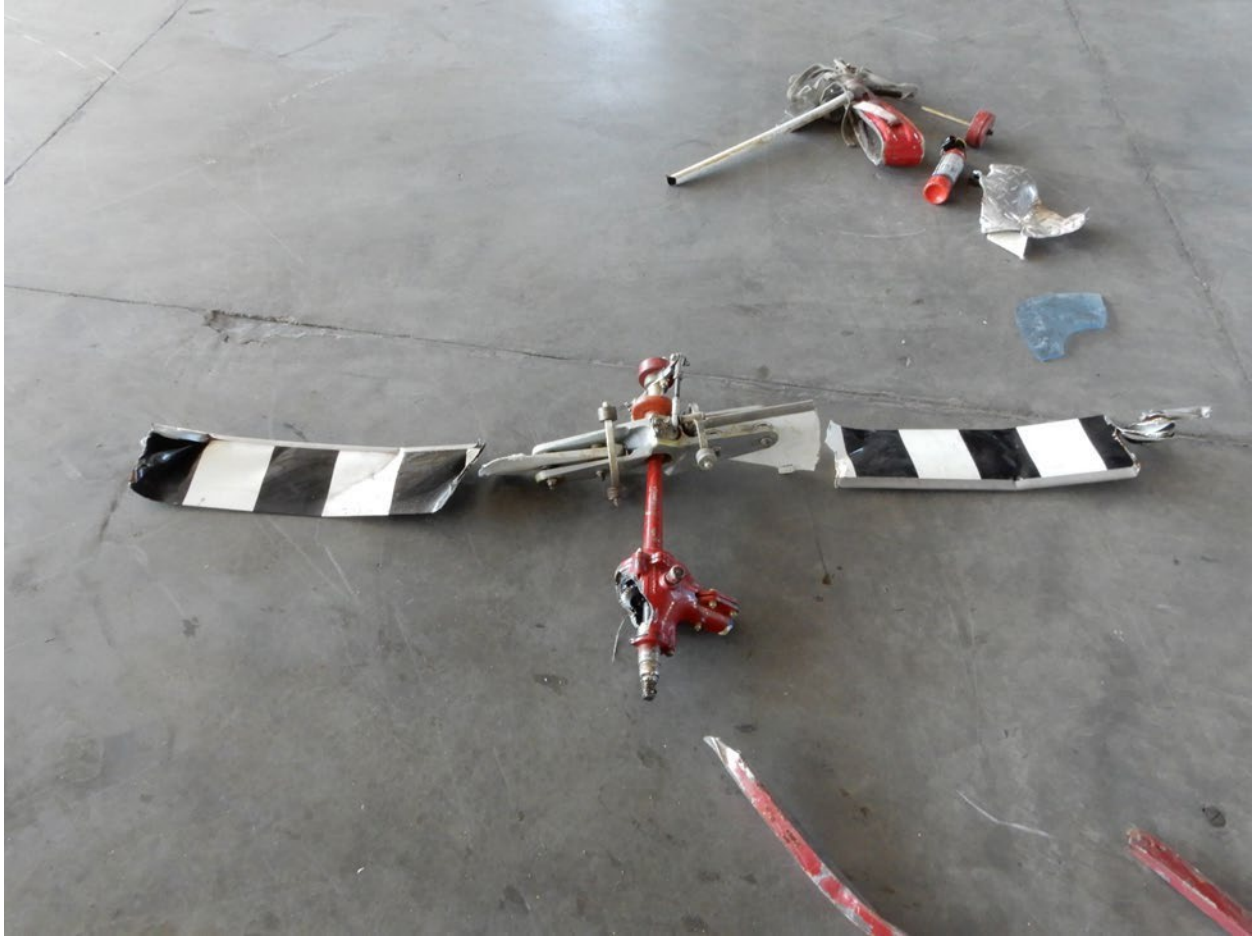
The tail rotor assembly separated from the tailboom at the gearbox. The gearbox casing fractured exposing the gears. No oil remained in the gearbox. The tail rotor driveshaft remained attached to the tailboom at the hangar bearings.

**Figure 3. Tail rotor assembly and 90° gearbox.**

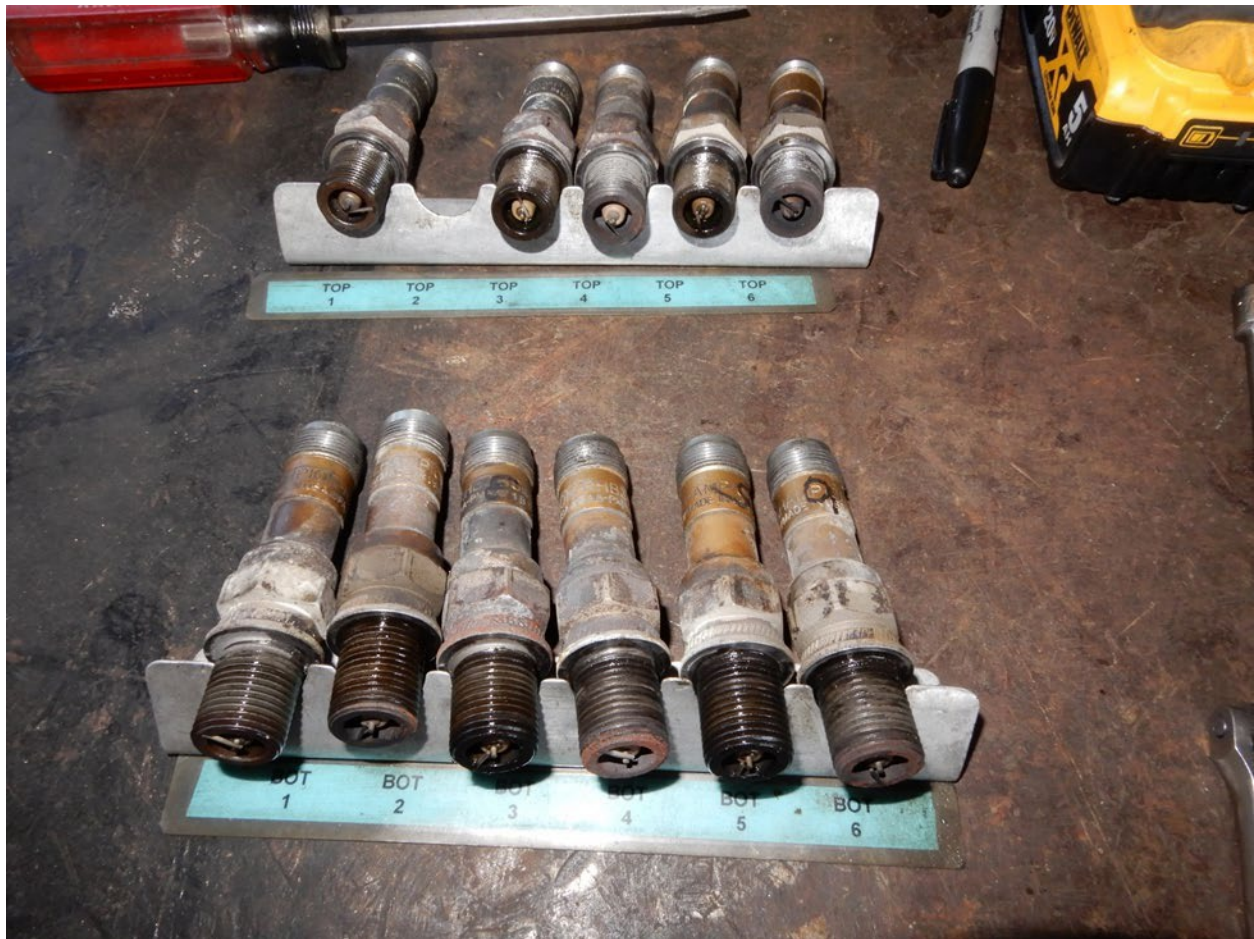
The spark plugs were removed and examined. All spark plugs display normal coloration. None of the 12 sparkplugs had the copper washer installed. That is the sparkplugs were installed on the engine without copper washers.

**Figure 4. Top and bottom spark plugs.**

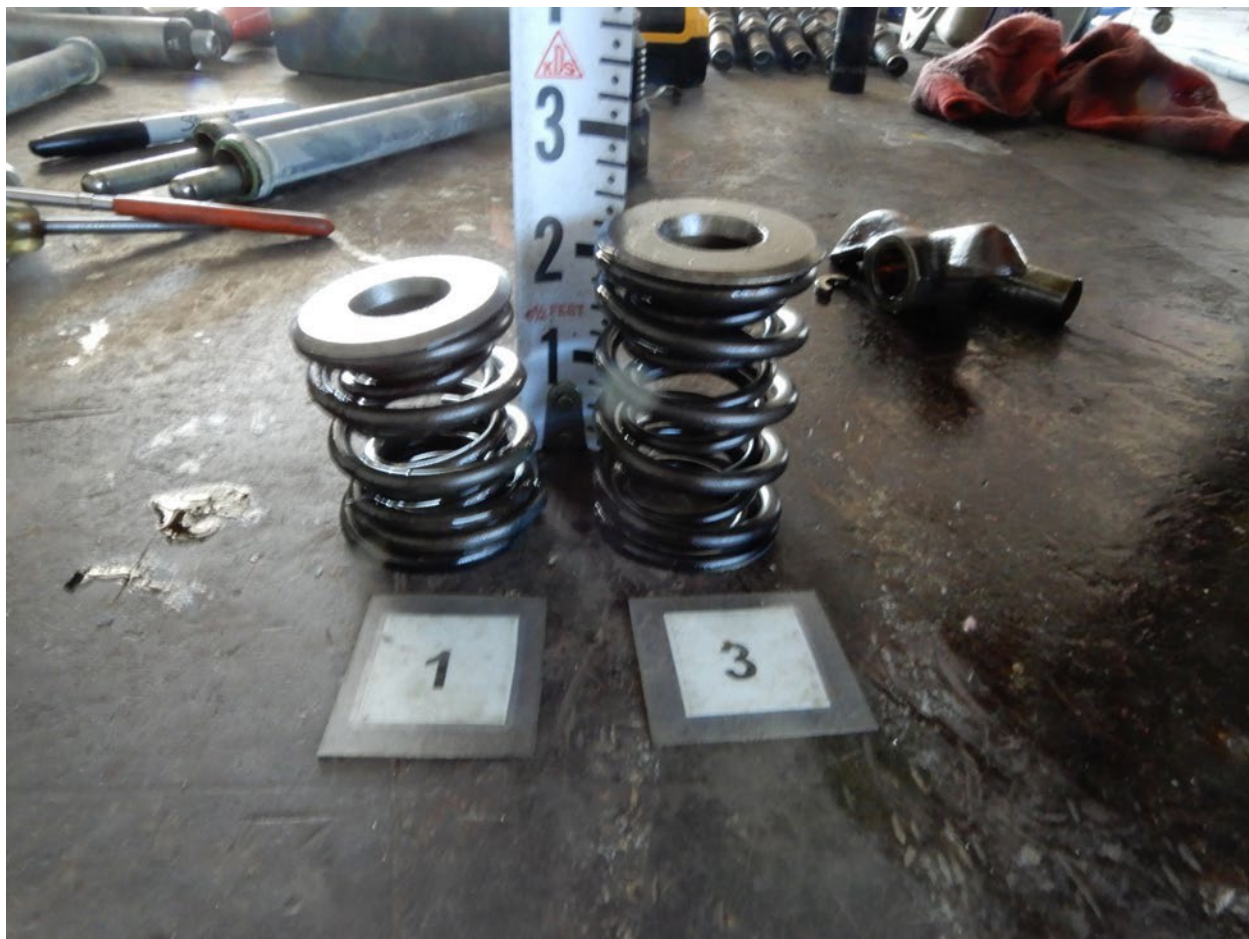
The number one cylinder, intake valve springs were found fractured into two pieces each. The cylinder was removed from the engine and examined. The number one intake valve was removed with difficulty due to a sharp edge that had formed at the valve where the two valve keepers are

**Figure 5. Number one intake valve springs compared to number three intake valve spring.**

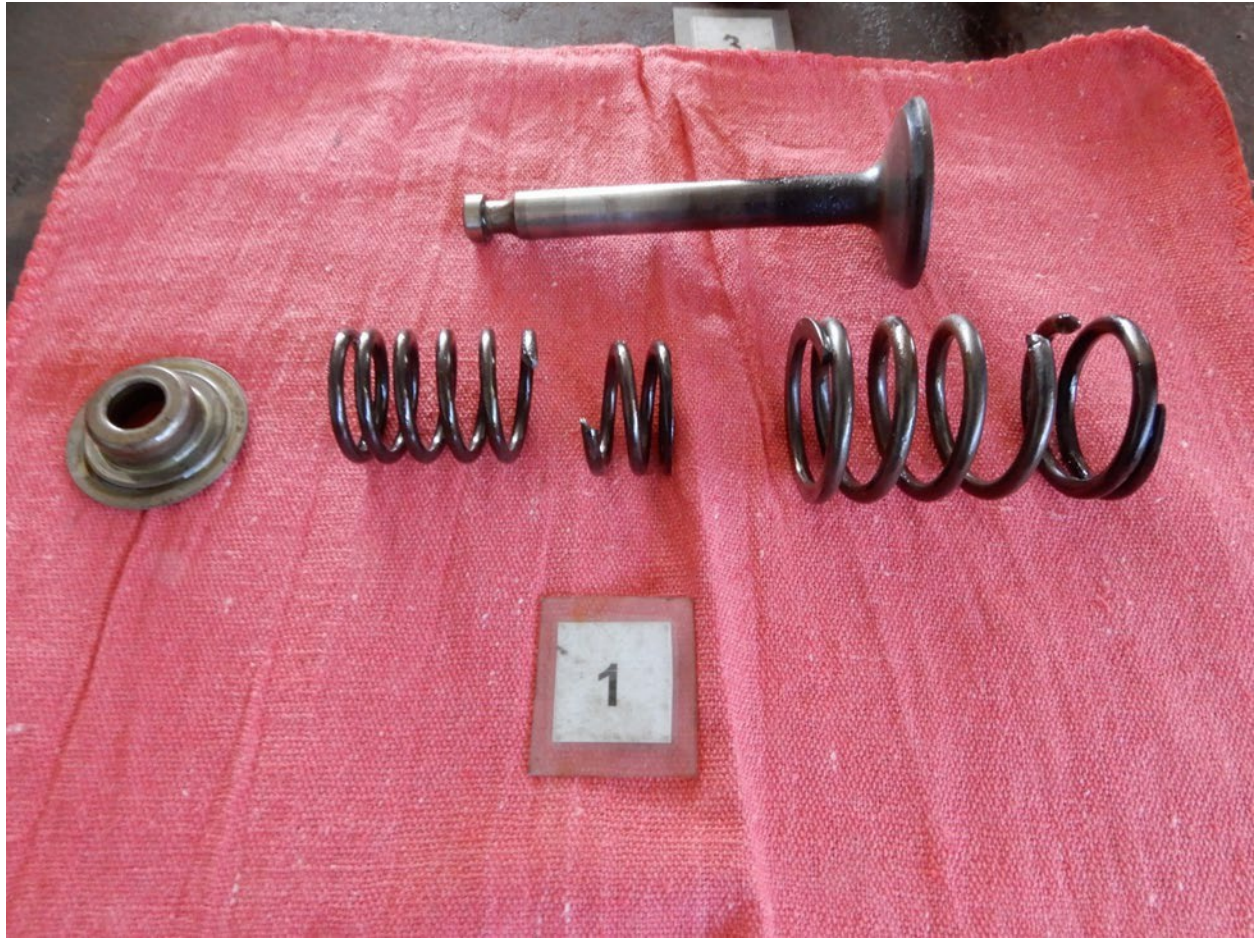
Examination of the airframe and engine occurred on February 25, 2020, at Air Transport Recovery facility, Phoenix, AZ. Examination of the airframe revealed no evidence of preimpact mechanical malfunction or failures that would have precluded normal operation. Examination of the engine revealed two cracked intake valve springs in the number one cylinder.

**Figure 6. Number one intake valve springs showing fractures on both springs.**
