## RECORD OF CONVERSATION

**Date: January 31, 2020**  
**Person Contacted: Mr. Greg Horrell (FAA Principal Maintenance Inspector)**  
**NTSB Accident Number: WPR19TA248**

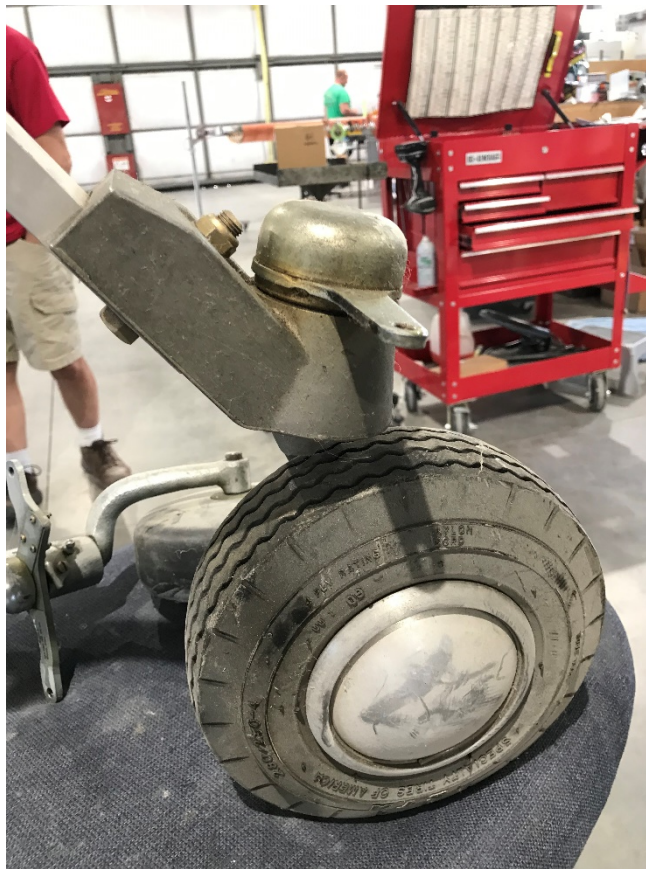
*Figure 1: Tailwheel*

The inspector reported that the airplane is equipped with a 1 ¼ inch tailwheel leaf spring. The new tailwheel, which was designed for a Maule airplane, was designed for a 1 ½ inch tailwheel leaf spring. Therefore, a shim would have needed to be installed in between the tailwheel and tailwheel leaf spring to ensure a proper installation. In addition, it would require a longer bolt to ensure the bolt would properly secure within the locking nut.

The owner reported to the FAA that he installed the tailwheel and did not put a shim between the tailwheel and the tailwheel leaf spring. However, he did install an elastic locking nut on the through bolt.

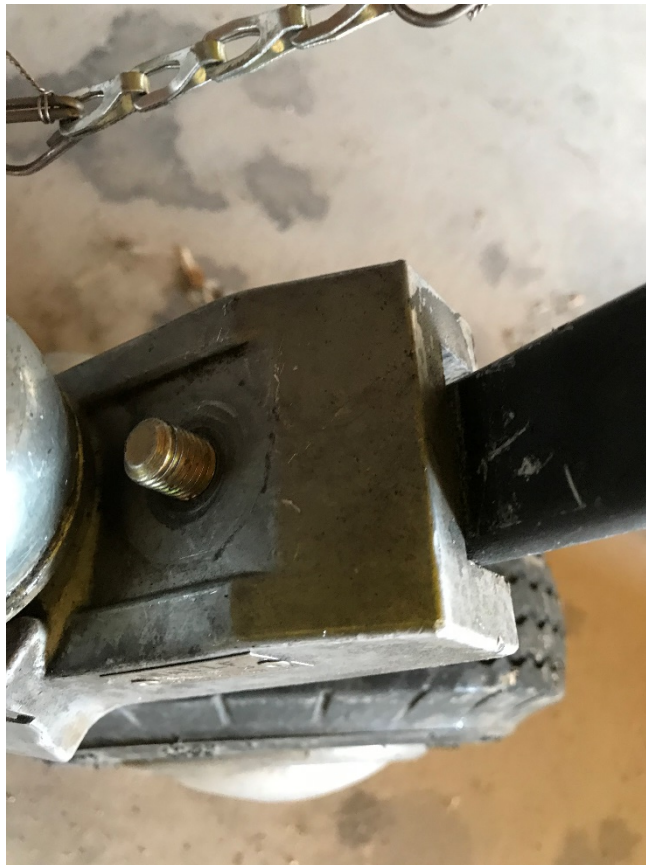
*Figure 2: Missing Nut*

An FAA on scene examination revealed the bolt was still present in the leaf spring, but the locking nut was not present (and was not located on the runway). There were no indications that a shim was installed. The bolt was removed from the leaf spring and measured; it was not long enough to reach the locking portion of the locking nut. Therefore, it is likely the tailwheel vibrated the nut loose causing excessive play in the tailwheel.
