WPR20CA090 Accident Pictures:

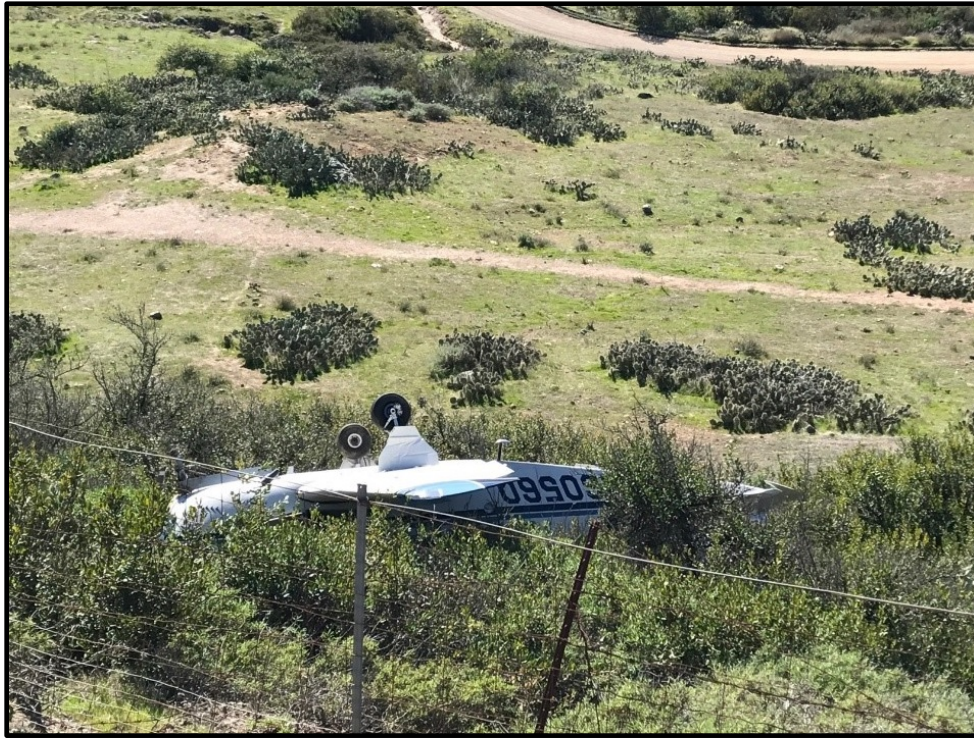
Figure 1: Airplane inverted at accident site (right side).

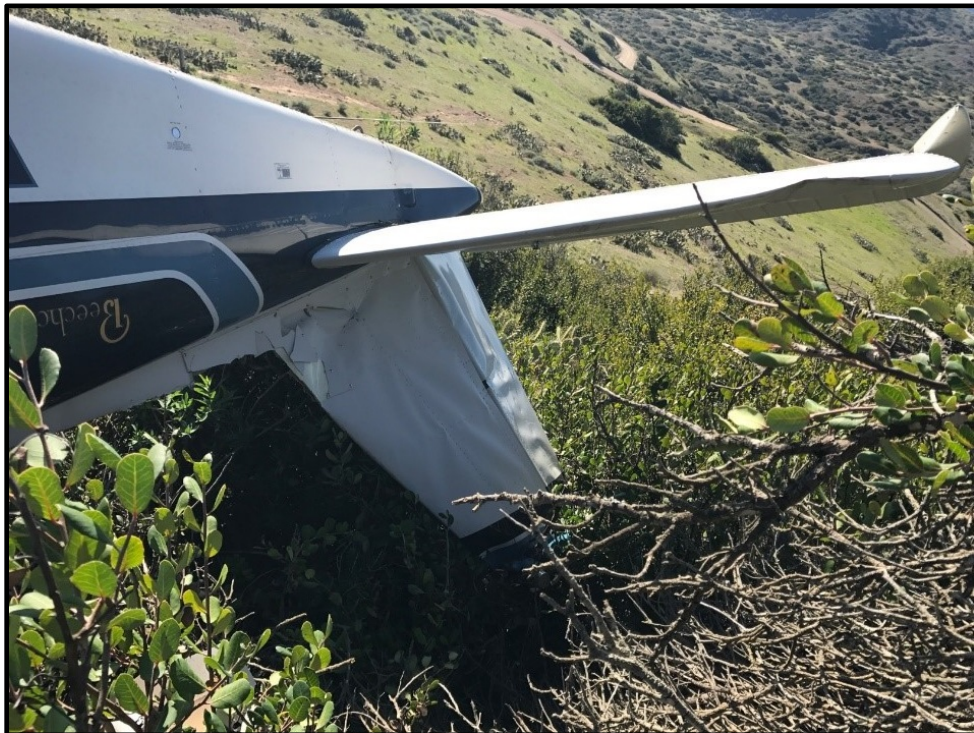
Figure 2: Airplane's damaged tail section (right side).
