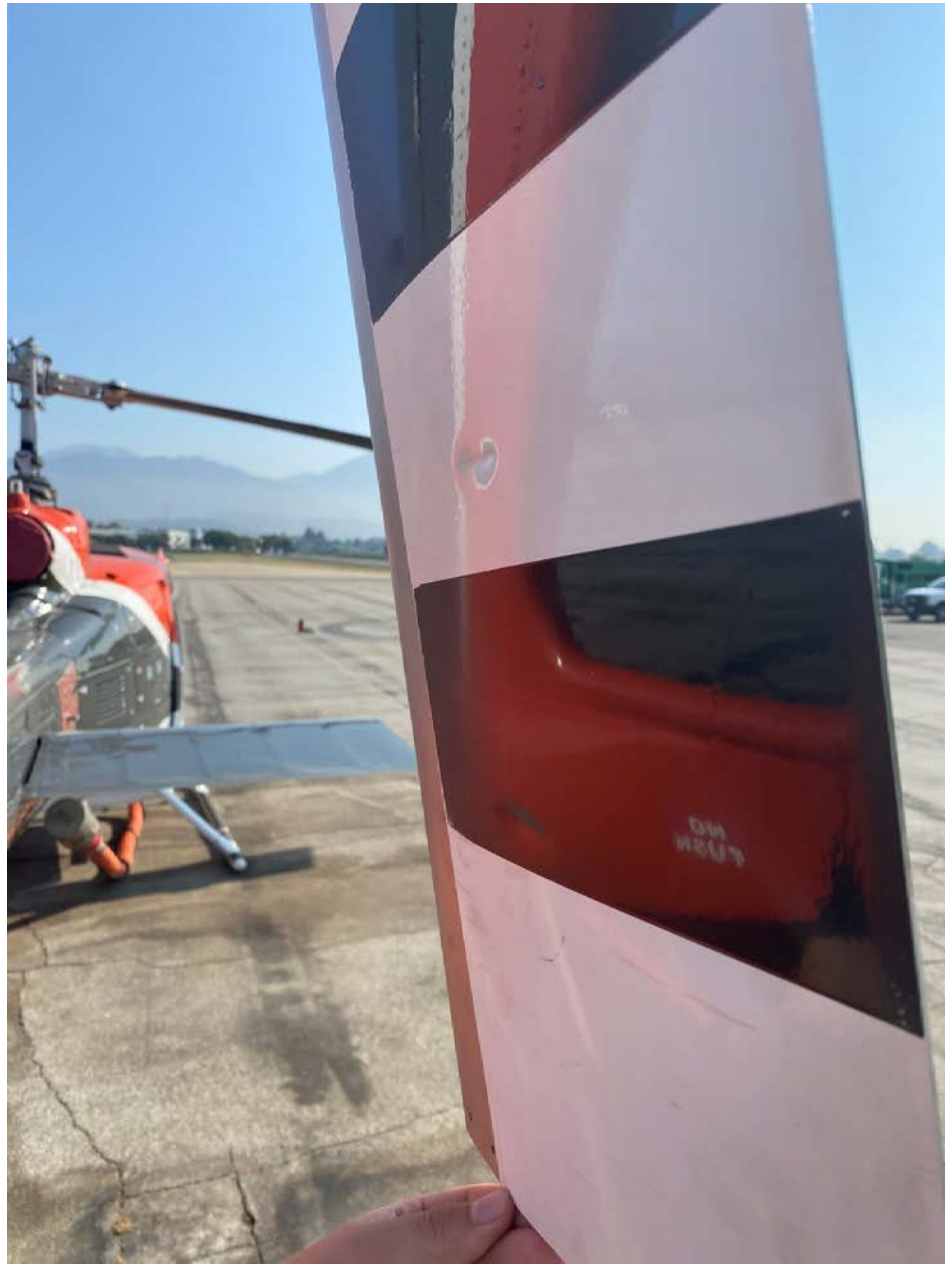
**Photo 1 – View of tail rotor damage (photo courtesy of Owner)**
