## **NATIONAL TRANSPORTATION SAFETY BOARD**

### **ONSITE EXAMINATION NOTES**

**WPR20FA005**

Location: Camarillo, CA  
Date: October 8, 2019  
Aircraft: N501BD  
NTSB IIC: Albert Nixon

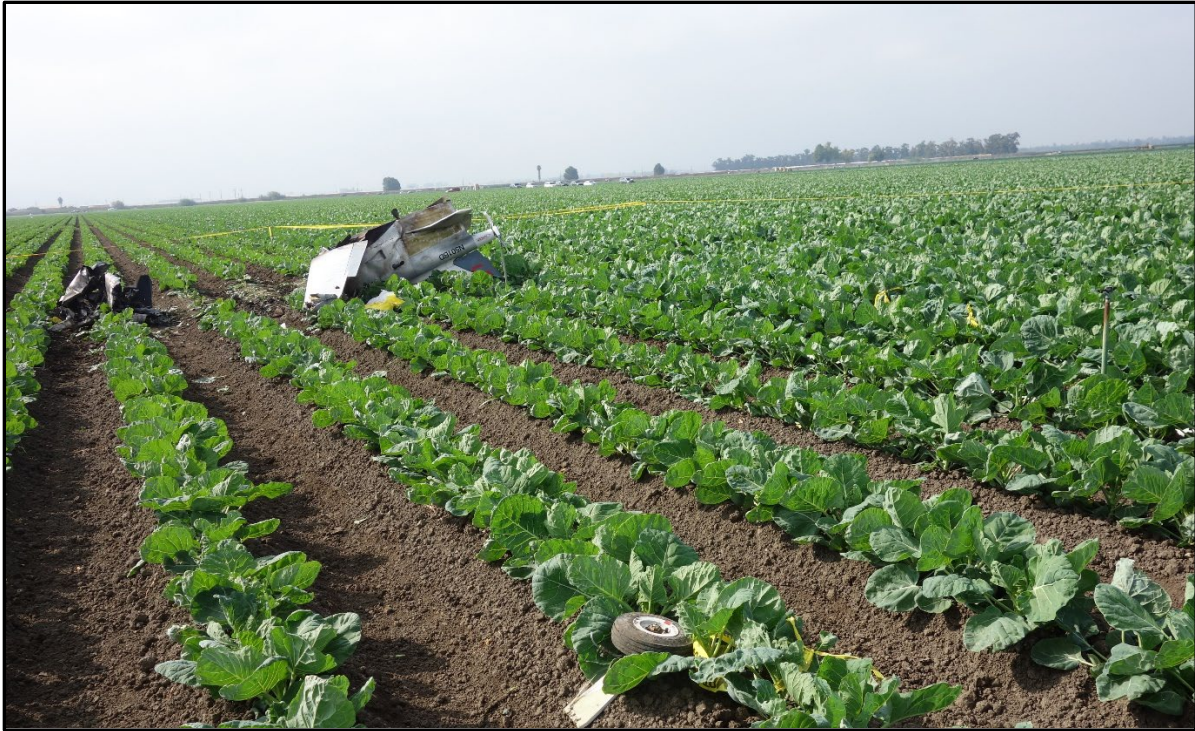
Figure 1: Airplane wreckage as viewed from the right side.

The right wing was attached and chordwise scratches were observed on bottom of the wing for the inboard half. The leading edge was intact. The right flap and aileron were attached at all their respective attachment points. The flap appeared to be near the neutral position. The right-wing tip was bent downwards. The fuel cap was observed secured. Fuel was observed leaking out of the wing root during recovery. The right main wheel assembly had separated and was located near the wreckage. The right main gear appeared to be extended.

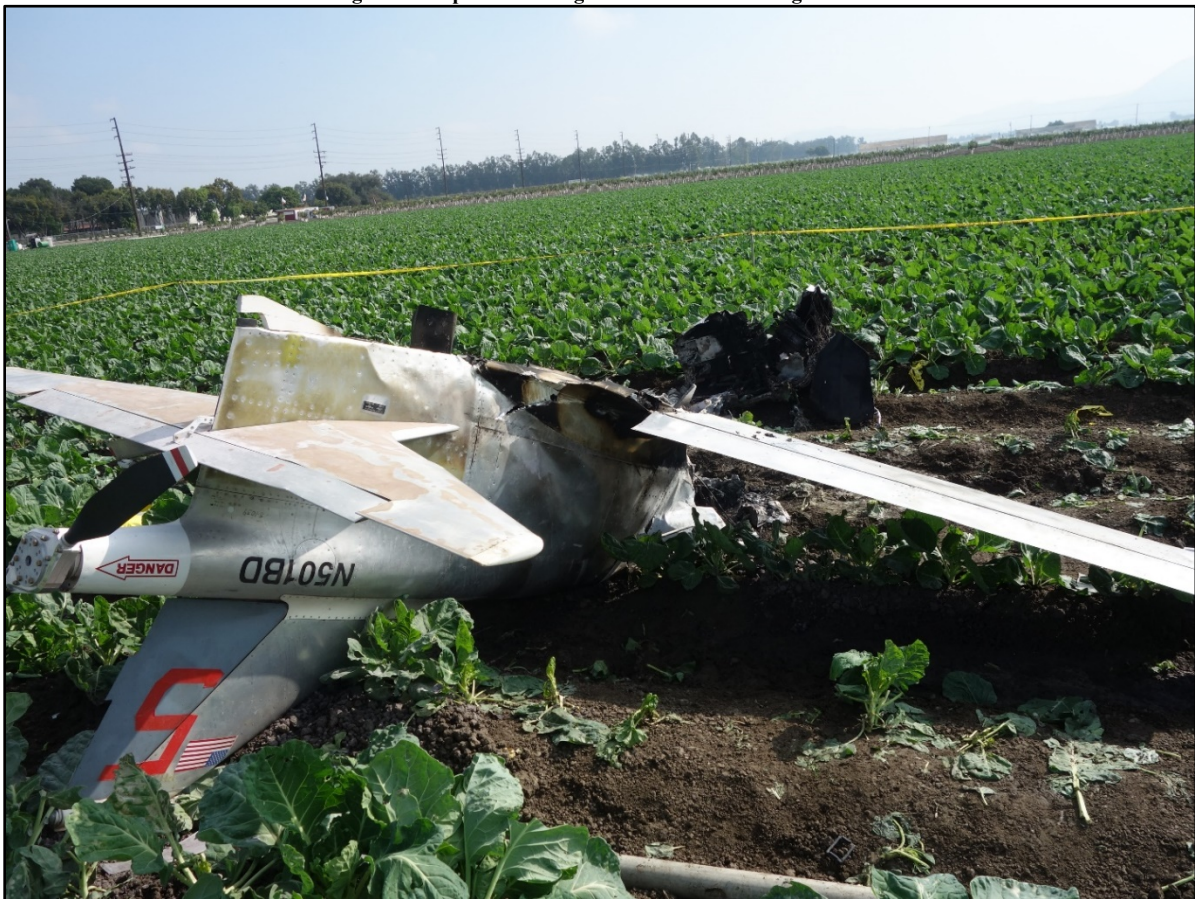
Figure 2: Airplane wreckage as viewed from the left side.

The left wing was attached and sustained damage to the leading edge about the outboard 1/3. Chordwise scratching was observed on the wing bottom. The left flap and aileron were attached at all their respective attachment points. The flap appeared to be near the neutral position. The scratches on the flap were consistent with the flap near the neutral position. The left tank fuel cap was observed secured. The left main wheel assembly had separated and were located near the main wreckage. The left main gear appeared to be extended. The wing tip was separated.
