## **NATIONAL TRANSPORTATION SAFETY BOARD**

# **AIRFRAME AND ENGINE EXAMINATION SUMMARY**

**WPR20FA005**

Location: Camarillo, California  
Date: October 8, 2019  
Aircraft: Bede N501BD, BD-5

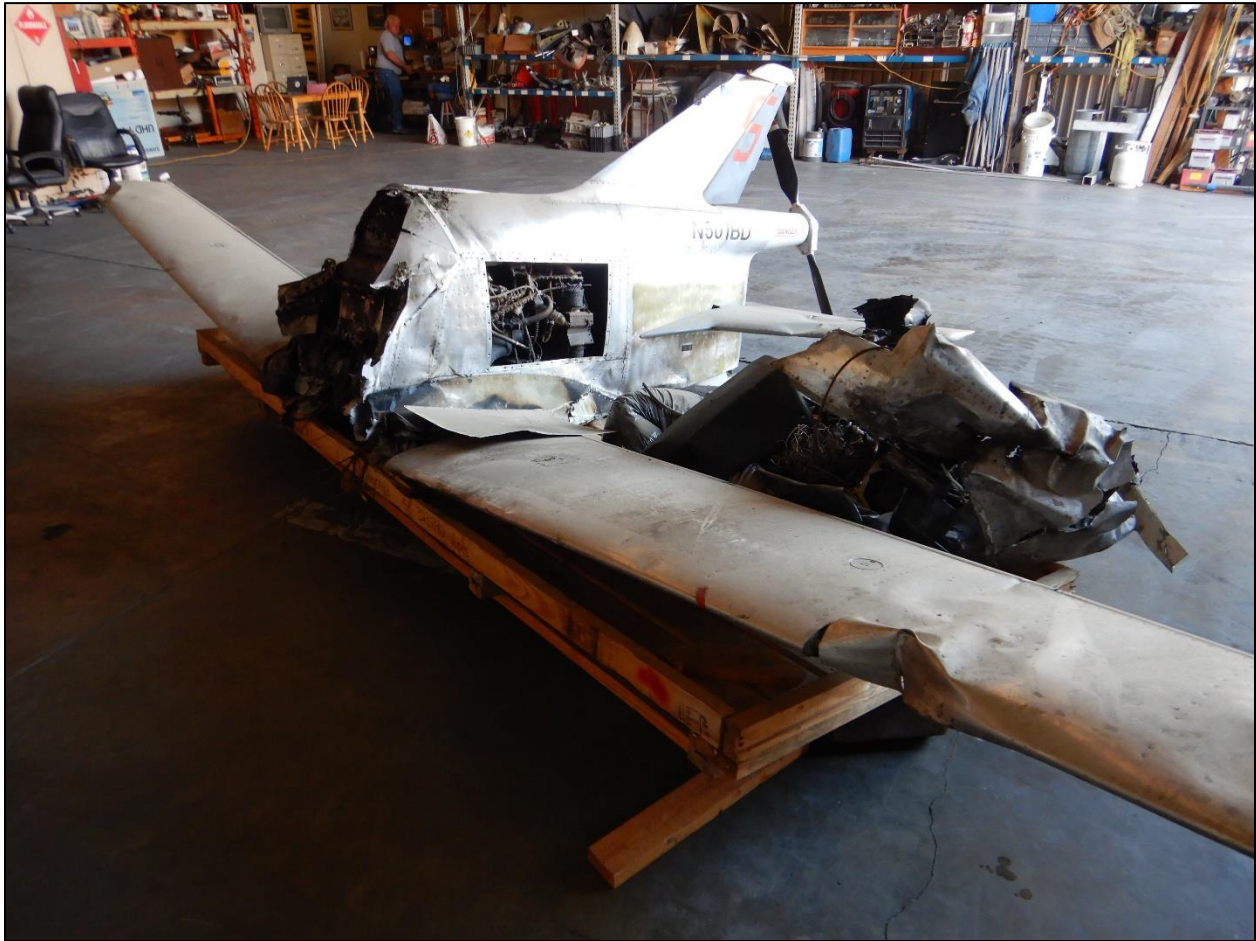
Figure 1-Wreckage Layout, Forward Left Side View

The airframe revealed thermal and impact damage to the cabin area. The cabin was separated near the aft cabin bulkhead to facilitate the relocation of the wreckage to a secured facility. Impact damage was evident to both wings and forward fuselage area. The engine and propeller assembly remained attached to the main wreckage.

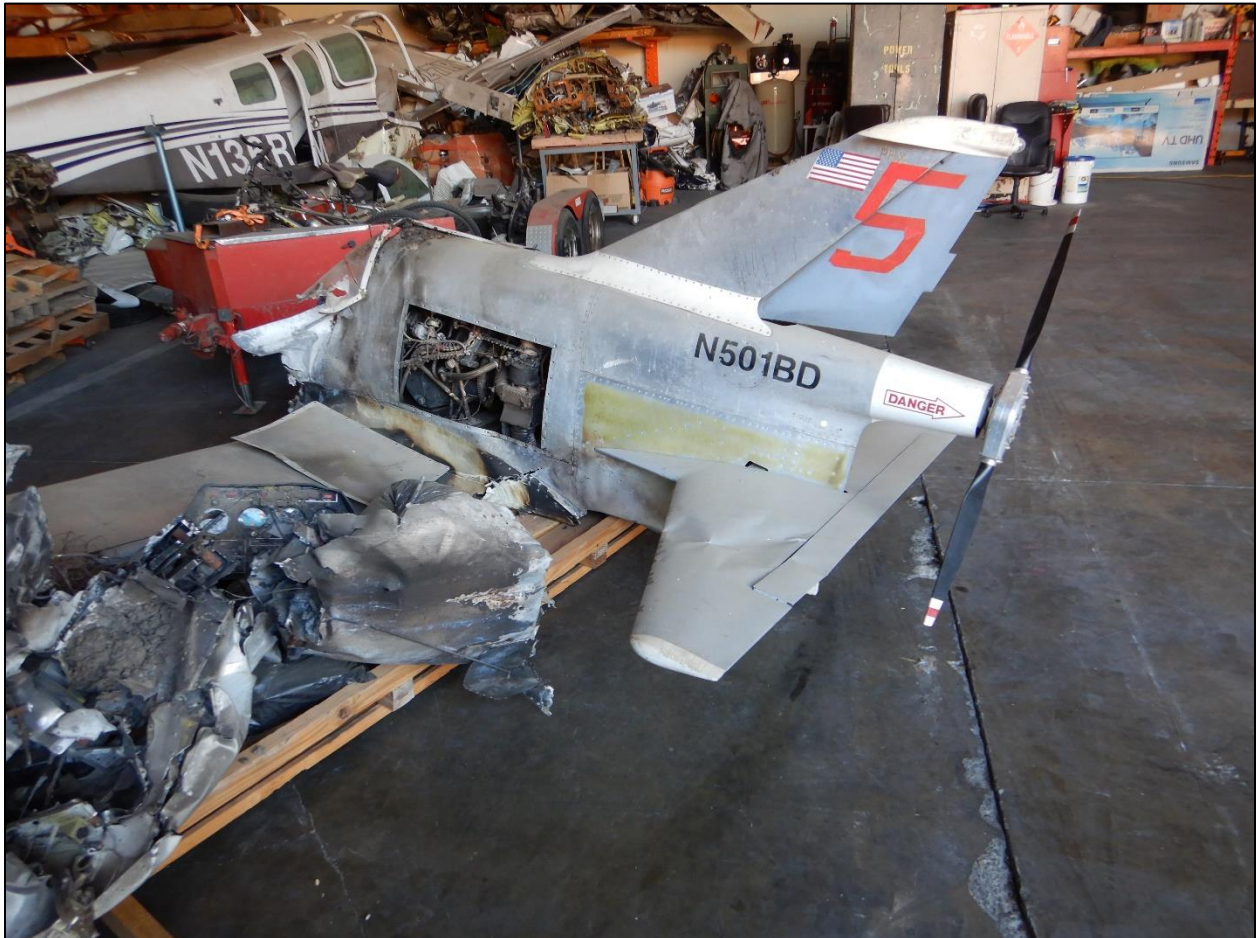
Figure 2-Wreckage layout, aft rear side view.

Flight control cable continuity was established from the stabilator, rudder, ailerons and flaps to the aft cabin bulkhead. The ailerons and flaps moved freely on their wing attachments and were disconnected from the torque tube connections at the wing root area. The stabilator and rudder cables were pulled from the aft cabin bulkhead area and movement of the flight controls was established.

The right wing tip fairing had impact damage. About 1 ft of the leading edge near the wing tip was bent down and the aileron outboard edge was damaged. The left wing had impact damage at the wing tip and the midsection of the leading edge. The wing fuel tank caps were removed and undamaged. The cap seals were intact and undamaged.

The rudder was undamaged and the stabilizer buckled on the left side.

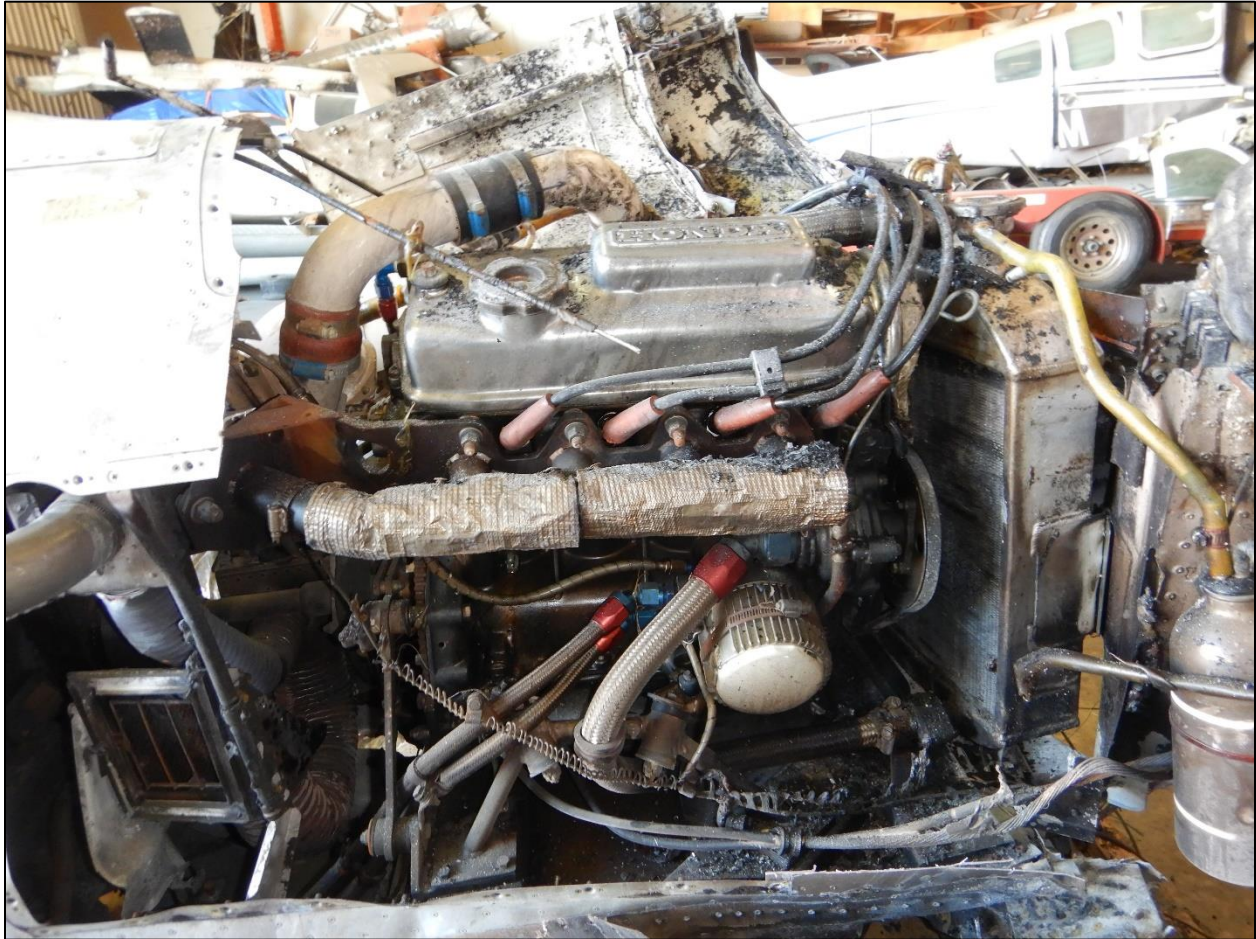
Figure 3-Engine, right side.

The engine remained attached to the fuselage engine mount assembly and was undamaged. The carburetor was removed from the engine and disassembled. No anomalies were noted during the examination of the carburetor and associated fuel lines. The carburetor fuel screen was removed and clear of debris. The turbocharger was removed from the engine and was undamaged. The turbine spun freely by hand and no anomalies were noted. The oil filter was removed from the engine and disassembled. Brass colored sediment was visible in the residual oil and the filter element folds.

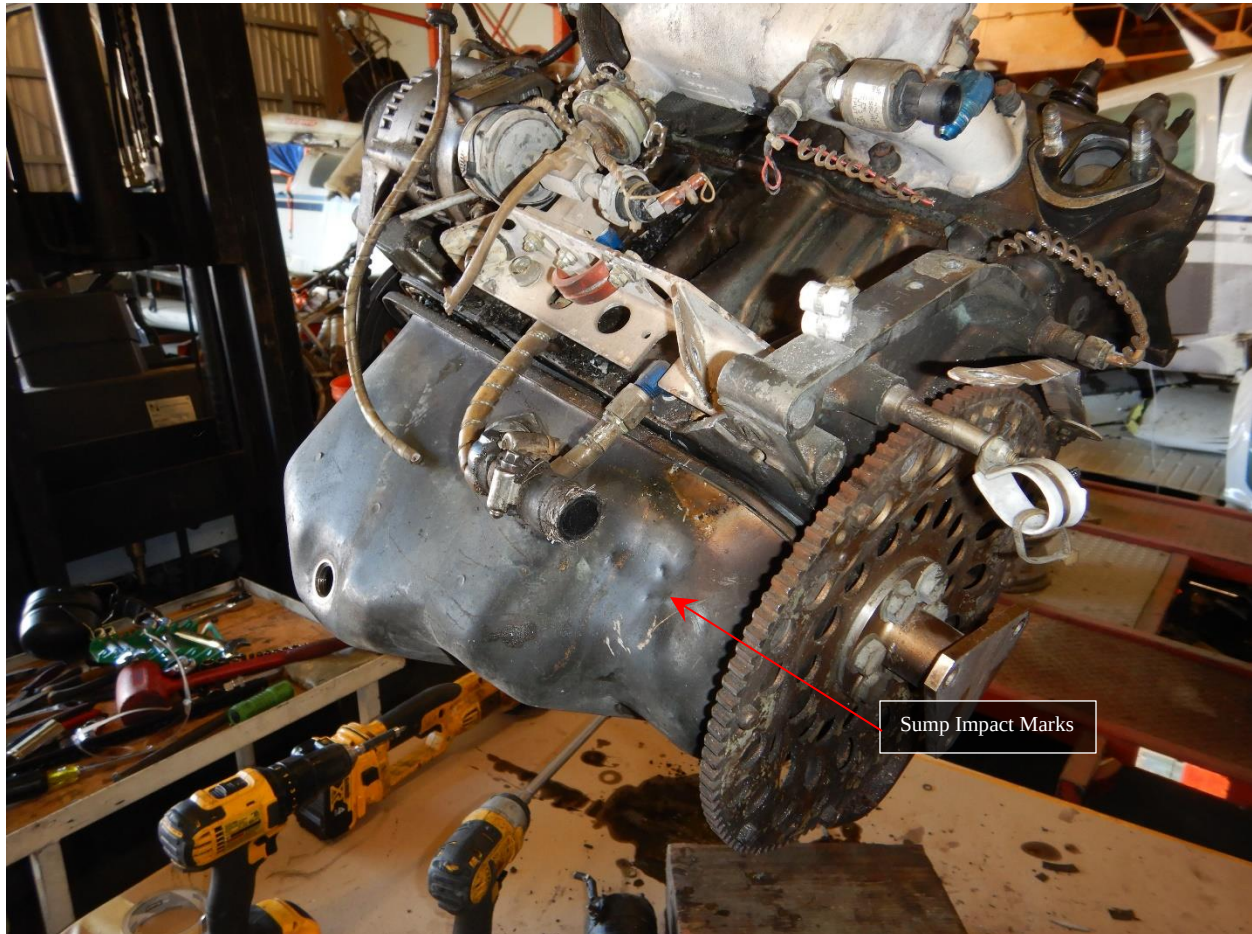
Figure 4-Engine, aft left side.

The spark plugs were removed and the electrode areas were undamaged and showed little wear. The plug electrode areas were wet with water. The cylinders were boroscoped and the combustion chambers showed normal operating signatures. The valve heads were undamaged. The crankshaft was rotated through the propeller assembly and engine and driveshaft and accessory drive continuity was established. The propeller drive shaft drive belt had thermal damage but remained intact. The alternator drive belt on the accessory section was undamaged. Thumb compression was attained on no. 1, 2 and 3 cylinders. The no. 4 piston would not move during the crankshaft rotation. The crankcase had impact damage near the no. 4 connecting rod area.

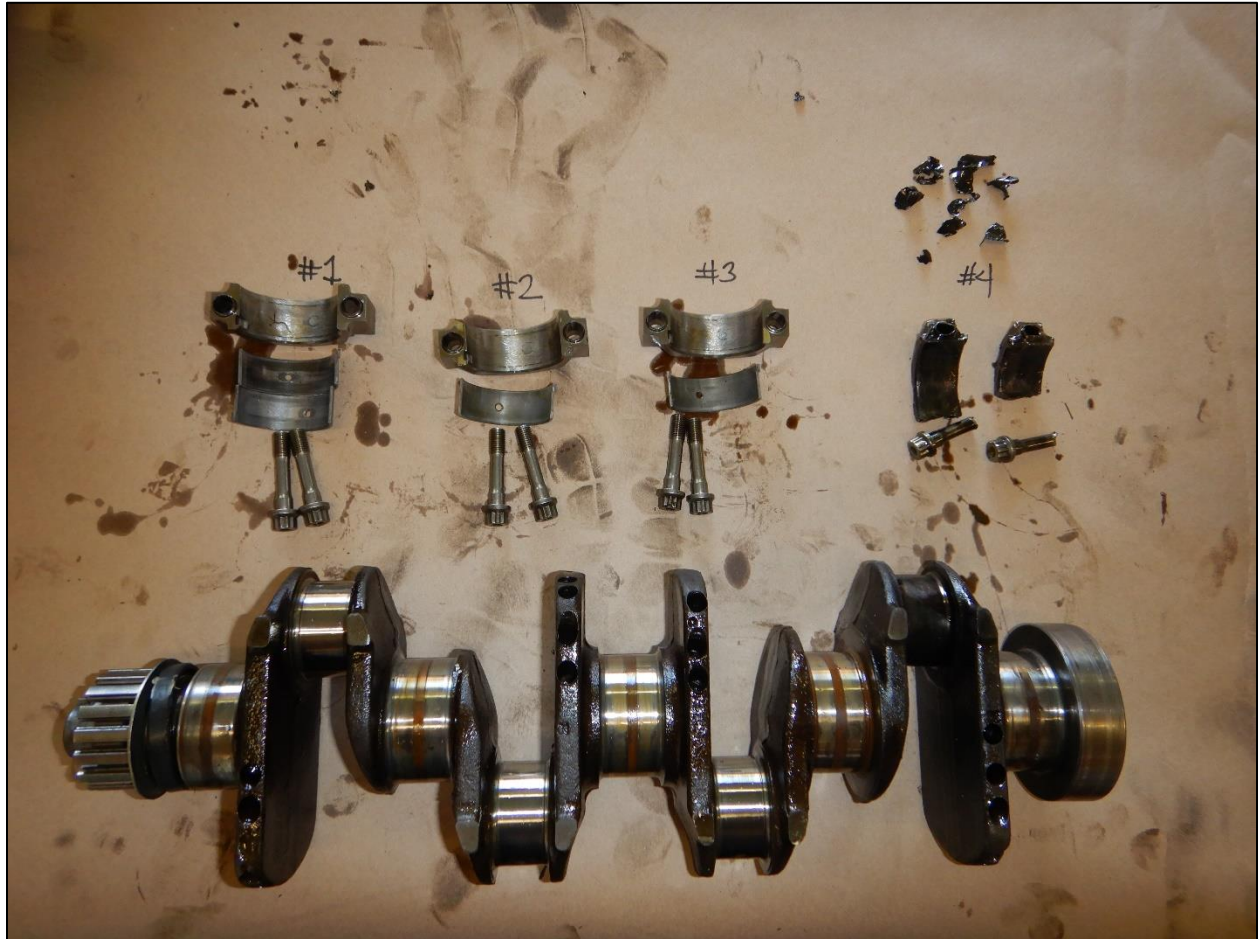
The engine was removed from the airframe and about 2 quarts of oil was drained from the oil sump. The oil sump had internal impact marks near the no. 4 cylinder area. The oil sump was removed and revealed metal bearing debris, two sections of the no. 4 connecting rod end cap and bolt sections in the residual oil. The bearing debris was small and thermally discolored and deformed.

**Figure 5-Crankshaft, connecting rod end caps, connecting rod bearings and bolts.**

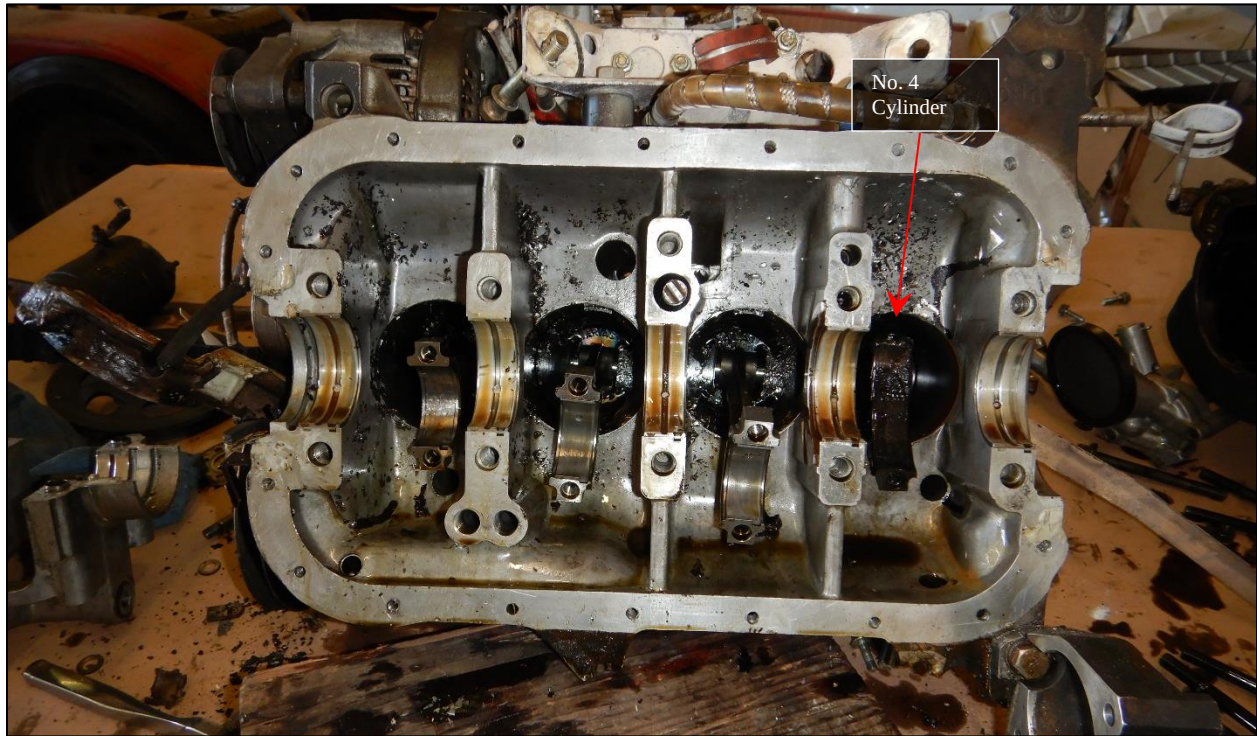
Figure 6-Upper crankcase and crankshaft bearings and support.

The connecting rod end caps were removed on the no. 1, 2 and 3 connecting rods. The lower crankshaft support assembly was removed and the crankshaft was removed from the engine. The support was damaged near the no. 4 connecting rod area. The crankshaft support through bolts and connecting rod bolts had high torque when removed. The crankshaft and connecting rod bearings (8 bearings), showed normal wear conditions.

The engine and crankshaft oil galleys were unobstructed. The crankshaft and remaining connecting rod bearing showed normal wear conditions.

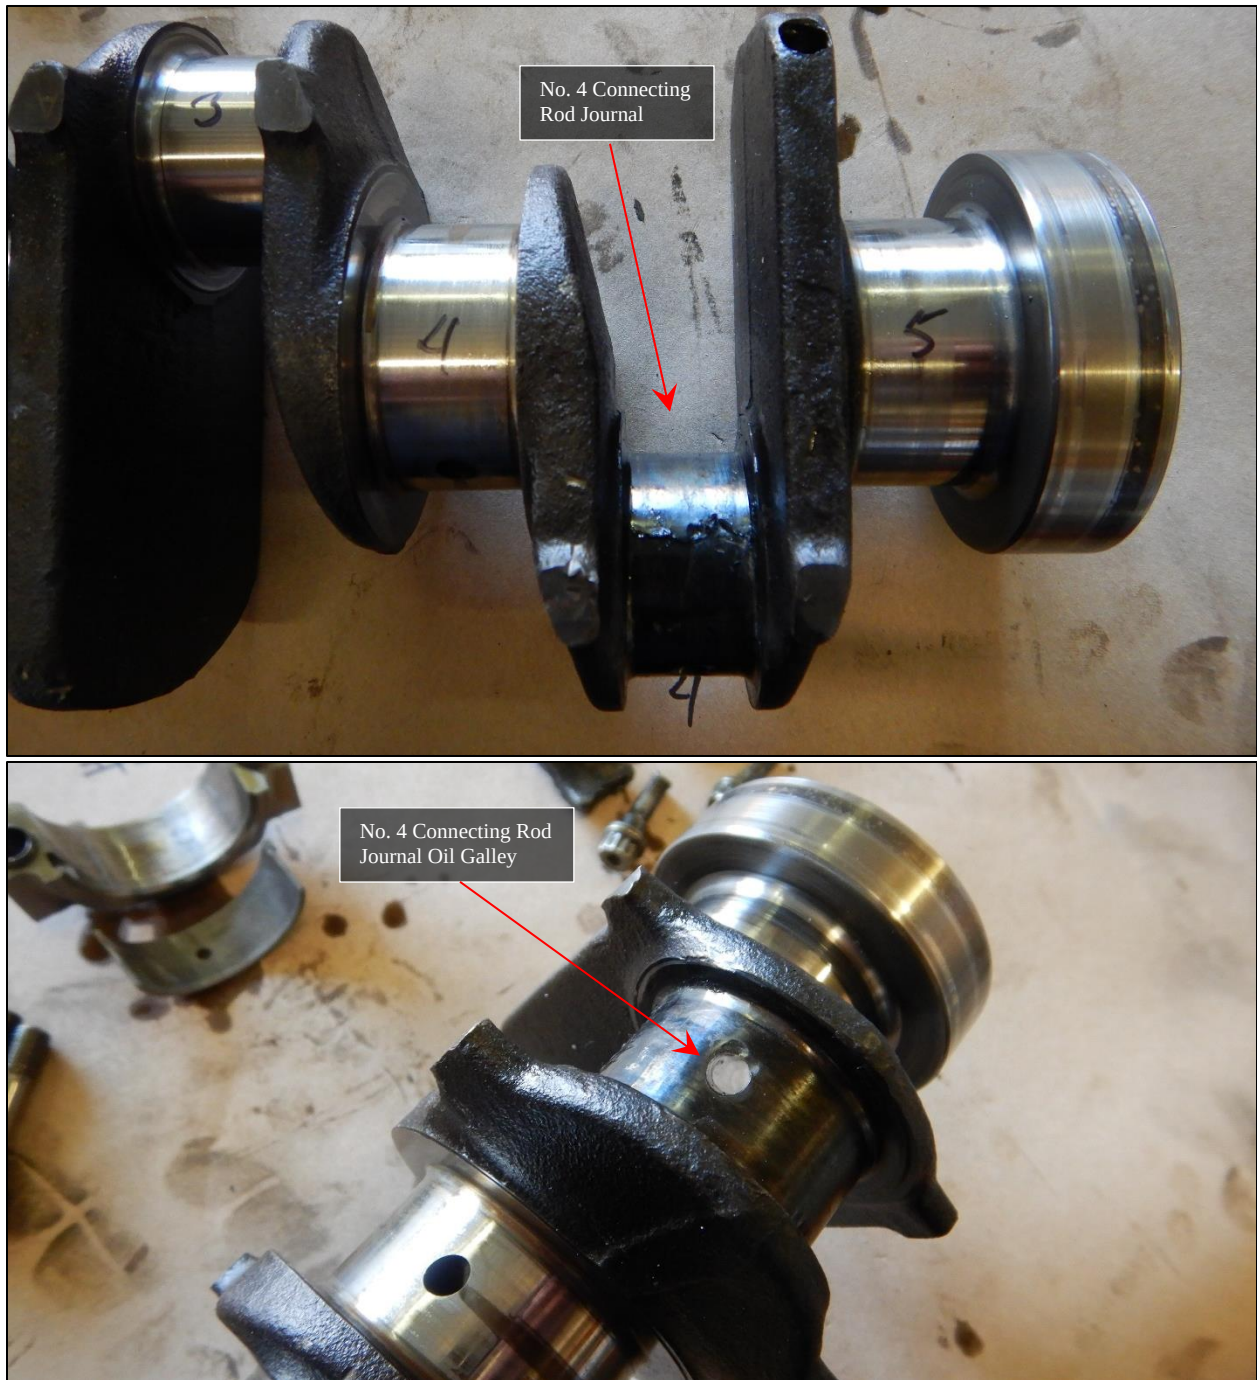
The no. 4 connecting rod bearing contact area on the crankshaft was thermally discolored and had mechanical deformation. The no. 4 connecting rod journal and the no. 5 main journal shared oil galley was unobstructed.

**Figure 8-Crankshaft no. 4 connecting rod journal.**

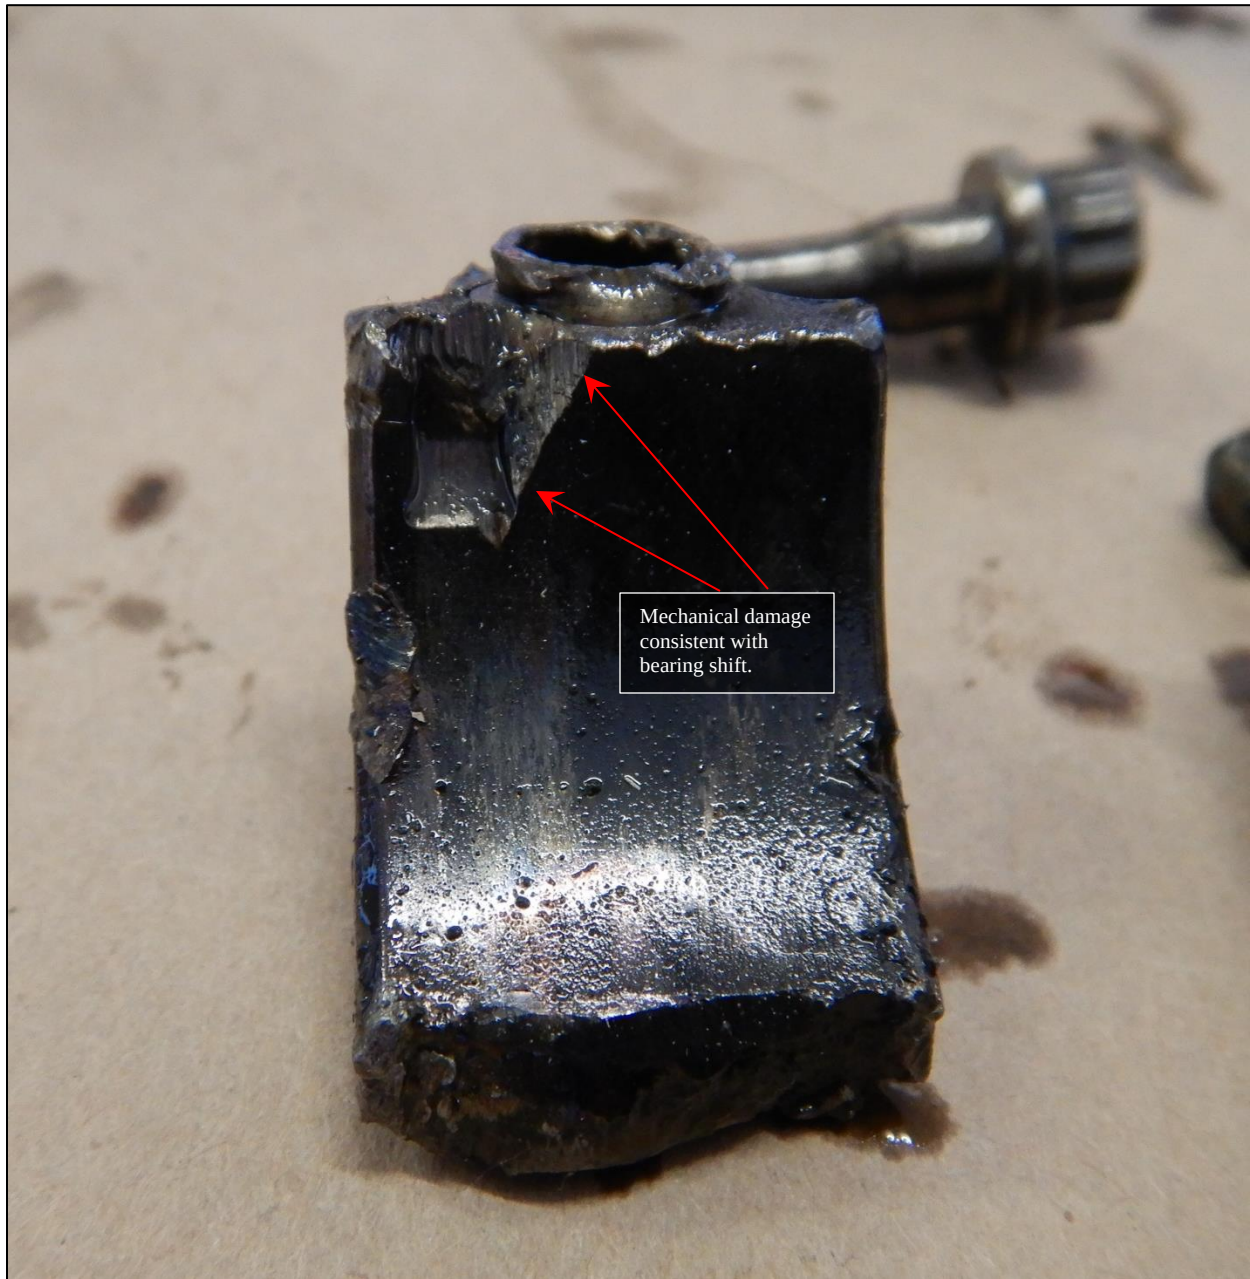
Figure 9-No. 4 connecting rod end cap section and bearing tang insert.

The no. 4 connecting rod end cap sections had thermal discoloration and mechanical damage. The section of the connecting rod end cap with the bearing tang insert, had mechanical damage consistent with bearing shift.

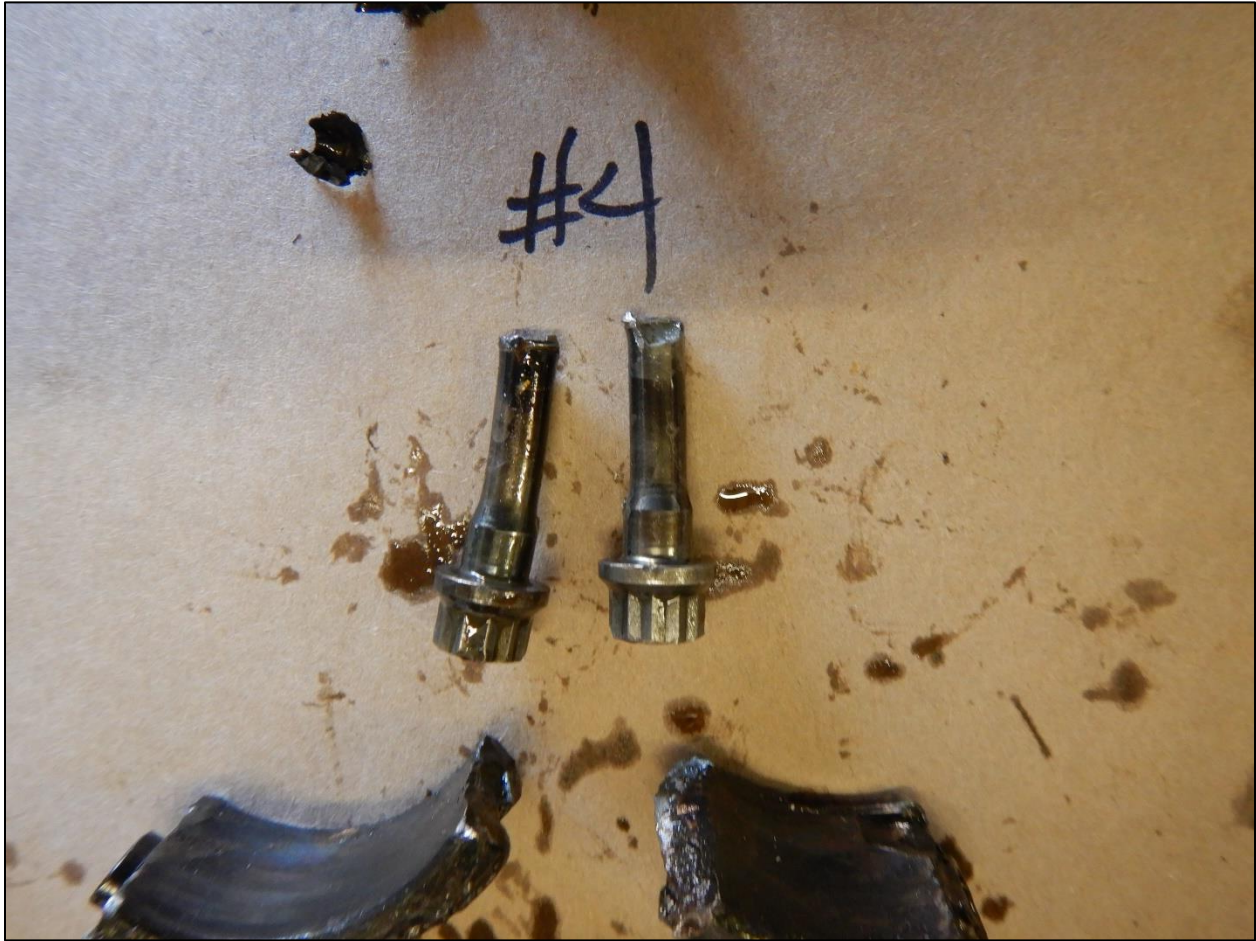
Figure 10-No. 4 connecting rod bolts.

The no. 4 connecting rod bolts were bent, and the separated surface areas were consistent with overload failure.
