## **NATIONAL TRANSPORTATION SAFETY BOARD**

# **ACCIDENT SITE AND WRECKAGE EXAMINATION SUMMARY**

**WPR20FA008**

Location: Angel Fire, New Mexico  
Date: October 20, 2019  
Aircraft: N7742P; Piper PA-24  
NTSB Investigator-in-Charge: Andrew Swick

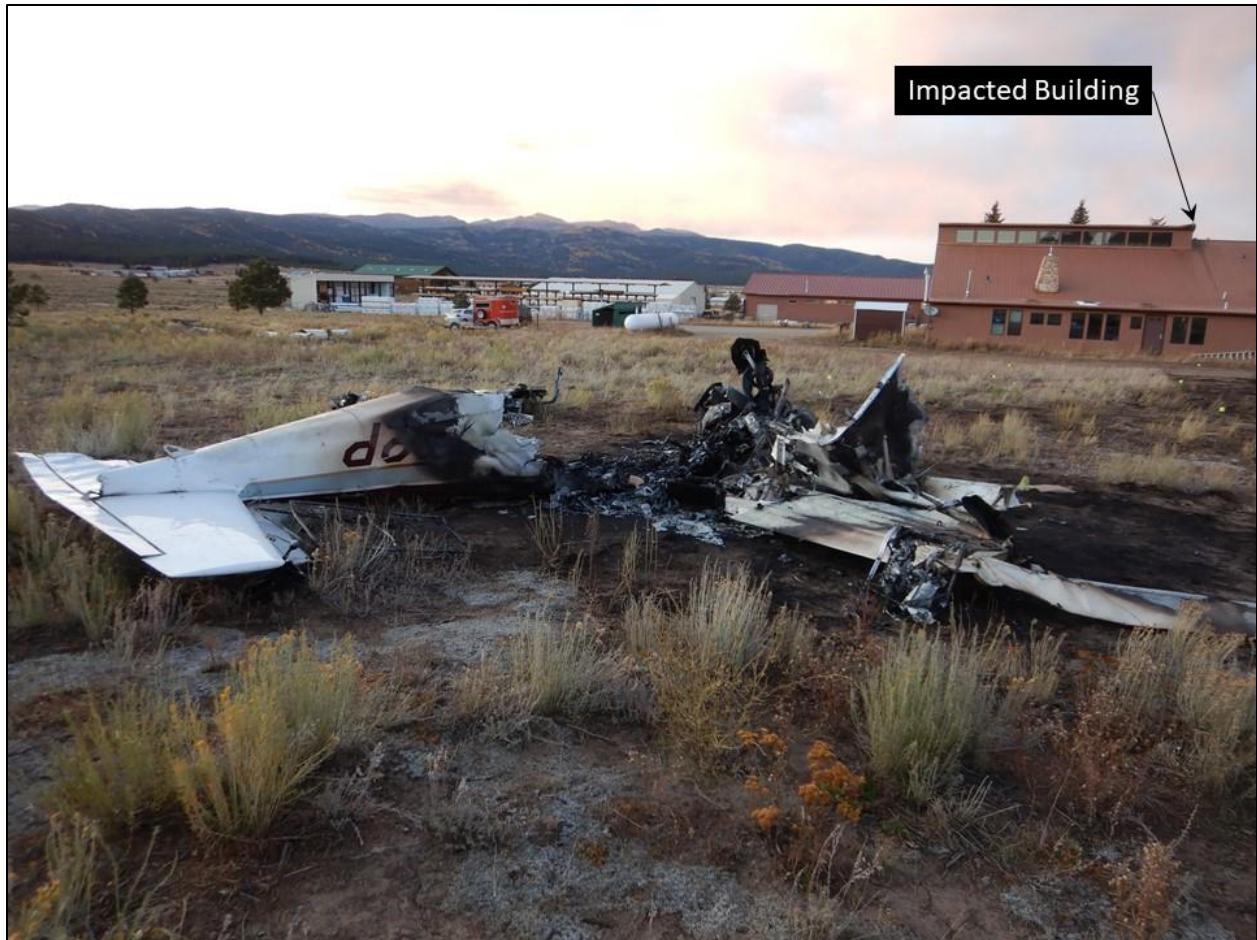
A security camera with a southward view, captured the airplane flying overhead about 50 ft above ground level, and flying over the adjacent road. The airplane was flying wings level and the landing gear was in the down position. As the airplane approached the light poles and power lines in the background, the airplane banks right and travels behind trees and buildings out of view. Another security camera located near the accident site captured the airplane impacting trees and a building, before cartwheeling to the ground in a nose-down attitude. The airplane came to rest in an inverted position and a post-accident fire ensued.

*Figure 1-Accident site and impacted building, northwest view.*

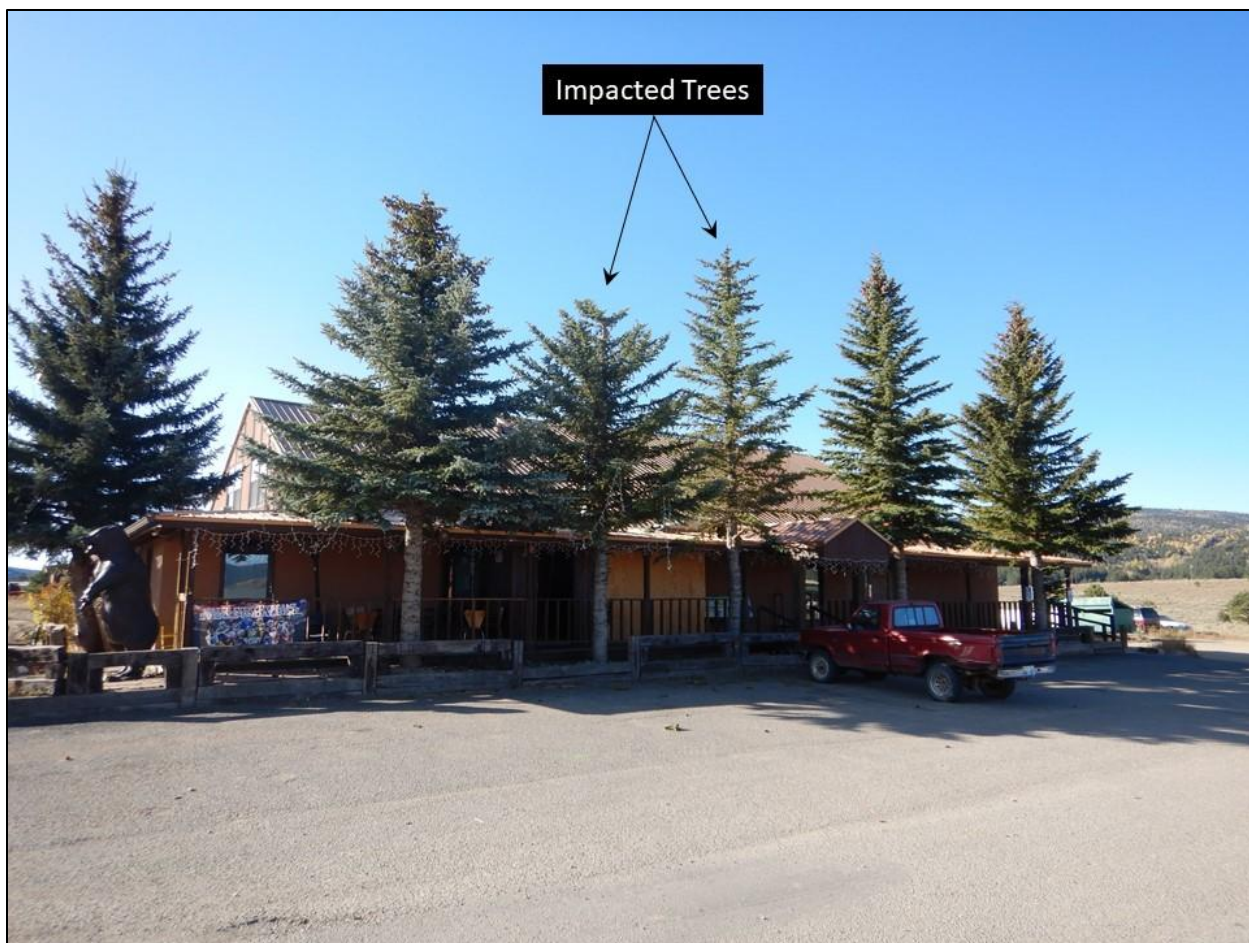
Examination of the accident site revealed that the first identified point of contact were two trees located on the north side of a building. (See figure 2) The right wing was found on the building's roof. The right main gear was found on the north side of the building and roof damage was found near the roof peak. The first ground impact was an area of disturbed ground surrounded by red lens fragments. The propeller separated from the engine and propeller blade strikes were found in the ground. The left outboard wing section separated. The main wreckage was found inverted and was the furthest in the debris field. The debris field was about 250 ft long and on a directional heading of about 190 degrees magnetic. Flight control cable continuity was attained, and all major structural components were found. Postaccident fire burned about 1/4 acre of brush covered terrain. The wreckage was recovered to a secure facility for further examination.

*Figure 2-Accident site tree strikes, southwest view.*

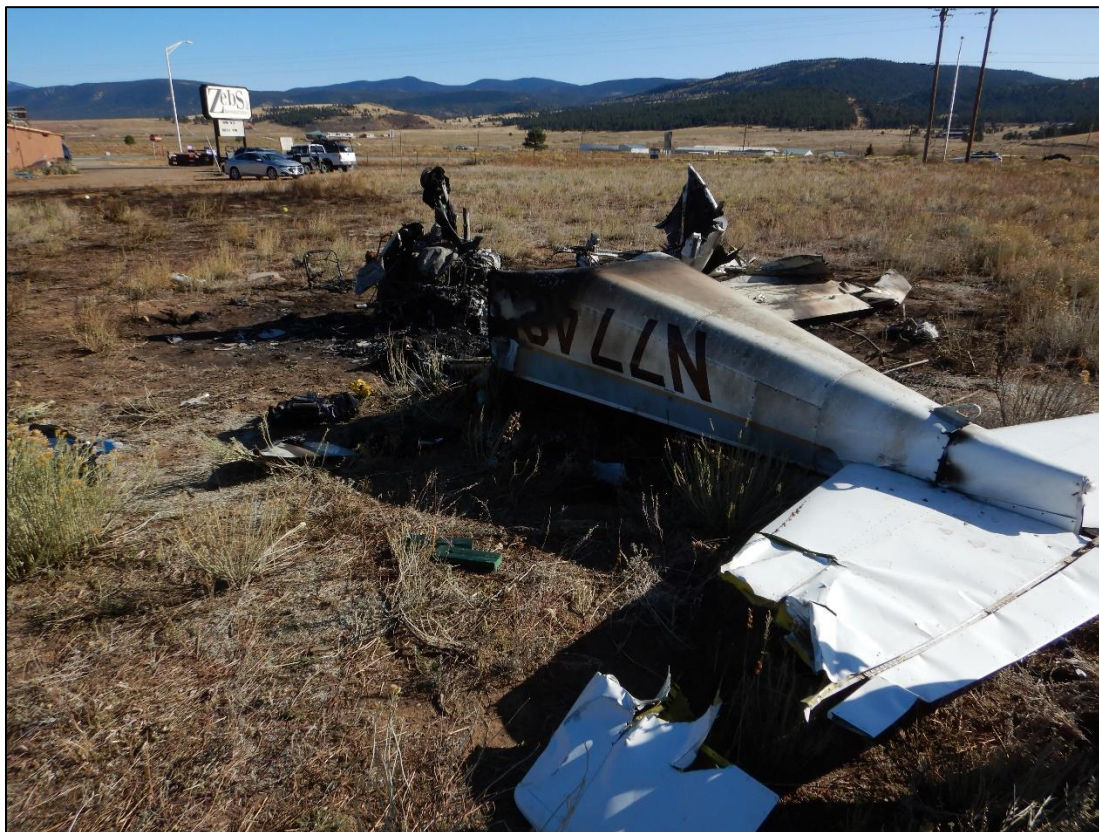
Prior to the examination of the accident site, the impacted building was temporarily repaired. The cabin area from the firewall to the aft baggage compartment was mostly consumed by fire. The center section of the main wing spar including a portion of the lower right fuselage had been pulled on to the left wing by first responders.

*Figure 3-Accident site, main wreckage.*

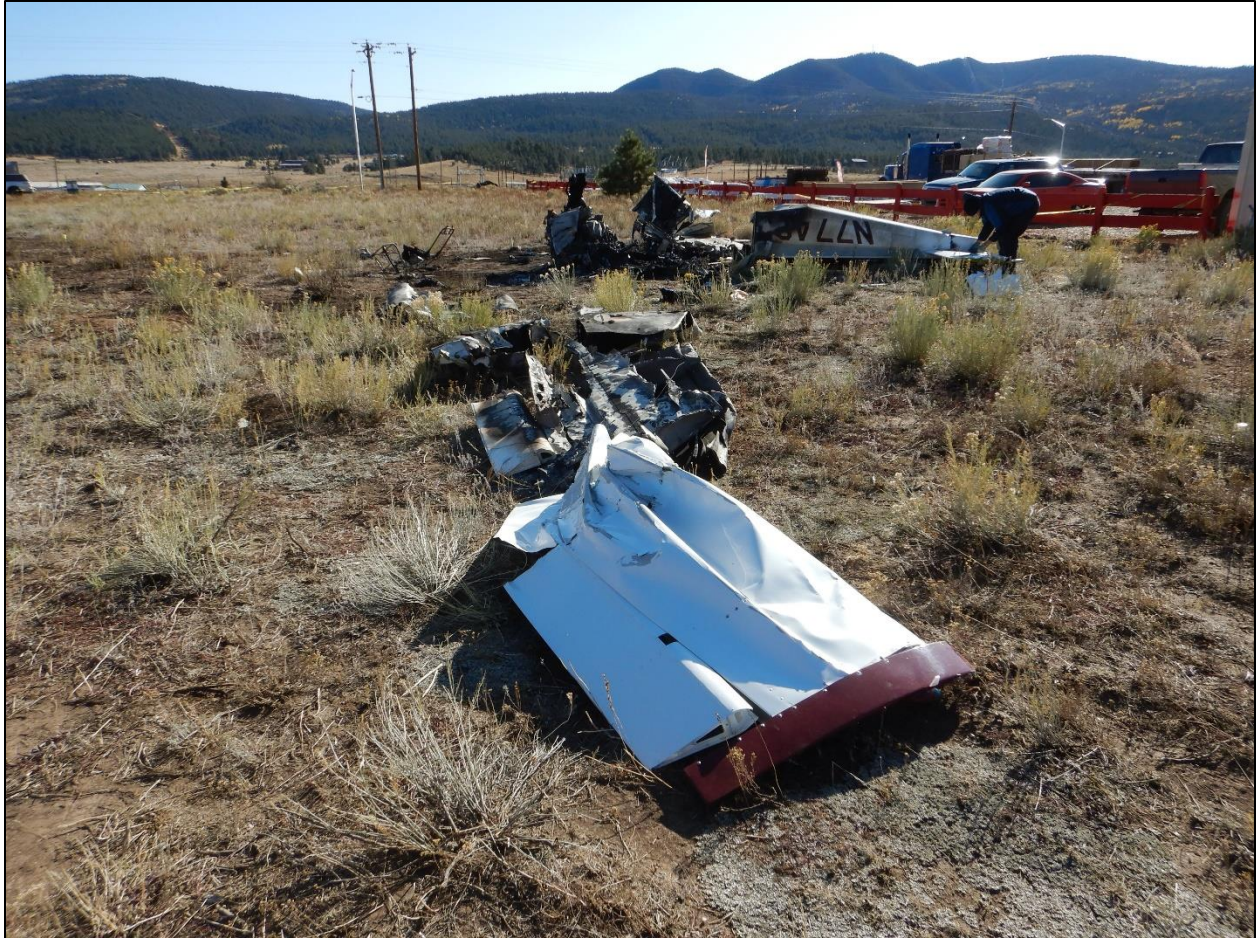
About a 3-4 ft section of the stabilator, rudder, aileron, and flap control cables had been cut away by first responders and were also placed on top of the left wing. The stabilator and rudder cables remained attached to their respective attach points in the cockpit and continuity was confirmed to the attach points at the control surfaces in the empennage. The aileron chain in the cockpit was intact and attached to the cables at each end. The cables were continuous from the cockpit to the wing roots except for the cuts made by the first responders. The flap control handle was impact and fire damaged and separated from the fuselage. The flap handle position was not determined. The flap control cables were continuous from the selector handle to the flap bellcranks in each wing except for cuts made by first responders.

*Figure 4-Accident site, main wreckage and right wing.*

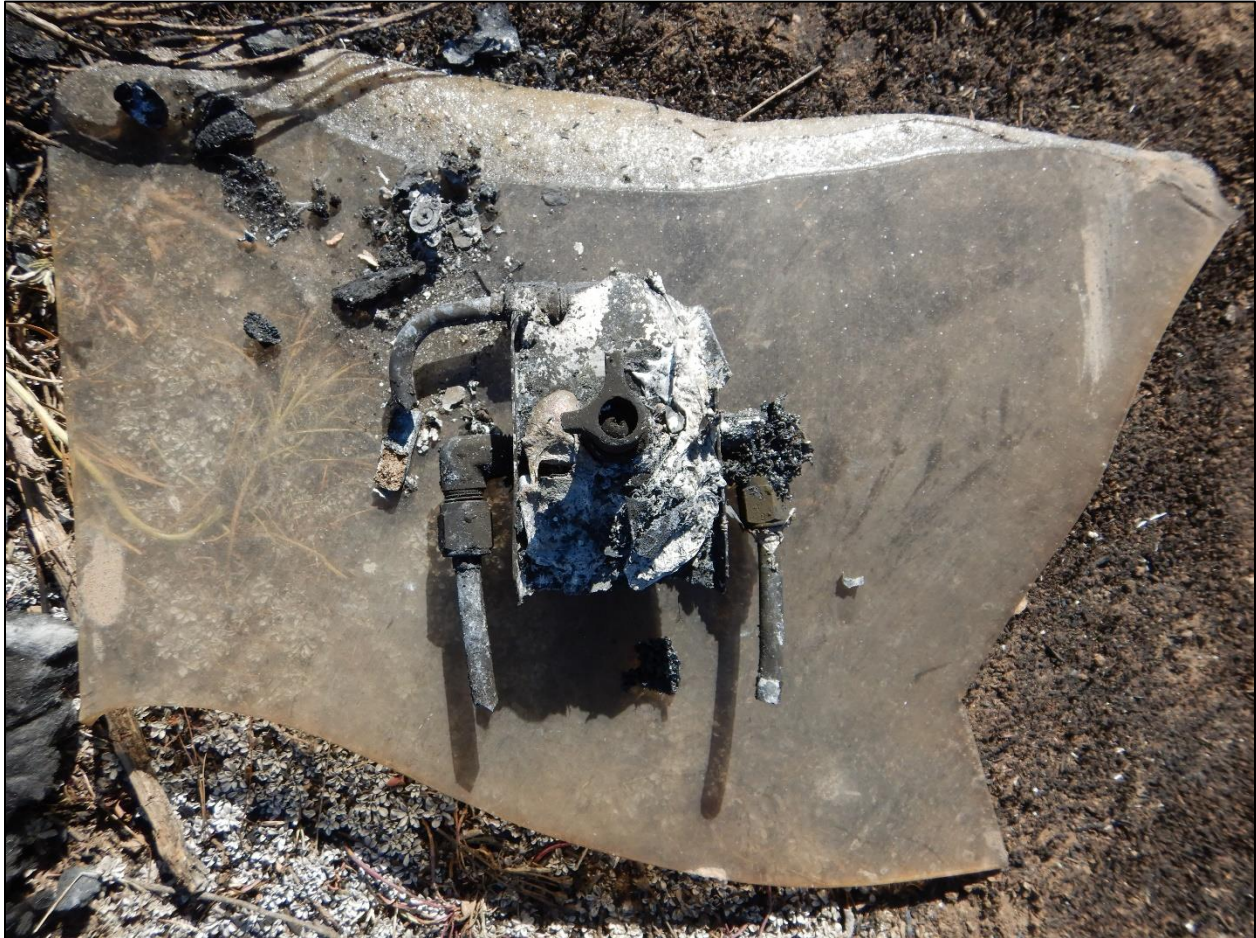
The fuel selector handle was impact damaged and fractured. The center portion of the handle remained attached to the fuel selector valve and was found in the left tank position. The fuel selector valve was fire damaged and separated from the fuselage. The fuel strainer bowl was fire damaged and separated from the fuselage. The bowl was disassembled in order to examine the strainer screen. No fuel was observed in the strainer bowl and soot was observed on portions of the fuel strainer screen.

*Figure 5-Accident site, fuel selector valve.*

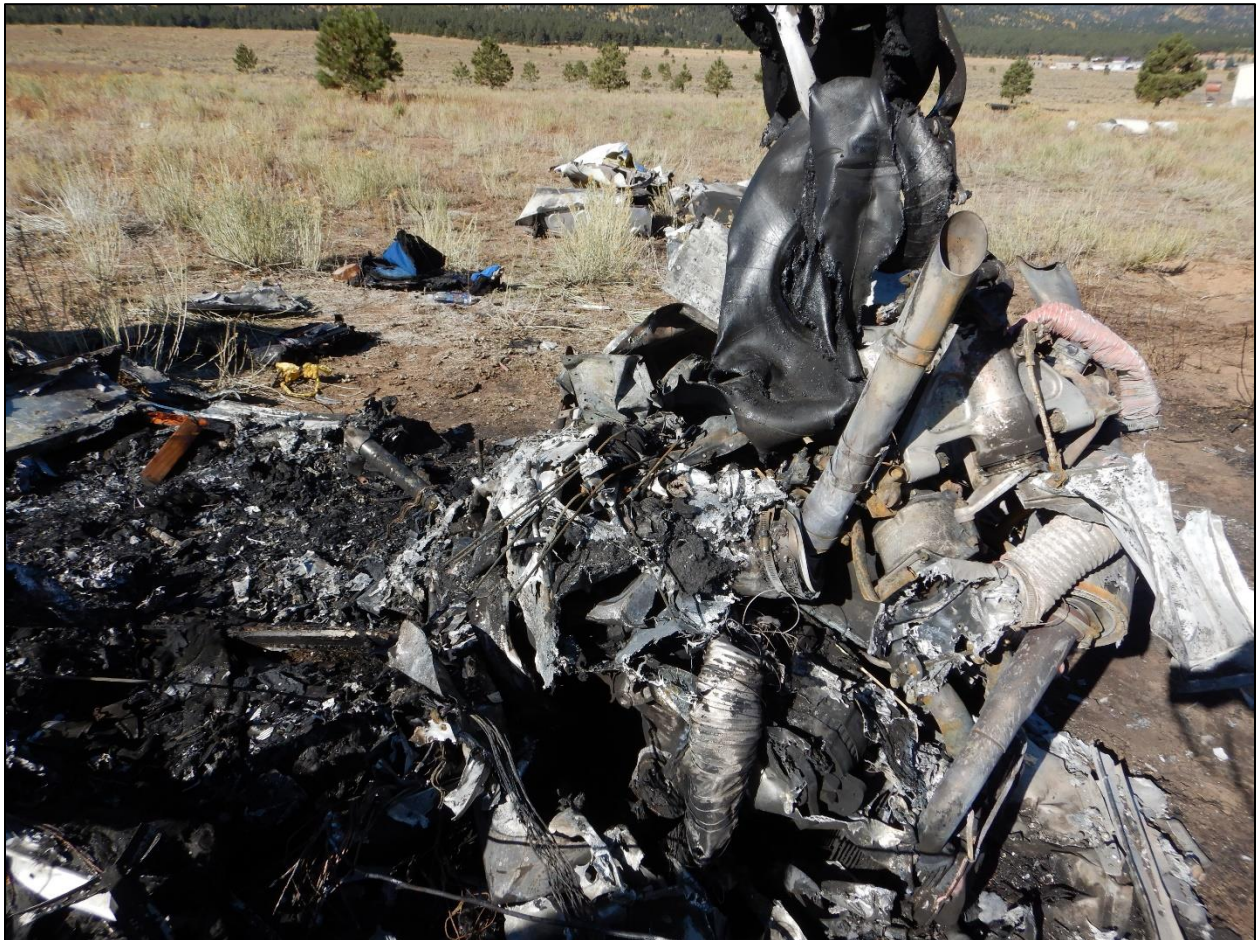
The cockpit engine and propeller controls were impact and fire damaged. The engine and propeller control cables were traced from the instrument panel to the engine compartment. The throttle cable remained attached to the throttle arm on the carburetor. The mixture control cable was not attached to the mixture control arm on the carburetor and no hardware was observed on the mixture control arm. The propeller cable remained attached to the propeller governor. The alternate air control cable was continuous to the alternate air door lever arm in the engine compartment. The induction system including the air filter and alternate air valve box were consumed by fire.

*Figure 6-Accident site, forward fuselage and engine assembly.*
