# NATIONAL TRANSPORTATION SAFETY BOARD

## MATERIALS LABORATORY FACTUAL REPORT

Report No. 21-047

Place : North Las Vegas, NV  
Date : 10/23/2019  
Vehicle : Robinson R44  
NTSB No. : WPR20FA013  
Investigator : Zöe Keliher

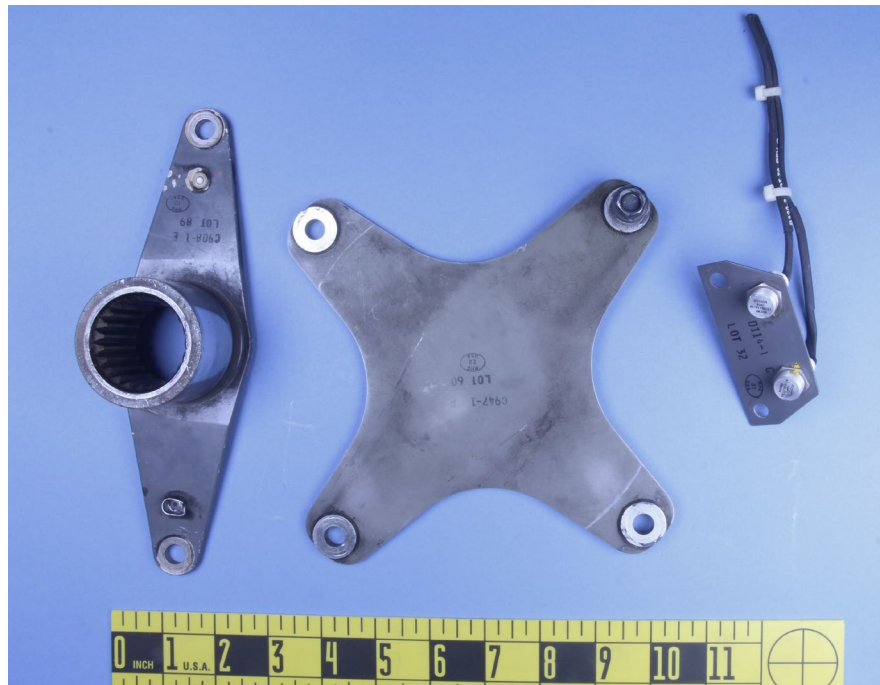
Tail rotor yoke with magnet holder remains (C908-1 E Lot 89), flex plate (C947-1 F Lot 60), Hall effect sensors and holder (D114-1 C Lot 32) as shown in Figure 1.

Figure 1: Tail rotor yoke with damaged magnet holder, flex plate, and hall effect sensors with holder.

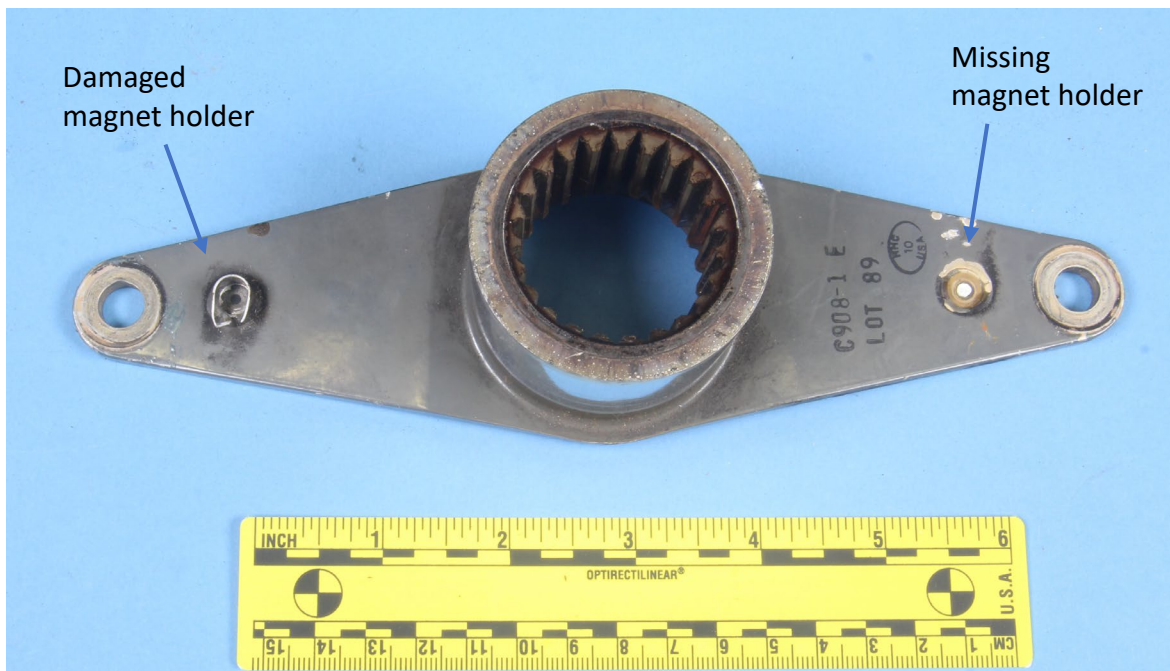
The tail rotor yoke was designed with two cylinders attached that were used to contain and secure the magnets used to trip the hall effect sensors for the tachometer display. As received, the tail rotor yoke was missing one of the two cylindrical magnet holders and the one magnet holder present was damaged and without a magnet (Figure 2). The missing magnet holder had been removed during testing that preceded this Materials Laboratory exam. The missing magnet holder on the yoke had been found intact and containing the magnet after the accident.

Figure 2: Tail rotor yoke with damaged magnet holder.

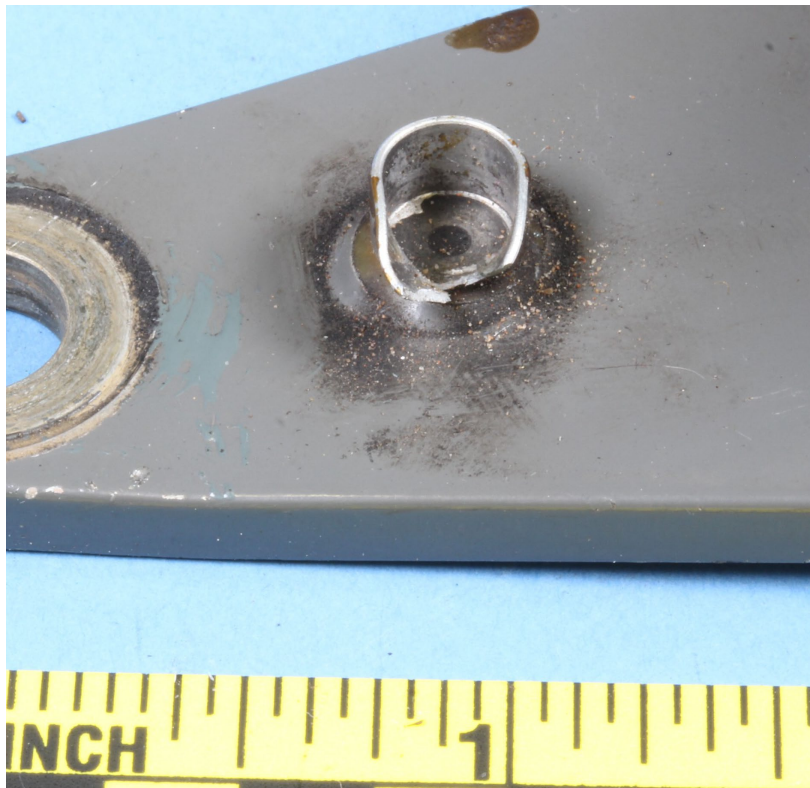
Examination of the damaged magnet holder revealed that the deformation and fracture to the magnet holder was not caused by impact directly with the magnet holder body. The fractured side exhibited deformation consistent with an object pushing from the inside of the holder radially outwards through the cylindrical wall (Figure 3). The intact side of the magnet holder did not exhibit deformation or contain any witness marks consistent with a strike (Figure 4). Another view of the damaged magnet holder perpendicular to its direction of motion also exhibits deformation consistent with an internal force pushing through the magnet holder side wall without any visible damage to the opposing side (Figure 5). In this figure certain material deposits can also be seen. There is a circular outline in an orange residue on the exterior of the magnet holder's cylindrical wall. There are areas on the open end of the magnet holder's cylindrical wall where a brownish – amber colored residue is present. There is also an area of similar appearing brownish – amber colored residue on the yoke. This residue had a brittle response when scraped with a tool. The interior surface of the magnet holder contained some small grains of what appeared to be sand or rock mostly on the bottom of the cylinder (Figure 6). On the intact portion of the interior of the cylindrical wall some small

Figure 3: Fractured side of damaged magnet holder.

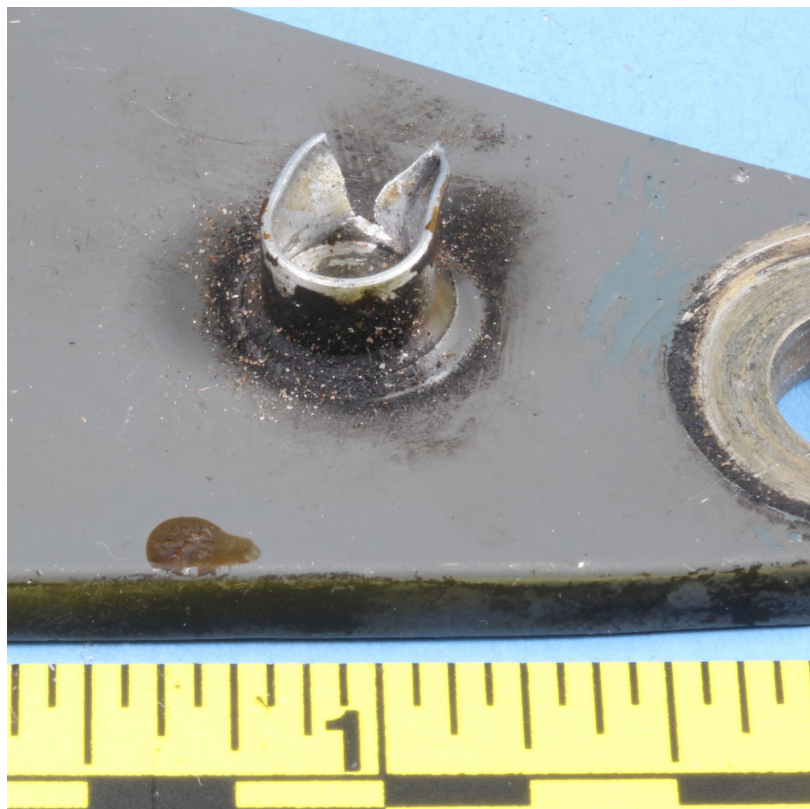
Figure 4: Intact side of damaged magnet holder.

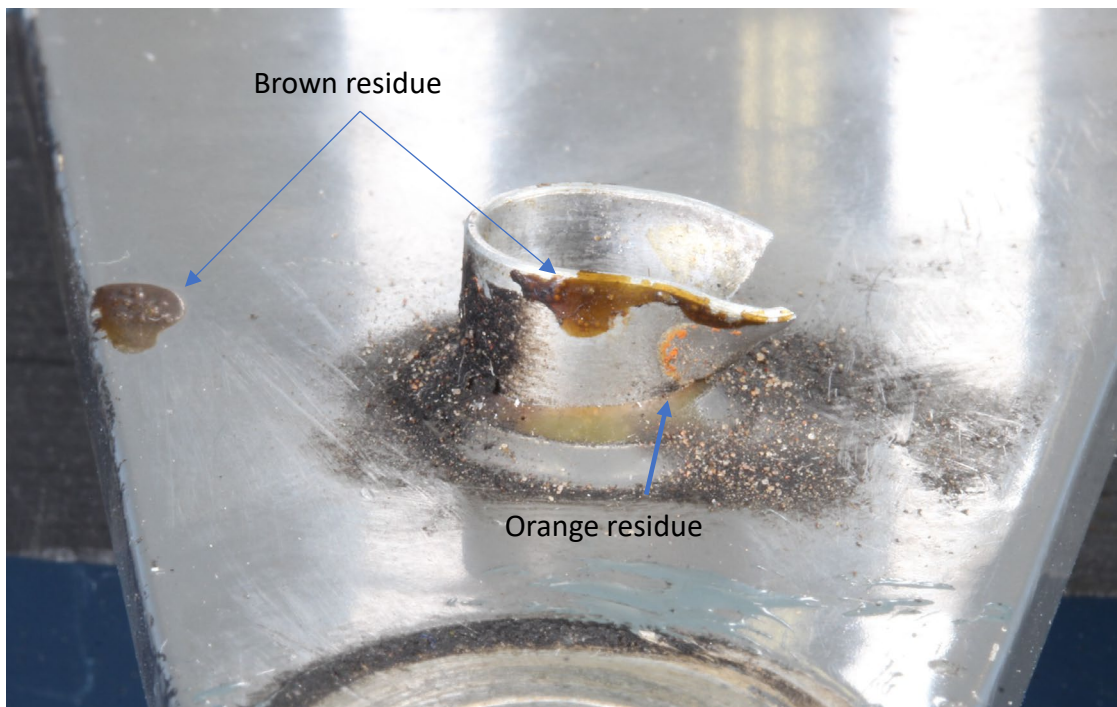
Figure 5: Residue deposits on damaged magnet holder.

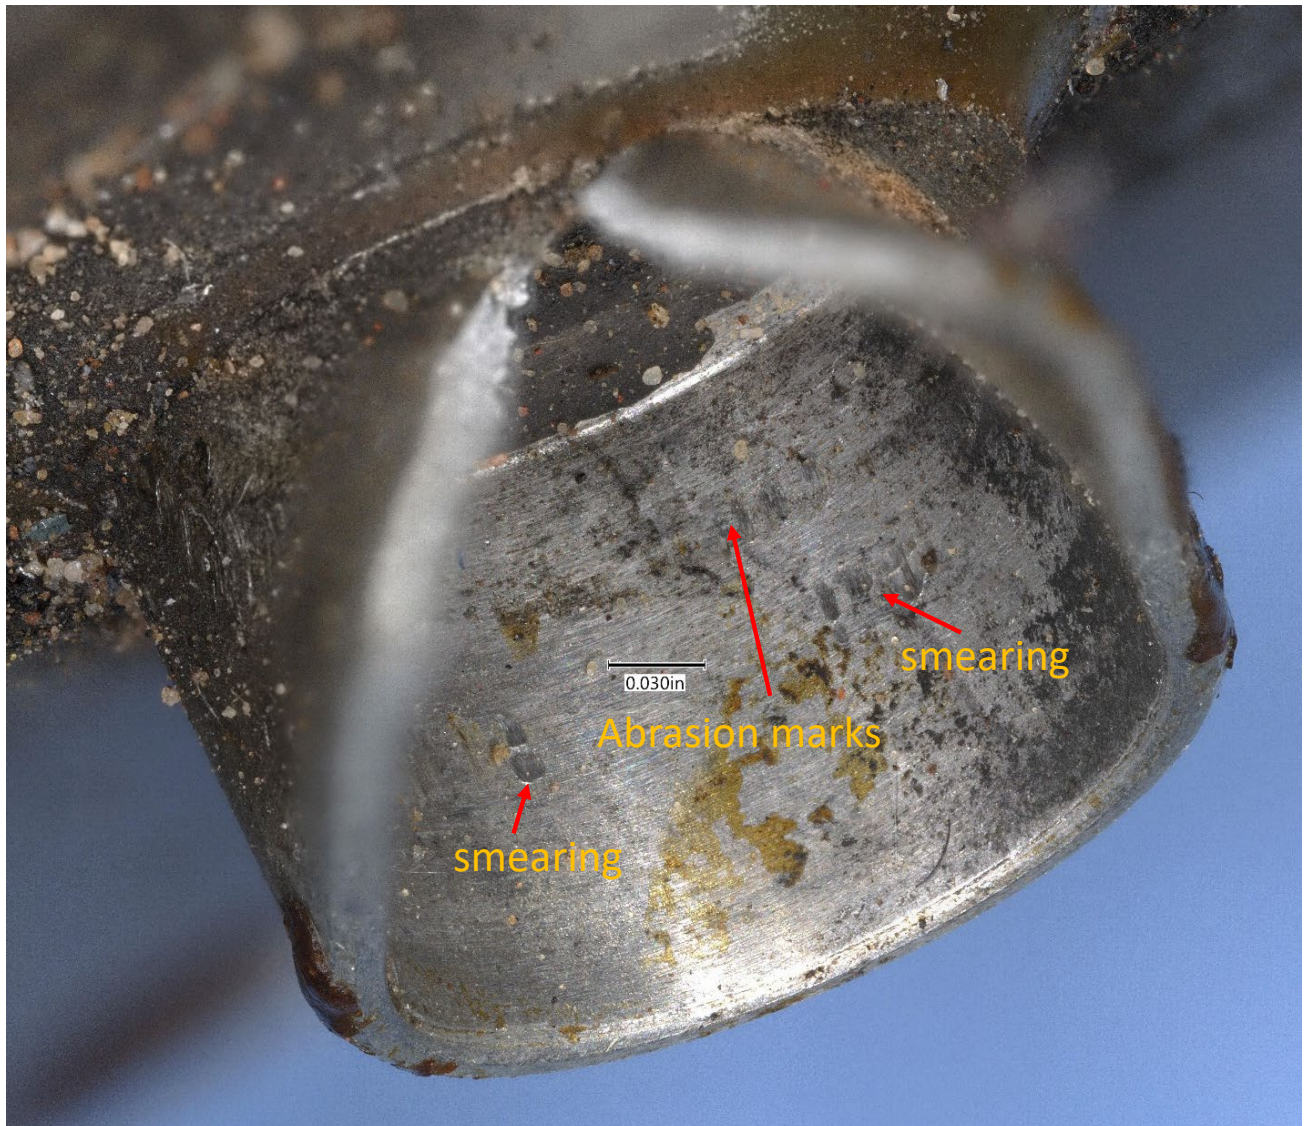
Figure 6: Interior surface of magnet holder.

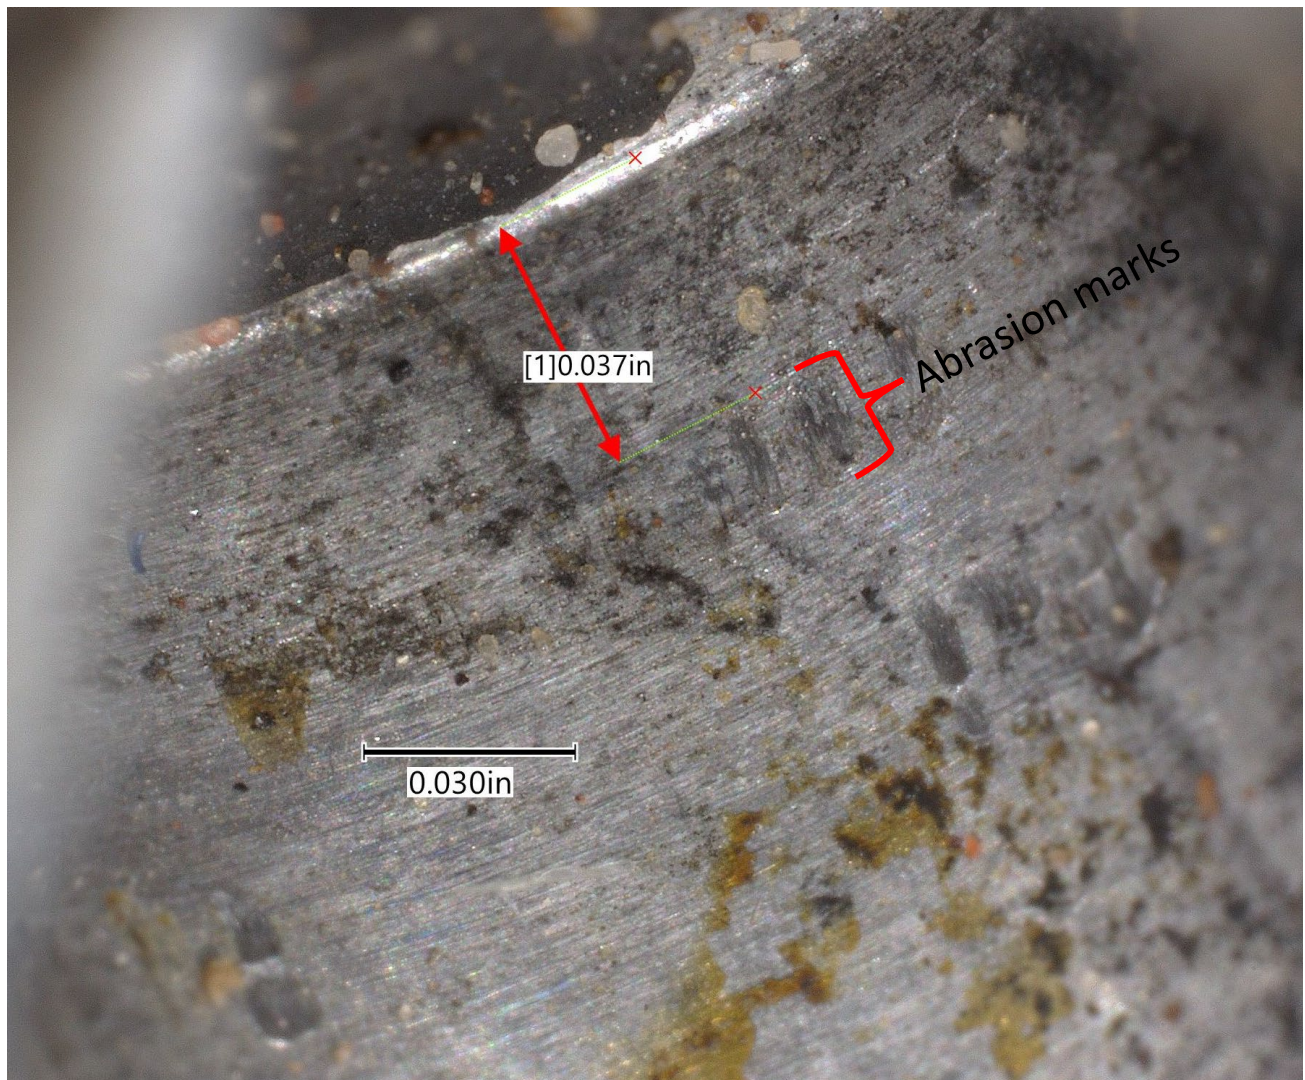
patches of residue similar in appearance to the brownish – amber residue previously discussed were observed. Some fine abrasions were noticed on the surface of the interior of the cylindrical wall near the bottom. These fine abrasions were approximately 0.037 inches from the bottom (figure 7). There were also areas of plastic deformation resembling a smearing like movement of material further up the interior of the cylindrical wall.

Figure 7: Close up of abrasion marks.

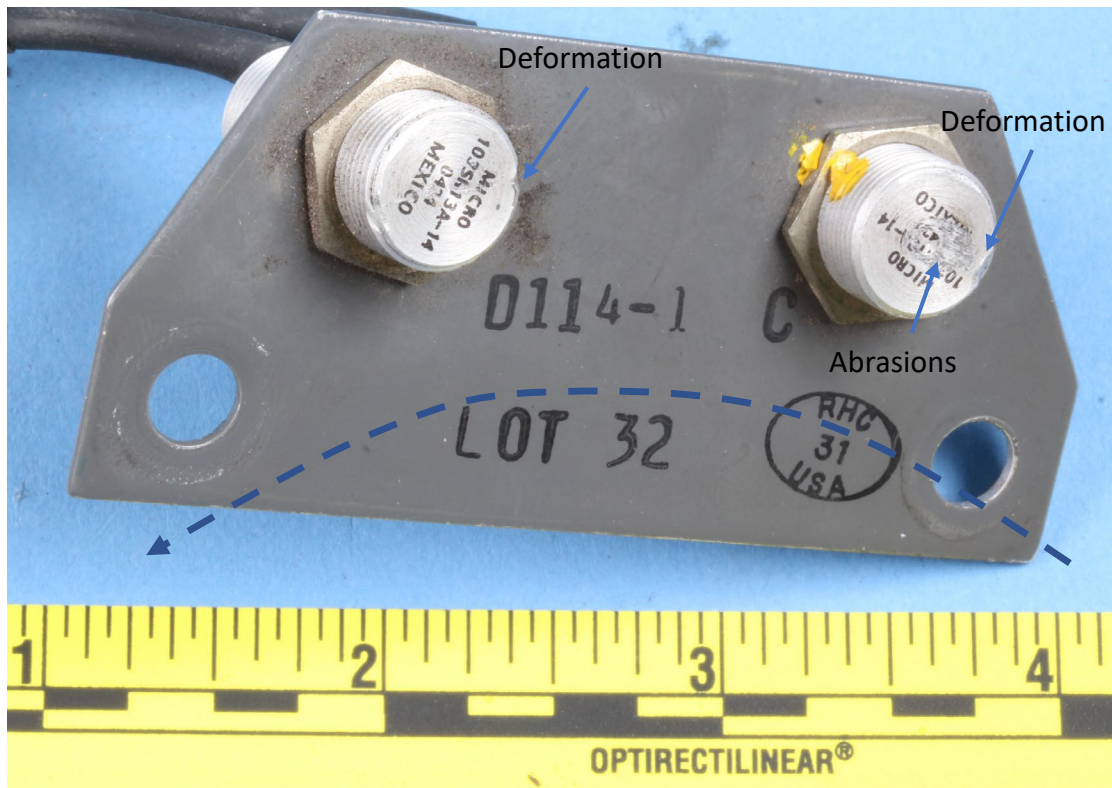
The Hall effect sensors exhibited some witness marks consistent with contact with a moving object (Figures 8, 9). These contact marks exhibited plastic deformation in a direction consistent with the intended movement between the magnets and the faces of the Hall effect sensors. The contact damage extended 0.025 down from the face of the sensor (Figure 10).

Figure 8: Hall effect sensors with contact damage. The dashed blue line with arrow indicates the direction of the motion of the magnets past the sensor faces.

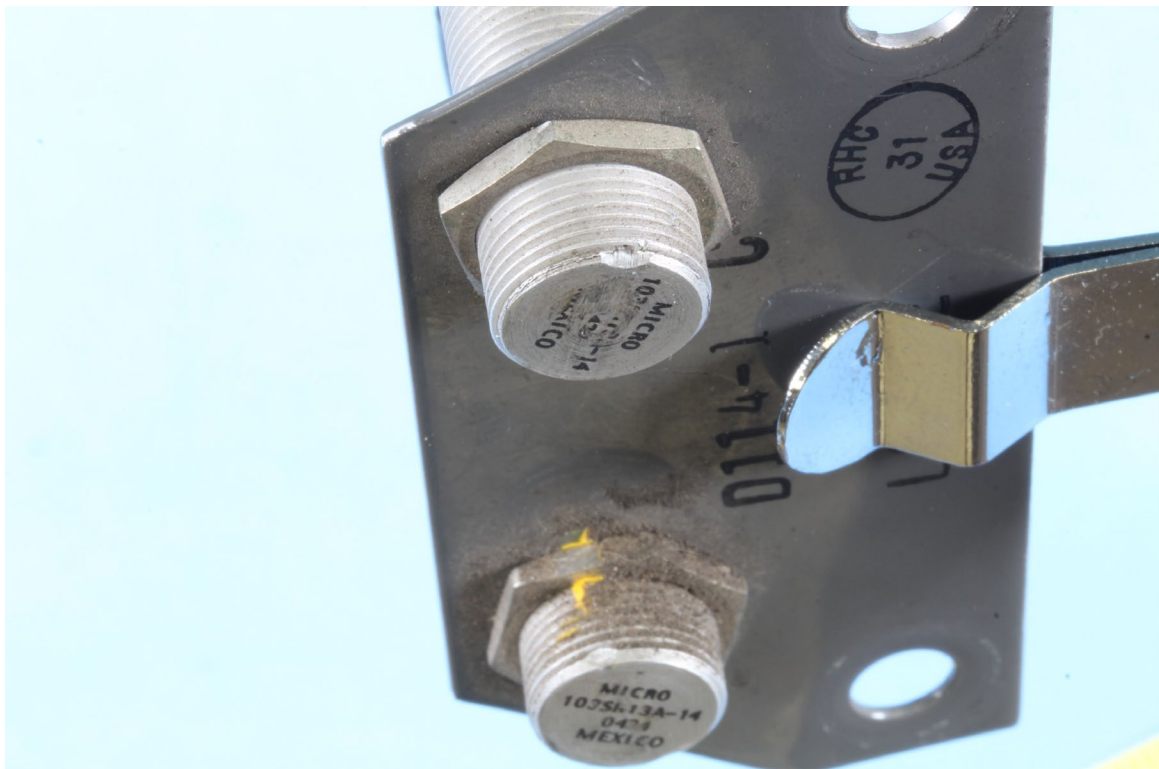
Figure 9: Hall effect sensors with contact damage.

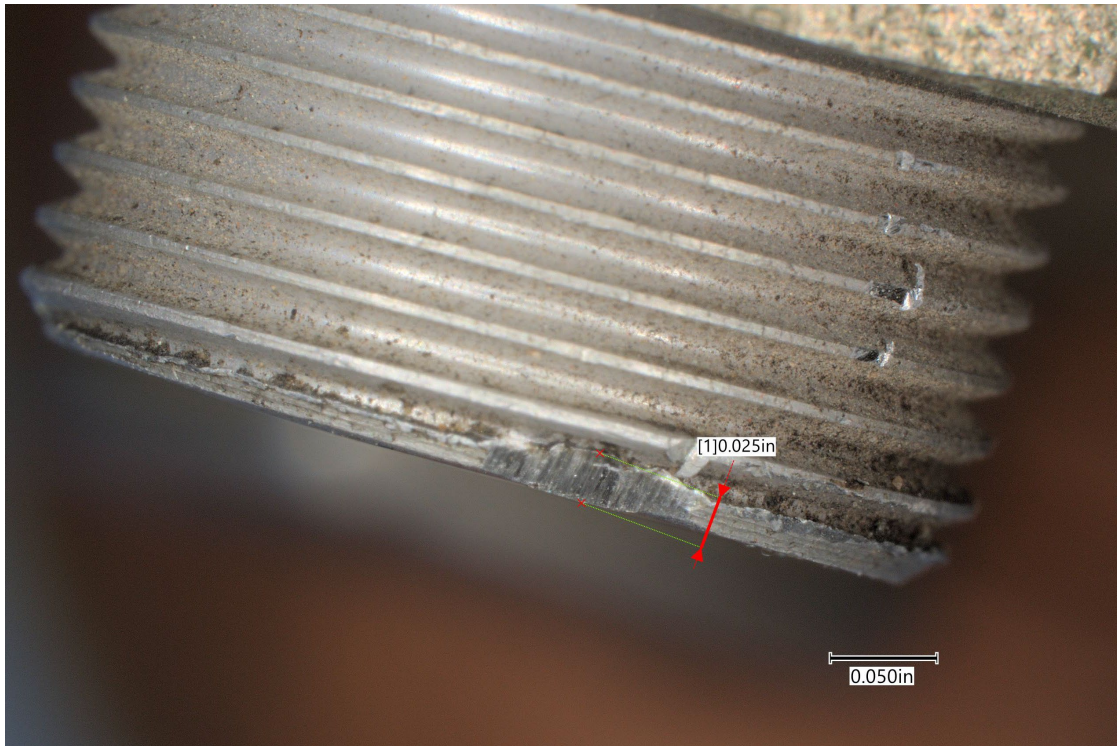
Figure 10: Depth of contact from face of Hall effect sensor.
