## RECORD OF CONVERSATION

NTSB Accident Number: WPR 20FA013

Aircraft Registration & Make/Model: N225JM / Robinson R-44

Accident Date: October 23, 2019

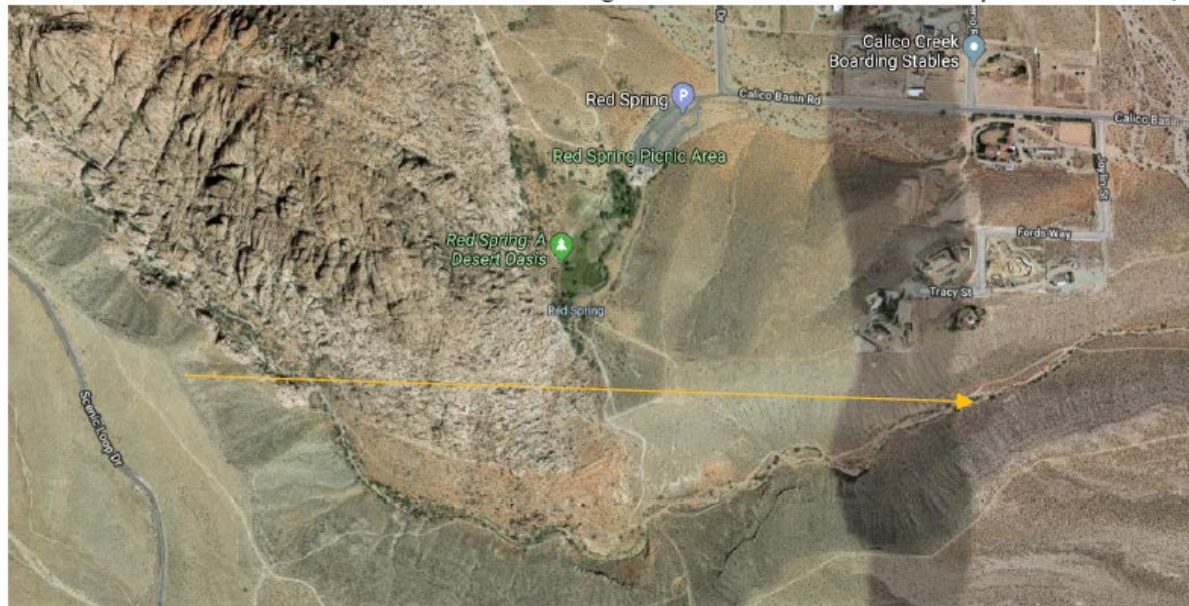
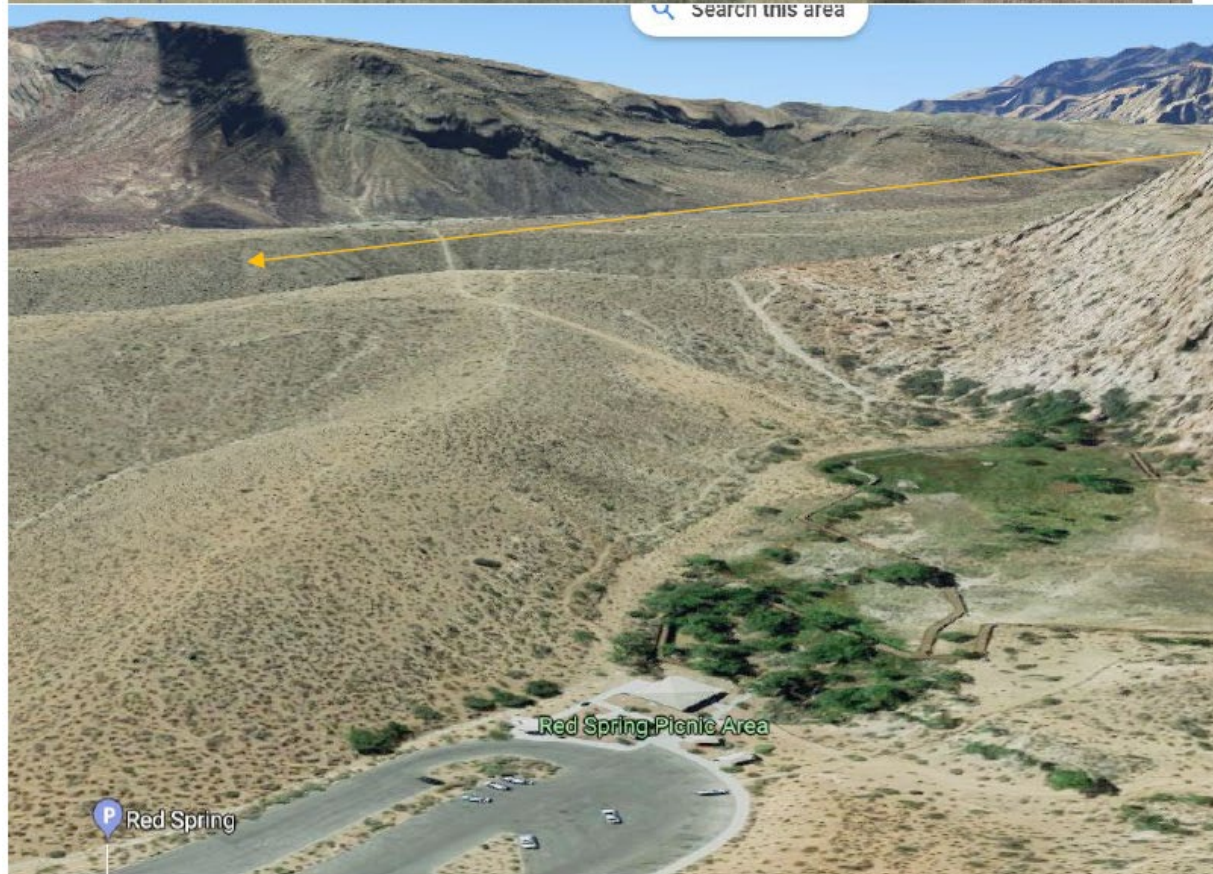
View from parking and boardwalk our view. Yellow line shows observed path, Looked to be about 350 feet up, however, that was relative to our ground level, we did not know that there was a canyon over the ridge.

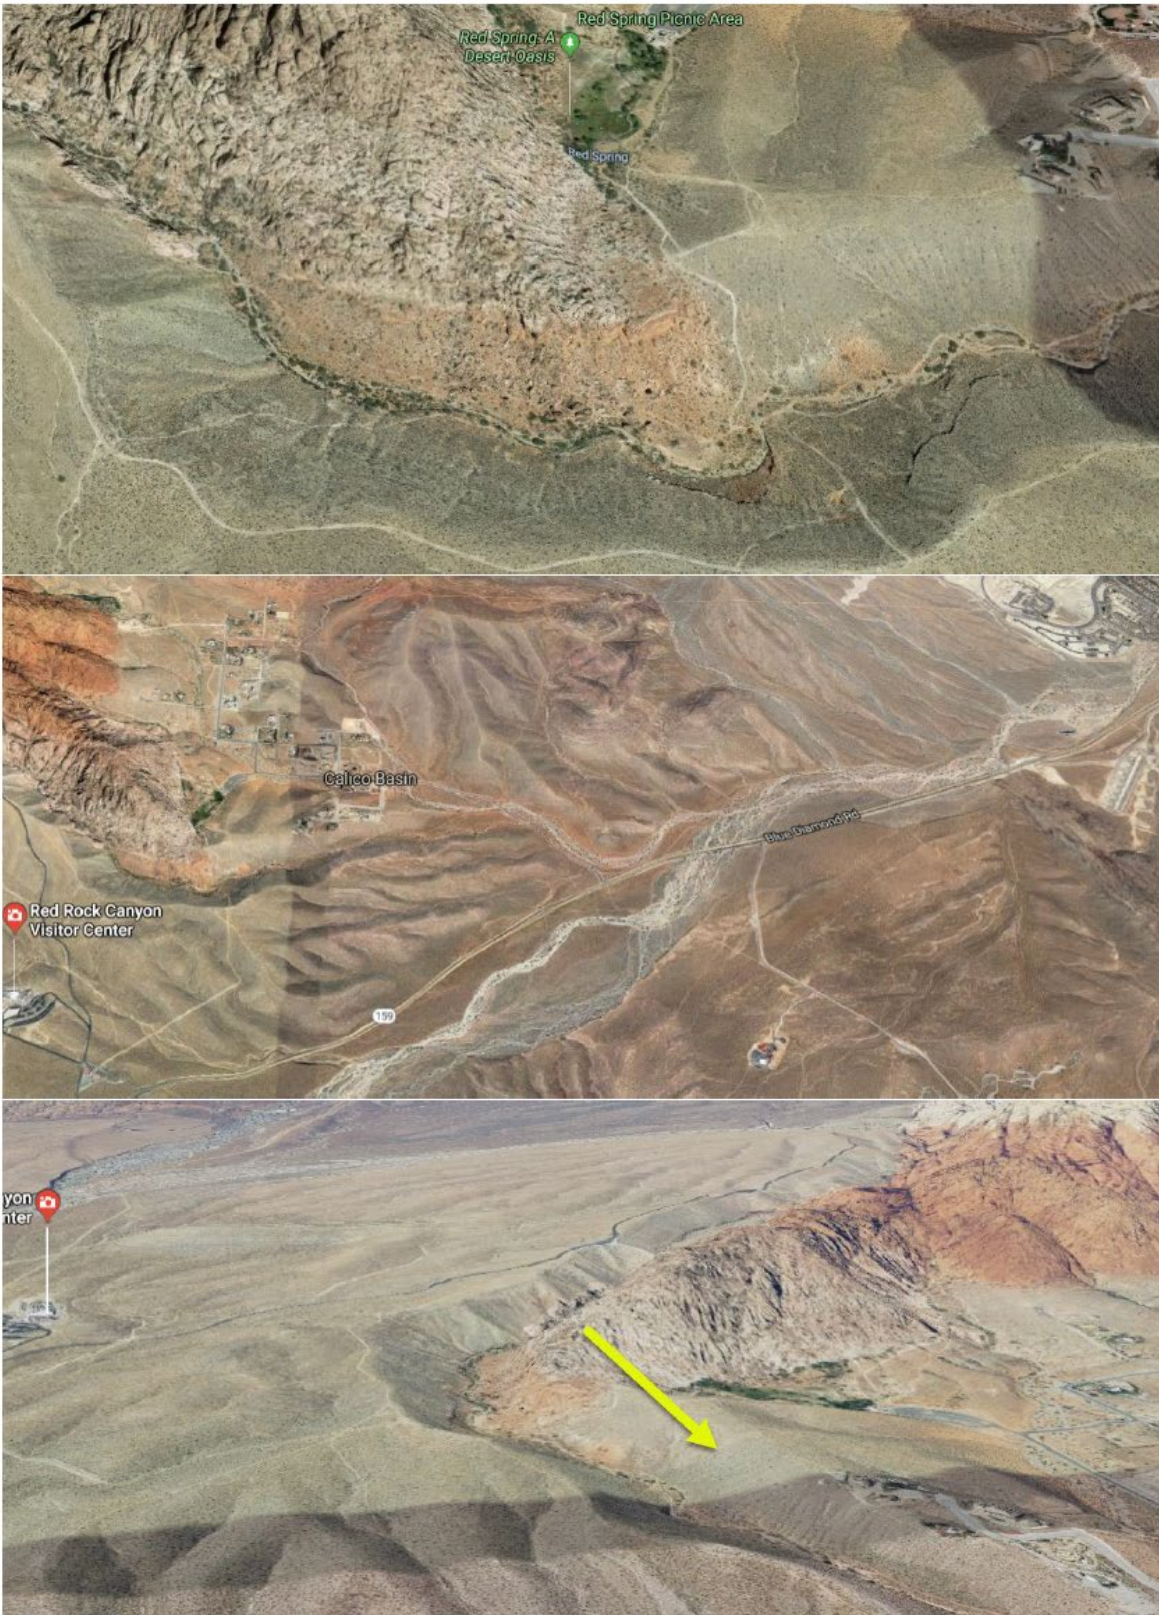
Unknown how far west of the ridge he was. It seemed to be in a slow turn to the south. Engine sounded normal.

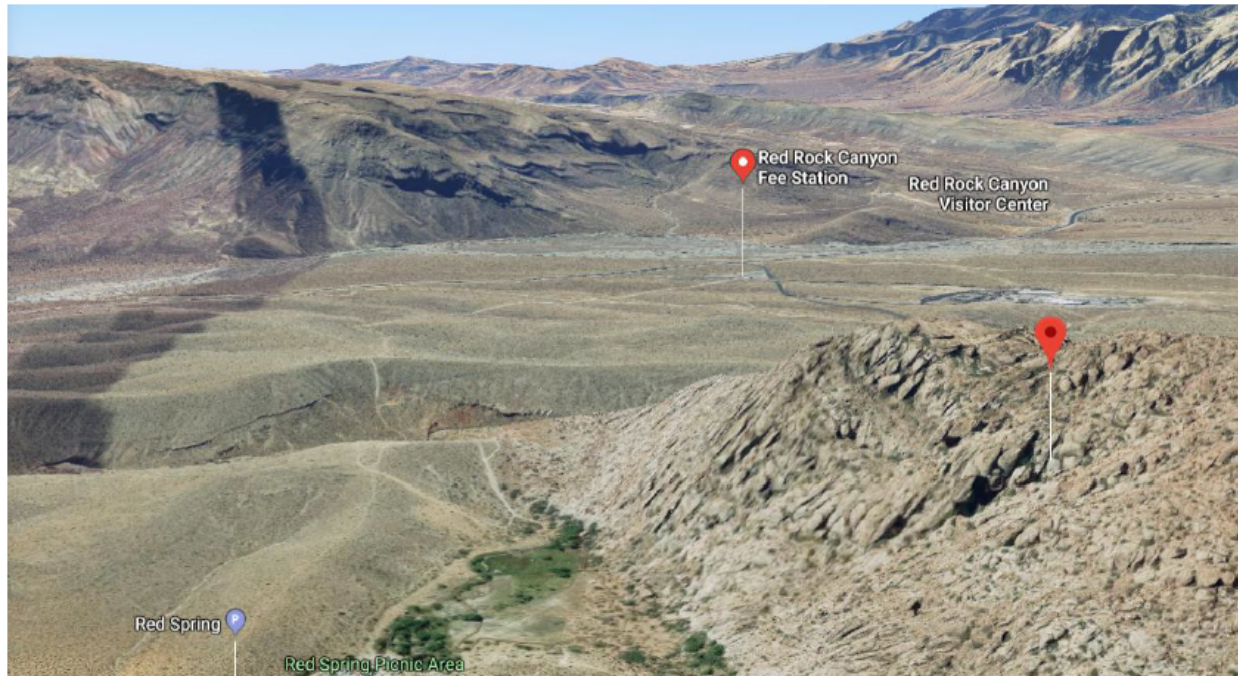
We were in the parking lot of the Red Spring picnic area or on the boardwalk at the Red Spring oasis. (in Calico basin south of Red Rock Canyon) Before 4pm on October 23, 2019. Viewed a helicopter coming from Red Rock Canyon “popped” out from behind the hill to the West/Northwest of the parking lot, coming from Red Rock Canyon. It was going south and disappeared from view quickly. Appeared to be descending. Engine sounded ok, was under power. I mentioned to my companion that it was too low (below 500 feet AGL from my viewpoint). It looked like it was about 350 feet, however, I was not aware of the canyon over the ridge so it may have been 500 feet above the canyon floor. It was between 3:30 and 4pm sometime as we looked to see when the boardwalk would close before we walked.
