## INVESTIGATION SUPPORT MATERIAL SUPPLEMENT

### HISTORY OF FLIGHT

On October 23, 2019, at 1553 mountain standard time, a Robinson R44 II Raven, N225JM, sustained substantial damage after impacting terrain following an auto-rotation in Las Vegas, Nevada. Binner Enterprises LLC, owned the helicopter and Airwork Las Vegas was operating the helicopter under the provisions of 14 *Code of Federal Regulations* (CFR) Part 91. The airline transport pilot and passenger survived the impact, but later succumbed to their injuries. The personal local flight departed from North Las Vegas Airport, Las Vegas, Nevada, about 1535. Visual meteorological conditions prevailed and no flight plan had been filed.

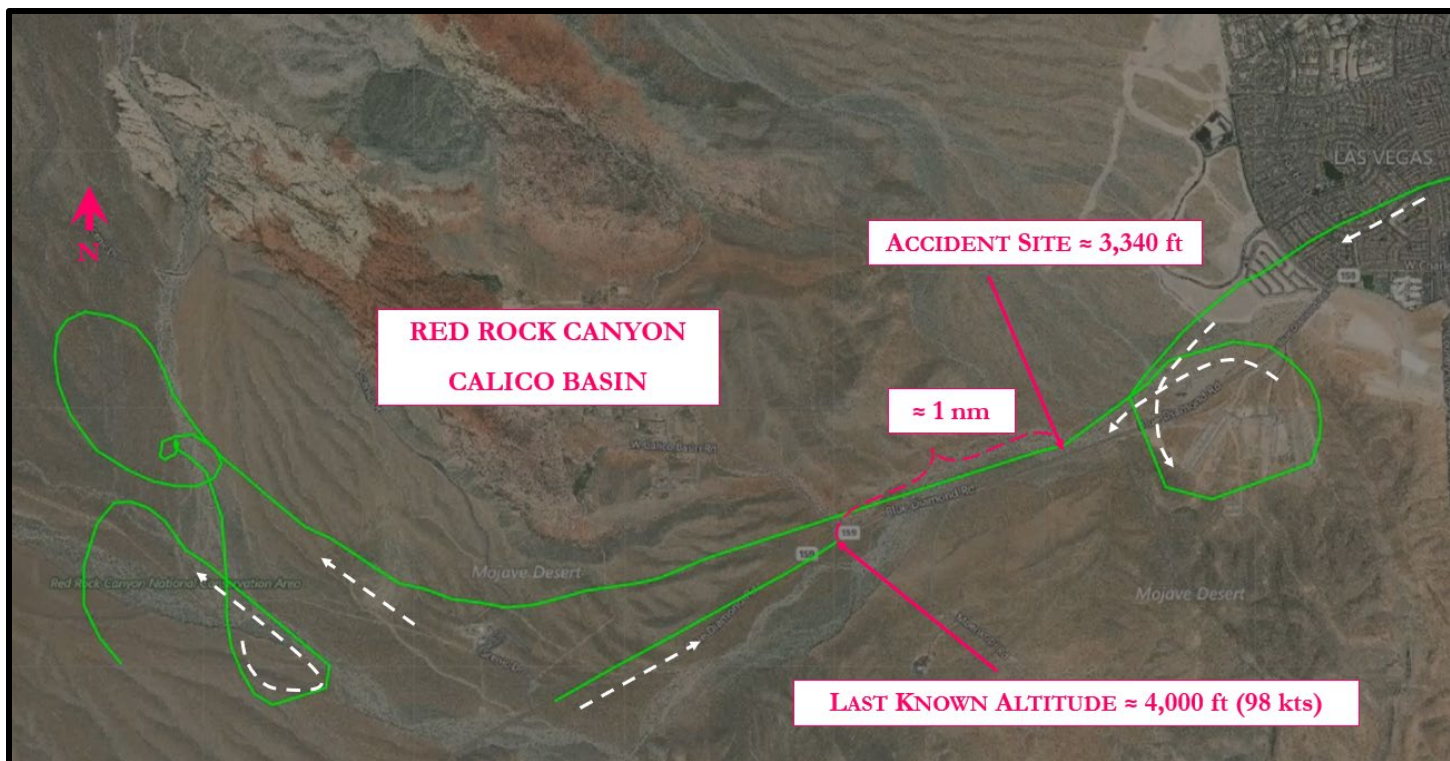
Picture 01: Radar Track Data

A review of the preliminary radar track data indicated that after departure, the helicopter departed and continued west-southwest toward the Red Rock Retention Basin checkpoint. After the track cleared the Class Bravo airspace the returns showed a left 360° orbit over Blue Diamond rd., consistent with the pilot circling over a remote control (RC) airpark and the Desert Sportsman's Rifle Club. Thereafter the radar showed a track consistent with the helicopter loosely following the road around Calico Basin and climbing up to 4,700 feet mean seal level (msl), equivalent to about 400 feet above ground level (agl). The helicopter then made a left turn and several maneuvers over the Red Rock National Conservation Area washes including a possible touchdown where the forward airspeed speed was reduced to 0 kts. After making several low-level maneuvers, the track was consistent with the helicopter adjoining Blue Diamond rd. and following the road heading north-northeast. The last radar hit was at 1553:23 and located on the road about 1 nautical mile (nm) west-southwest from the accident site. The last 30 seconds of the track revealed the helicopter was following the road with an airspeed of about 120 to 100 kts at an altitude between 500 to 700 feet agl.

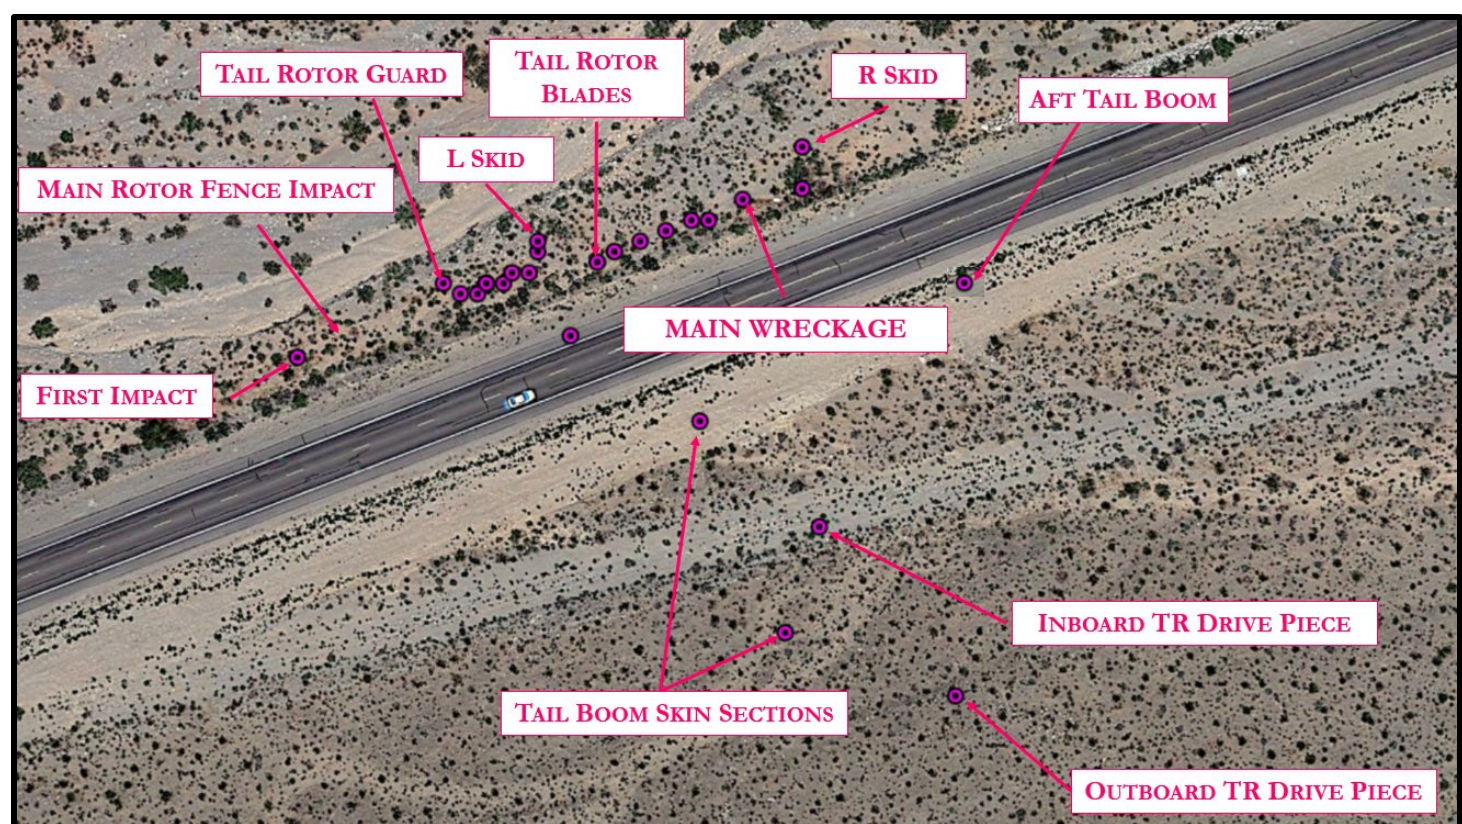
Picture 03: Wreckage GPS Points

The accident site was located in the desert terrain about 10 nm from the departure airport on a bearing of  $250^\circ$ . The wreckage was found distributed in a ravine over a 200 foot distance on a median magnetic bearing of about  $070^\circ$ . The ravine and debris field ran parallel to the road and was located about 4-5 feet below the pavement. The first identified area of impact was a

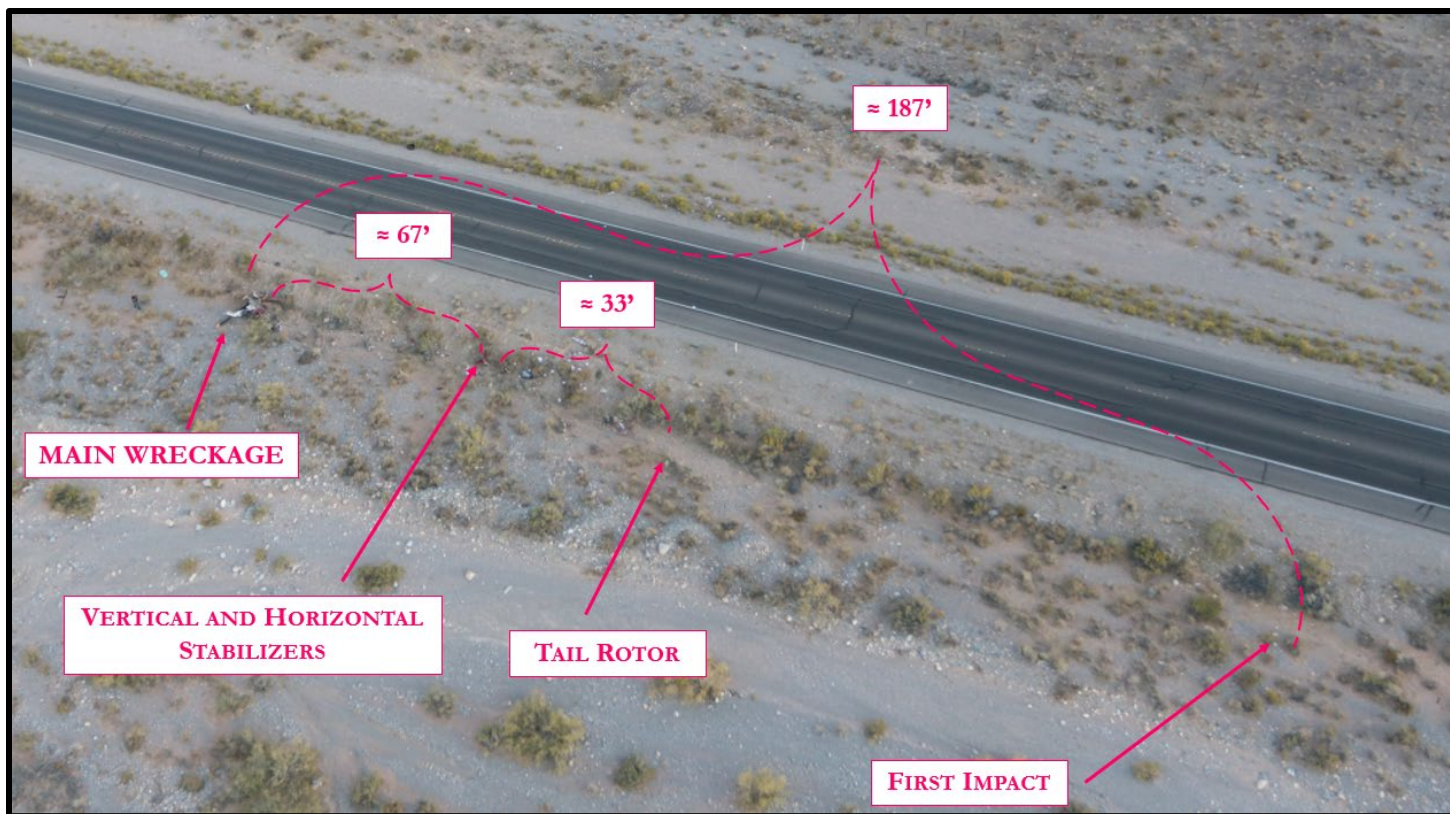
Picture 05: Wreckage Distance from main Wreckage to First Identified Point of Impact

approximate 5 inch line (oriented parallel to the road) of scraping and maroon-colored paint transfer across a rock. Adjacent to that line was another parallel line of paint transfer that was red in color. The orientation and colors were consistent with the tail rotor guard (candy-cane: white and red) and tailskid (maroon) making contact first indicative of a nose-up attitude.

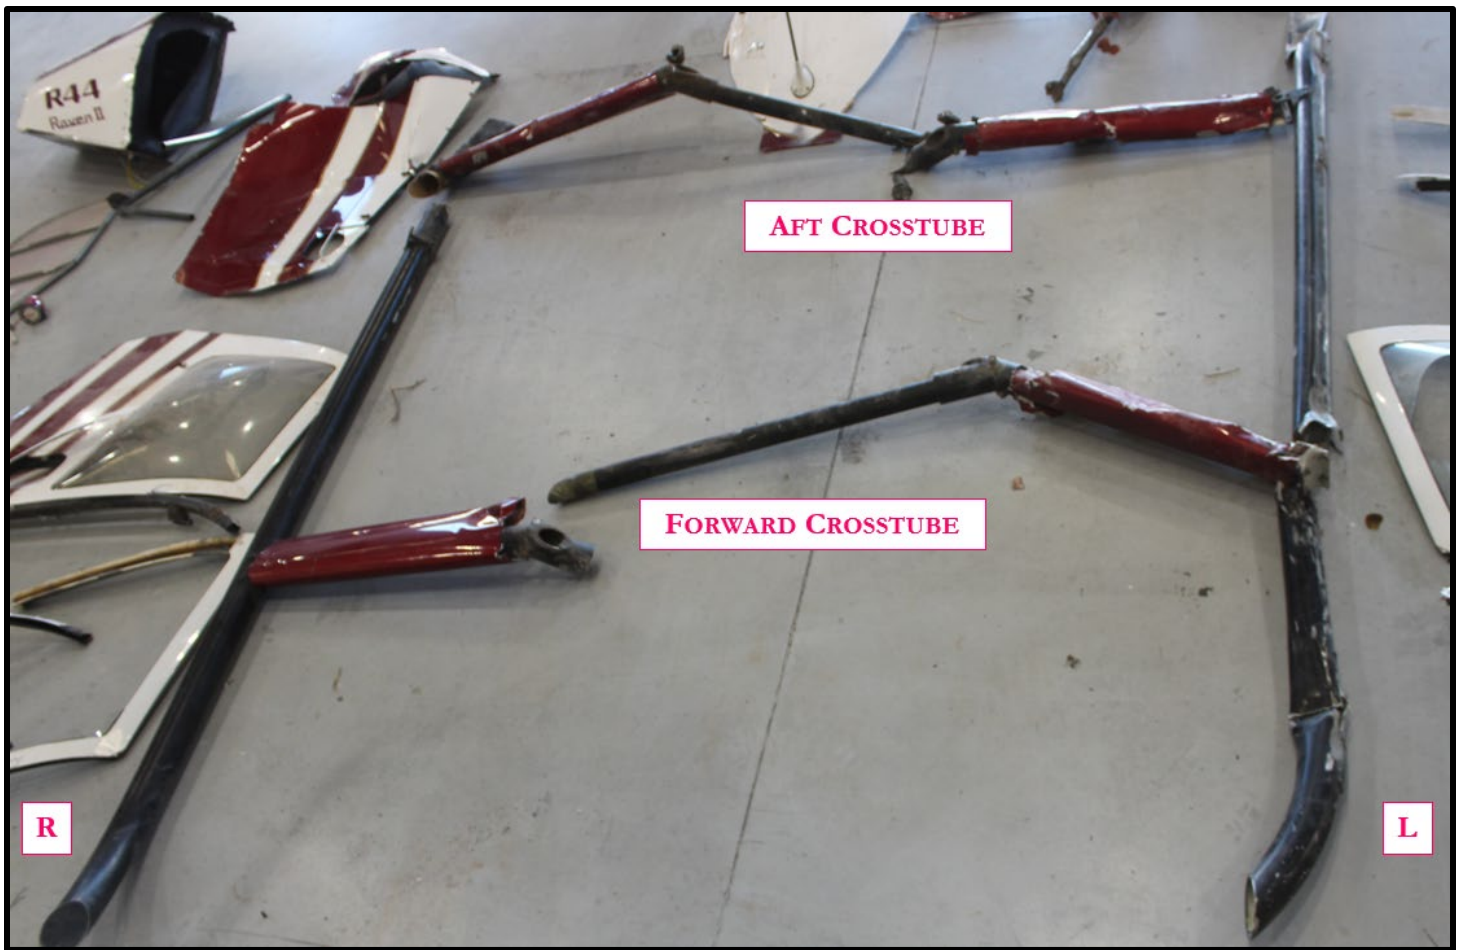
*Picture 08: Landing Skids*

The left landing gear sustained more damage than the right. The left forward crossbar sustained crush damage consistent with the left skid impacting the ground and tearing aft. The right skid sustained less damage and was found furthest from the wreckage.

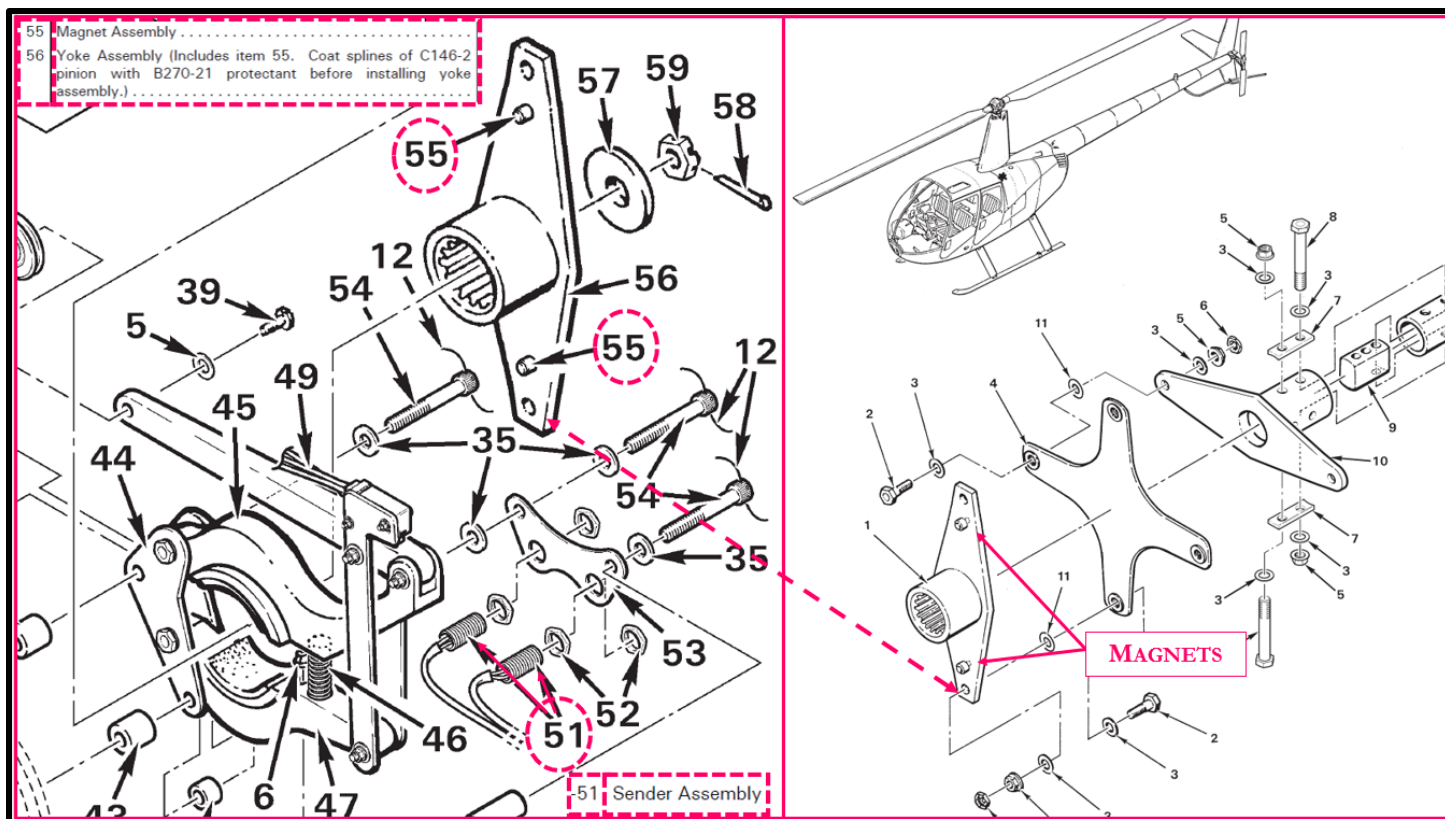
Picture 09: Rotor Tachometer Assembly

An electronic engine and rotor dual tachometer was equipped on the helicopter. The rotor tachometer signal is provided by two magnets at the main gearbox drive yoke that pass by an electronic Hall Effect devices. Robinson representative reported that with only 1 magnet installed, the main rotor tachometer rpm would indicate about 50% of the actual rotor rpm.

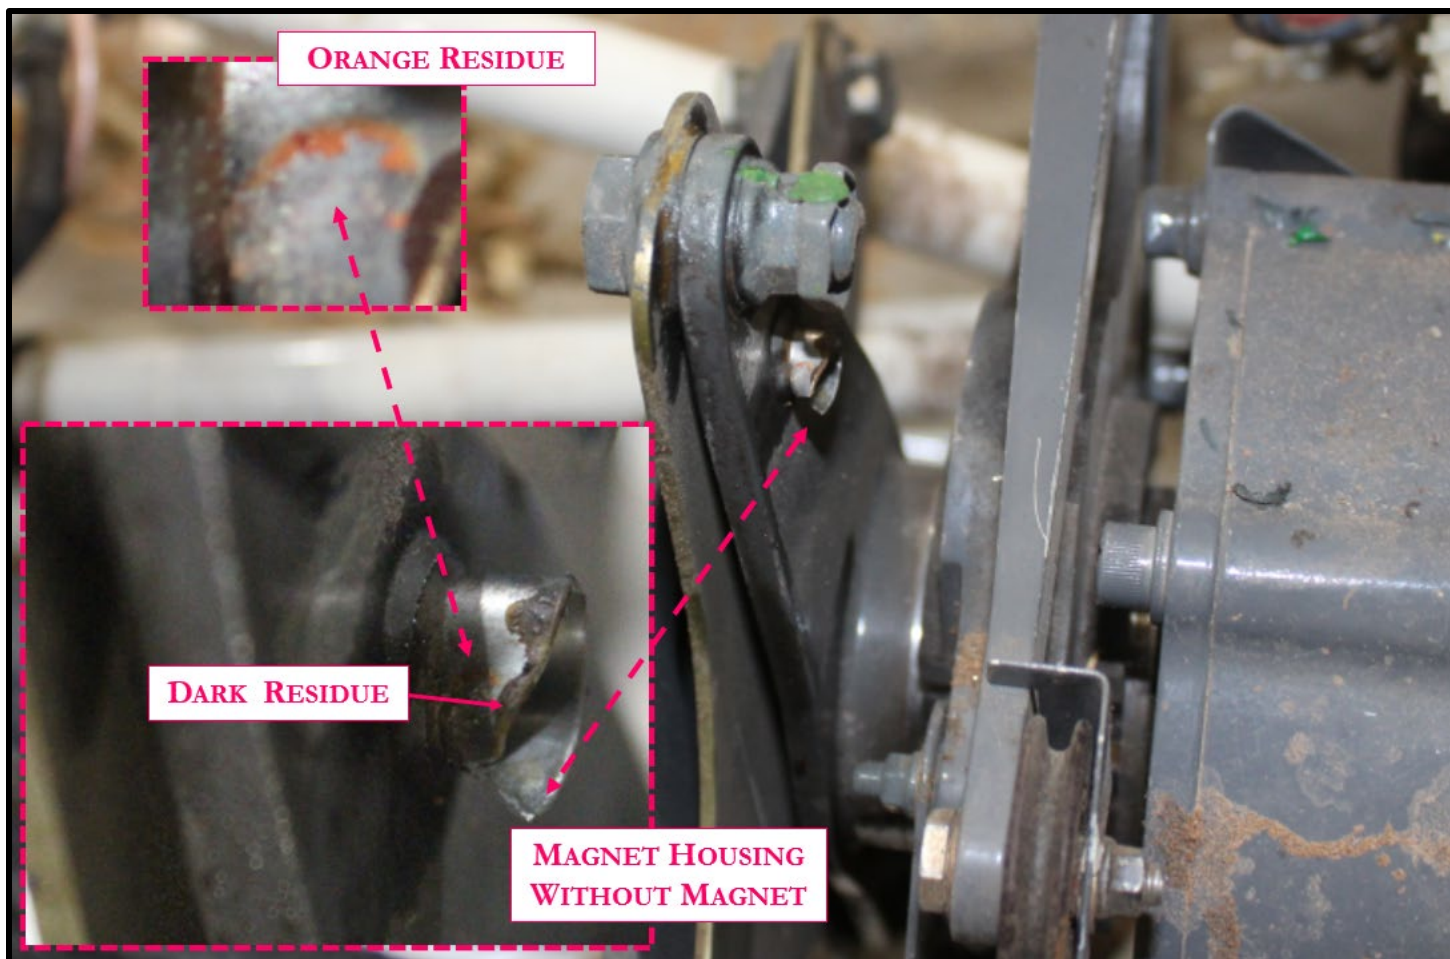
Picture 11: Magnet Housing on Yoke Assembly

Examination of the engine compartment revealed one magnet assembly part number (p/n) B570-1 associated with the main rotor tachometer indicating system was separated from the Yoke Assembly, p/n C908-1; the magnet was located on the fuselage frame near the firewall.

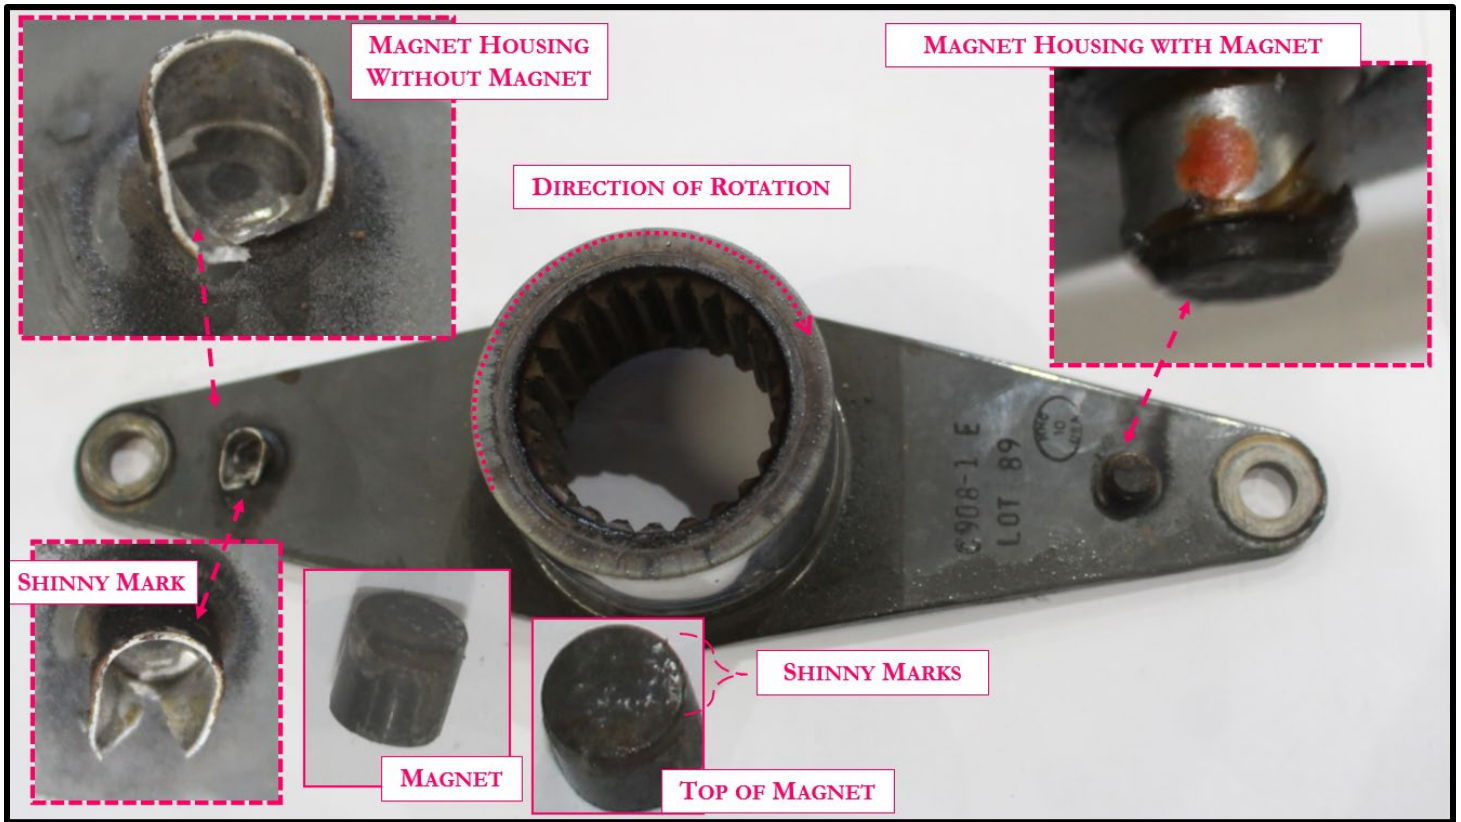
Picture 13: Magnet Assemblies on the Yoke

The magnet housing was shiny at the top of one side (the direction of rotation) consistent with contact of the magnet against a sender. The other magnet assembly remained secured to the yoke assembly. Both the housings showed a color consistent with a dark residue and a yellow/orange mark was on both housings and senders. The yoke assembly was not damaged.

A Robinson Helicopter Company representative reported there have been instances of a magnet separating from a magnet assembly which prompted issuance of Service Bulletin (SB) 86<sup>1</sup>, which required an adhesive be applied between the magnet and the magnet housing and a yellow dot placed on the magnet housing.

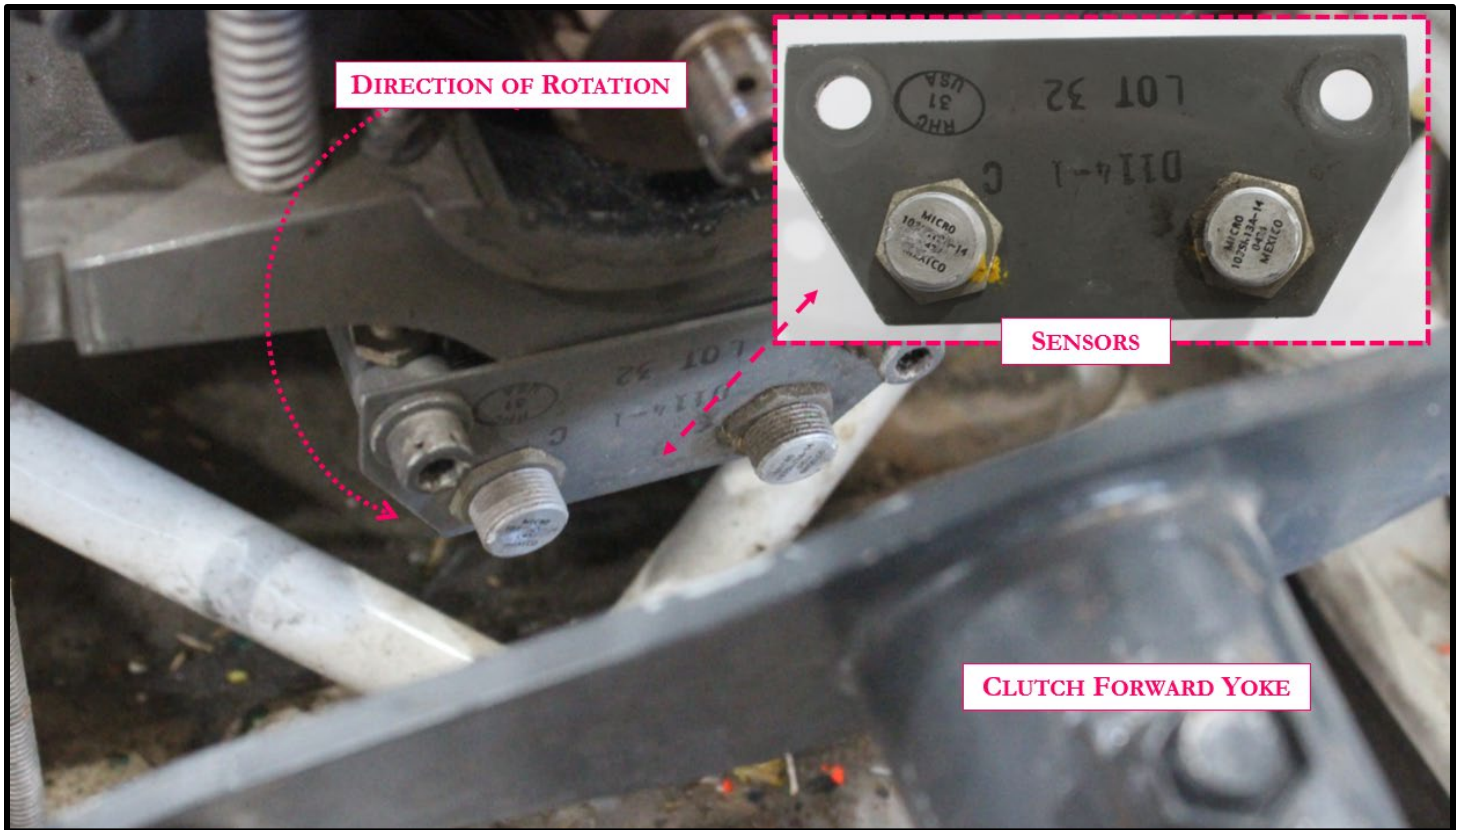
Picture 15: Sensor Location

There was evidence of slight damage to both sensors, consistent with the magnet assembly separation. The lowest numeric marking on the dual tachometer associated with the main rotor is 50, with 2 graduated lines beneath.

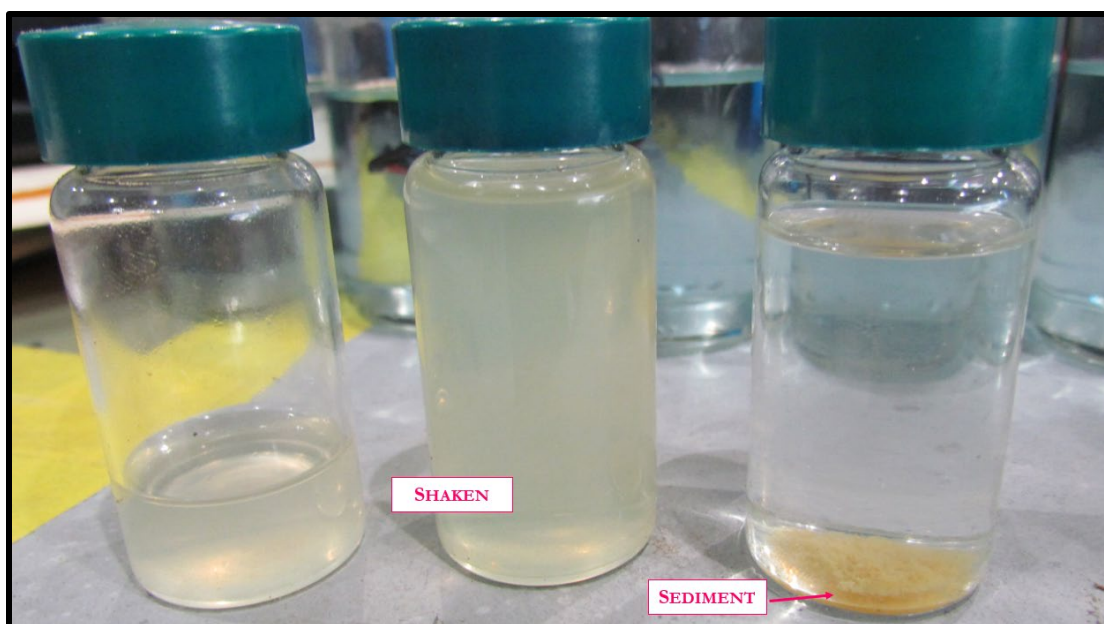
Picture 18: Fuel from Gascolator

Investigator removed the gascolator at the accident site. The bowl was full with a liquid consistent in odor with that of 100LL AVGAS, but the color was an orange-yellow; there was some debris in the bowl that was akin to a gelatinous consistency (the liquid was captured in glass bottles for possible future testing). During recovery fuel began to pour from the system where the T had broken at the return line to the aux tank. Investigators cut the interconnect line and clamped it for recovery purposes.

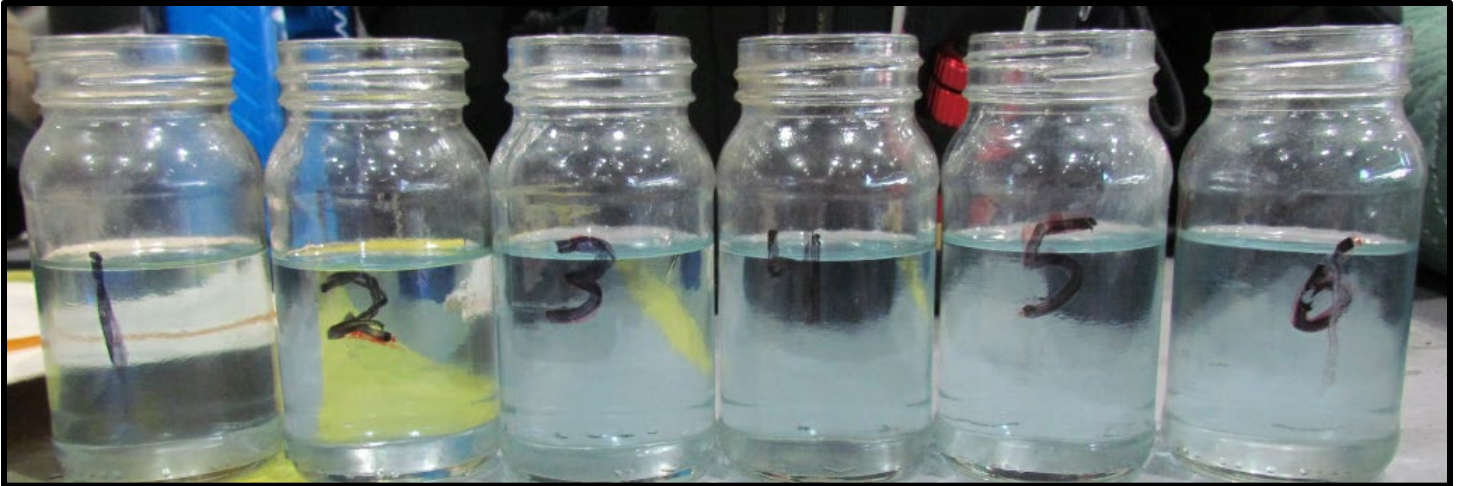
*Picture 19: Fuel Collected from Injectors*

Investigators removed the fuel injector lines from their respective cylinders and examined each injector; they were clean from particulates. The injectors were reinstalled and glass bottles were placed under each one. The pump was again activated, and fuel flowed to each jar; the fuel was blue and clear of contaminants.

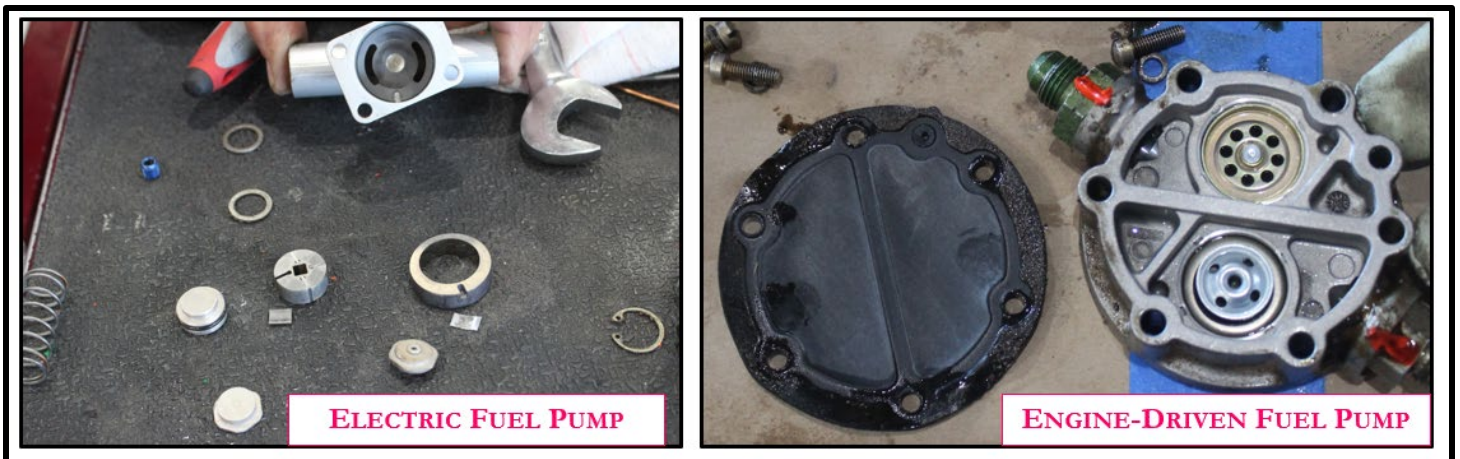
*Picture 20: Fuel Pumps*

The engine-driven fuel pump remained attached to the engine. Movement of the lever resulted in suction and expulsion of air from the fuel lines. Disassembly of the fuel pump revealed that it was free of internal mechanical malfunction and obstruction to flow; the diaphragm was intact. The electric-driven fuel pump vanes were intact and no contaminants were found.

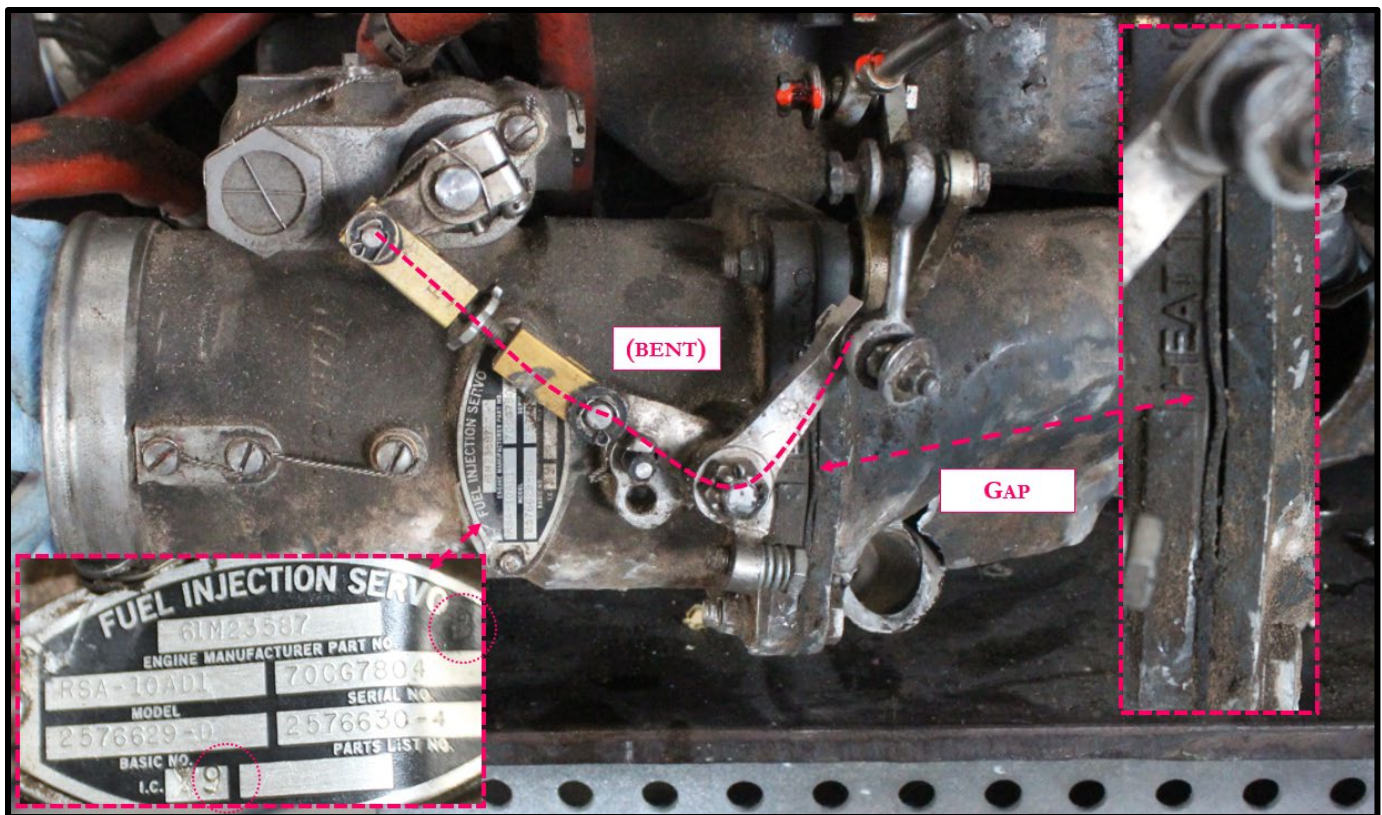
Picture 21: Fuel Servo (mounted on engine)

The servo still contained the black data plate, which according to the manufacturer was to be changed to a yellow data plate at overhaul. There was a gap between the servo body and the intake adapter flange, consistent with impact. The throttle spring was intact and the linkages contained bends consistent with impact damage. Upon disassembly, investigators noted a black residue on the top of the air diaphragm, which according to the manufacture was normal for a unit that had been in service. The diaphragms were intact and pliable. The fuel screen was clean from debris. The mixture and throttle arms moved from stop to stop. There was no evidence of mechanical malfunctions or failures.

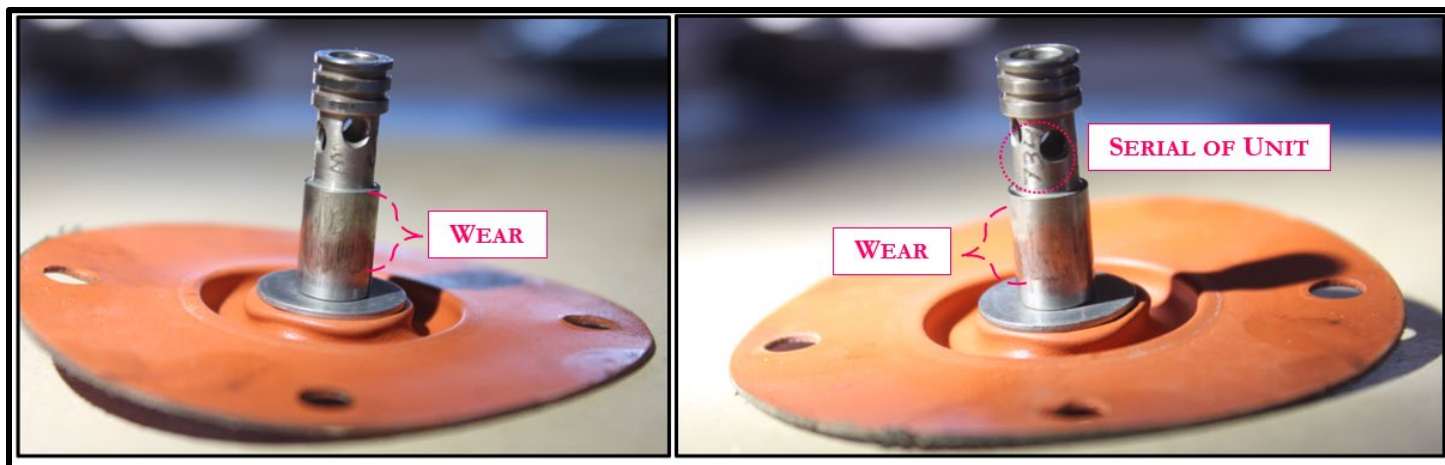
Picture 23: Flow Divider Diaphragm

The flow divider/spider was disassembled. The diaphragm was pliable and contained not rips. The piston had the serial number of the unit vibropeened on the body. The piston had wear marks on the upper body.

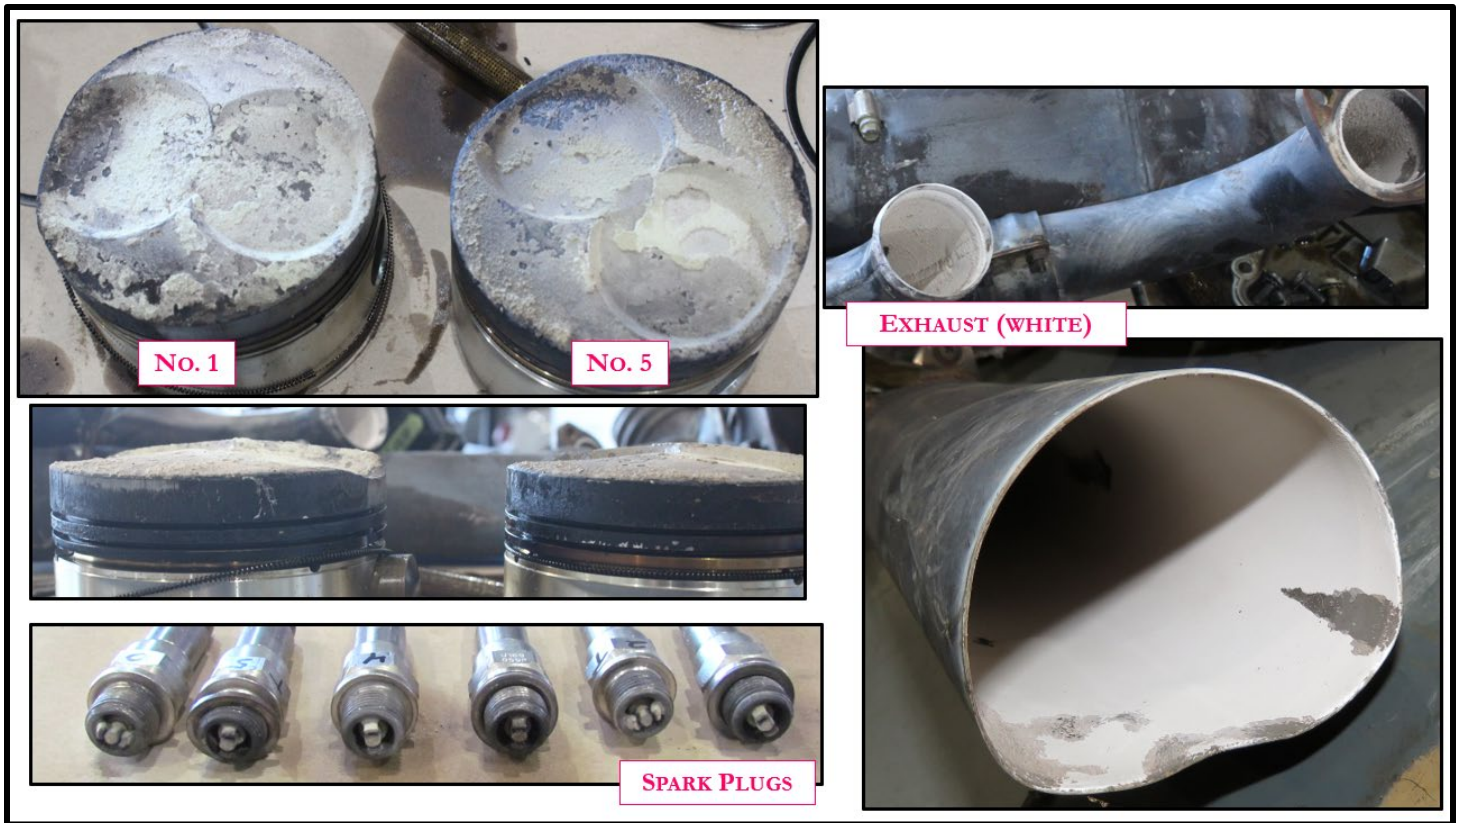
*Picture 24: Combustion Signatures*

An external visual examination of the engine revealed that it had sustained crush damage to the bottom of the crankcase, with the majority of damage to the oil pan. The spark plugs were removed. No mechanical damage was noted and the electrodes and posts exhibited a light ash white coloration, which according to the Lycoming representative was consistent with a very lean operation(s).

The cylinders' combustion chambers were examined through the spark plug holes utilizing a lighted borescope. The combustion chambers remained mechanically undamaged, and there was no evidence of foreign object ingestion. The valves were intact and undamaged. There was no evidence of valve to piston face contact. The piston faces all displayed a whitish coloration and the valve faces were white and orange, consistent with a lean operation. White residue/soot was additionally seen throughout the remainder of the exhaust system.

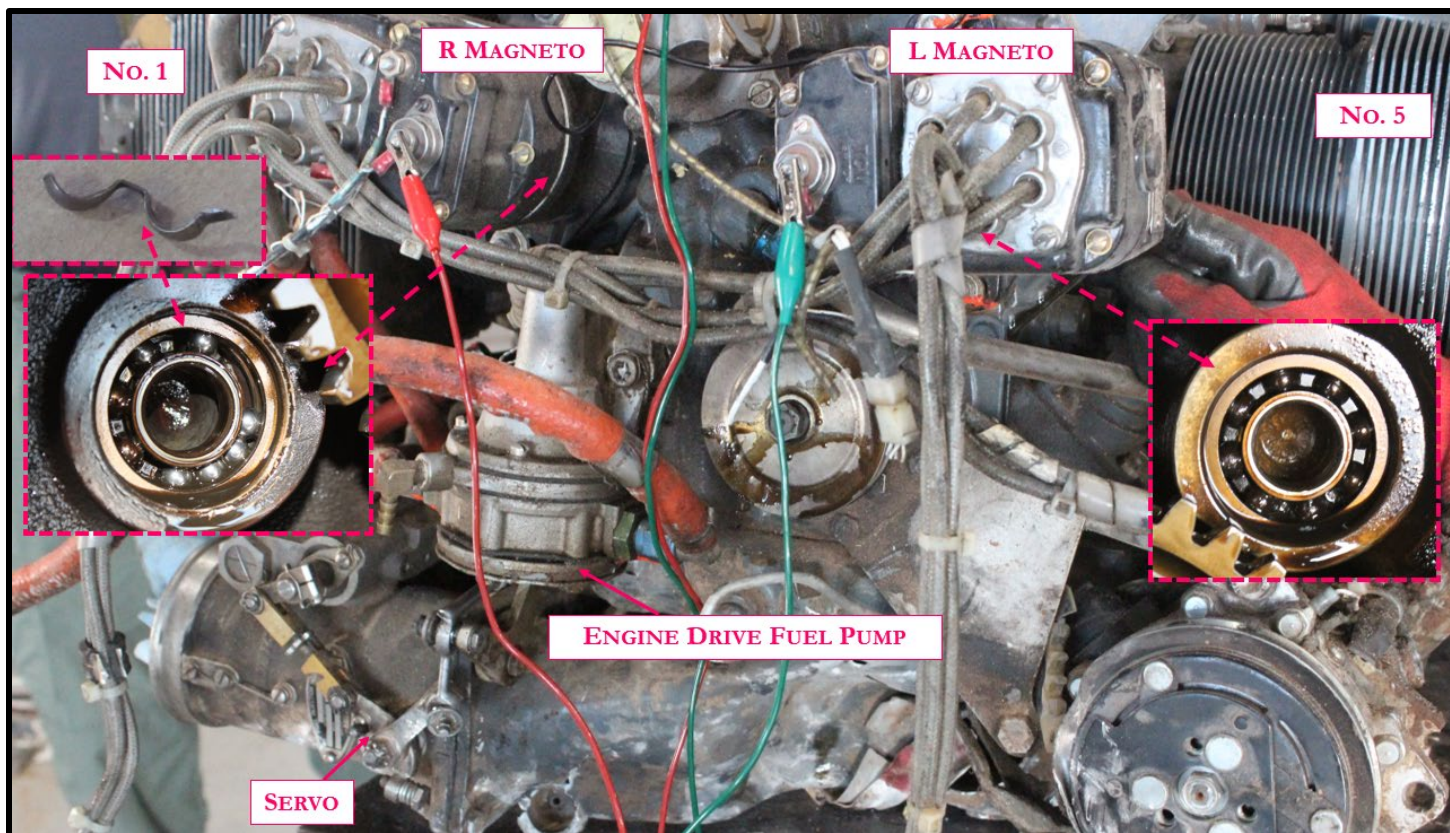
Picture 25: Magnetos

The ignition harnesses were attached from both magnetos to their respective spark plugs. The magnetos were secured to its respective mounting pads. The right magneto (on the side of the even cylinders) was timed at 20°; the left magneto was at 18°. Removal of the right magneto revealed that the bearing cage had broken; the broken piece was found in the oil sump. The magnetos were put on a test bench; the left magneto operated normally and the right magneto vibrated but operated normally with even spark at each post. Both magnetos were rotated by hand and moved freely.
