## **NATIONAL TRANSPORTATION SAFETY BOARD**

# **AIRFRAME AND ENGINE EXAMINATION**

**WPR20FA015**

Location: American Falls, Idaho  
Date: October 25, 2019, 1200 MDT  
Aircraft: Mooney M-20J, Missile 300 / N  
NTSB IIC: Fabian Salazar

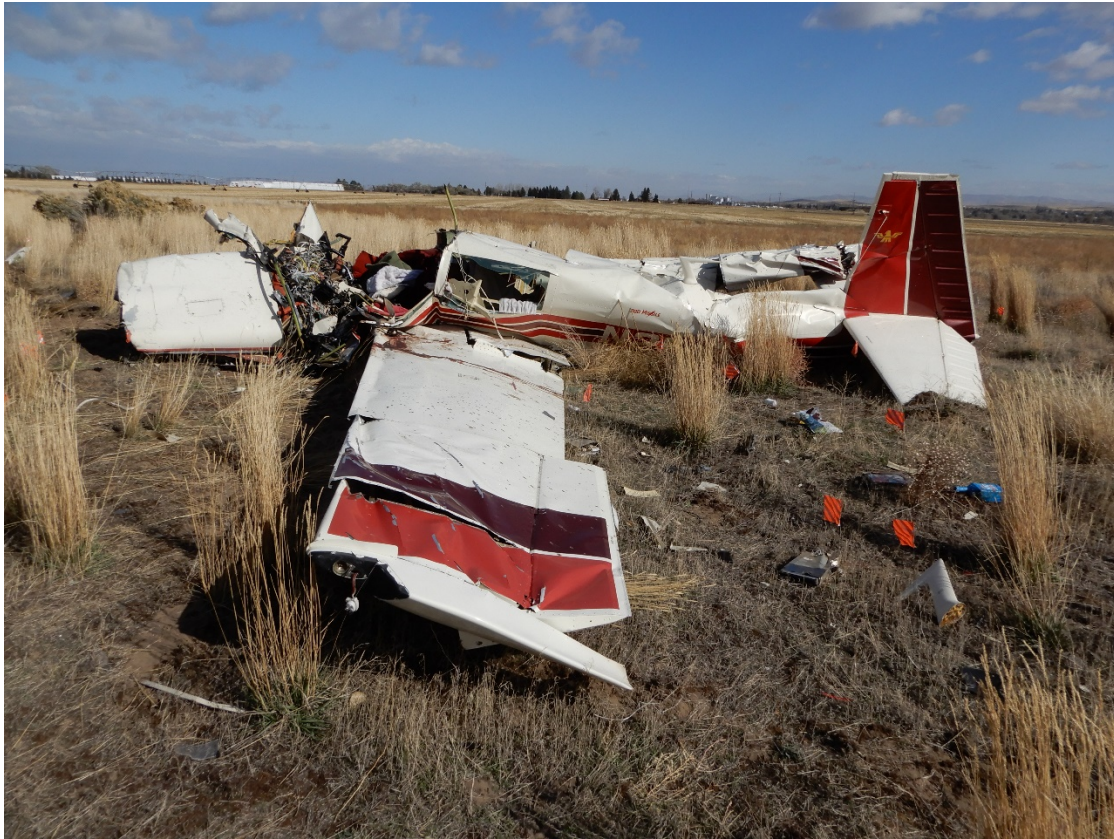
**Left-Side Fuselage.** The left side of the fuselage was substantially damaged and displayed heavy dents, wrinkles, and tears in the sheet metal. A large fracture of the fuselage, in front of the leading edge of the left wing, exposed the cabin.

**Figure 1. Left-side view of N201BJ at the accident site.**

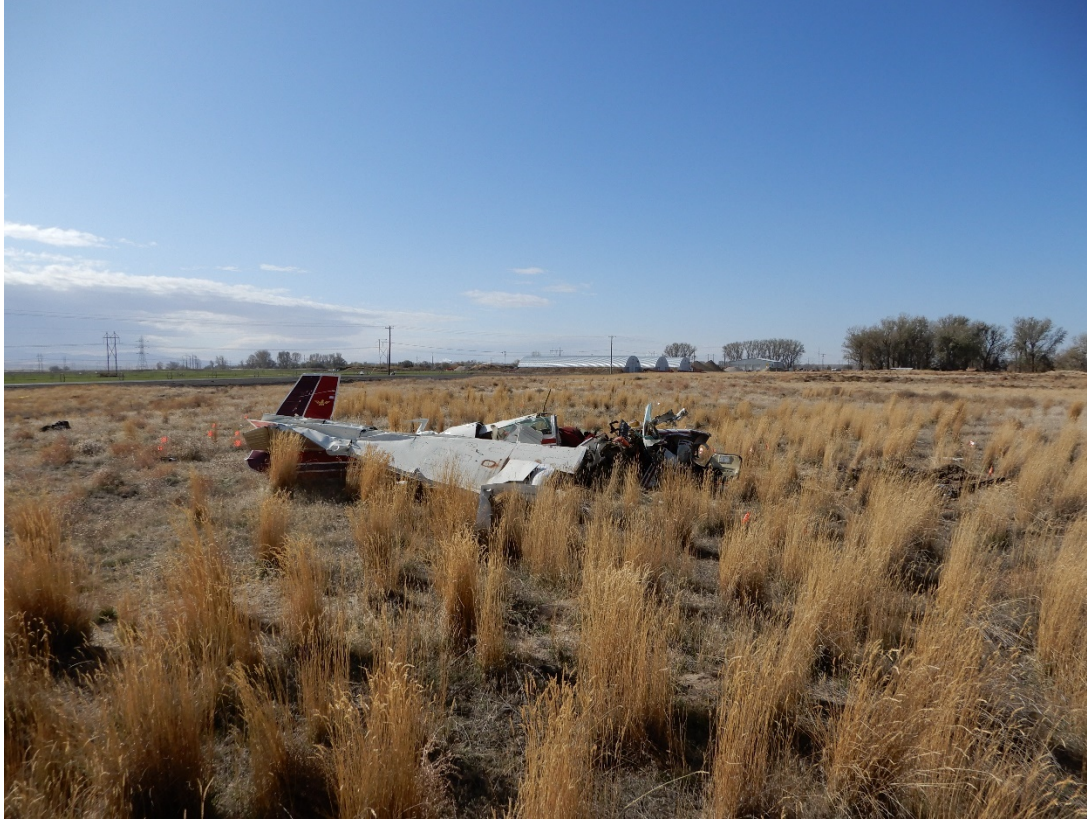
**Right-Side Aft Fuselage.** The aft fuselage was substantially damaged with dents, wrinkles, and tears in the sheet metal. A crease pushing inwards from the right-hand side about mid-span of the aft fuselage. The crease distorted the aft fuselage about 15° to the left.

**Figure 2. Right-side view of N201BJ at the accident site.**

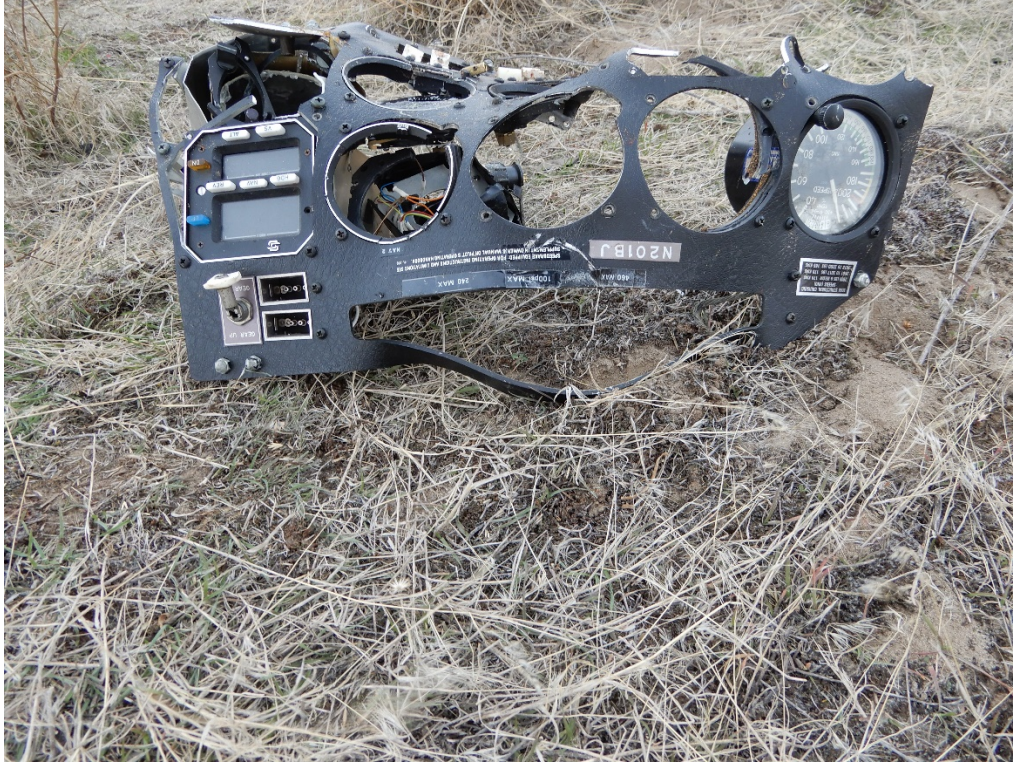
The cabin area was substantially damaged with the instrument panel fractured into several pieces, liberating most of the instruments and radios. The instrument panel was pushed aft toward the pilot's seat exposing the backside and the wiring.

**Figure 3. Instrument panel.**

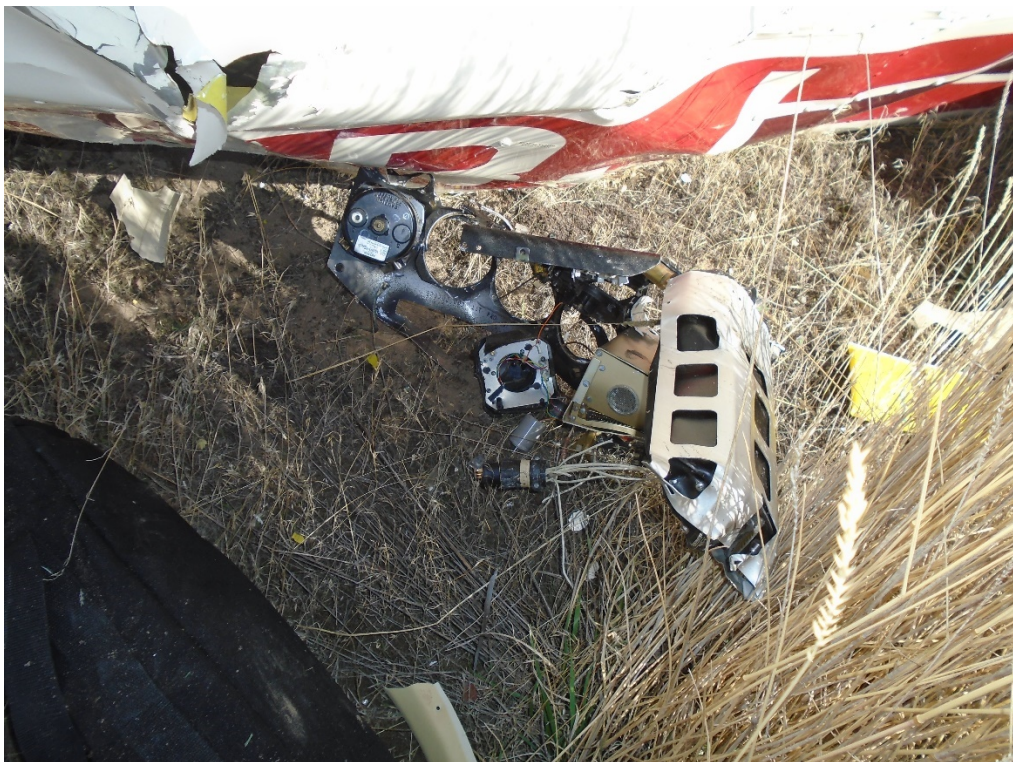
**Figure 4. Instrument panel as found at accident site.**

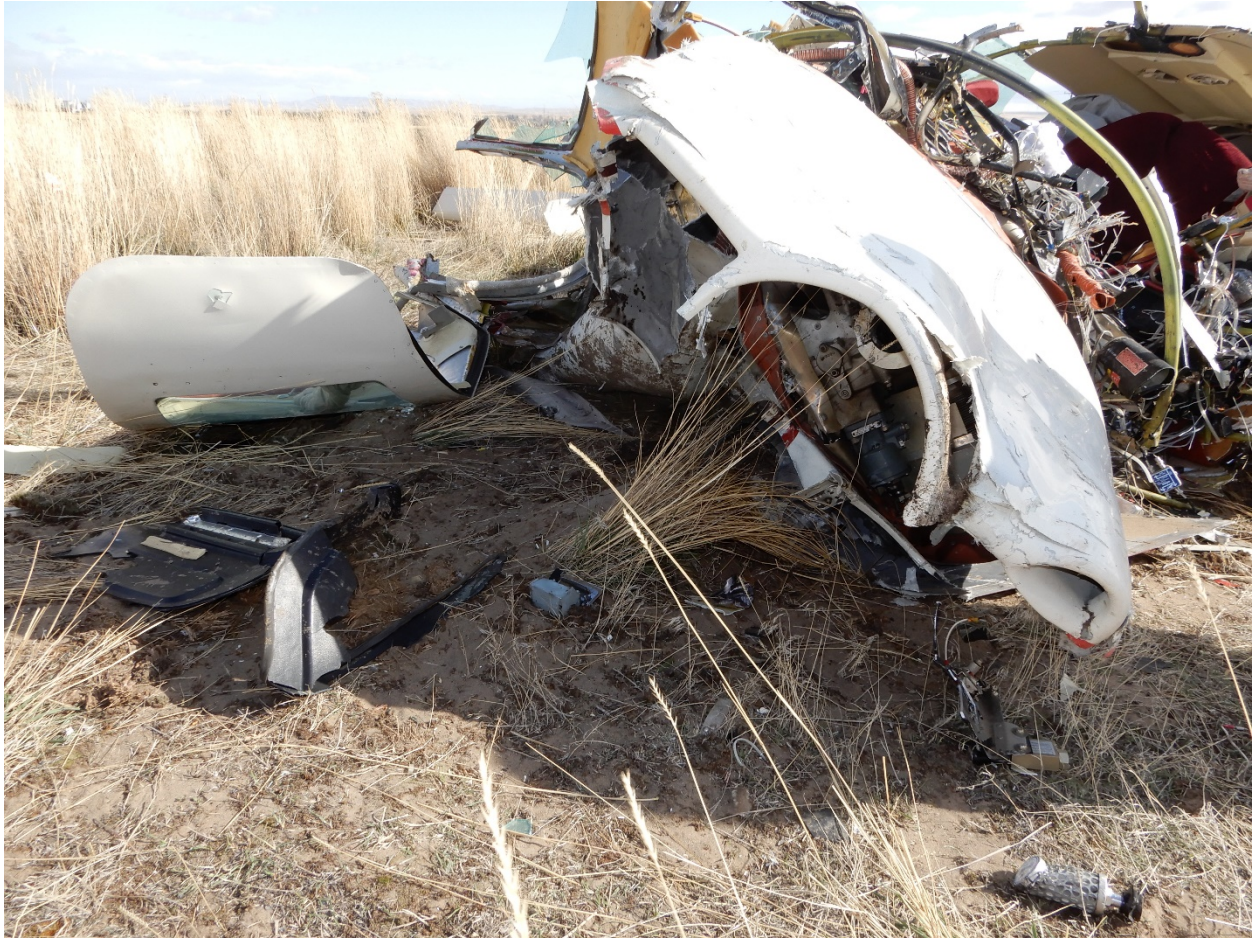
**Engine cowling.** The top of the engine cowling was forward of the engine about 18 inches. The left side of the engine cowling was buried in the soil at the accident site. Post-accident

examination revealed the left-side engine cowling was fractured exposing the engine compartment. Fragments of the cowling were found in the debris field. The area was crush damaged with signatures of pushing aft and upwards. The right side of the engine cowling was substantially damaged with upward and aft crushing. The lower engine cowling was substantially damaged and pushed up and aft. The composite material was cracked and torn.

**Figure 5. Front view, showing the displaced upper engine cowling.**

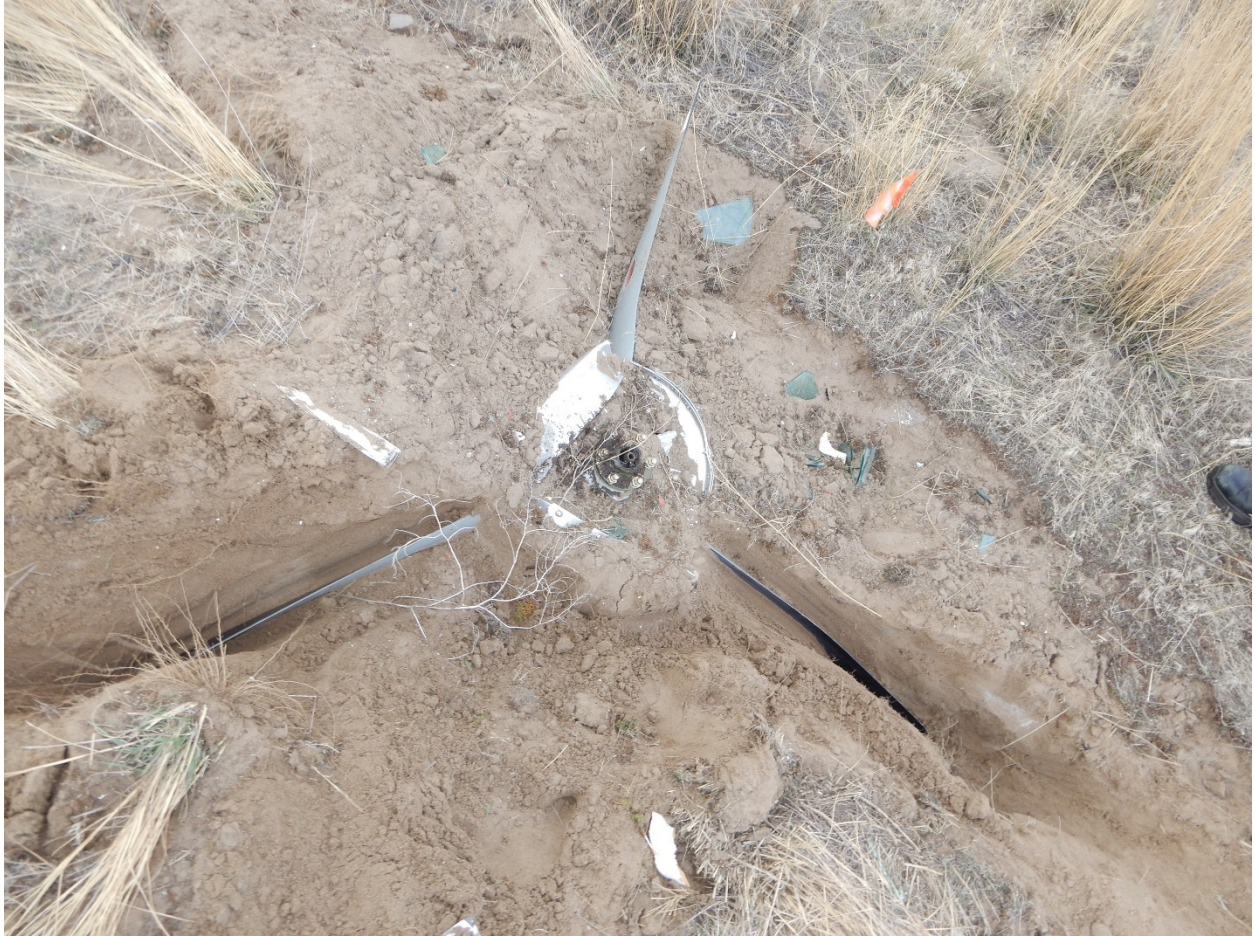
Propeller. The propeller was examined by a specialist from Hartzell Propellers on November 15, 2019. "A propeller teardown examination was conducted to document impact damage signatures. The propeller assembly fractured from the engine crankshaft and the propeller mounting flange remained attached to the propeller hub with all mounting studs and dowel pins intact. All three blades were found in the feathered position at the accident site. The spinner dome was crushed and torn; there were two counterweight impressions made in the spinner dome indicating the blade angle was in the feathered position at impact. The hydraulic unit including the cylinder, piston, pitch change rod and feathering spring was crushed and fractured. The piston and pitch change rod were in the aft, feathered position. Due to safety concerns no attempt was made to remove the feathering spring. The aft hub half was removed to facilitate removal of the blades and preload plates. Two blades exhibited chordwise abrasion/paint removal on the face side in the shank-to-mid blade region along with chordwise abrasion/paint removal from the mid blade-to-tip region. Two blades were bent in the aft direction with no remarkable compound bending/twisting. One blade had no remarkable bending or twisting. All three pitch change knobs were intact with one exhibiting bending opposite low pitch. All three preload plates had no remarkable fork contact impact signatures, and the fork bumpers were undamaged. There were no discrepancies found that would have degraded or prevented normal operation. All damage was consistent with high impact forces."

**Figure 6. Propeller, as found at the accident site.**

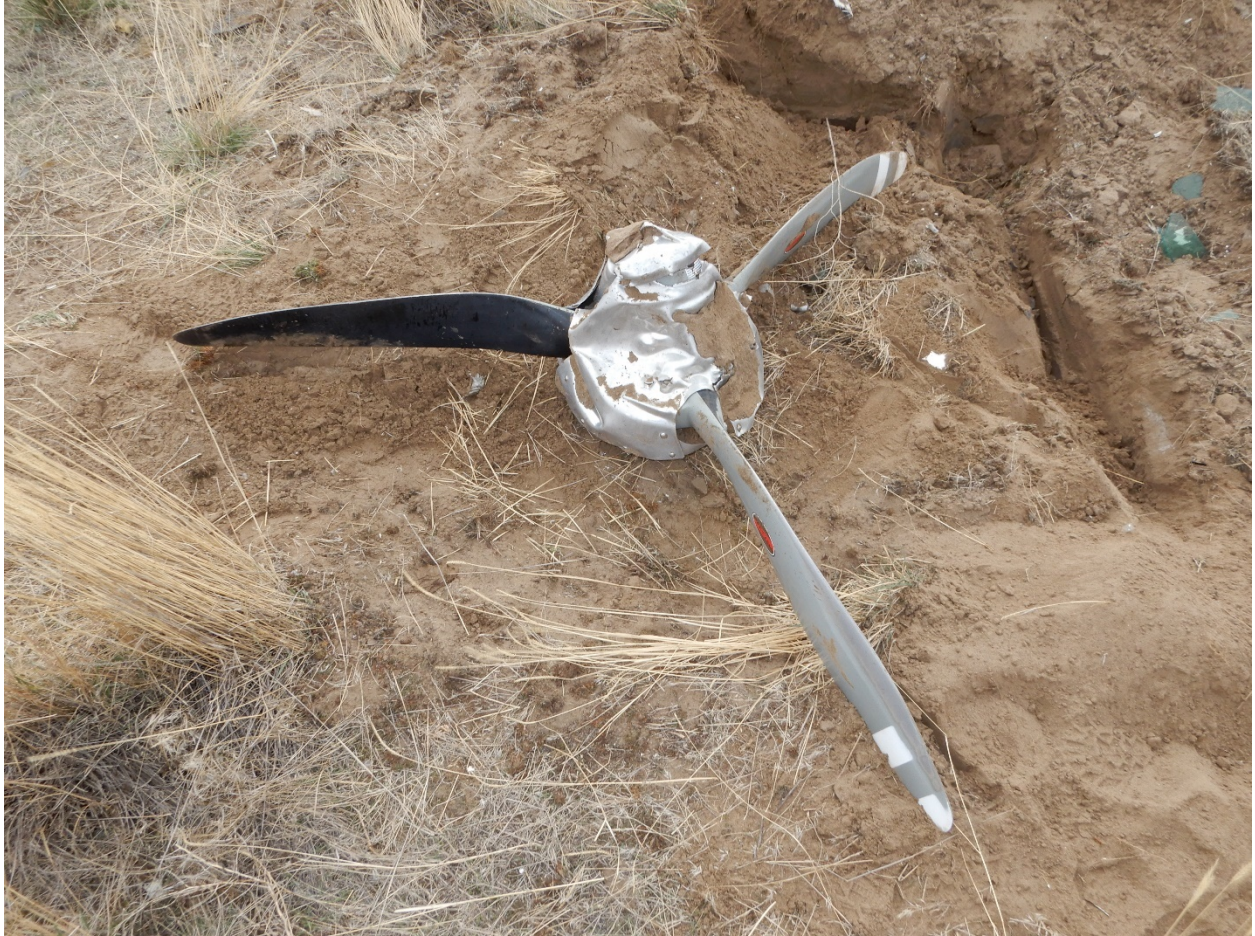
**Figure 7. Propeller after it was removed from the soil.**

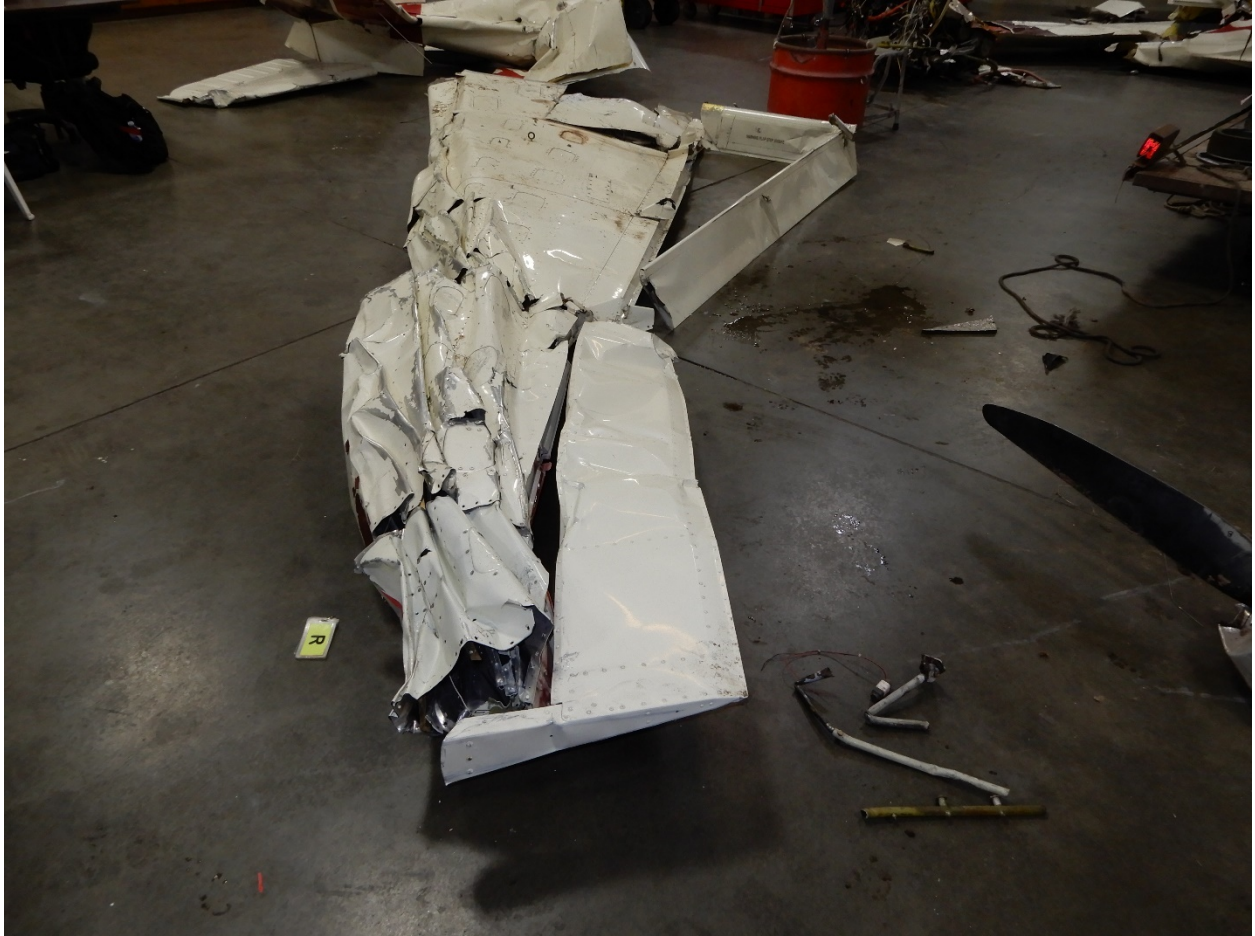
**Right Wing.** The wing was separated from the fuselage and displaced aft to the point the wing tip was found resting on the right horizontal stabilizer. The leading edge was substantially crushed aft, from the tip toward the root. The greatest damage to the leading edge was found at the wing tip. The spar was fractured. The right flap remained attached at the inboard hinge and separated at the middle and outboard hinge. The flap displayed a 90° bend about mid-span. The right aileron remained attached at both hinges but would not move freely. The right-wing tip had separated from the wing and found adjacent to the right-wing gouge in the soil. A line of disturbed soil consistent with the leading edge of the right wing was located adjacent the wing tip. The right main fuel tank and the right auxiliary tank were found to be empty. Both fuel caps were found secured with soft pliable rubber seals intact. The navigation and anti-collision lights were located at the wing tip and shattered.

**Figure 8. The right wing, underside view, showing the aileron and partially attached flap.**

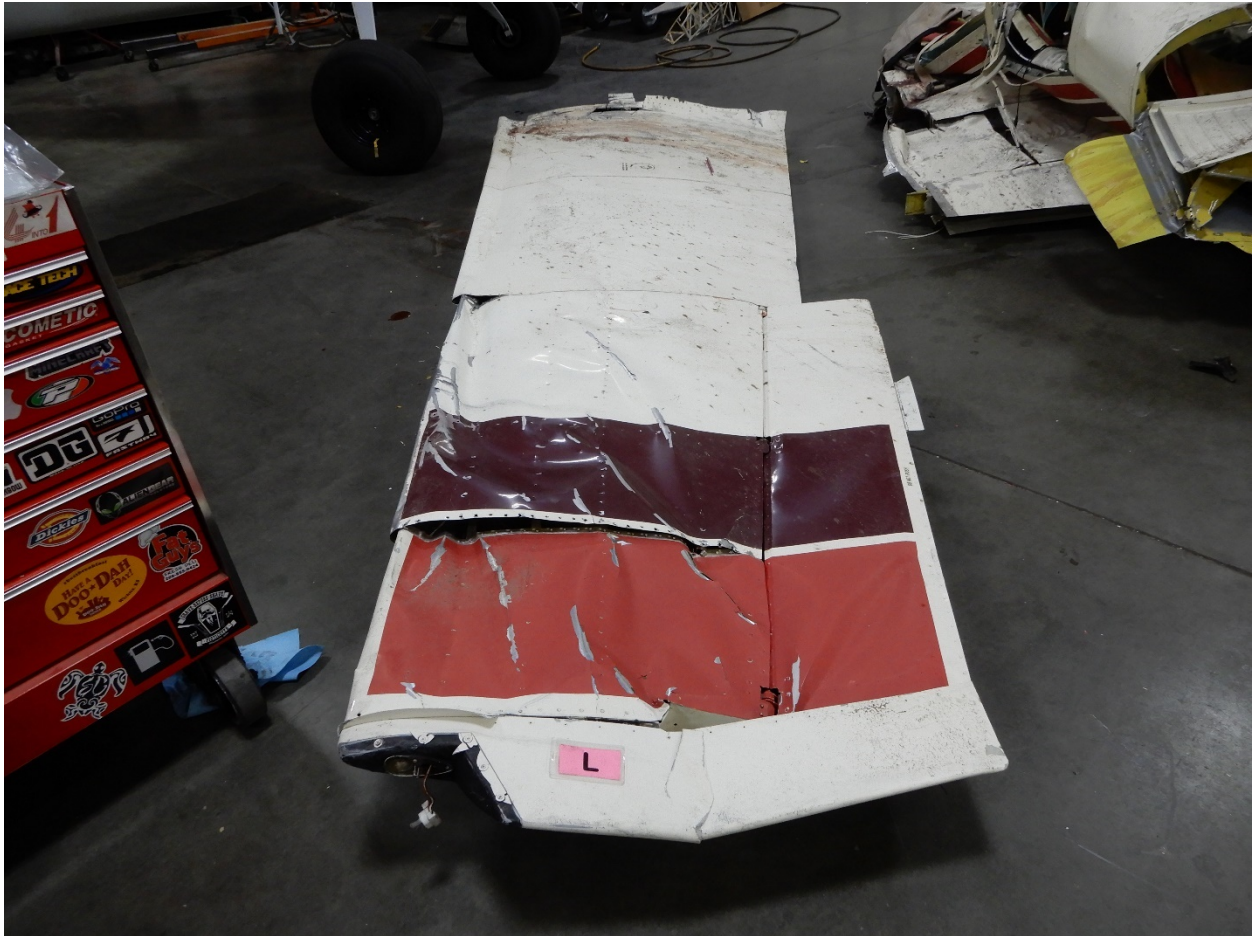
**Left Wing.** The left wing remained attached to the fuselage. The leading edge was damaged throughout its span. The flap remained attached at the outboard hinge and was found underneath the wing. The remaining hinges were fractured. The flap was damaged throughout its span and had a greater than 90° bend. The aileron remained attached at the hinges and was damaged throughout its span. The aileron counterweight was displaced underneath the wing and would not allow the aileron to move. The main fuel tank and the auxiliary fuel tanks were empty. The two fuel caps were found secured with soft pliable rubber seals. The navigation and anti-collision lights were located at the wing tip and shattered

**Figure 9. The left wing, top-side view, showing the aileron, and composite wing tip.**

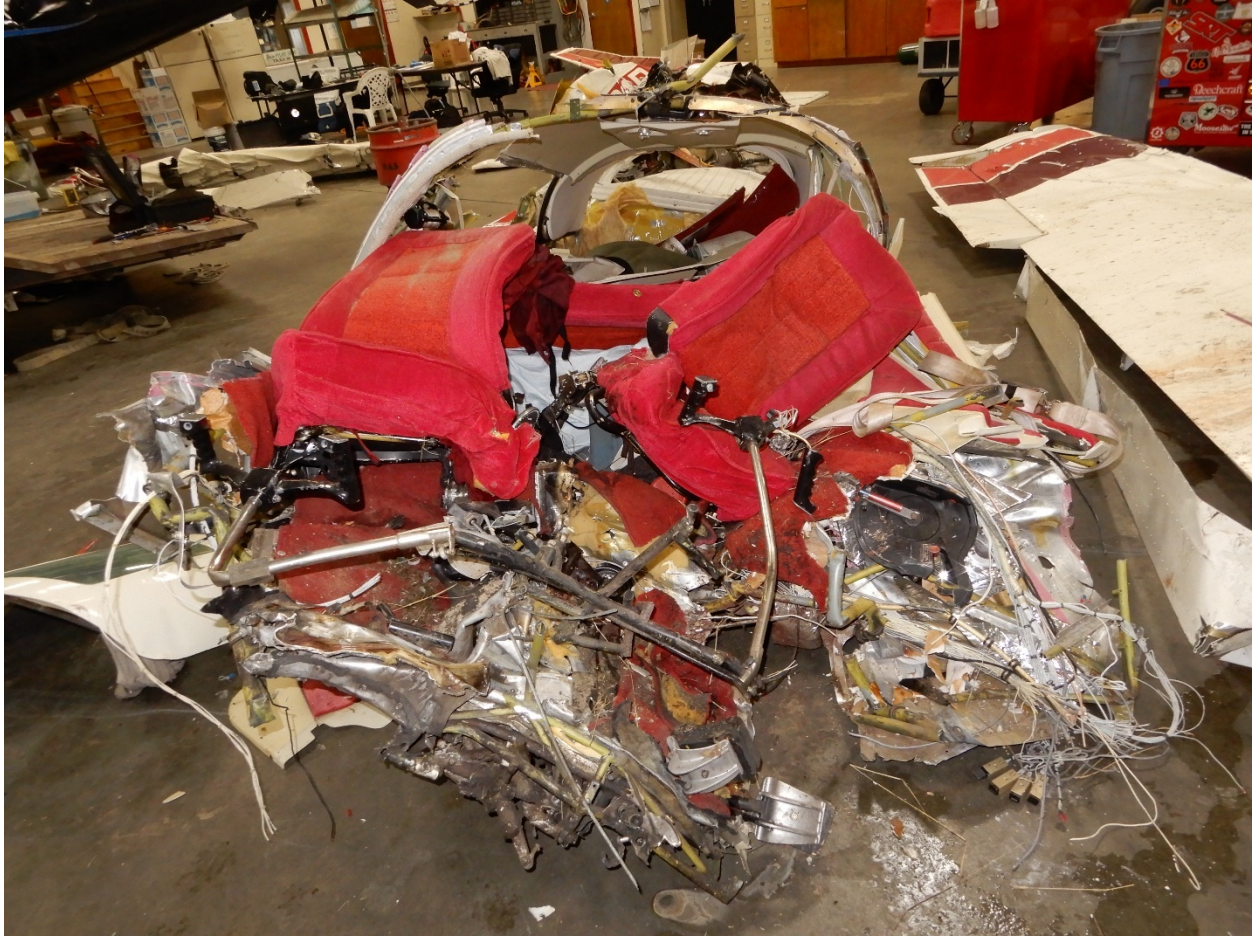
Flight Control Continuity. Flight control continuity was established from all flight controls surfaces (ailerons, elevators, rudder) to the flight controls in the cockpit. The vertical stabilizer trim displayed a three-inch spacing, and 5 threads exposed.

**Figure 10. Front view showing the flight controls and cabin area.**

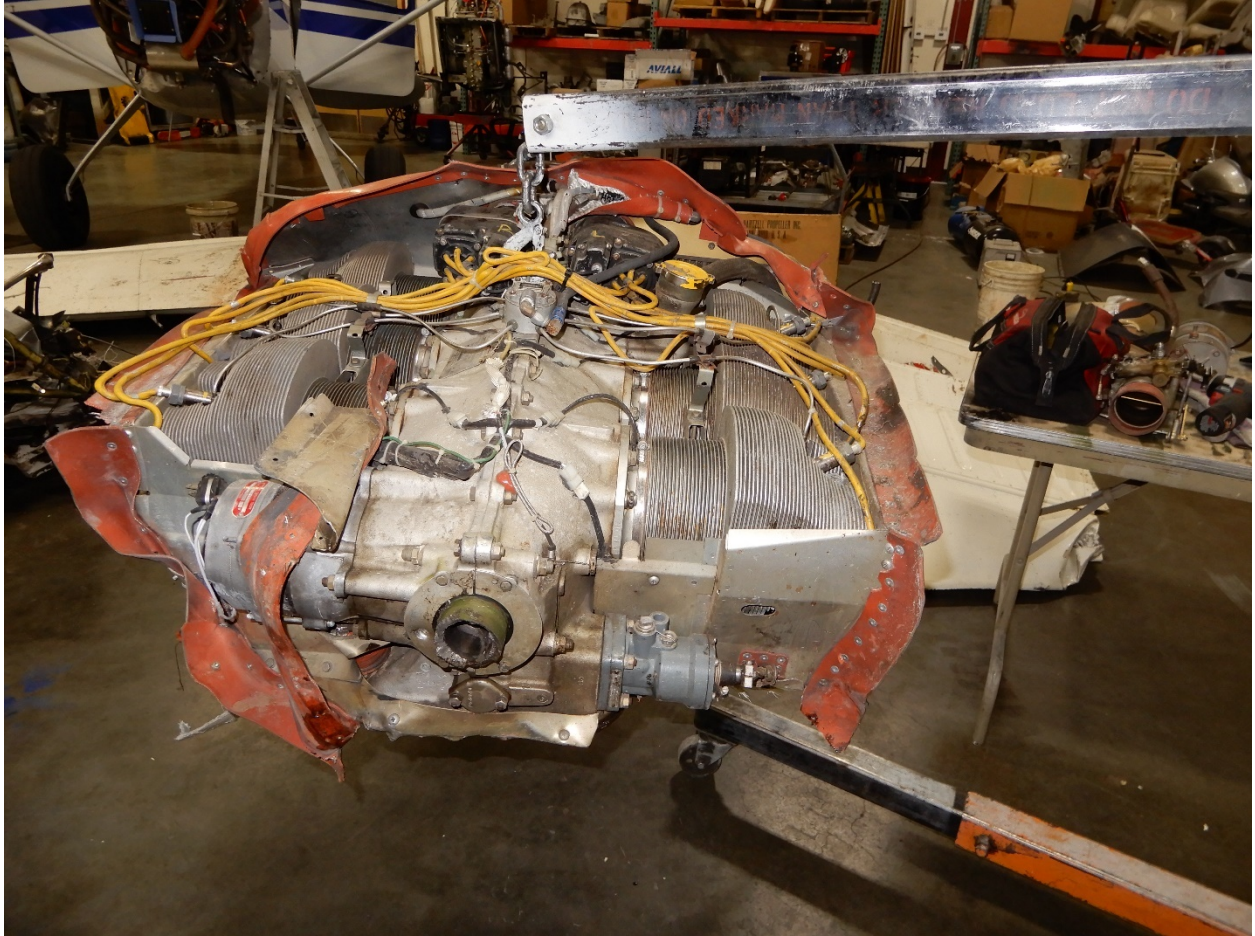
**Figure 11. Front view of the engine. Photo courtesy of Continental Aerospace Technologies.**

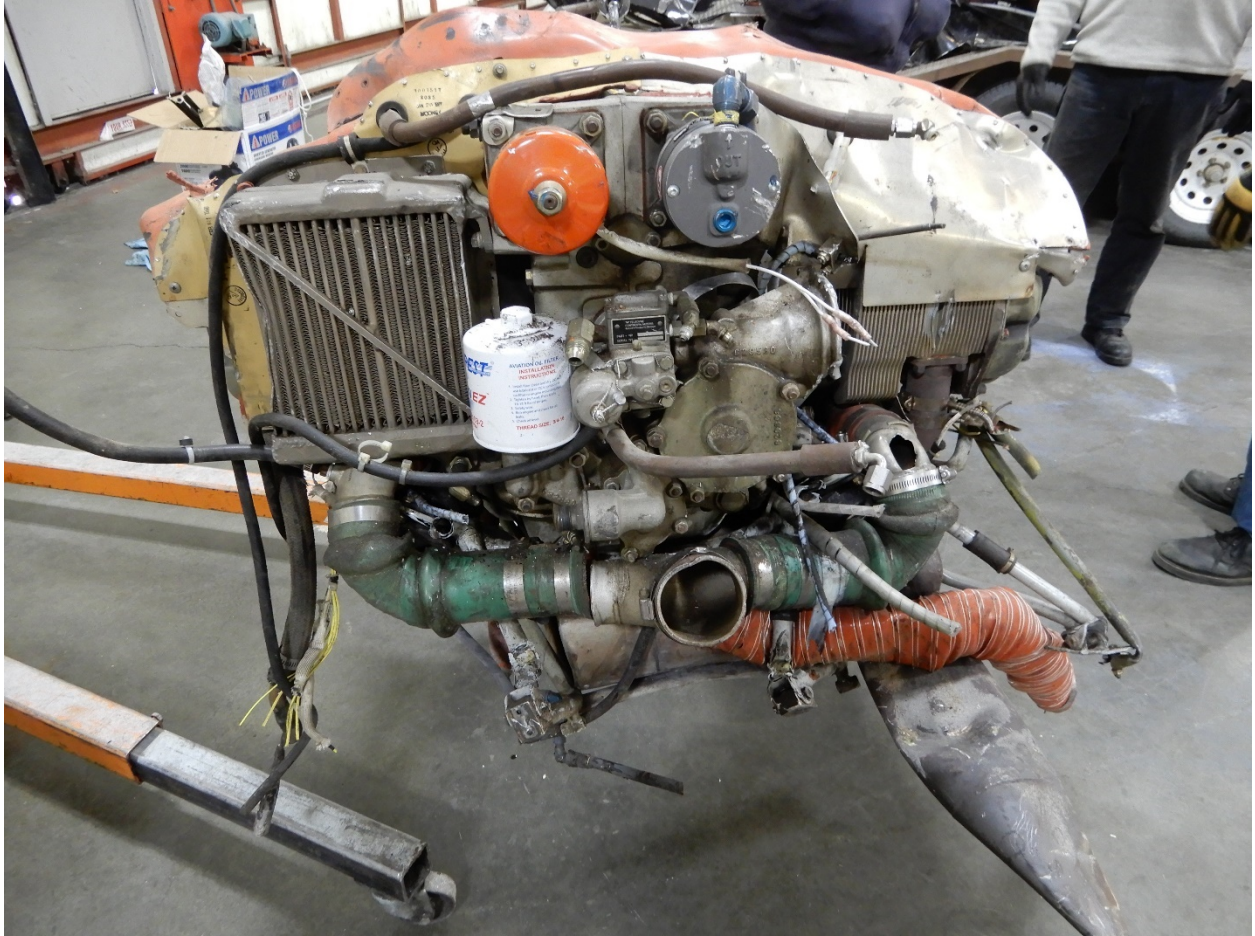
**Figure 12. Rear view of the engine. Photo courtesy of Continental Aerospace Technologies.**

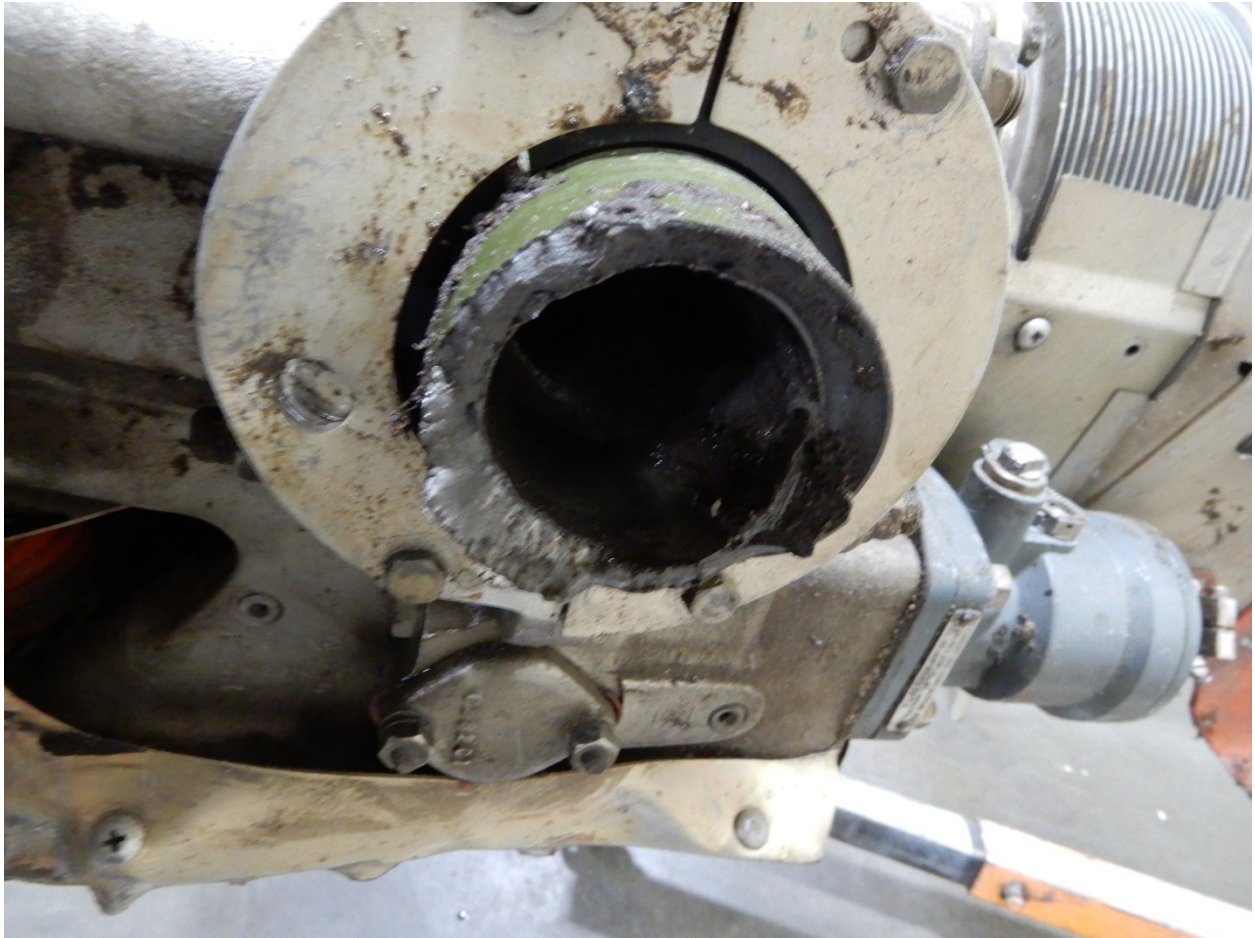
The propeller flange separated from the propeller shaft. The separation was consistent with an overload fracture.

**Figure 13. Propeller shaft. Photo courtesy of Continental Aerospace Technologies.**

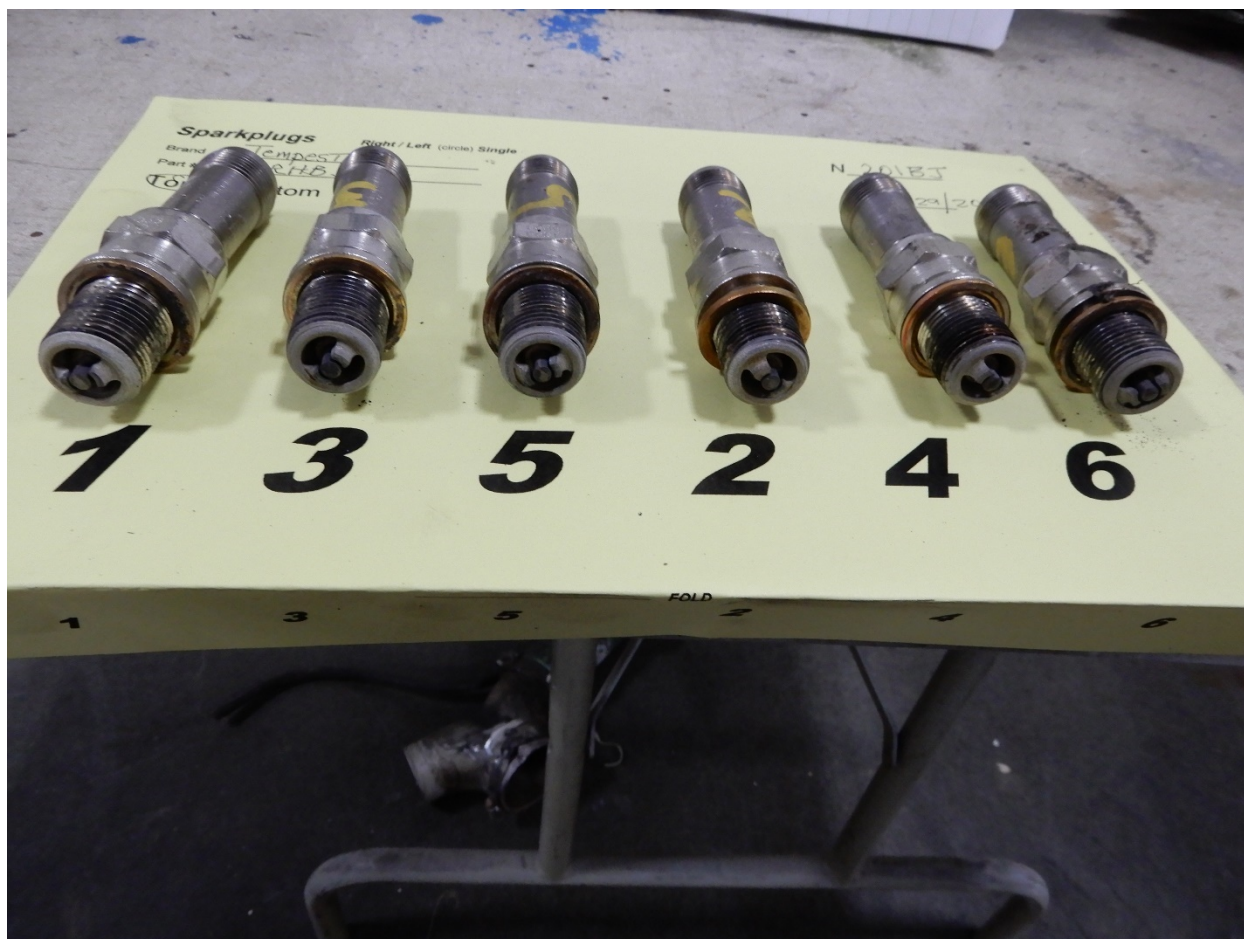
The top spark plugs were removed from the engine. All displayed a dry light gray appearance at the electrodes. When compared with a Champion Sparkplug "Check-A-Plug" chart, all exhibited normal wear.

Figure 14. Top-side spark plugs. Photo courtesy of Continental Aerospace Technologies.

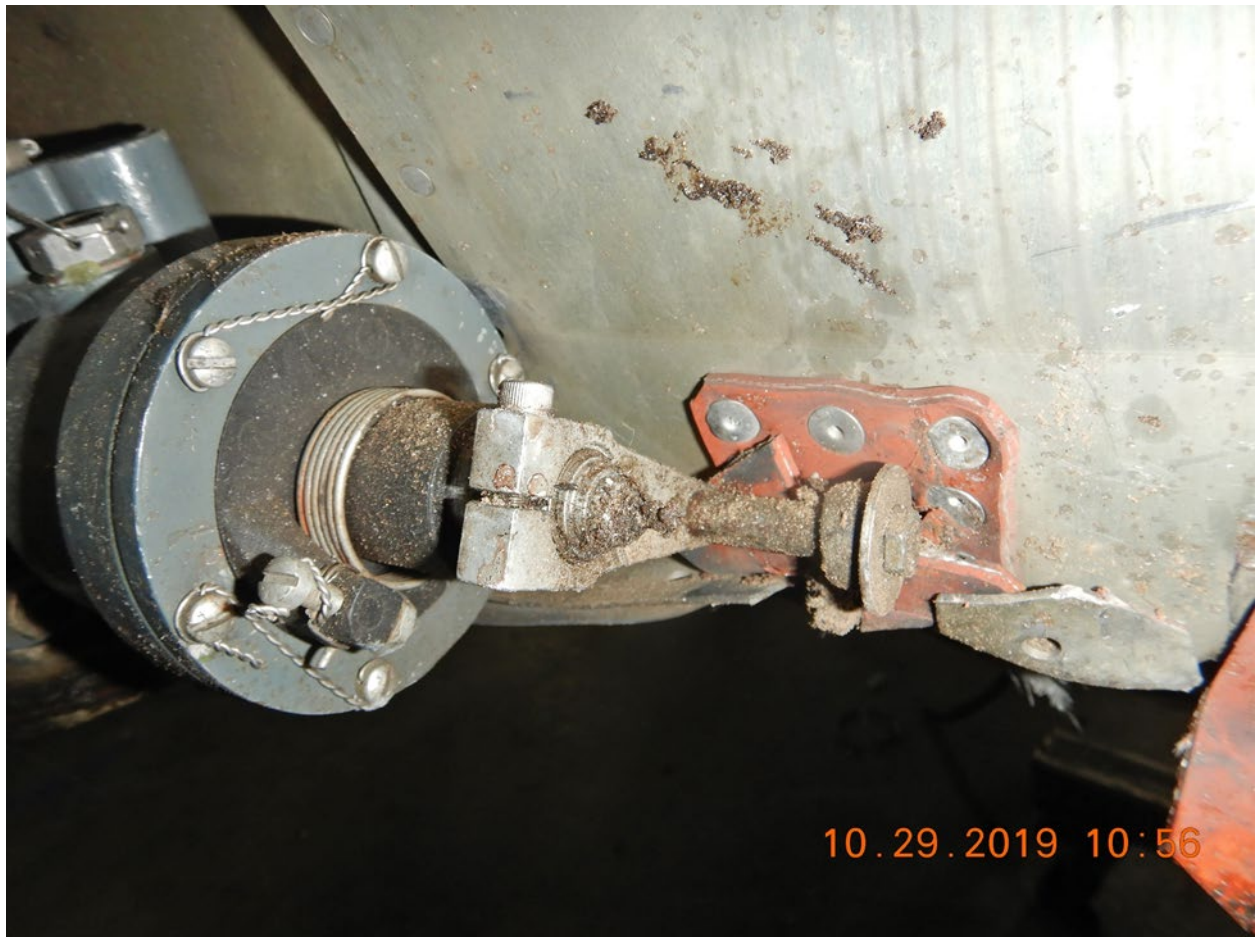
The propeller governor remained attached to the front left side of the engine. The governor was found in the feather position.

**Figure 15. Propeller Governor. Photo courtesy of Continental Aerospace Technologies.**

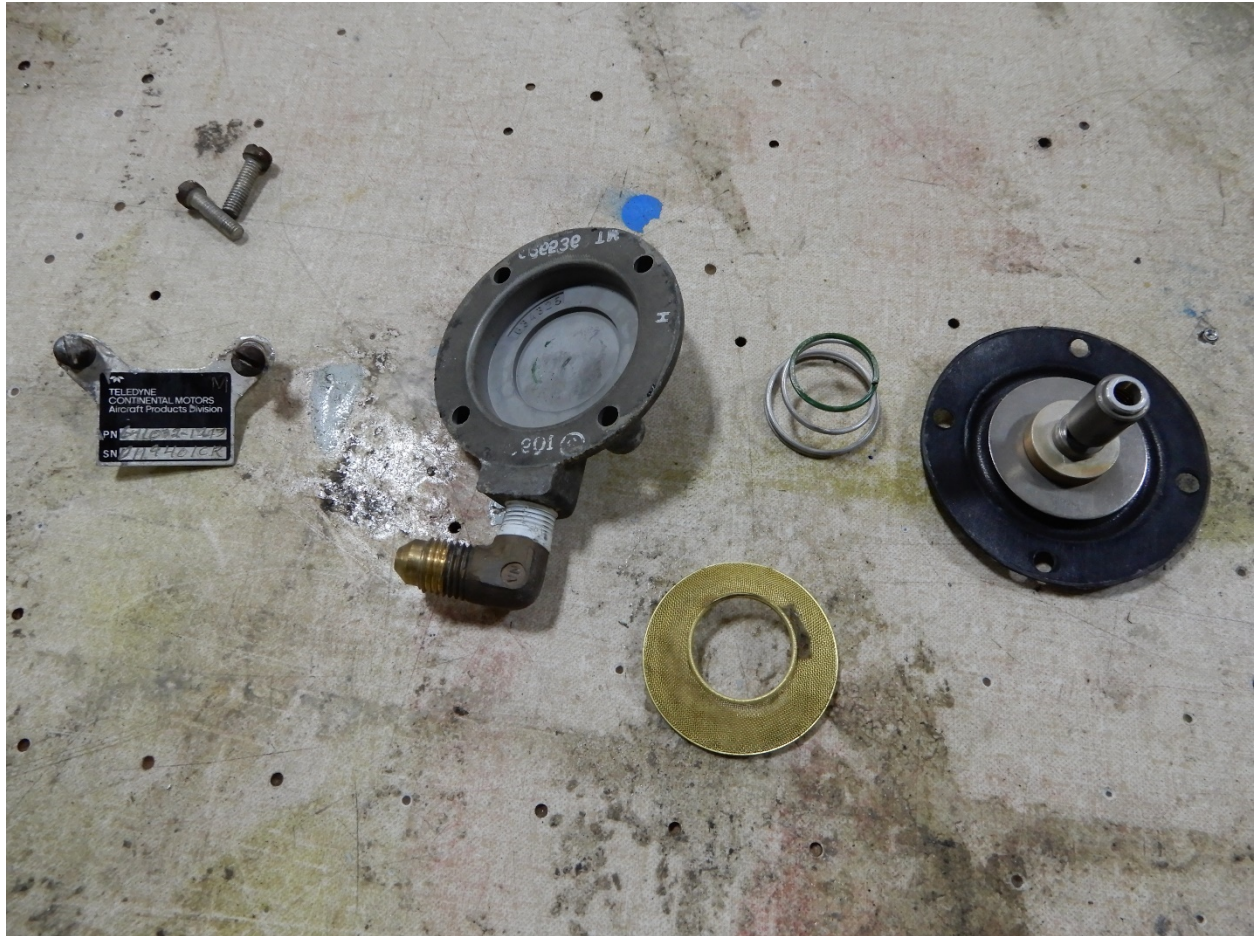
The fuel manifold was examined and found to contain a clear fluid consistent with aviation gasoline. The fuel screen held a small piece of lint.

**Figure 16. Fuel manifold. Photo courtesy of Continental Aerospace Technologies.**

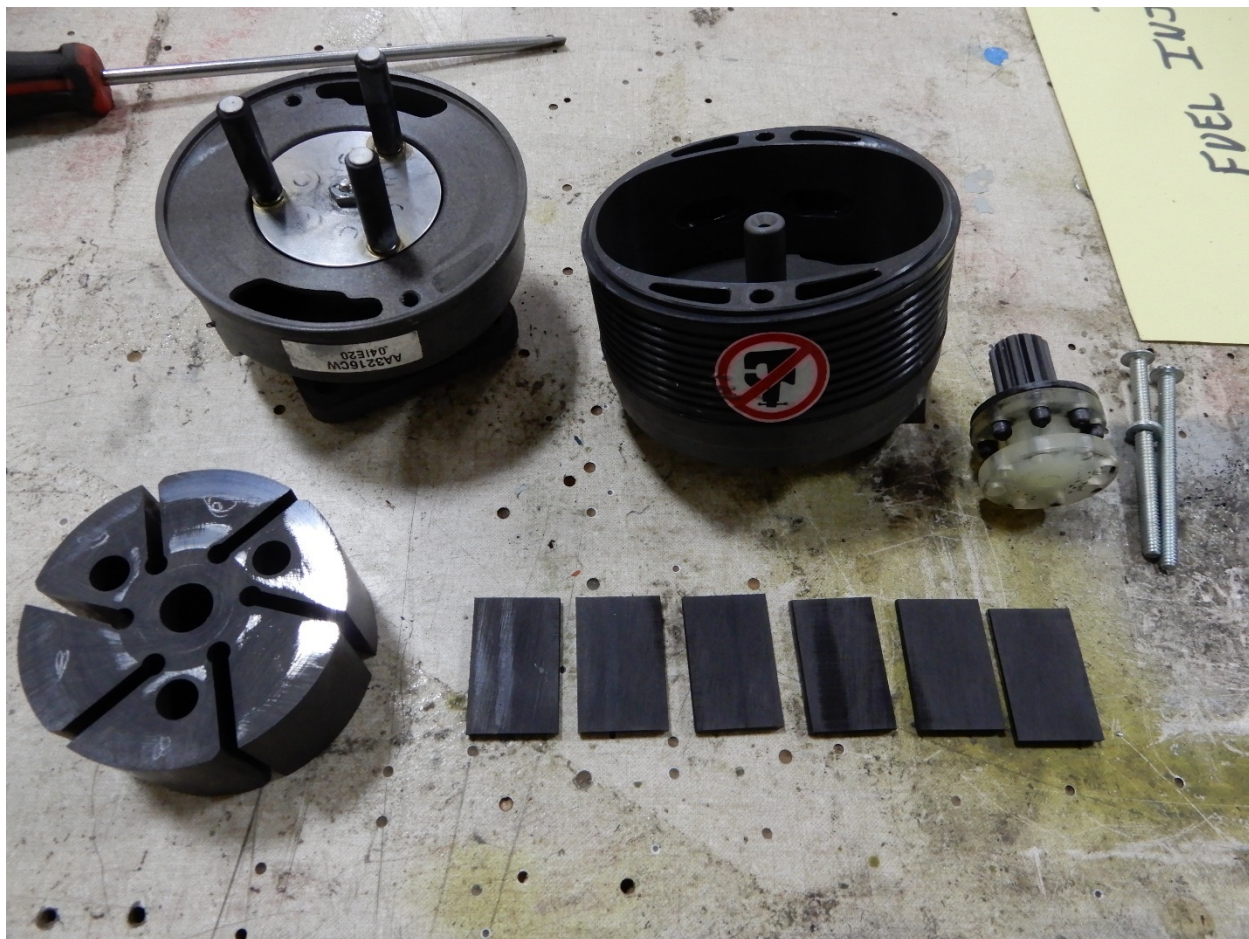
The vacuum pump remained attached to the rear of the engine. Examination revealed the internal components were normal in appearance, with no breaks in the sub-components. The drive gear was intact.

**Figure 17. Vacuum pump. Photo courtesy of Continental Aerospace Technologies.**

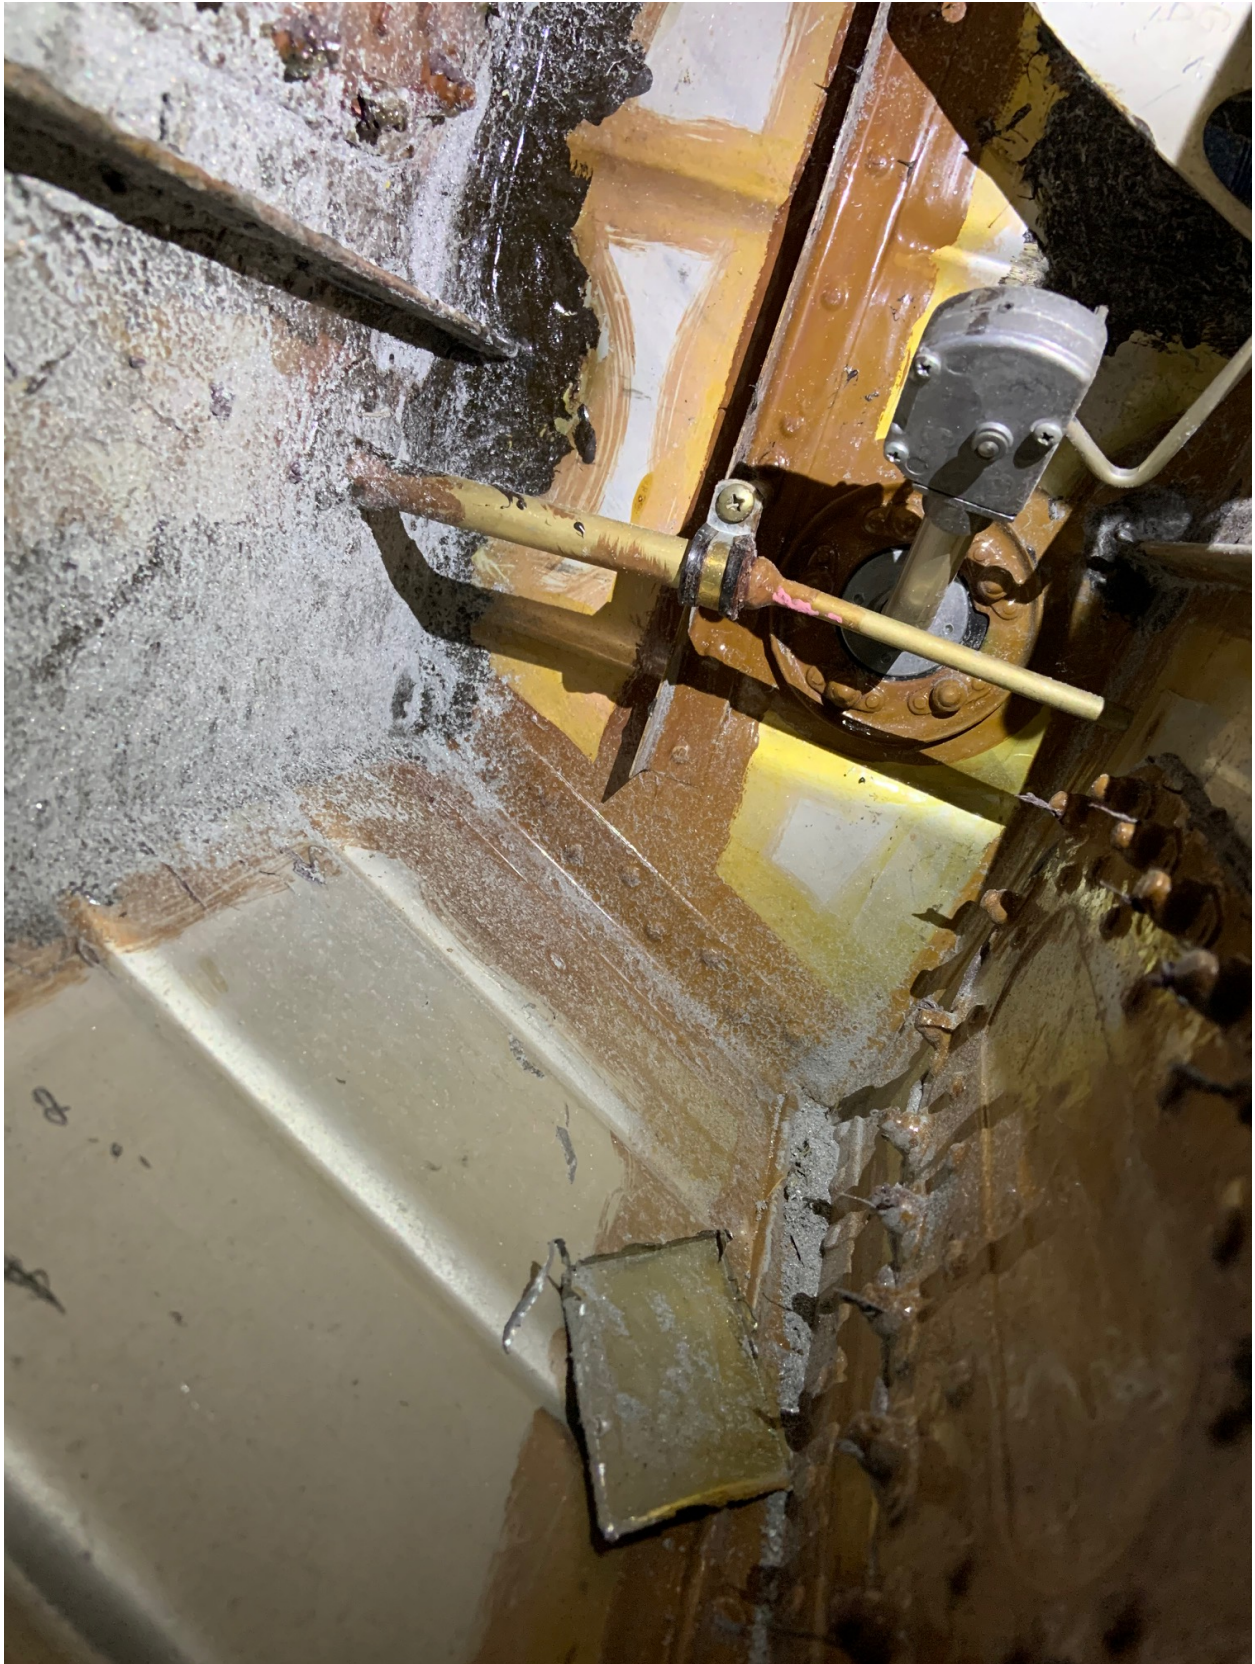
**Figure 18. Inner forward wall of one of the main fuel tanks. Photo courtesy of SP Aircraft Recovery.**
