## **NATIONAL TRANSPORTATION SAFETY BOARD**

# **AIRFRAME AND ENGINE EXAMINATION**

**WPR20FA015**

Location: American Falls, Idaho  
Date: October 25, 2019, 1200 MDT  
Aircraft: Mooney M-20J, Missile 300 / N  
NTSB IIC: Fabian Salazar

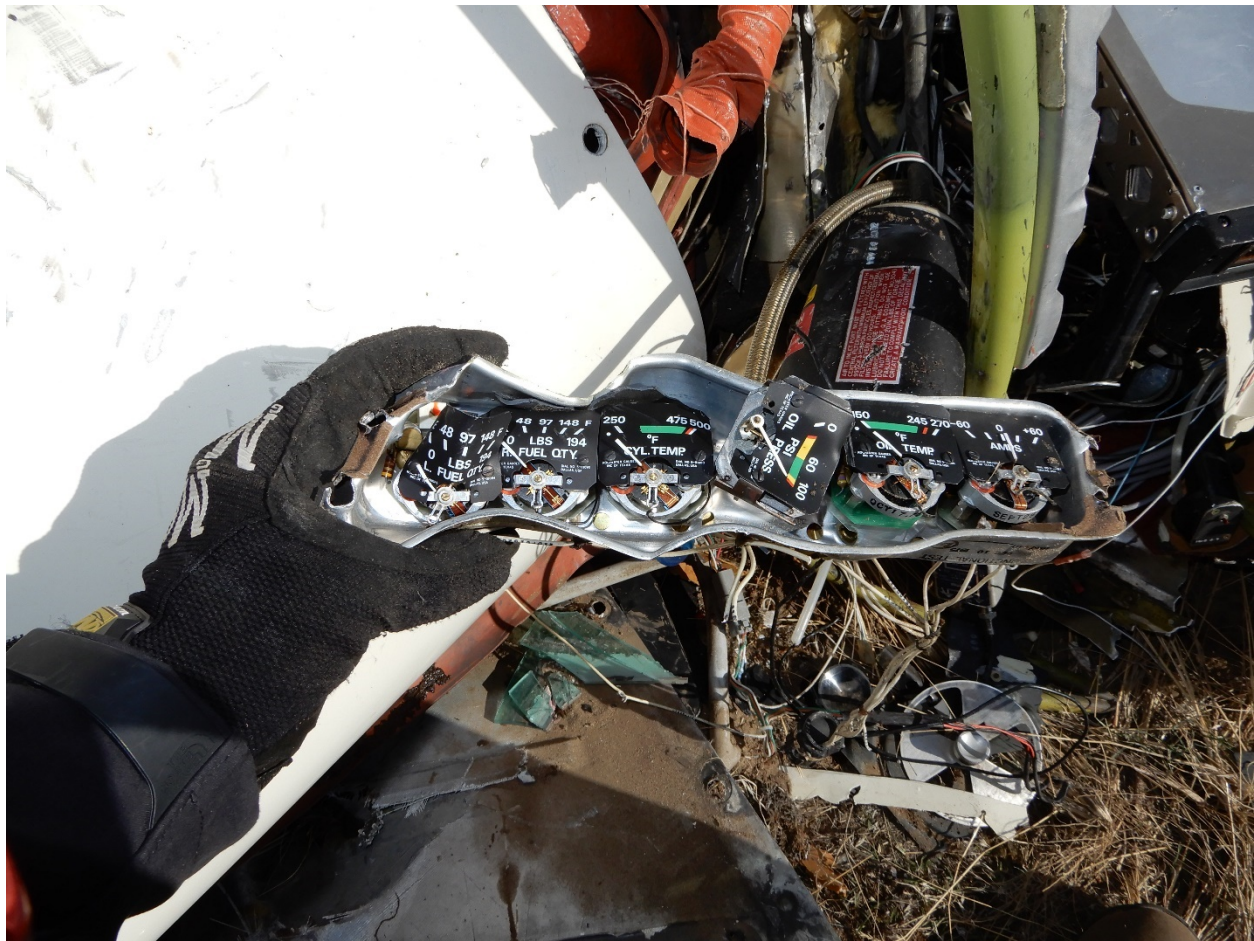
Ignition switch: The ignition key was found in the ignition switch and in the BOTH position.  
Left fuel tank: 0 gallons  
Right fuel tank: 0 gallons  
Cylinder Temp: 0°F  
Oil Pressure: 100 PSI  
Oil Temperature: <150°F  
Amps: 0 amps

**Figure 19. Fuel gauges and engine gauges.**

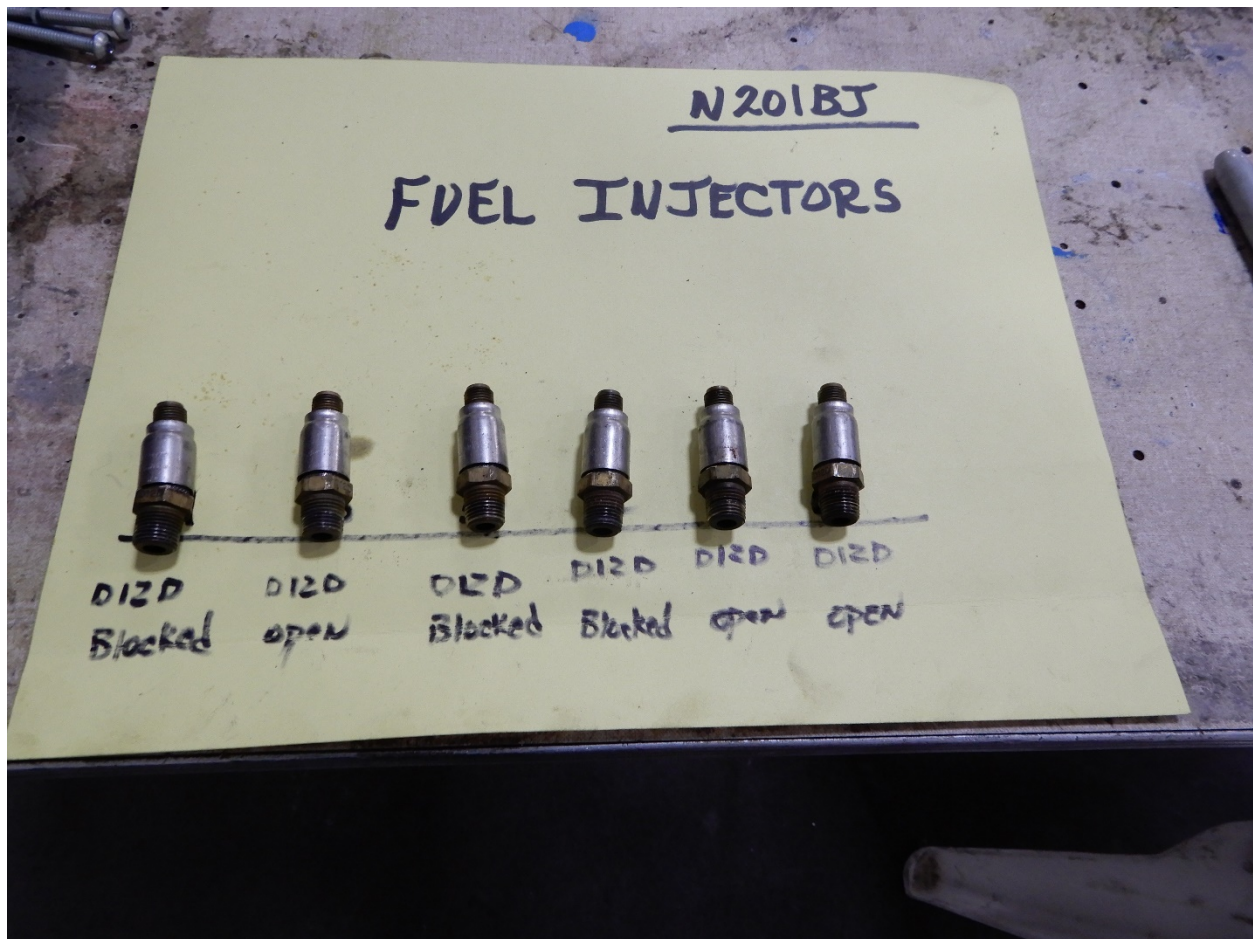
The fuel injectors were removed and examined. The Three of the injectors displayed a blockage.

Figure 20. Fuel injectors. Photo courtesy of Continental Aerospace Technologies.

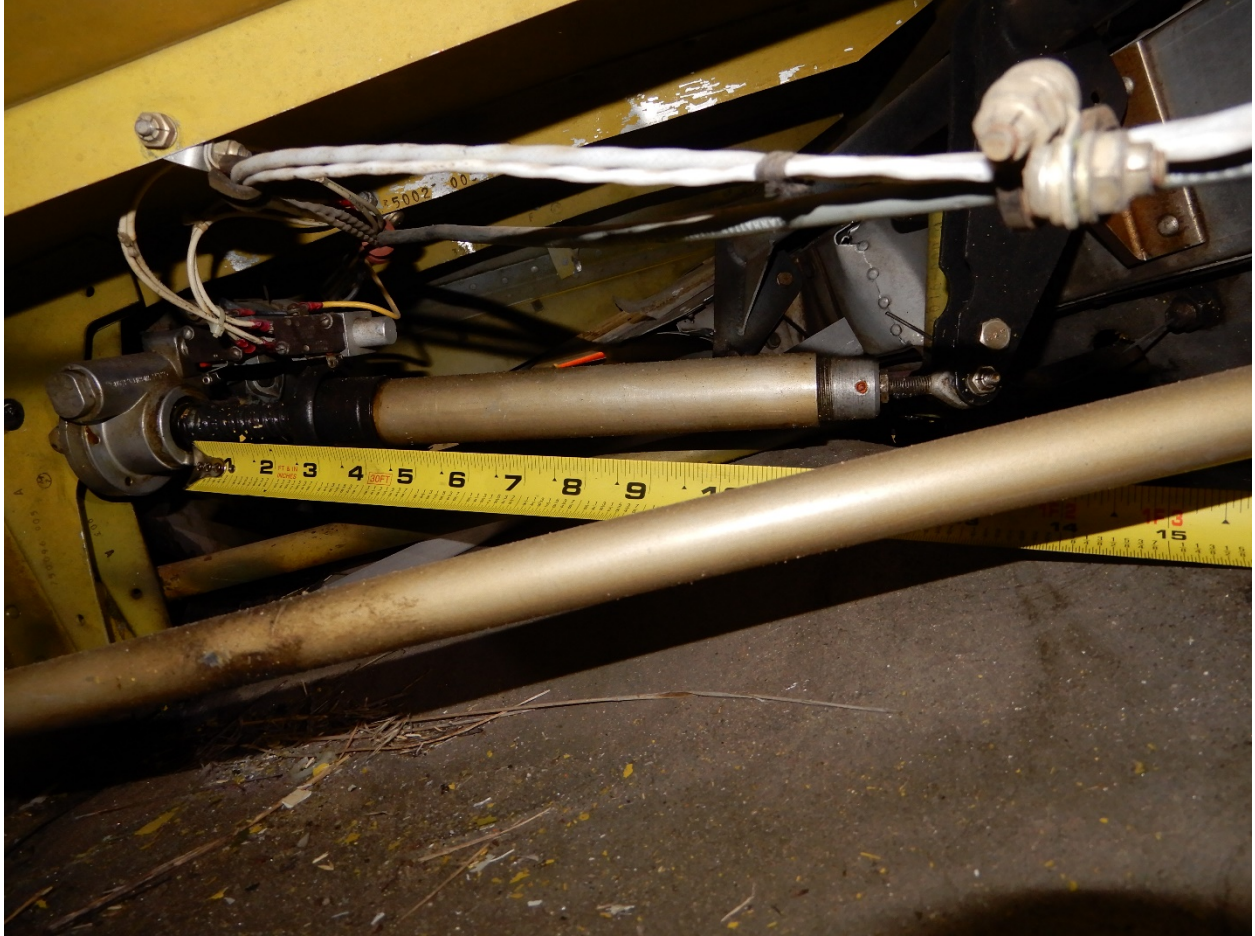
The flap actuator remained attached to the inner fuselage and displayed about 2.5 inches extension of the threads.

**Figure 21. Flap actuator.**
