## **NATIONAL TRANSPORTATION SAFETY BOARD**

# **AIRFRAME AND ENGINE EXAMINATION**

**WPR20FA016**

Location: Jordan Valley, Oregon  
Date: October 25, 2019  
Aircraft: Enstrom 280F, Registration N280F, Serial Number 1501  
NTSB IIC: Elliott Simpson

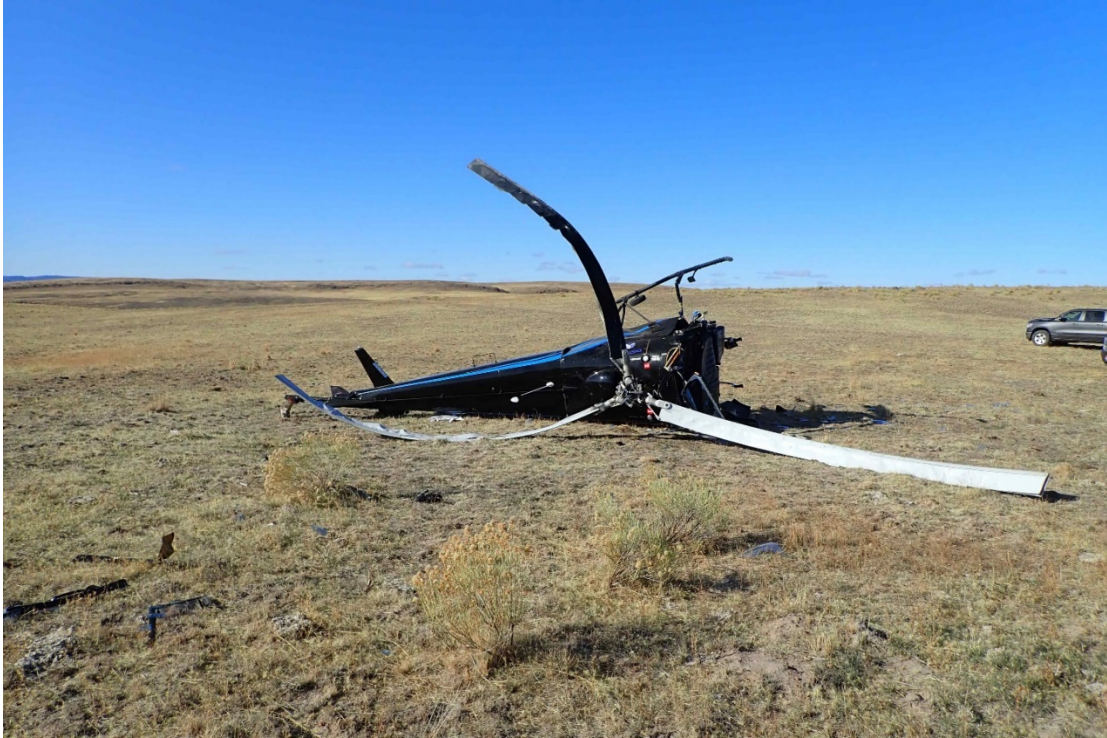
Photo 1 – Helicopter at the Accident Site

The helicopter was located on its right side at the accident site (photo 1). The cabin area sustained crush damage, resulting in fragmentation of the entire canopy and the composite canopy structure, completely exposing the cabin contents. The lower cabin support structure including the flight controls, instrument panel, and seat bottoms had folded about 90° downwards (photo 2).

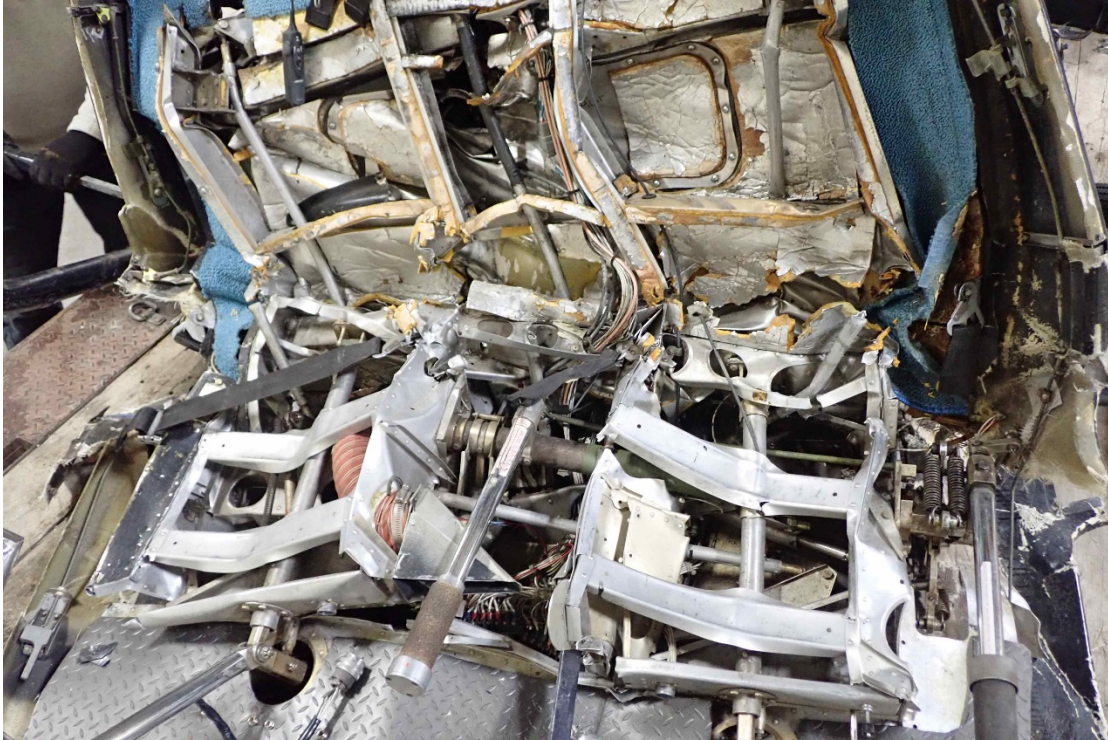
Photo 3 – Seat Assemblies with Cushions Removed

The lower seat assemblies exhibited crush damage downwards and to the right, while the seat backs had crushed aft and to the right (photo 3). The left seatbelts and shoulder straps had been cut by first response personnel to facilitate removal of the pilot. The right seatbelts had been unbuckled by the passenger during egress.

All three main rotor blades had been cut off during recovery. According to maintenance records, the helicopter was equipped with Air Wolf T-T straps, and this was corroborated by inspection. All three walking beams remained attached to their respective push-pull tubes at the top of the mast. The tubes were continuous through the main rotor mast down to the lower swashplate assembly. The swashplate assembly was intact and undamaged, and remained attached to the collective walking beam and the lateral cyclic interconnect tubes (photo 11). The collective walking beam had separated just forward of its hinge point, and control tube continuity was established through the cabin wall bellcrank, and down to the cabin wall and floor intersection, where it had separated at the area where the cabin floor had folded down. Cyclic left and right lateral control tube continuity had been established, with separation observed for the left and right tubes in the same cabin wall bend location. Forward of the cabin floor join, the cyclic and collective controls were continuous to their respective cabin flight controls, although they had been impinged against the crushed seat supports (photo 3).

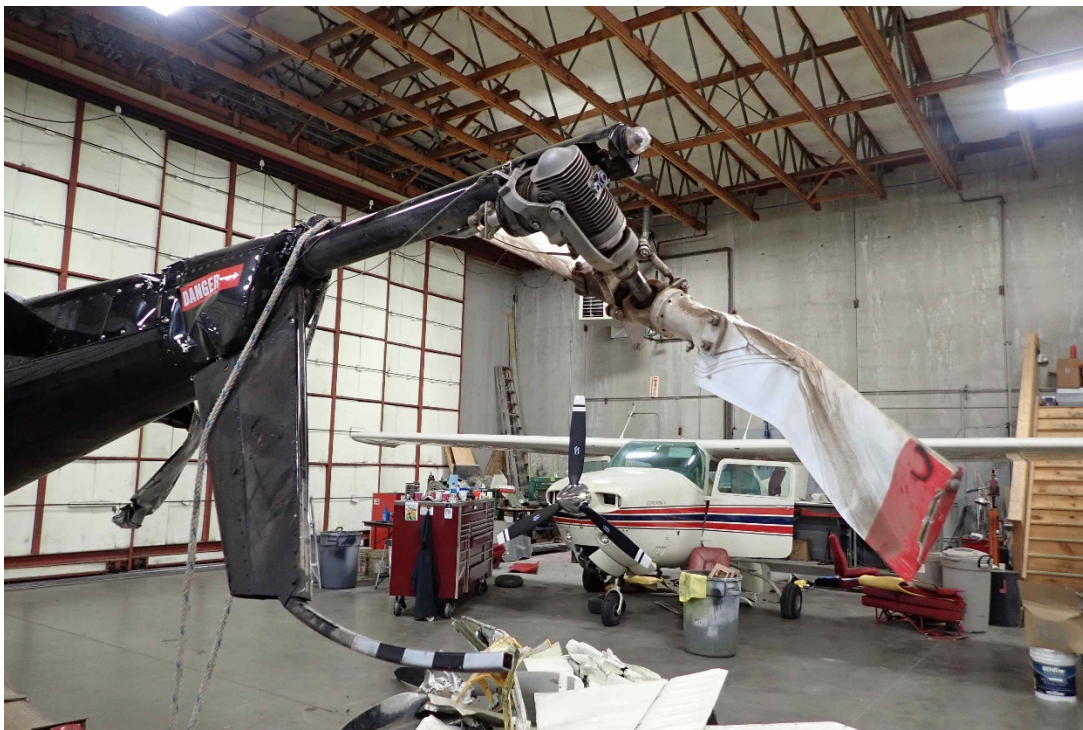
Photo 4 – Tail Rotor Assembly

The tailboom was intact and remained attached to the airframe. The right horizontal stabilizer had bent down about 90° midspan. The tailrotor gearbox remained attached to the gearbox boom, but the entire assembly had rotated about 180° along the longitudinal axis (photo 4). Closer examination revealed that the boom mounting bolts within the tailcone had sheared, and there was a crack in the lower right-hand side of the gearbox clamp housing. The tail stinger was undamaged and did not display any evidence of ground contact.

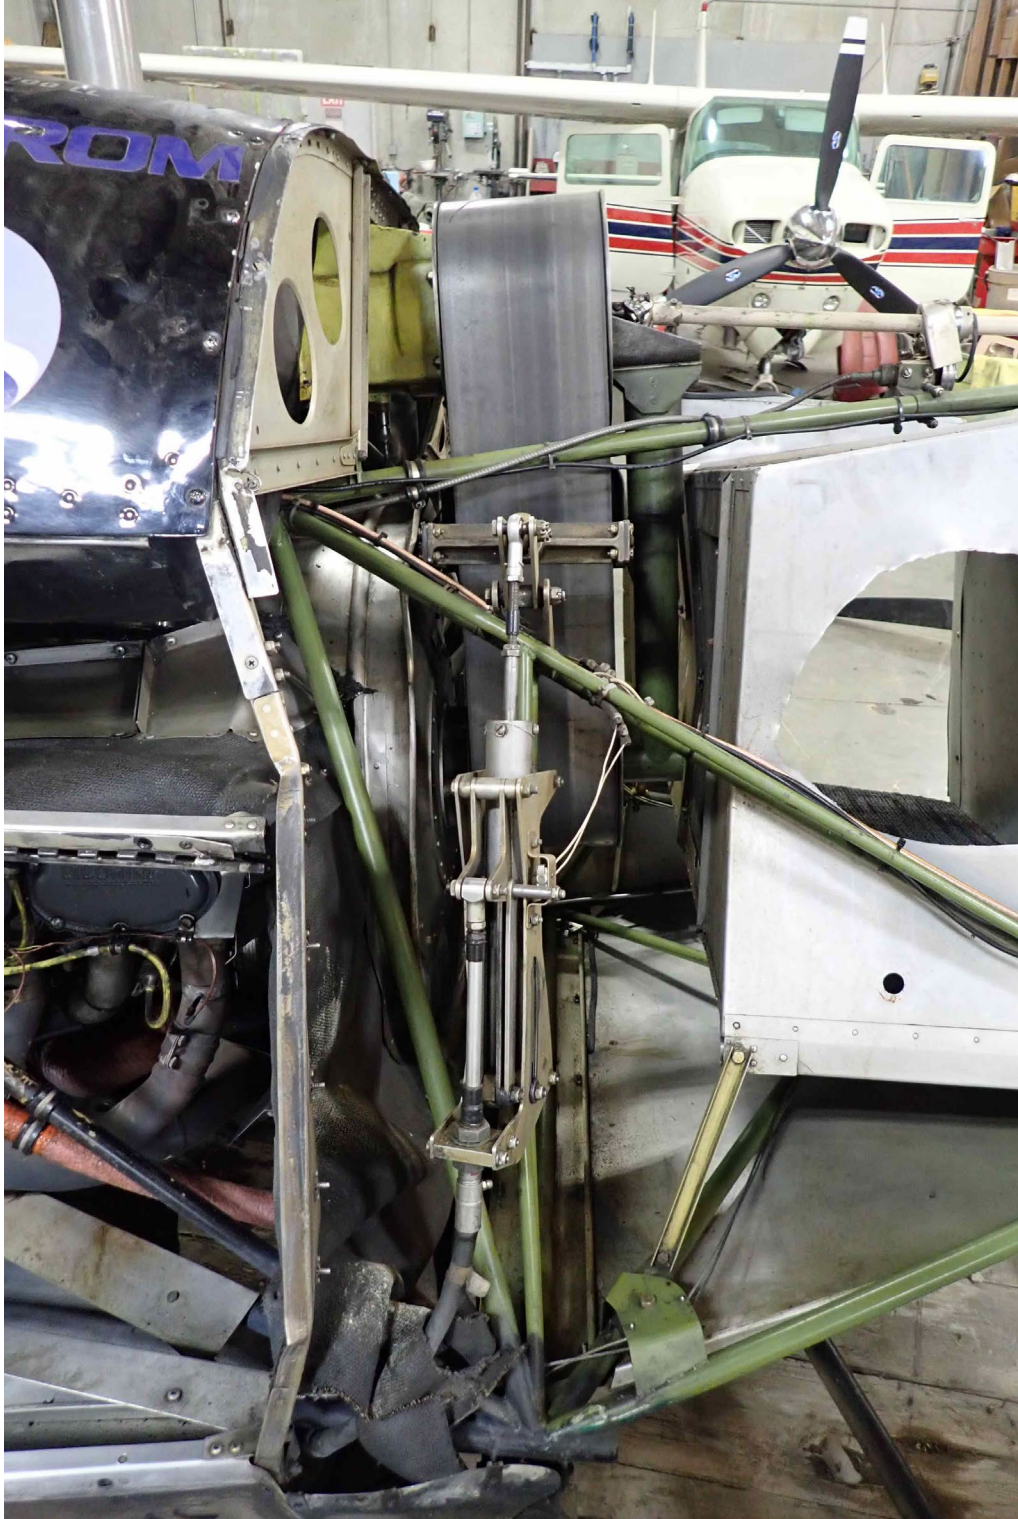
Photo 5 – Clutch and Drive Belt

The main transmission clutch was found in the fully engaged position (photo 5), with the clutch light microswitch activated (photo 6). The main transmission drive belt was slightly slack, however bending damage was observed to tubular frame members above engine, indicating downward movement of main transmission. The clutch microswitch was subsequently tested for operation utilizing a multimeter, and the switch functioned appropriately.

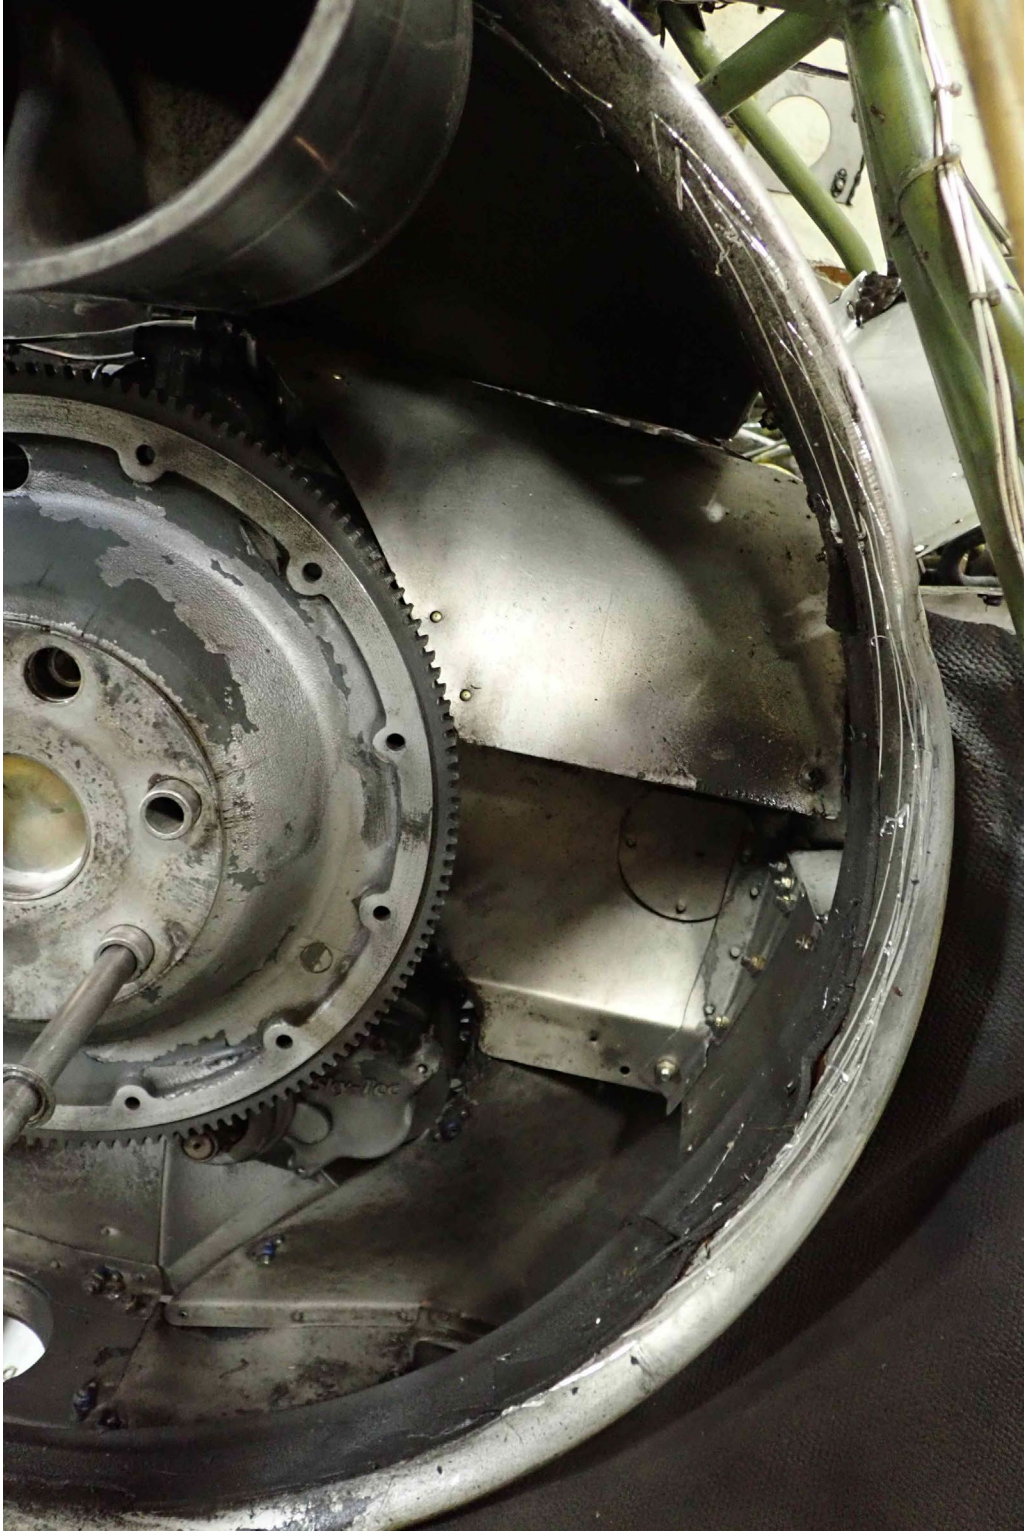
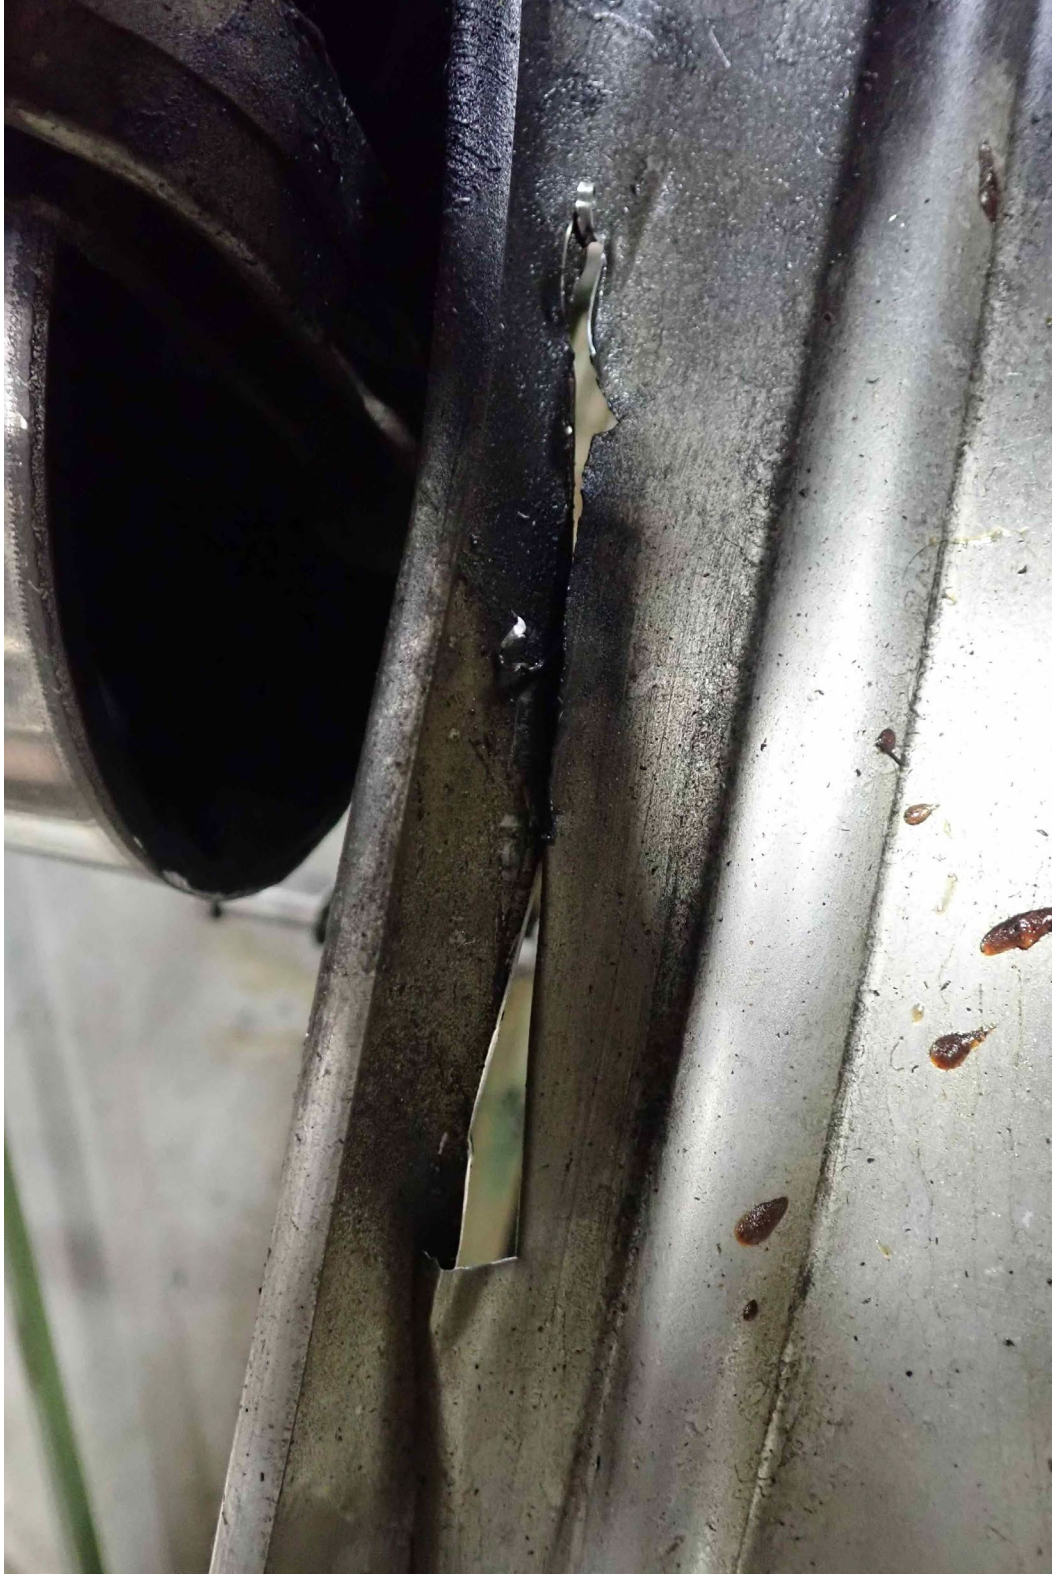
The main transmission gearbox appeared undamaged, and rotation of the main rotor mast by hand, resulted in movement of the gearbox input shaft and the tailrotor blades. The movement felt smooth and unrestricted. The freewheeling clutch allowed for driveshaft lock in the driven direction, and rotation in the freewheeling direction. Five of the engine cooling fan blades had bent about 90° opposite the direction of rotation (photo 7), and rotational scoring and gouging was observed on the right side of the fan shroud adjacent to the blade tips (photo 8, 9).

Photo 8 – Cooling Fan Shroud

Photo 9 – Cooling Fan Shroud

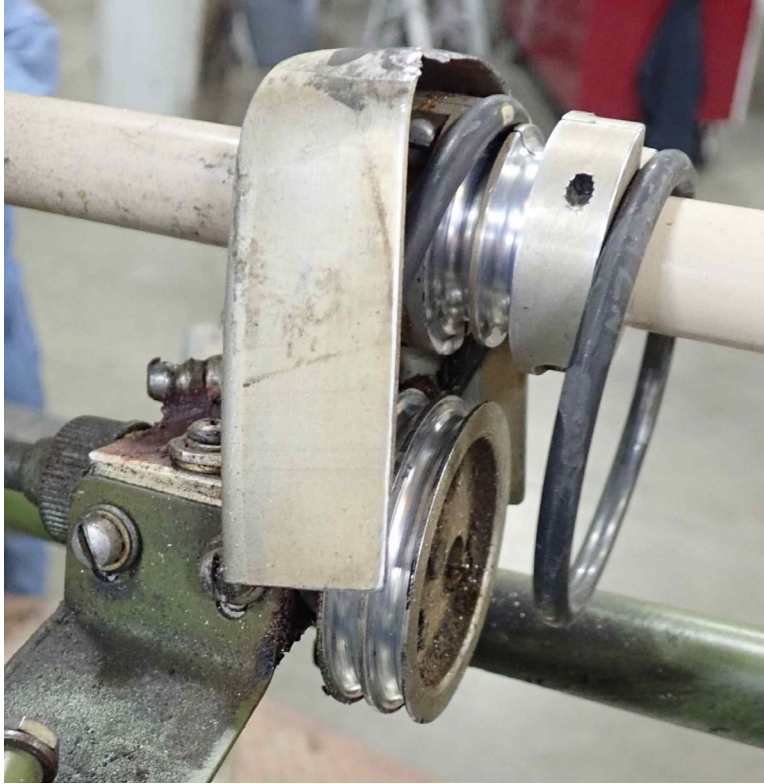
Photo 10 – Main Rotor Tachometer Drive

The engine tachometer cable was continuous from the engine accessory case through to the tachometer in the instrument panel. The main rotor speed cable was similarly continuous from the tailrotor drive shaft drive unit through to the tachometer. The two rubber O-ring/drive belts were undamaged, and proximate to the drive shaft and drive unit (photo 10). The tachometer was retained for further examination.

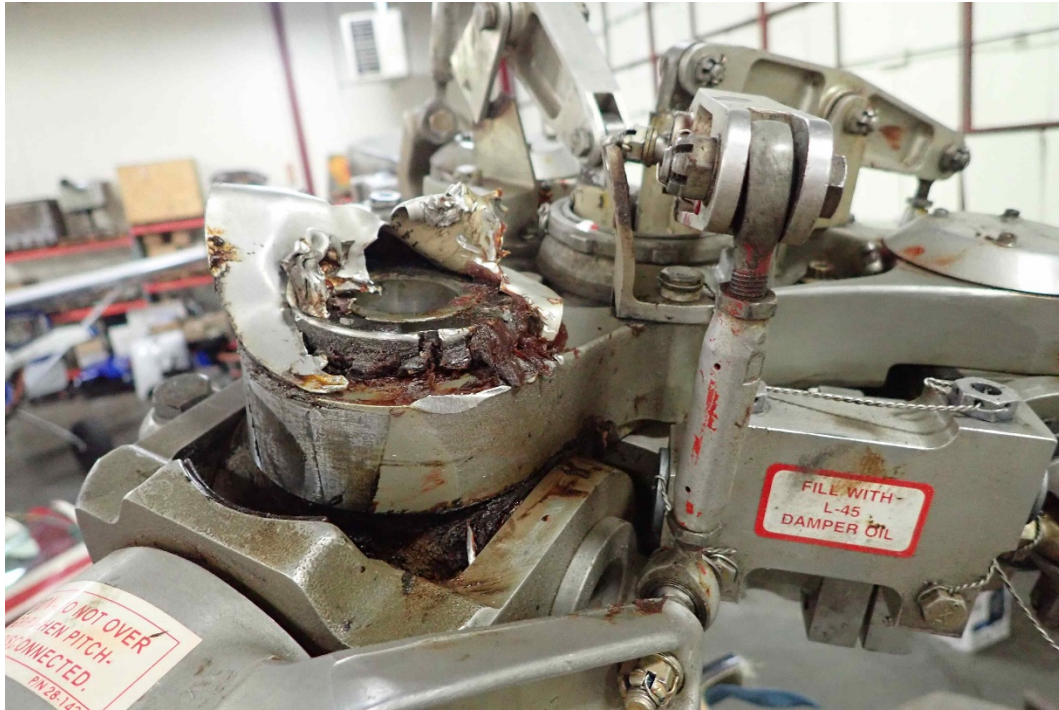
Photo 12 – Number One Blade Grip Assembly

The number one main rotor blade grip was level, but the lead-lag hinge cover had torn (photo 12), and gouges were observed on the pitch horn, indicating the blade had pitched up to approximately 90°. The pivot bracket for the walking beam had broken in an upwards direction, which was further consistent with a movement to high pitch (photo 13). The damper had partially opened; and the two bottom bolt heads in its cap had detached (photo 14). According to the Enstrom representative, such damage is consistent with rapid deceleration of the rotor blade after one of the other two blades strikes a solid object (such as the ground) while significant energy remains within the rotor system. The rotor blade was bent upward approximately 30° in a curve starting near the root (photo 15). It was also bent opposite the direction of rotation by about 5°; the bend appeared to start roughly 5 feet inboard from the tip. The top rivets on the tip cap were sheared, and most of the trailing edge had opened from the inboard trim tab to the tip. Chordwise abrasions and mud were present on the leading edge cap strip on the outboard 2 ft section of the blade.

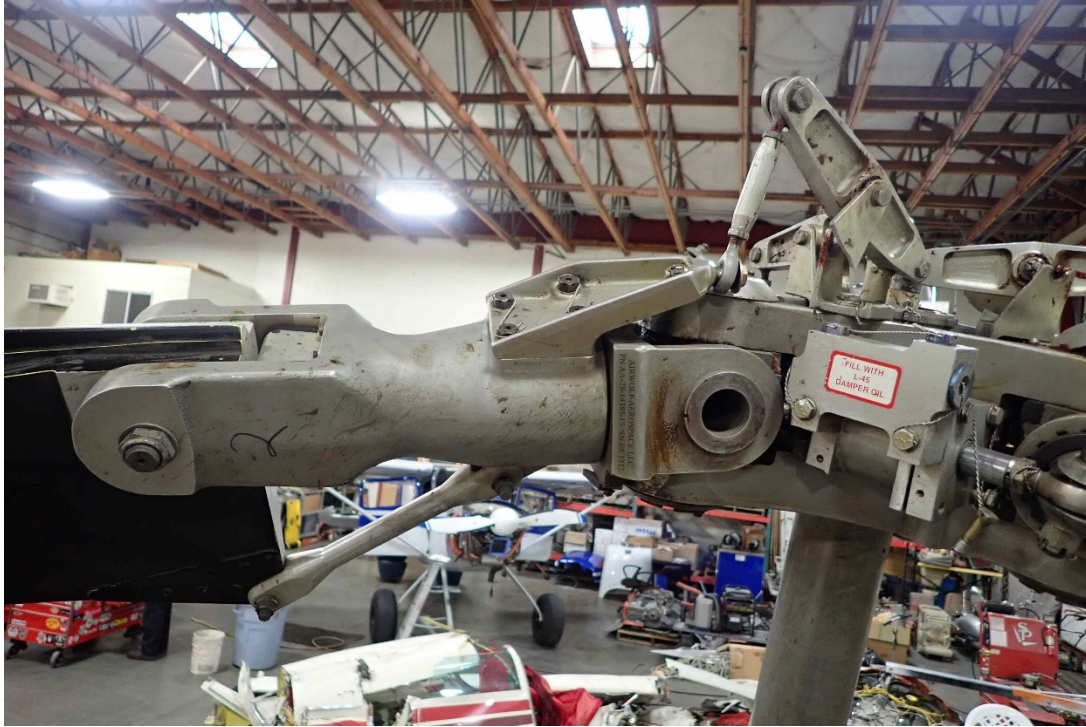
Photo 16 – Number Two Blade Grip Assembly

The number two main rotor blade grip was pitched up about 75°, and the walking beam pivot bracket had broken (photo 16), and the damper was mostly compressed. The blade was bent upward approximately 40° in a curve starting near the root, and bent about 10° opposite the direction of rotation approximately in a curve starting at the inboard trim tab (photo 17). The tip cap was in place, and the trailing edge was open for the entire blade length; the inboard trim tab was detached. There were no observable rotational scratches to the upper blade surface, and 45° chordwise abrasions were present on the leading edge cap strip and the underside of the blade, starting 4 ft inboard from the tip (photo 18).

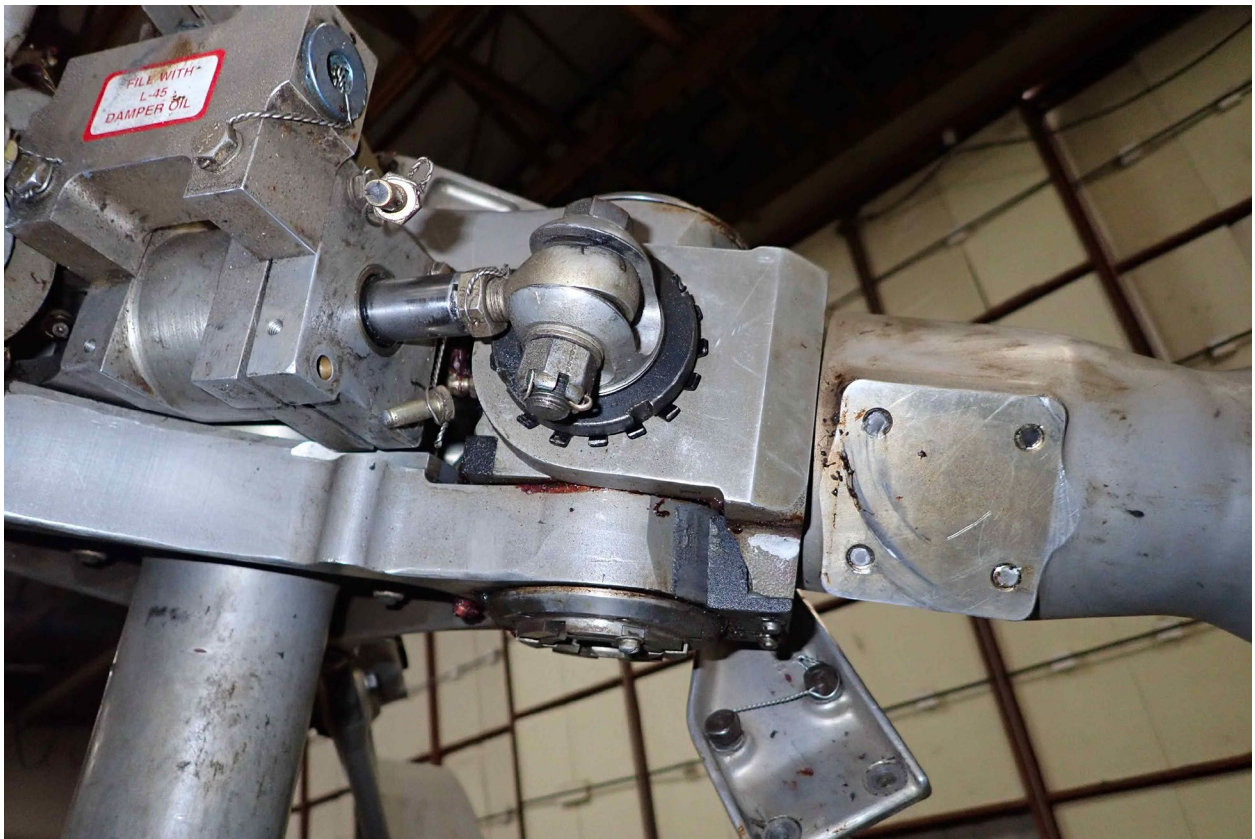
Photo 19 – Number Three Blade Grip Assembly

The number three main rotor blade grip had pitched down about 150°, and the pitch horn was detached with its bolts sheared (photo 19). The damper had partially opened, and its two bottom cap bolt heads had detached (photo 20), with damage similar to blade one. The blade was bent upward approximately 30° through to the inboard trim tab and then bent slightly downward outboard of the trim tab (photo 21). The blade was also bent opposite the direction of rotation

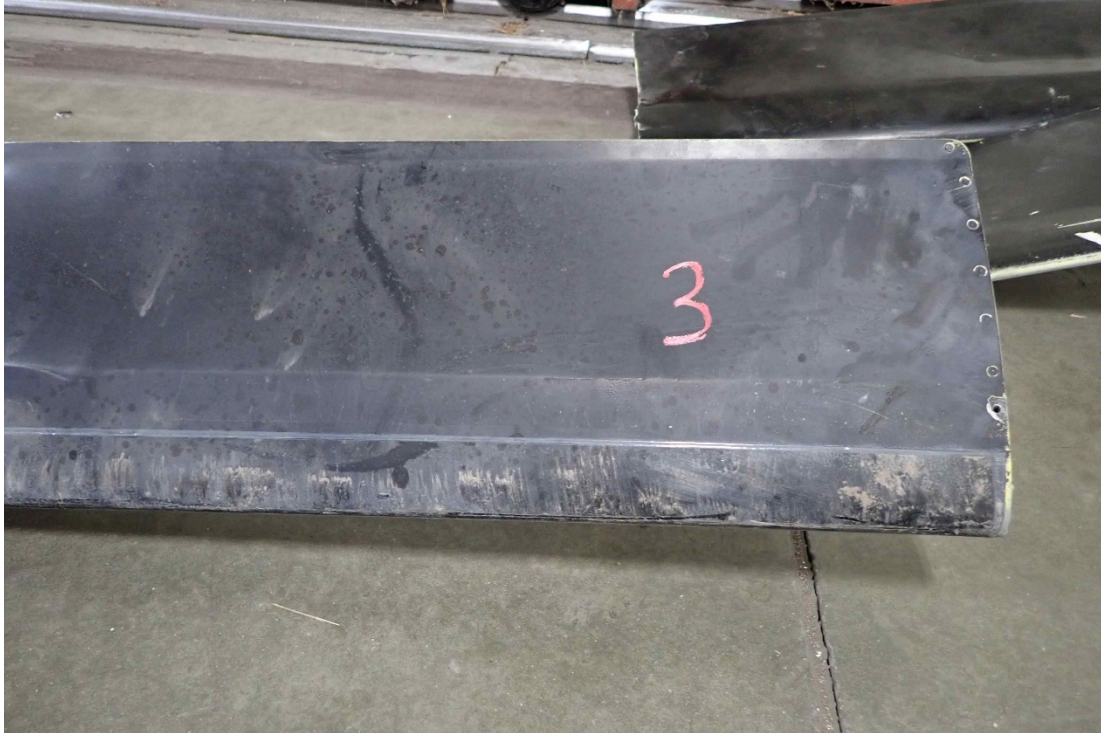
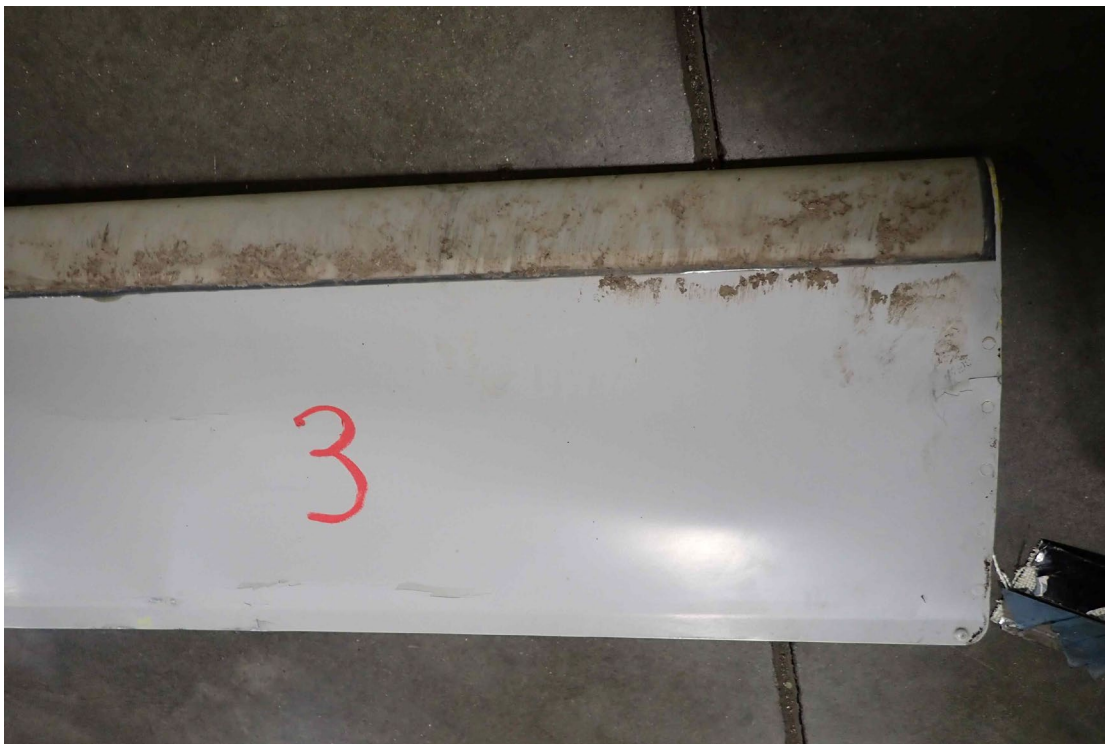
approximately 10° - 15°, outboard of the inboard tab. The trailing edge seam was open from the root to approximately 13 inches inboard of the outboard trim tab. Chordwise abrasions and mud were present on the upper surfaces of the leading edge cap strip on the outboard 2 ft of the blade (photo 22, 23).

Photo 22 – Number Three Blade Underside

Photo 23 – Number Three Blade Upper side

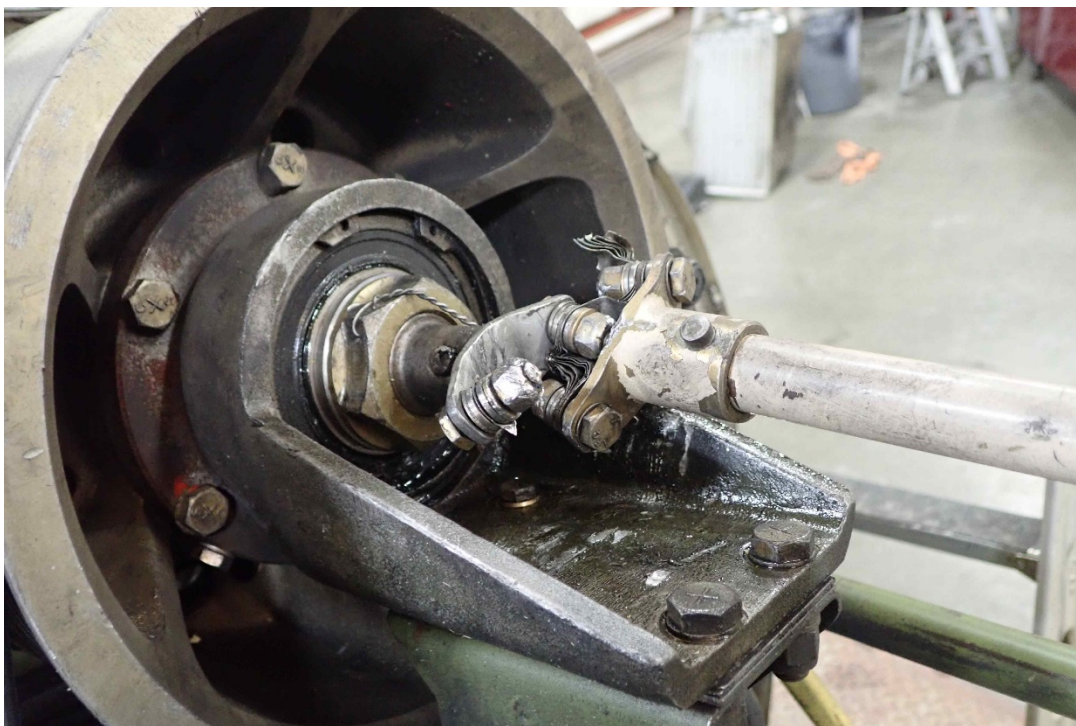
Photo 24 – Forward Tailrotor Coupling

The tailrotor drive shaft was continuous from the upper drivebelt pulley through to the tailrotor gearbox. All tailrotor drive couplings were intact, with the exception of the forward coupling which remained partially attached by one of the two spring legs (photo 24). Rotational scoring was observed in the upper pulley support structure, adjacent to the spring leg (photo 25). The tailrotor blades remained attached to the hub; one blade had bent about 30° from the root, the second blade appeared undamaged. Neither blade exhibited any indications of chordwise scratches, and both blade tip strike tabs were undamaged. Tailrotor pitch control continuity was

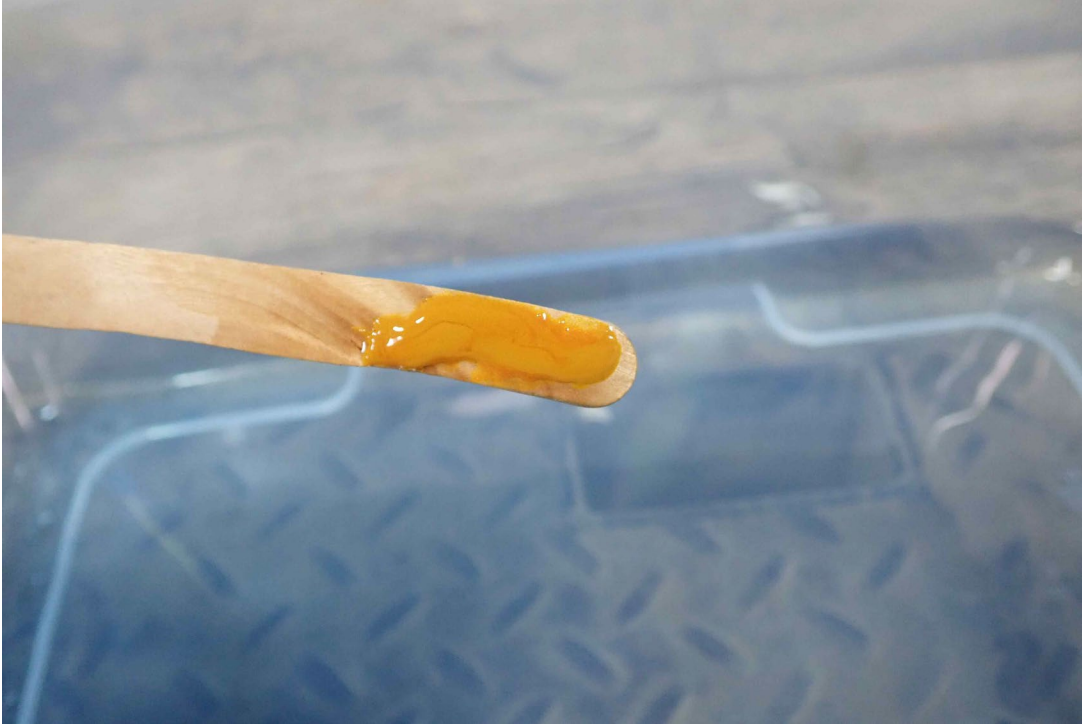
Photo 27 – Fuel from Right Tank

About 2 quarts gallon of blue-colored fuel was drained from the right fuel tank. The fuel had the odor of aviation gasoline, was clear and free of debris, and no water was present when tested with water detecting paste (photo 27). All fuel supply lines were clear and did not display any evidence of blockage. Fuel was present in all fuel supply lines through to the gascolator and fuel injection servo. The forward inlet fitting of the gascolator had broken away. The gascolator screen was free of debris, and its installation clip was found to be installed back to front. The bowl contained about 3 tablespoons of blue-colored fuel; no water was present when the fuel was tested with water detecting paste.

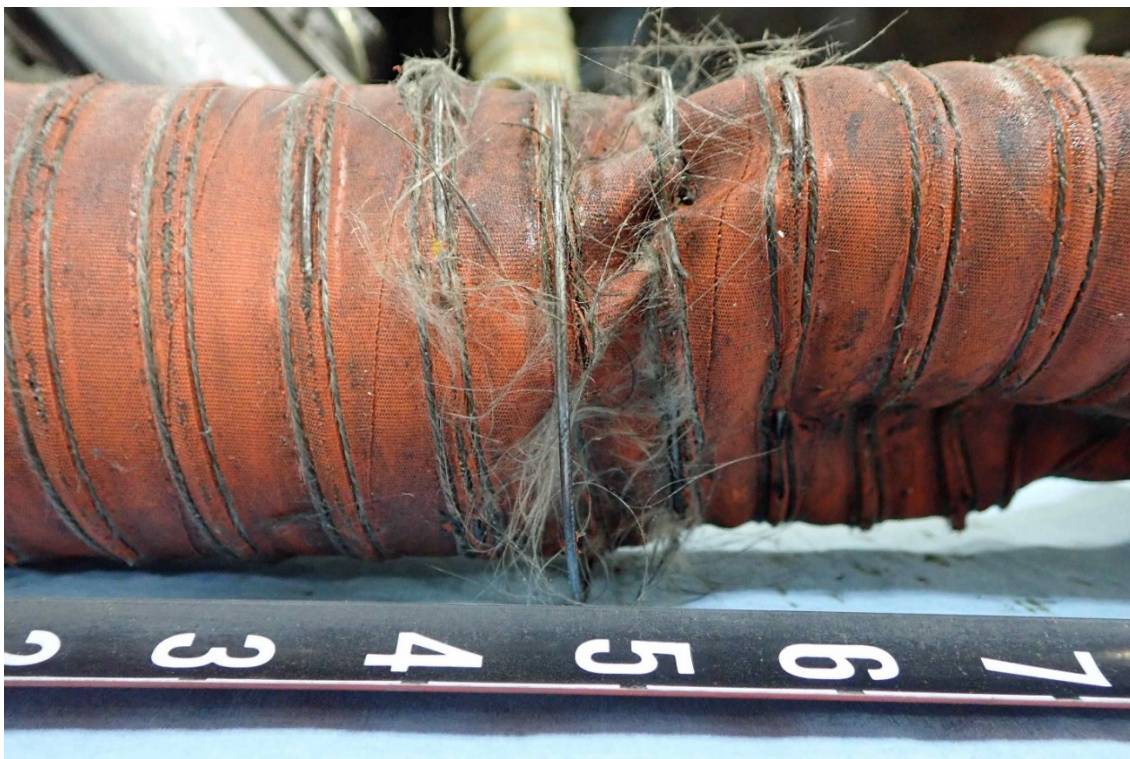
Photo 31 – Engine Air Inlet Tube

The engine sustained minimal damage during the accident sequence. There was no evidence of crankcase breach or catastrophic internal failure. The throttle and mixture controls were continuous from their respective control arms through to the cabin controls. At the accident site, the throttle was found just short of the idle position (photo 28), and the mixture control was about 1 inch short of the full forward position (photo 29). The inlet air filter was free of obstruction, and the filter assembly spring-loaded alternate air and backfire doors could be opened by hand. The induction air inlet tube, which connected the air filter assembly to the fuel injection servo inlet (attachment 1) sustained impact damage and was impinged against the bent airframe structure on impact (photo 30). The tube also exhibited multiple areas where the rubber surface had chaffed and delaminated away from the steel wound spring core (photo 31). The tube was retained for further examination.

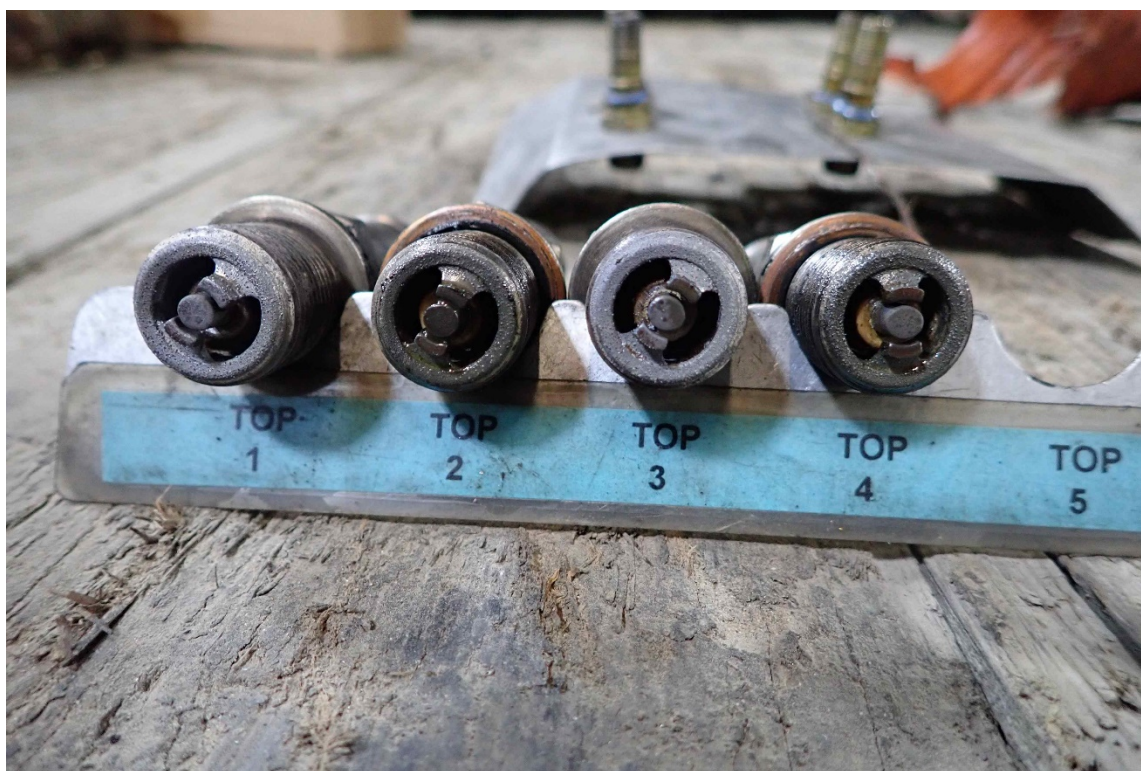
Photo 32 – Top Spark Plugs

The top and bottom spark plugs were removed and examined. Their electrodes remained mechanically undamaged, coated in light grey deposits, and displayed normal wear signatures when compared with the Champion Spark Plugs AV-27 Check-A-Plug chart (photo 32). The spark plugs for cylinders two and four (the cylinders on the lower side at the accident site) were coated in oil. Visual inspection of the combustion chambers was accomplished through the spark plug bores utilizing a borescope; there was no evidence of catastrophic internal damage and all combustion surfaces exhibited light grey deposits consistent with normal operation.

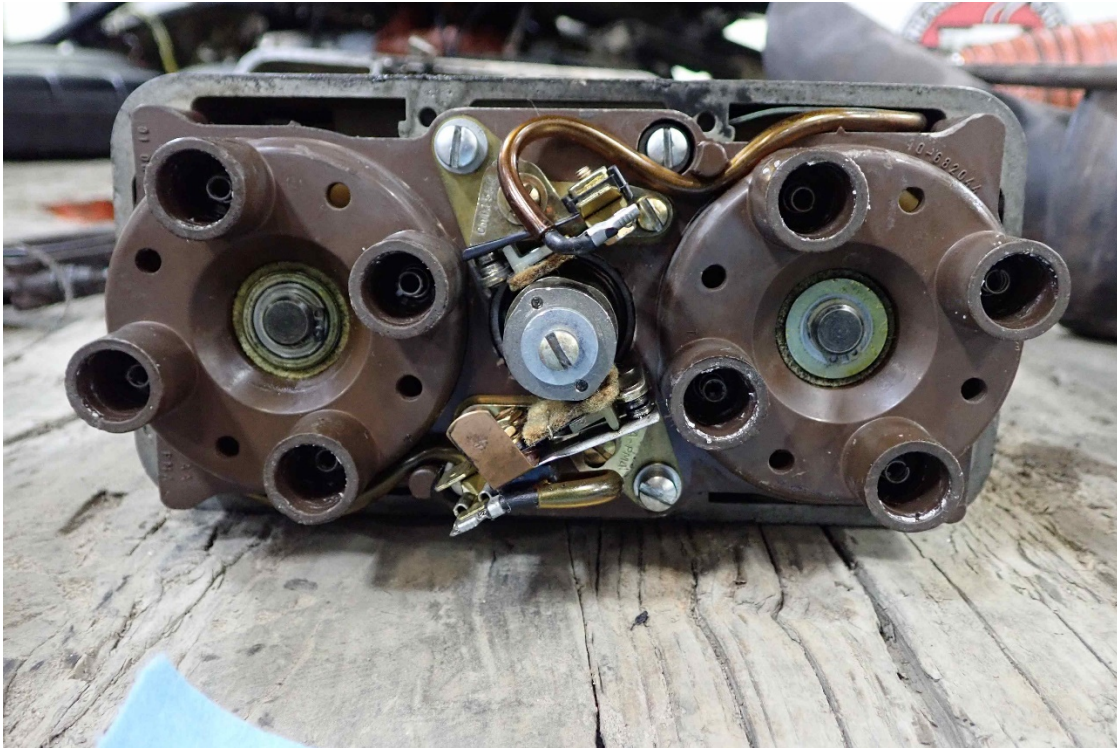
Photo 33 – Dual Magneto

The dual magneto appeared intact and undamaged, and sparks were observed at the output leads on the magneto cap while the input shaft was rotated by hand. Disassembly of the magneto revealed that the points appeared to operate correctly and had appropriate gaps, there were no indications of arcing damage such as sooting, and all gears rotated smoothly with their teeth still intact (photo 33).

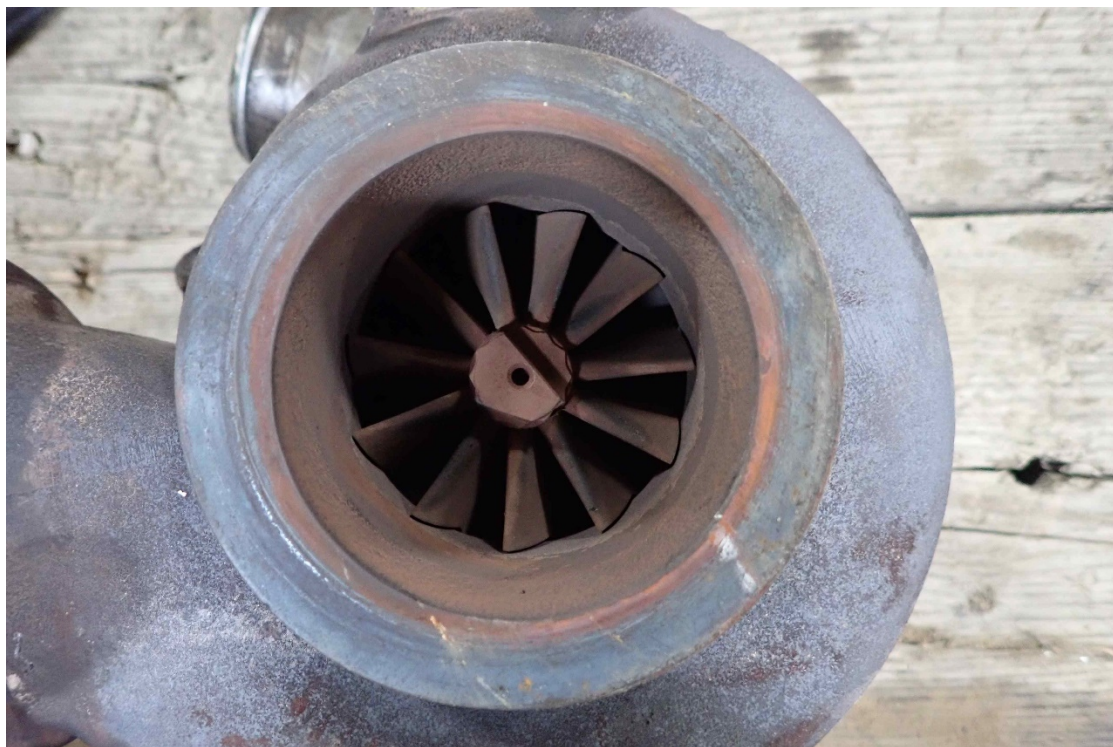
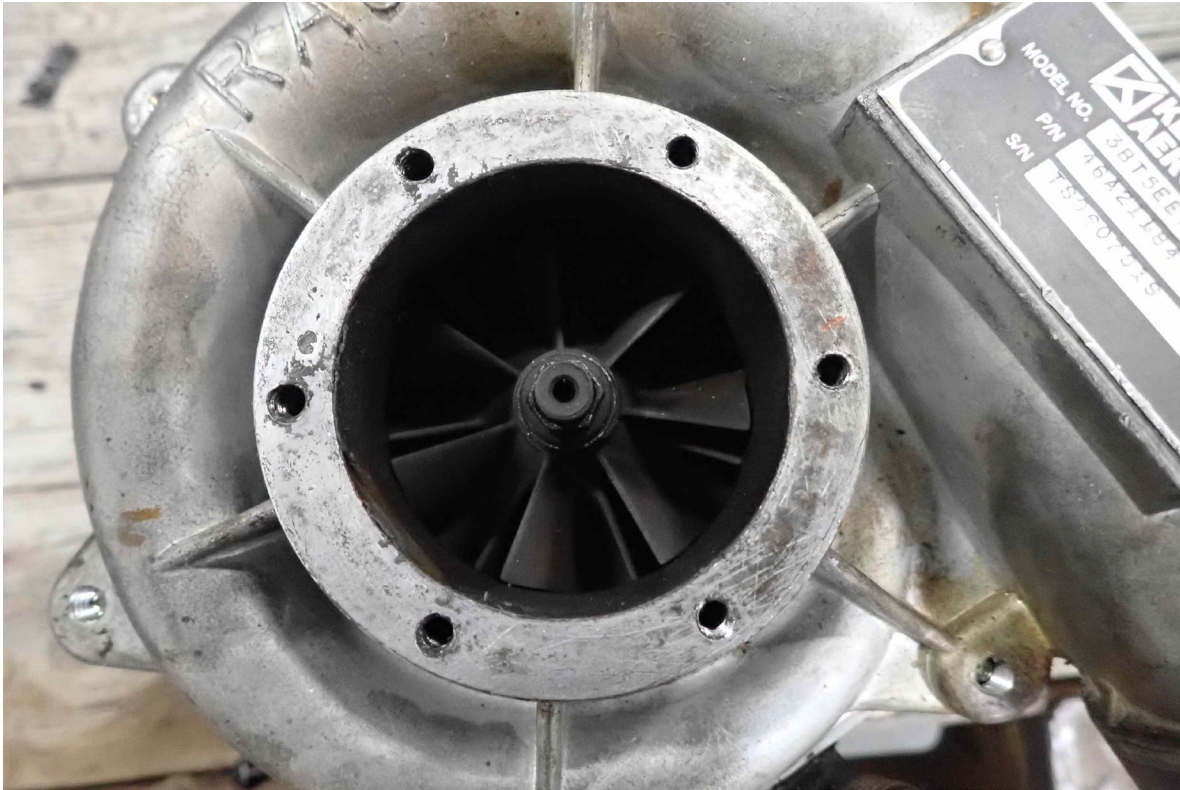
The turbo charger remained firmly attached to its inlet and exhaust pipes, and both respective V-band clamps were intact. The wastegate valve appeared in the open position, and its control rod remained connected to the throttle linkage assembly at the fuel injection servo. The turbo charger turbine and compressor sections remained interconnected and could be rotated freely by hand. All blades appeared intact and undamaged, with no evidence to suggest they had rubbed against the housing surface (photo 34, 35).

Photo 34 – Turbo Charger Turbine

Photo 35 – Turbo Charger Compressor
