## **NATIONAL TRANSPORTATION SAFETY BOARD**

### **FUEL SERVO EXAMINATION**

**WPR20FA016**

Location: Jordan Valley, Oregon  
Date: October 25, 2019  
Aircraft: Enstrom 280F, Registration N280F, Serial Number 1501  
NTSB IIC: Elliott Simpson

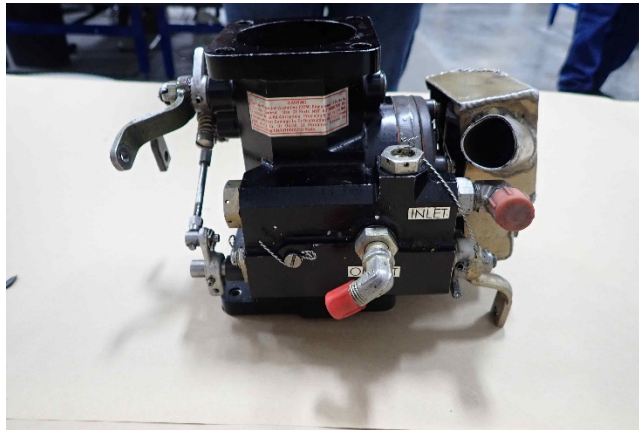
Photo 1 – Fuel Servo Unit

The unit was intact and did not appear to have sustained any damage (Photo 1).

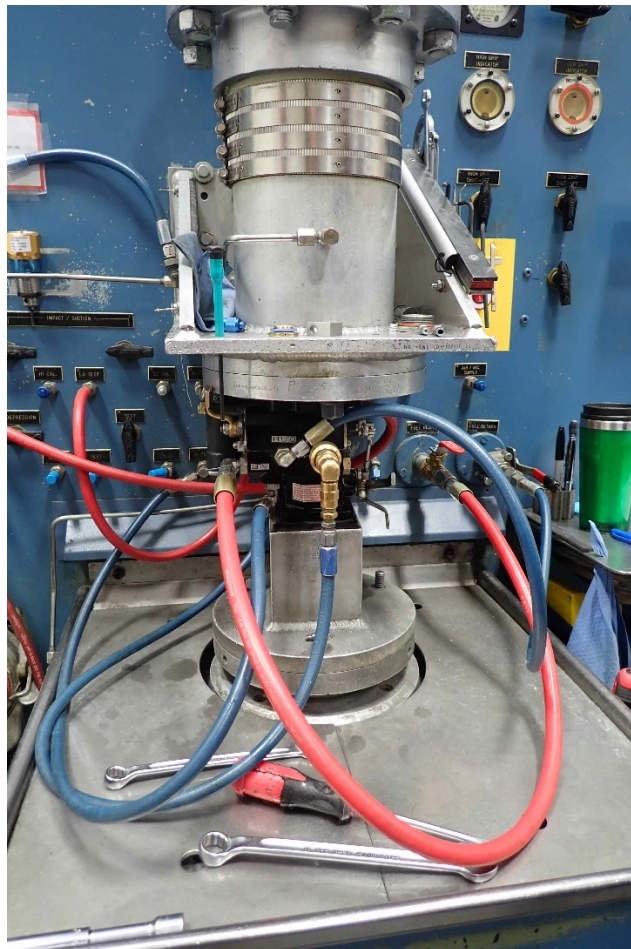
Photo 2 – Fuel Servo Installed in Airflow Bench

The unit was installed on an airflow bench that had been calibrated for the RSA5 servo (Photo 2). The unit was then tested in accordance with Precision Airmotive overhaul test standards. All test results fell within nominal levels, except for the zero suction test point, (zero airflow, rich mixture control, throttle wide open), which exhibited a fuel flow of 47.1 lbs/hr (Nominal 38 to 42 lbs/hr).
