## **NATIONAL TRANSPORTATION SAFETY BOARD**

### **ENGINE EXAMINATION SUMMARY**

**WPR20FA018**

Location: Brawley, California  
Date: October 31, 2019  
Aircraft: Cessna 150A, N7158X  
NTSB Investigator-in-Charge: Tealeye Cornejo

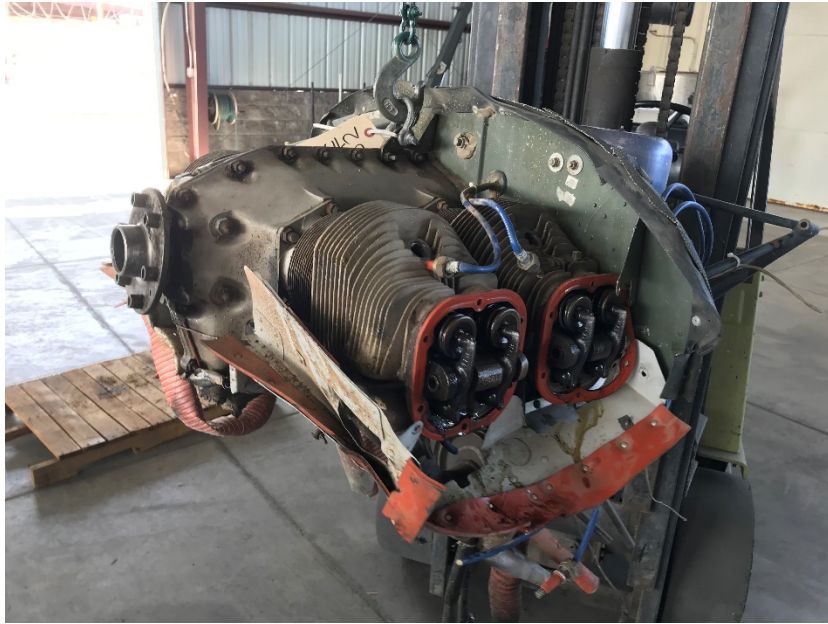
**Photo 1: View of the engine.**

Examination of the recovered engine, a Continental Motors O-200-A – S/N: 253911, revealed that the engine remained attached to the engine mount, however, was separated from the airframe. The propeller and vacuum pump were separated from the engine. The crankshaft propeller flange exhibited impact damage. The number 1 and 3 upper ignition harnesses were impact damaged. The top spark plugs were removed along with the rocker box covers. The crankshaft was rotated by hand using a hand tool. Thumb compression was obtained on all 4 cylinders. Spark was obtained on all 8 ignition leads (1 and 3 were cut). Equal movement of the intake and exhaust rocker arms was observed when the crankshaft was rotated.

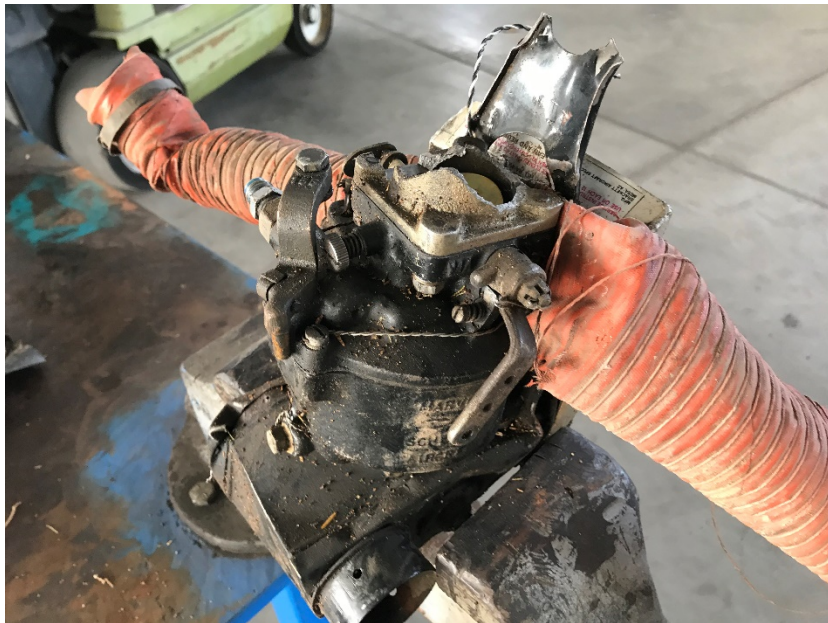
**Photo 2: View of the carburetor.**

The carburetor remained partially attached by its cables, scat hose, airbox bracket, and fuel lines, however, was separated at its mounting flange. The inlet fuel screen was removed and found to be free of debris. The throttle and mixture arms moved from stop to stop by hand. The carburetor was disassembled. No debris was observed within the float bowl. The floats were intact. The needle valve appeared to be seating normally.

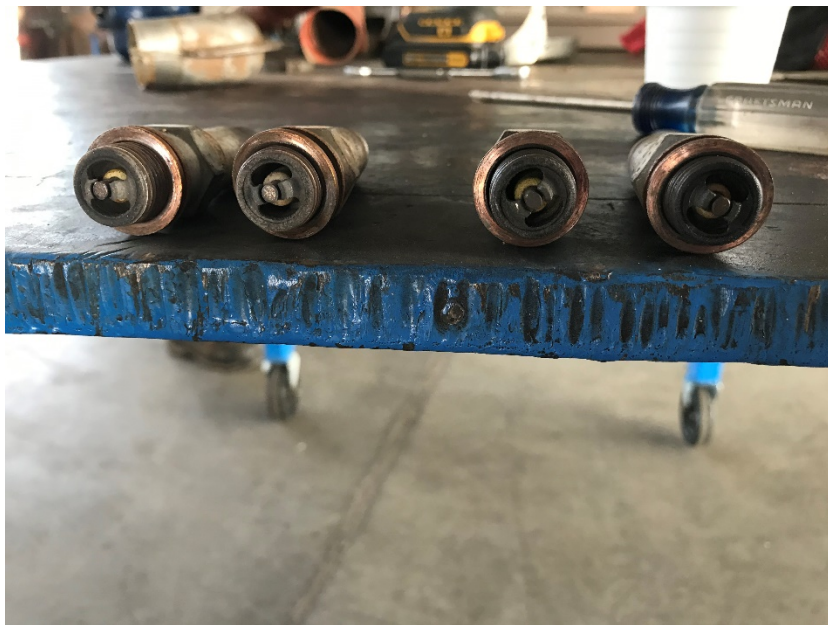
The upper spark plugs exhibited worn out – normal signatures with dark gray colored deposits within the electrode area.

**Photo 6: Upper spark plugs (1 through 4, left to right)**
