# ENGINE EXAMINATION REPORT

| ENGINE MODEL | O-200-A48 |
| AIRCRAFT MAKE & MODEL | Cessna 150A |
| FILE NUMBER | 19-131 |

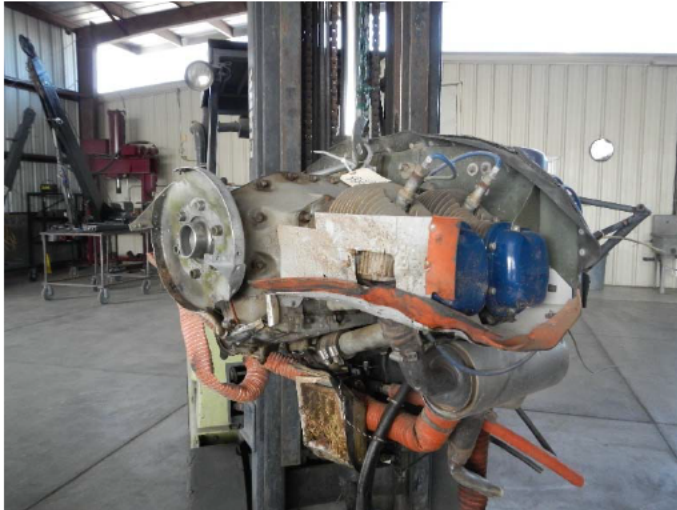
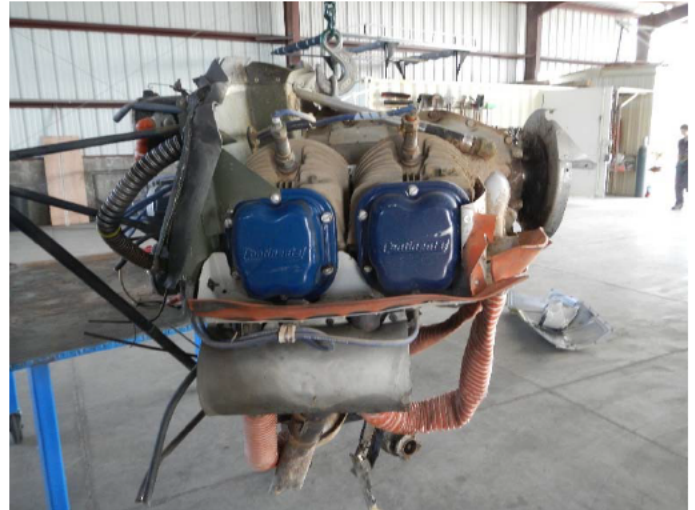
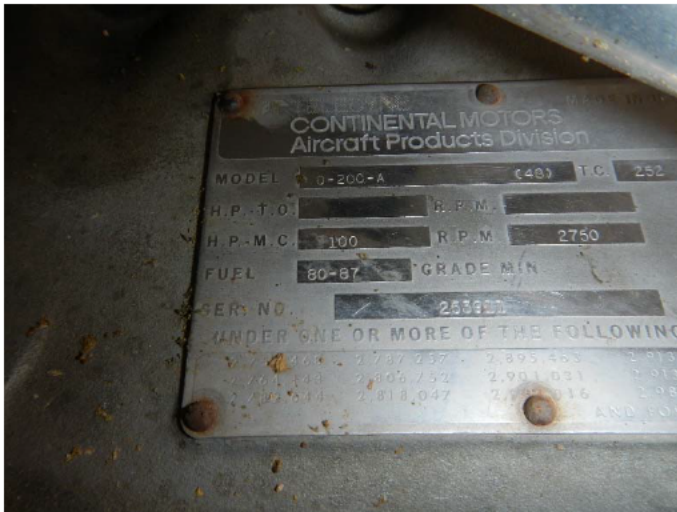
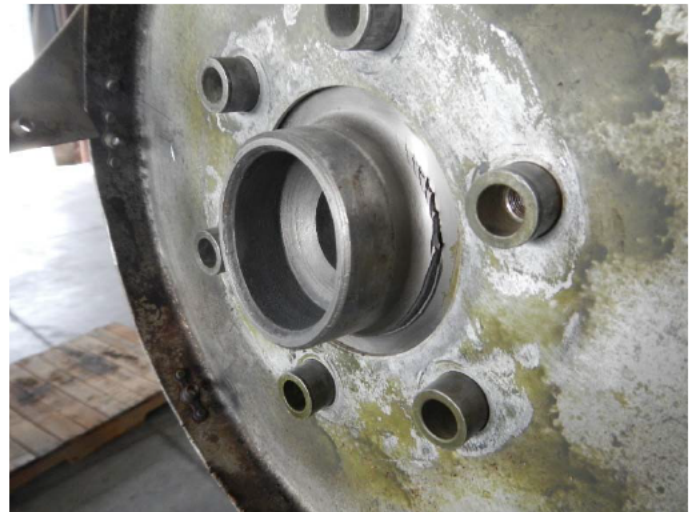
The engine remained attached to the engine mount, however, was separated from the airframe. The propeller and vacuum pump were separated from the engine. The crankshaft propeller flange exhibited impact damage. The number 1 and 3 upper ignition harnesses were impact damaged. The carburetor remained partially attached by its cables, scat hose, airbox bracket, and fuel lines, however, was separated at its mounting flange.

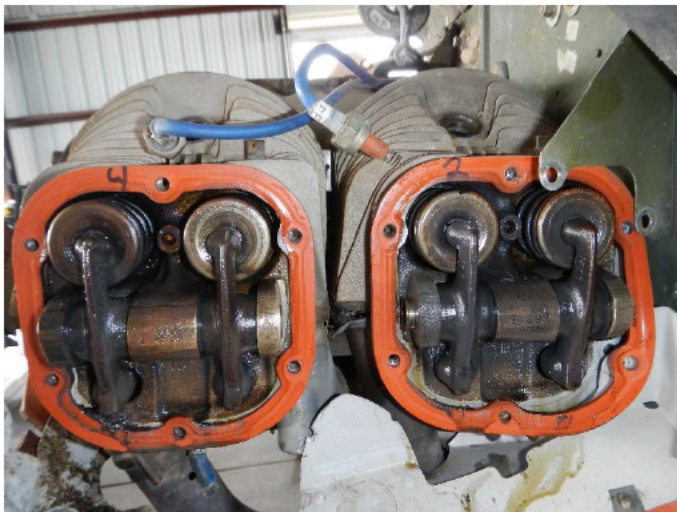
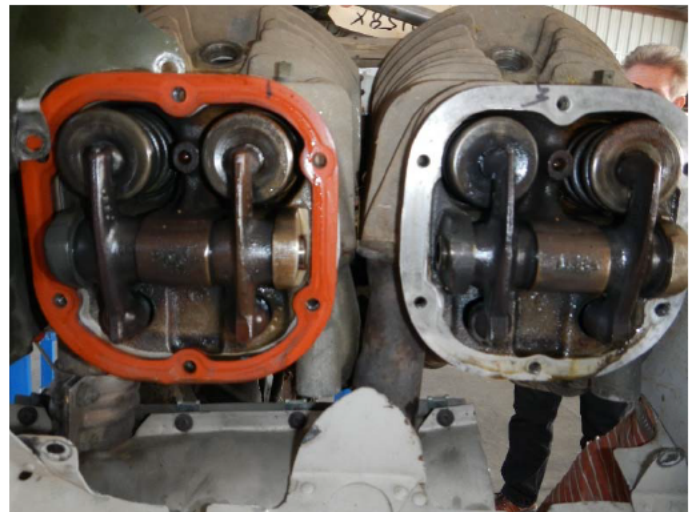
The top spark plugs were removed along with the rocker box covers. The crankshaft was rotated by hand using a hand tool. Thumb compression was obtained on all 4 cylinders. Spark was obtained on all 8 ignition leads (1 and 3 were cut). Equal movement of the intake and exhaust rocker arms was observed when the crankshaft was rotated. The cylinder combustion chambers were examined with a lighted borescope and no anomalies were observed.

The carburetor was removed and examined. The inlet fuel screen was removed and found to be free of debris. The throttle and mixture arms moved from stop to stop by hand. The carburetor was disassembled. No debris was observed within the float bowl. The floats were intact. The needle valve appeared to be seating normally.

The upper spark plugs exhibited worn out – normal signatures with dark gray colored deposits within the electrode area.

The exhaust was impact damaged. The shrouds were removed and no evidence of any exhaust leaks was observed.

The induction system was intact.

The airbox was impact damaged
