## **NATIONAL TRANSPORTATION SAFETY BOARD**

### **ON-SITE REPORT**

**WPR20FA018**

Location: Brawley, California  
Date: October 31, 2019  
Aircraft: Airplane, Cessna 150A Registration Number: N7158X,  
Serial #: 15059258  
NTSB IIC: Tealeye Cornejo

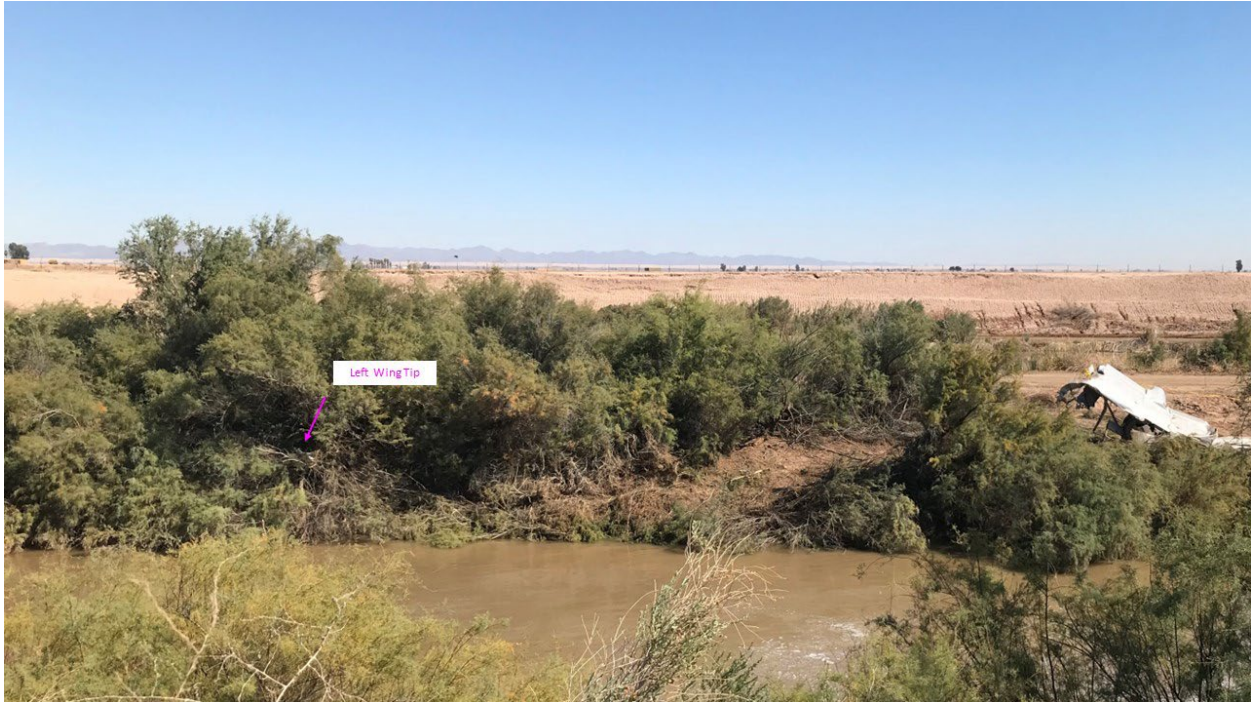
Photo 1 - Overview of Accident Site (Photo Courtesy of NTSB)

The debris path was about 80 ft in length and just north of the main wreckage. The first identified point of impact (FIPC) was the left-wing tip that was embedded in the desert trees shrub. The debris path continued away from the river to the southeast where the right-wing caught the trees shrub and swung the airplane back toward the west with the nose pointing back toward the river. Right main landing gear separated and was in the debris path.

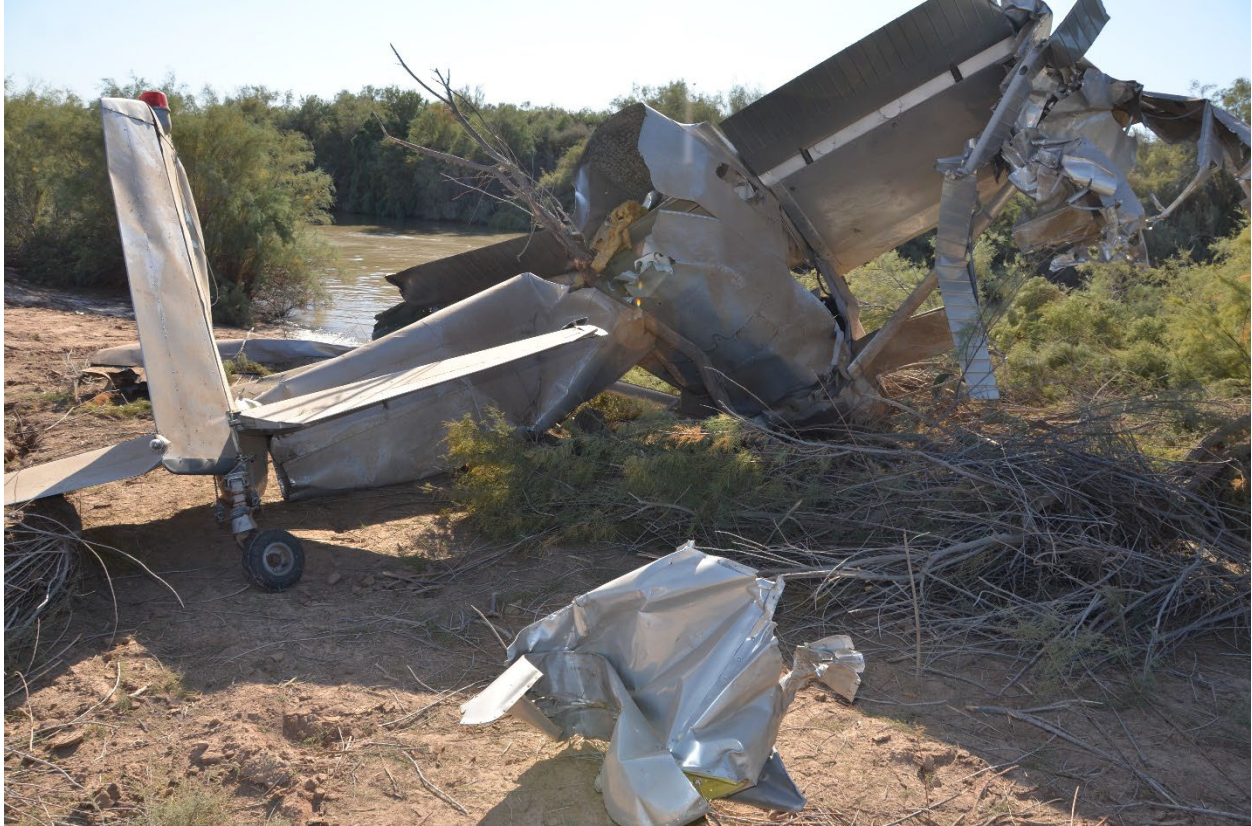
The entire airplane came to rest upright on the shoreline of the Alamo River in desert shrub trees on a magnetic heading of  $257^{\circ}$ . it appears to have collided with the side of the riverbank in a nose low attitude.

Photo 2 - Rear View of Accident Airplane (Photo Courtesy of Coroner)

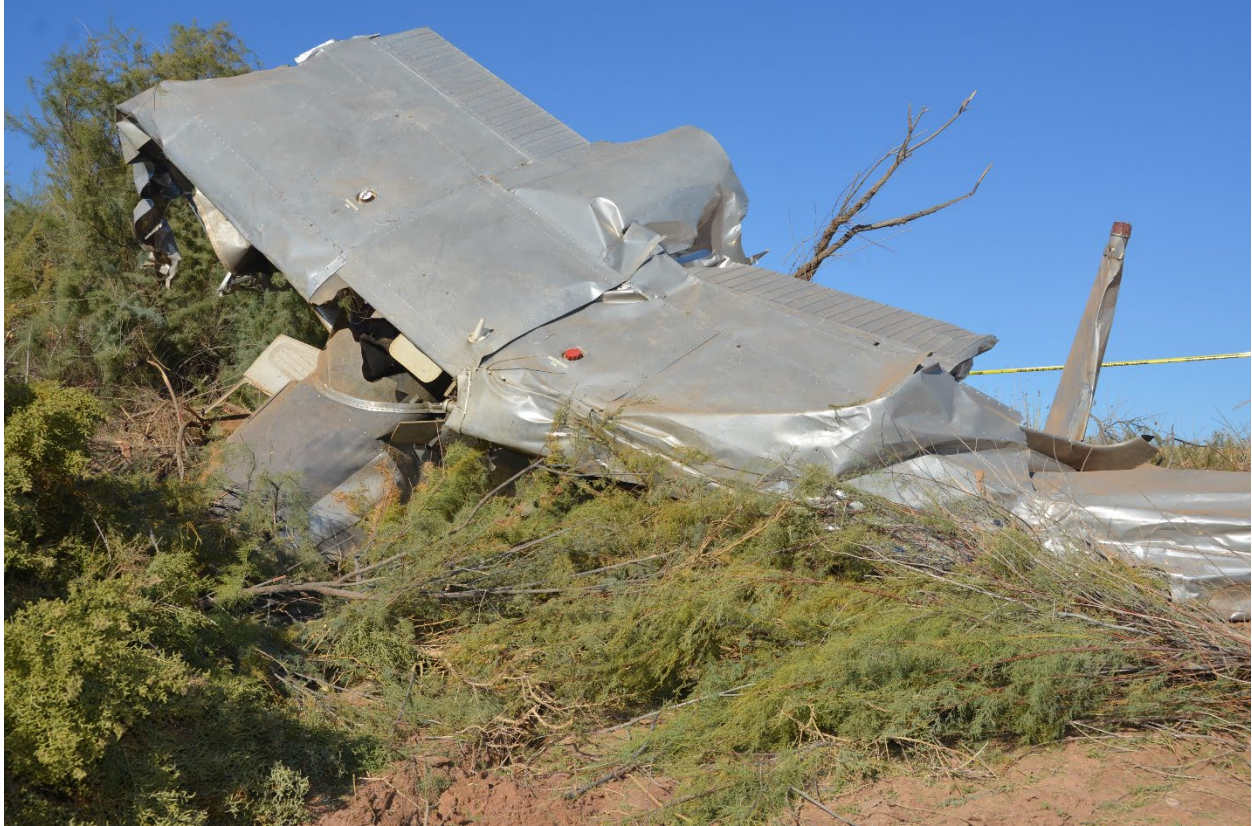
Photo 3 - Front View of Airplane (Photo Courtesy of Coroner)

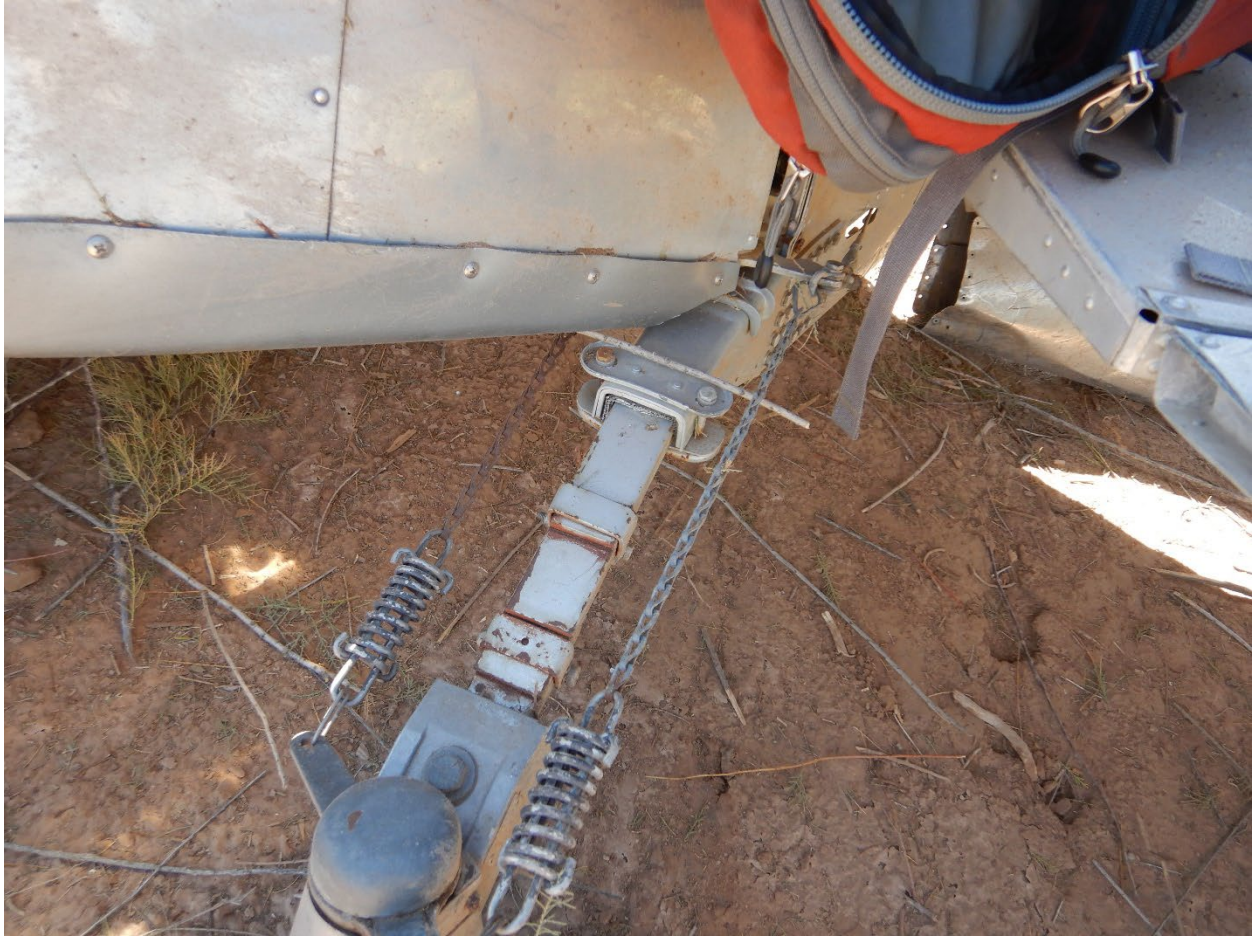
Photo 4 - View of Tail Wheel Assembly (Photo Courtesy of Textron Aviation)

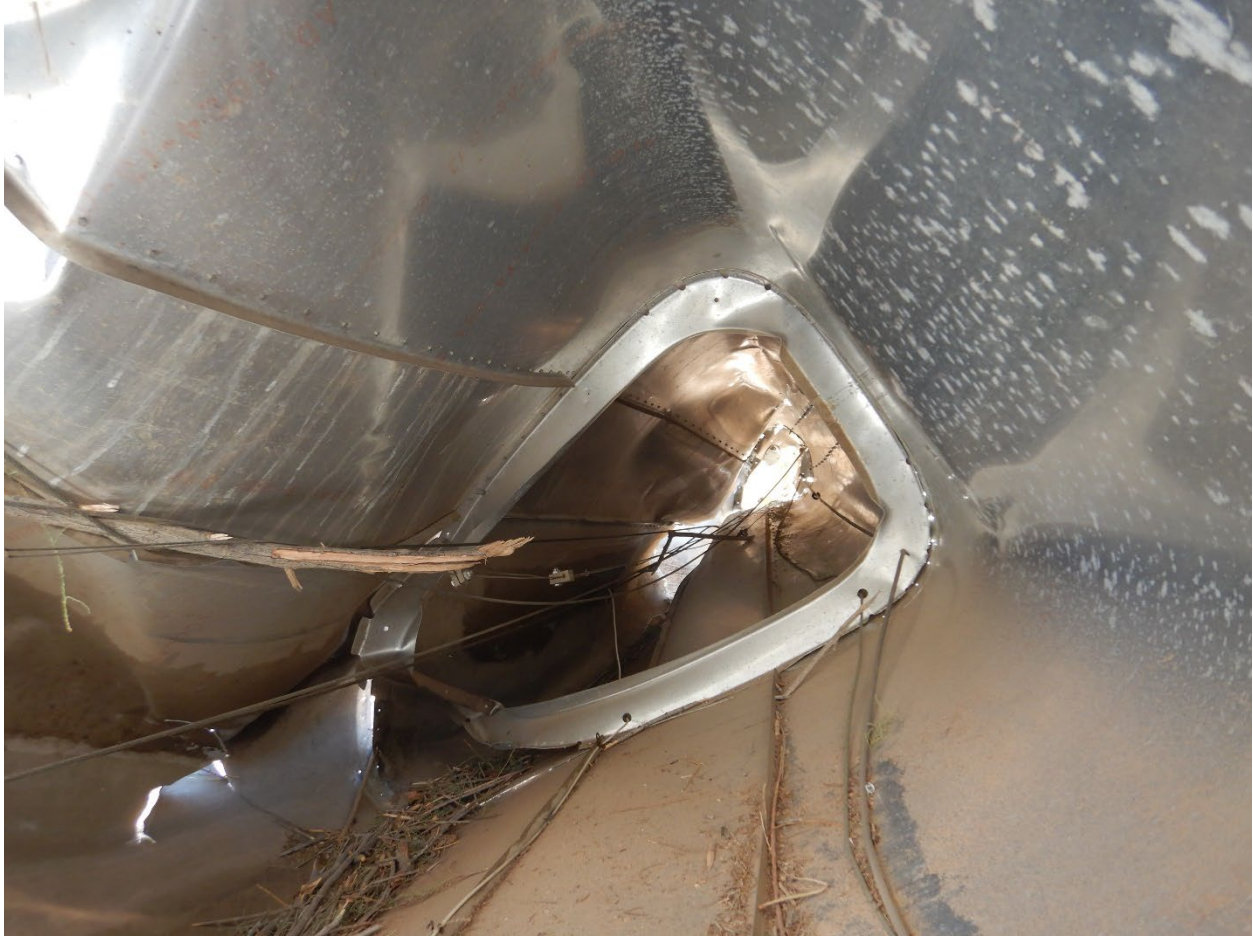
Photo 5 - View of Flight Control Cables (Photo courtesy of Textron Aviation)

The cockpit separated from the empennage and tail sections. Flight control continuity was established from the cockpit to each flight control surface. Flap indicator and actuator were UP, and the handle was stowed. Master switch was in the OFF position but was impact damaged.

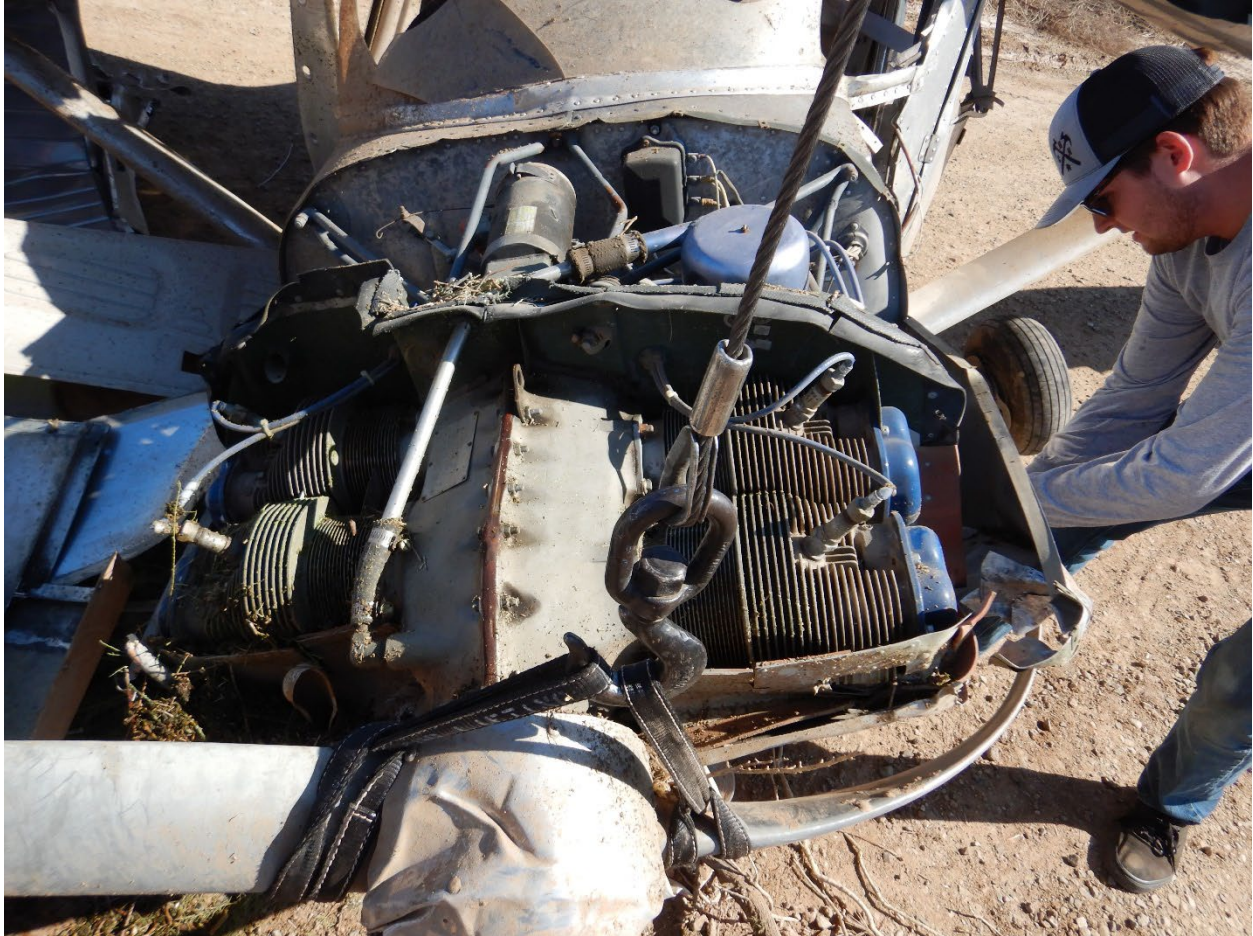
The two-bladed propeller remained attached to the engine; the engine partially separated from the firewall. One propeller blade was undamaged and straight. The other propeller blade had bent aft toward the cockpit but was relatively undamaged.

There were no obvious holes in the engine case. The carburetor separated from the induction tubing at its mounting flange. About 1.5 gallons of 100LL fuel (blue in color)

Photo 6 - View of Engine and Propellers (Photo Courtesy of Textron Aviation)

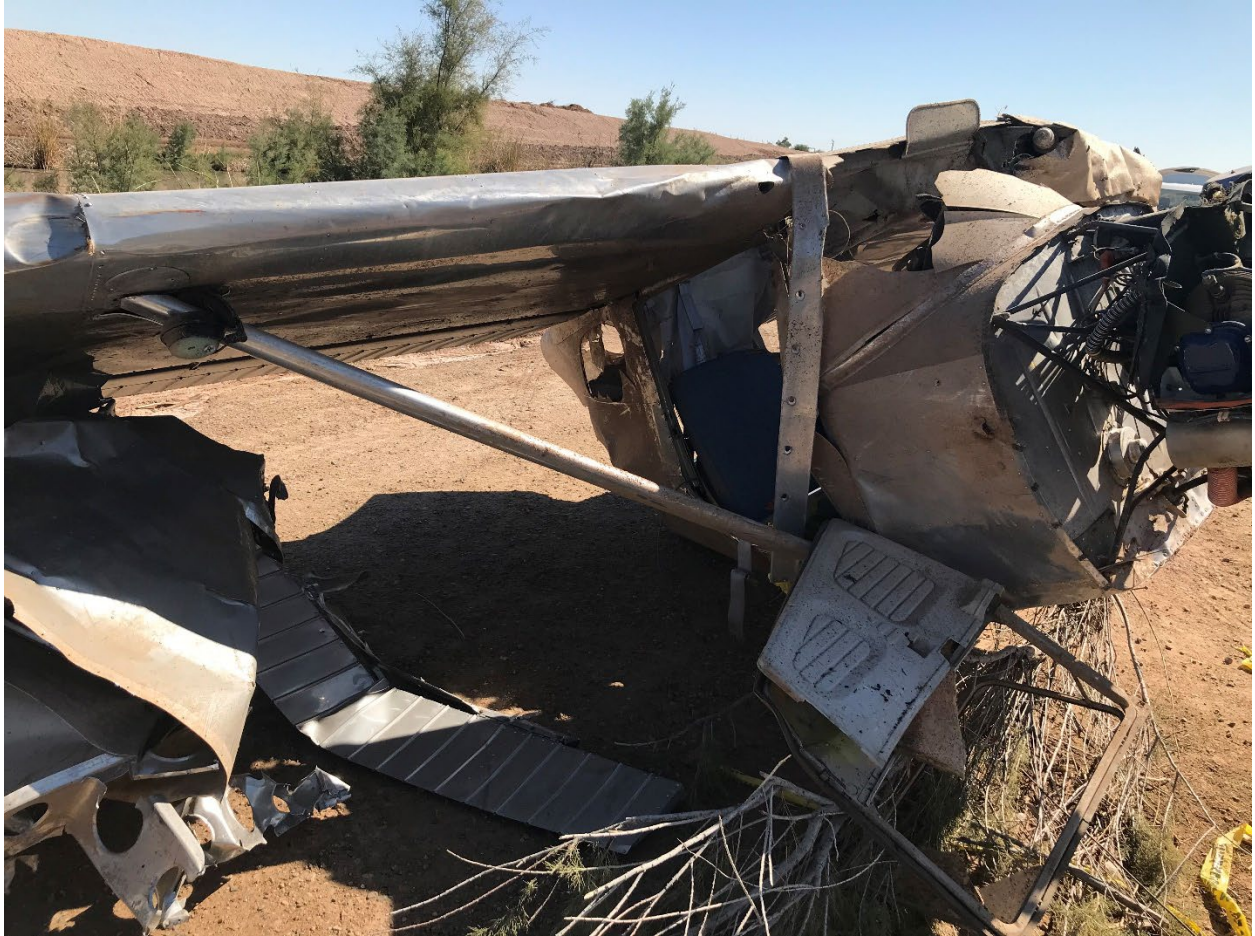
Photo 7 - Side View of Airplane (Photo Courtesy of NTSB)
