## **NATIONAL TRANSPORTATION SAFETY BOARD**

### **ON SCENE OBSERVATIONS**

**WPR20FA019**

Location: Upland, CA  
Date: November 7, 2019  
Aircraft: Cirrus SR22, Registration N220MT, Serial #2748  
NTSB IIC: Samantha Link

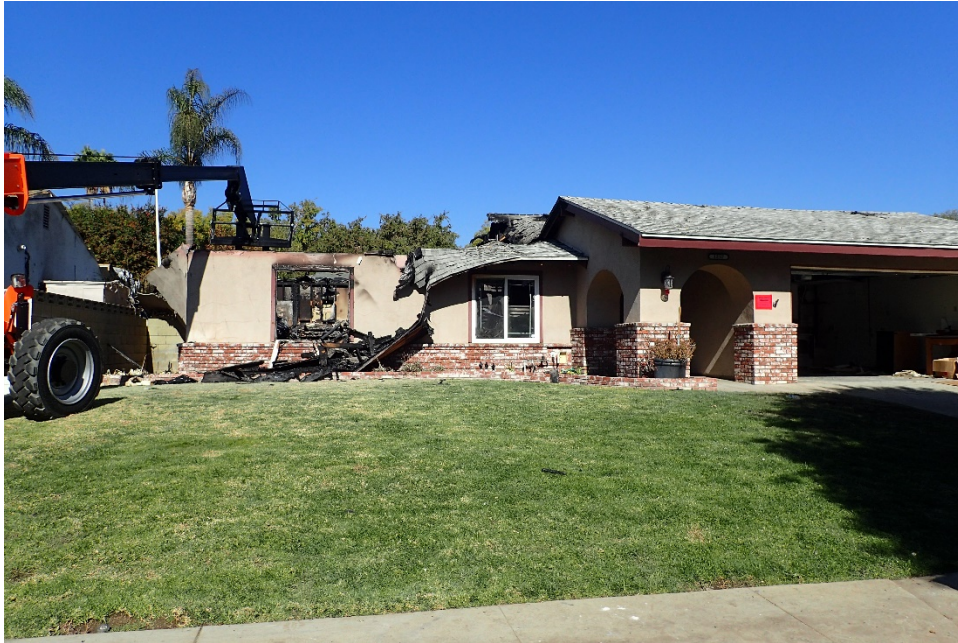
- The western wall of the house and an adjacent brick wall exhibited extensive crush damage. A large portion of the outboard end of the left wing and wingtip, left aileron, and a fragment of the left flap were present on the neighbor's property.

Figure 1: Font of House

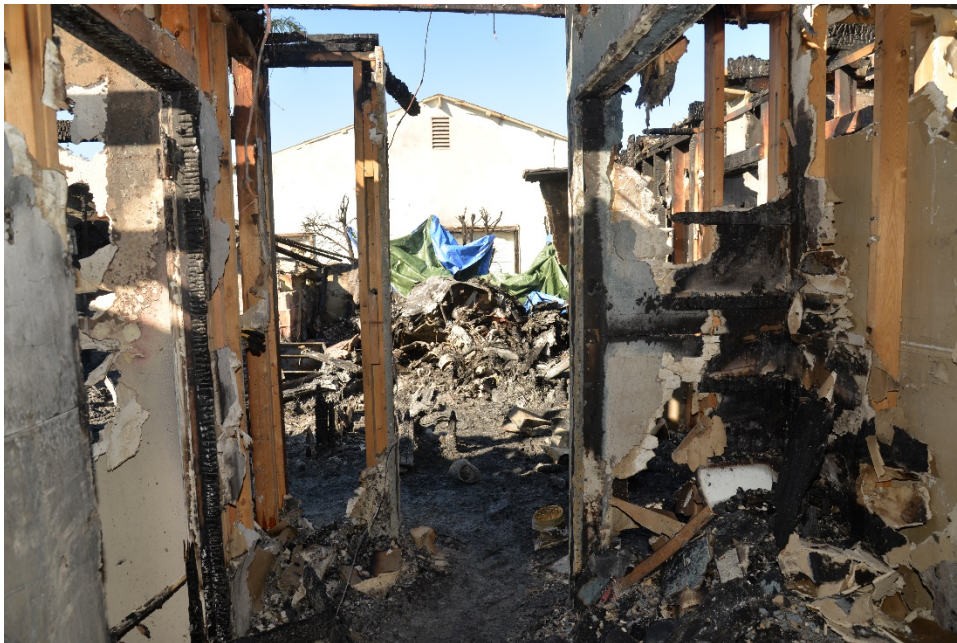
- The airplane came to rest inside of a house within a residential area about 1/2 mile from the runway 24 threshold of the Cable Airport, Upland California.
  - A post crash fire ensued
  - The airplane was destroyed, and the house was heavily damaged.
- The wreckage was mostly contained within the western most room of the house. The roof and the contents of the room were completely consumed by fire.

Figure 2: Overview of Main Wreckage from Adjacent Room

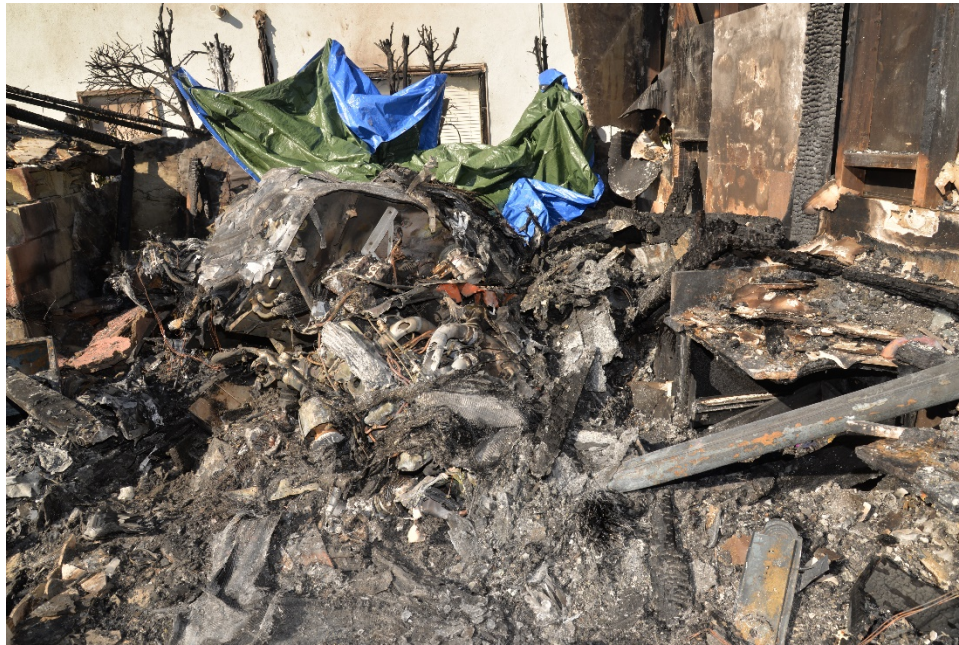
- All three propeller blades remained attached at the hub but were separated at the blade root. Two blades were completely separated and only the balance tube was present; one of the balance tubes was bent aft at about a 45-degree angle, and the second balance tube was bent slightly. Only about 1/3 of the blade root remained on the third propeller; the blade root exhibited heavy thermal damage. The outboard about 2/3rds was not present.

- The spinner remained attached and was mostly whole, although it exhibited some crush damage and heavy thermal damage.
- The parachute risers and suspension lines were draped over a palm tree slightly northwest of the main wreckage. And the parachute was found in an adjacent neighbor's yard. The slider was observed at the base of the parachute. The beeswax coating on the vent lines at the apex of the parachute canopy remained stuck together consistent with a packed state.

Figure 3: Front of Airplane

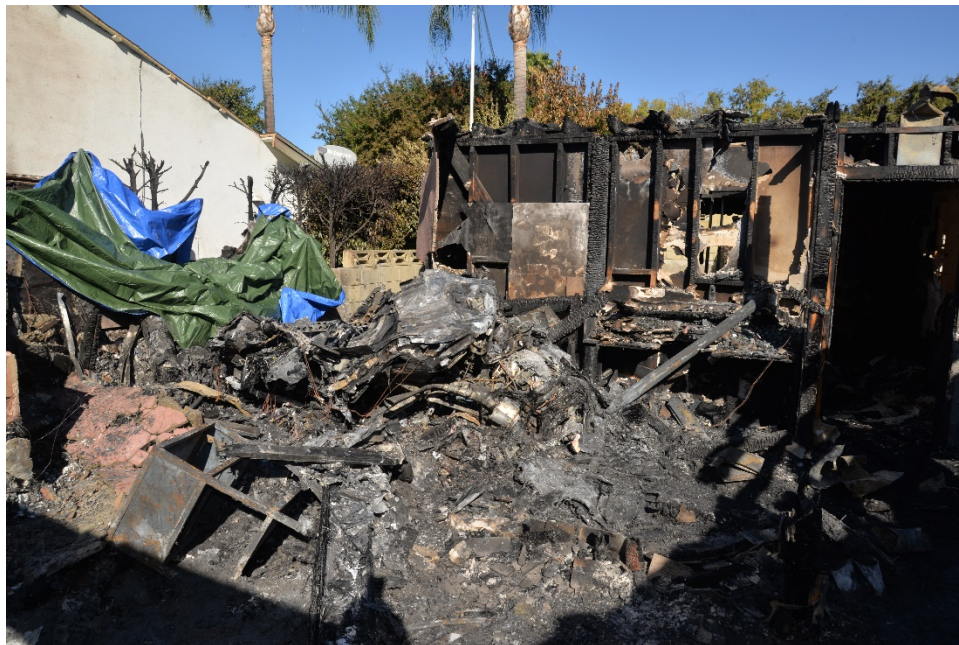
- Most of the airframe was consumed by the post impact fire. The engine cowling, forward fuselage, cabin fuselage, aft cabin, aft fuselage, most of the left and right wings, the horizontal and vertical stabilizers were not present.

Figure 4: Right Side of Airplane

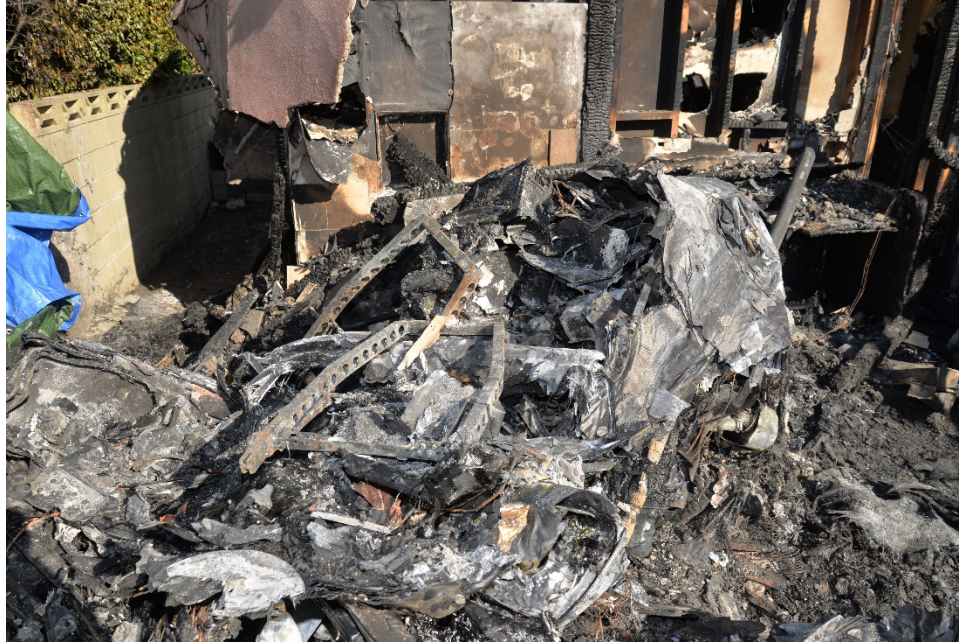
- There were no obvious visual signs of mechanical failure or malfunction of the engine.
  - Just aft of the instrument panel were the seat frames for front pilot and passenger seats.

Figure 5: Cabin Area

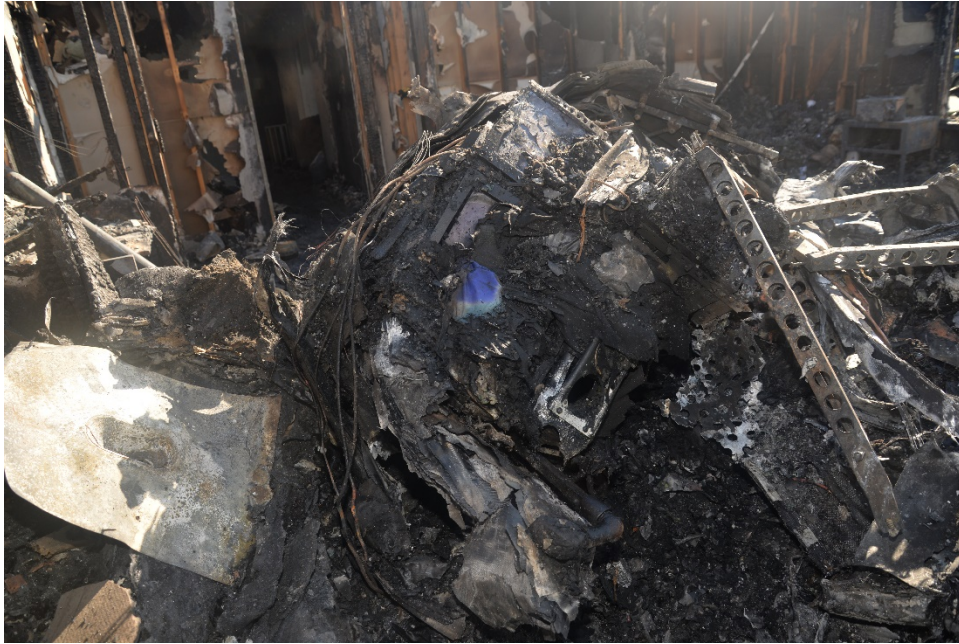
- The engine came to rest upright and nose low. The firewall and instrument panel remained attached to the engine; however, they exhibited heavy thermal damage and were covered in burned debris.

Figure 6: Instrument Panel

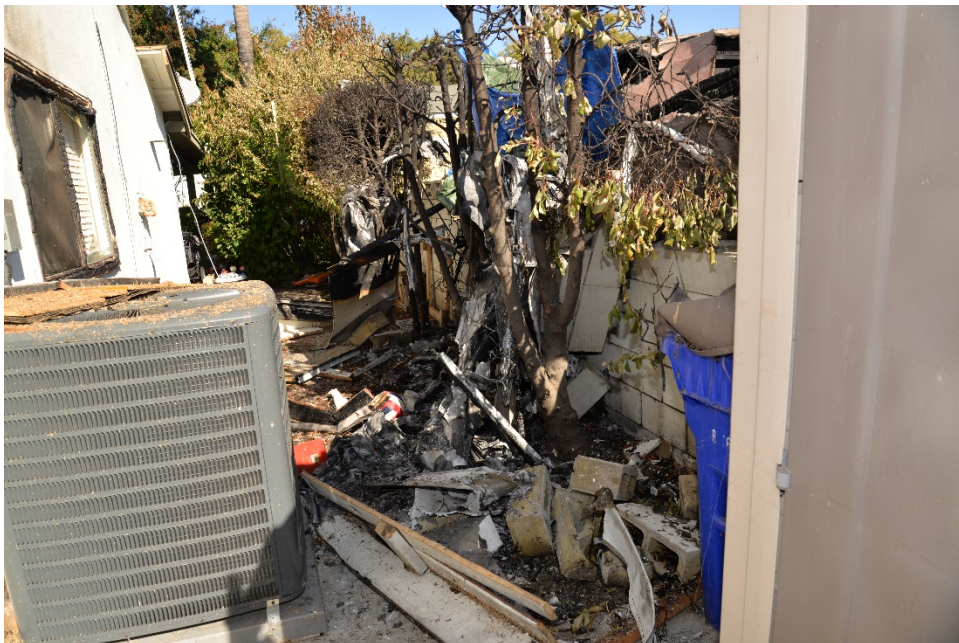
Figure 7: Neighbor Side Yard

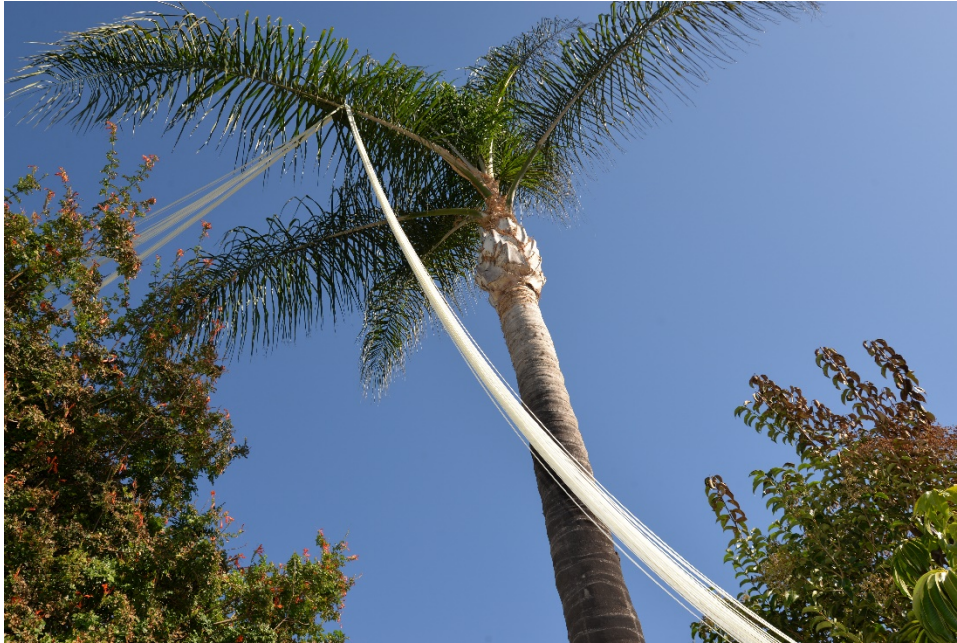
**Figure 8: Extended Parachute Suspension Lines**

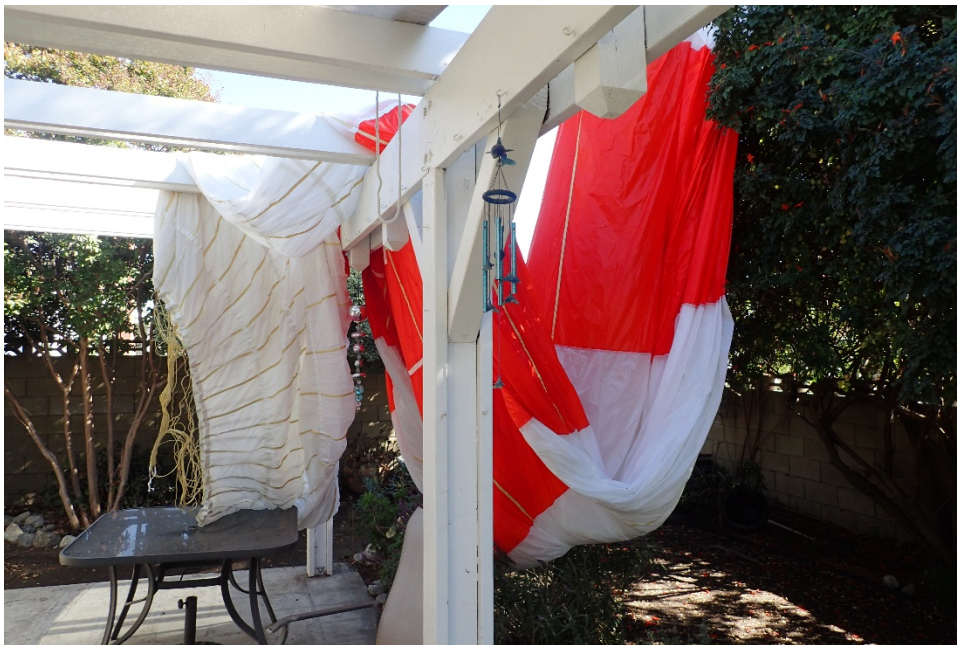
**Figure 9: Parachute**

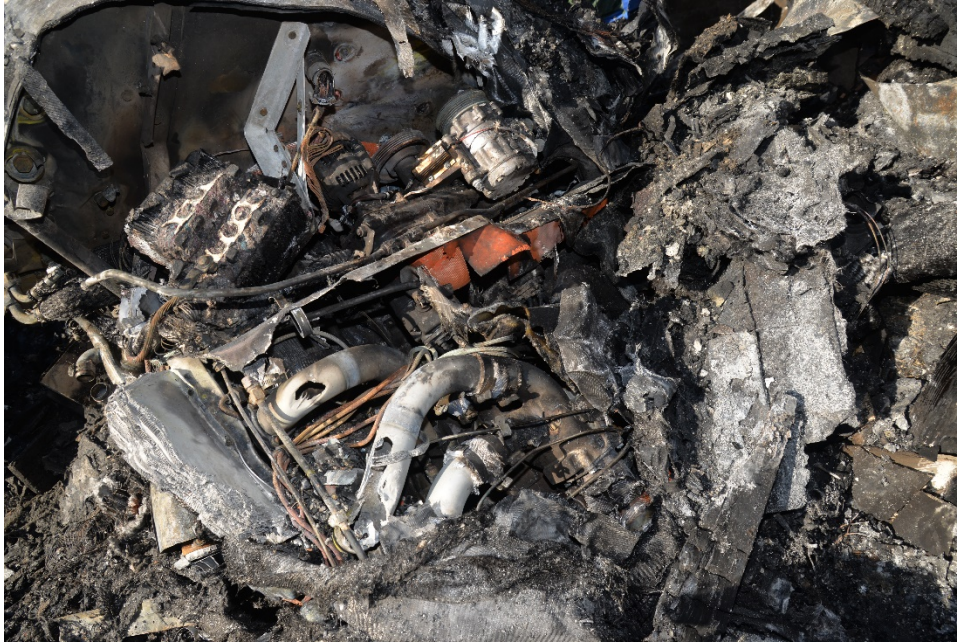
- The engine came to rest upright and it exhibited heavy thermal related damage. It was heavily covered in fire related debris.
- There were no obvious visual signs of mechanical malfunctions or failures.

Figure 10: Engine at Accident Site
