## **NATIONAL TRANSPORTATION SAFETY BOARD**

# **AIRFRAME AND ENGINE EXAMINATION**

**WPR20FA019**

Location: Upland, CA  
Date: November 7, 2019  
Aircraft: Cirrus SR22, Registration N220MT, Serial #2748  
NTSB IIC: Samantha Link

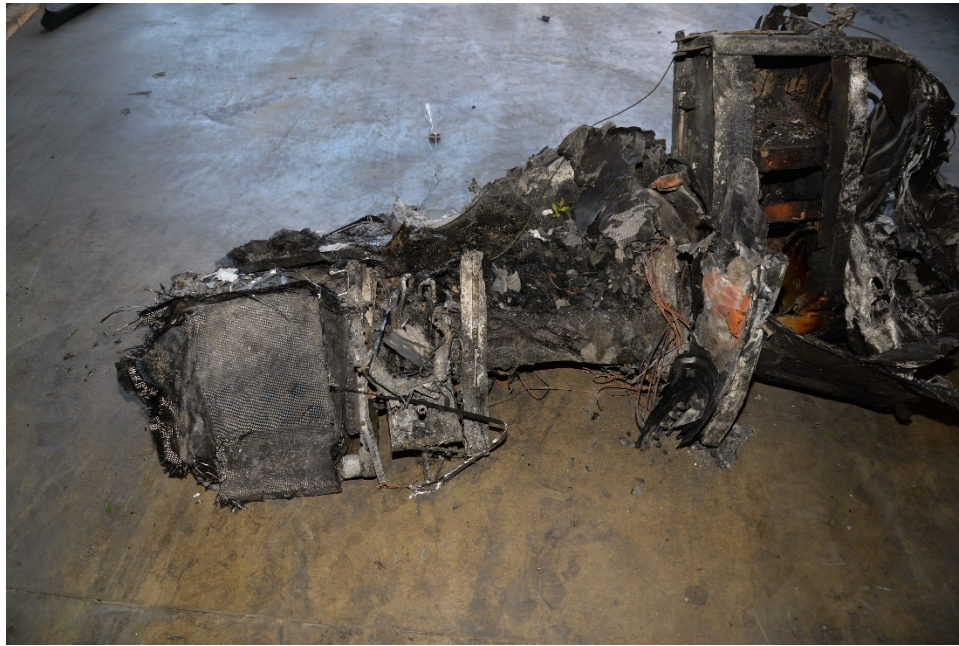
Figure 1: Left Wing Root (photo 1), Front Two Seats, and Fuel Selector

- The left main landing gear leg was present and still secured.
  - In addition, the front pilot and passenger seat frames remained attached to the left wing spar tunnel.

- Both seat frames exhibited heavy thermal damage.
  - The fuel selector was located in between the two front seats and exhibited heavy thermal damage; the selector handle was not present, but the shaft leading up to it was.

- The fuel lines leading into and out of the fuel selector were present and remained attached to the selector.
- The left wing tip was present and exhibited some thermal damage. The left aileron remained attached.

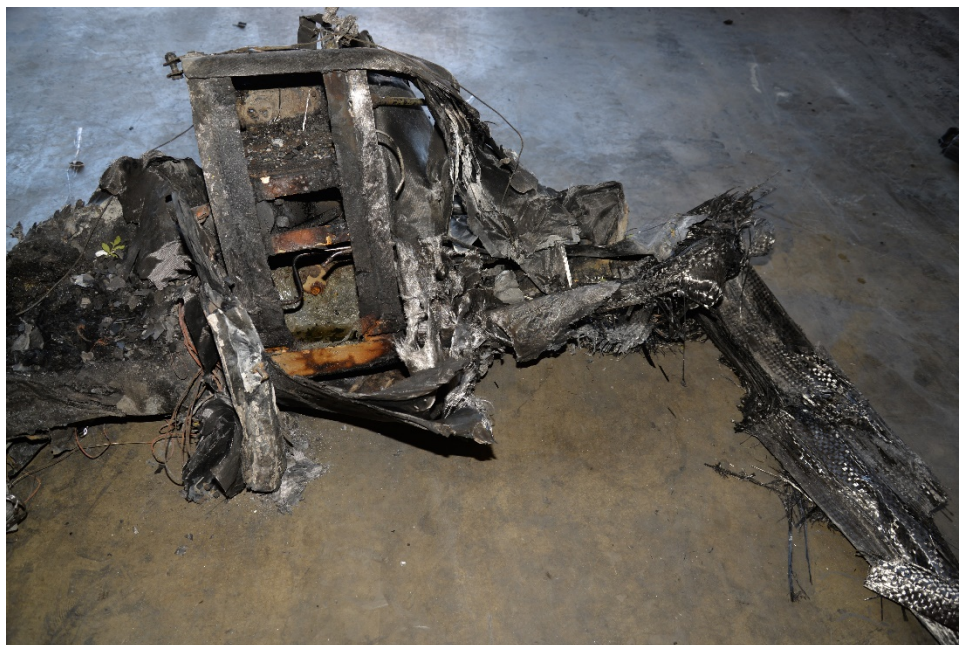
Figure 2: Left Wing Root (photo 2) and Remaining Left Spar

- Most of the airframe was consumed by the post impact fire. The engine cowling, forward fuselage, cabin fuselage, aft cabin, aft fuselage, most of the left and right wings, the horizontal and vertical stabilizers were not present.
- The empennage was laid out:
  - Both elevators were present and exhibited thermal damage.
  - The rudder was present and exhibited thermal damage.
  - The horizontal and vertical stabilizers were not present.
- The left wing root structure was present and exhibited heavy thermal damage.
  - The inboard portion of the left wing spar was present and attached to the wing root structure. The spar exhibited heavy thermal damage.

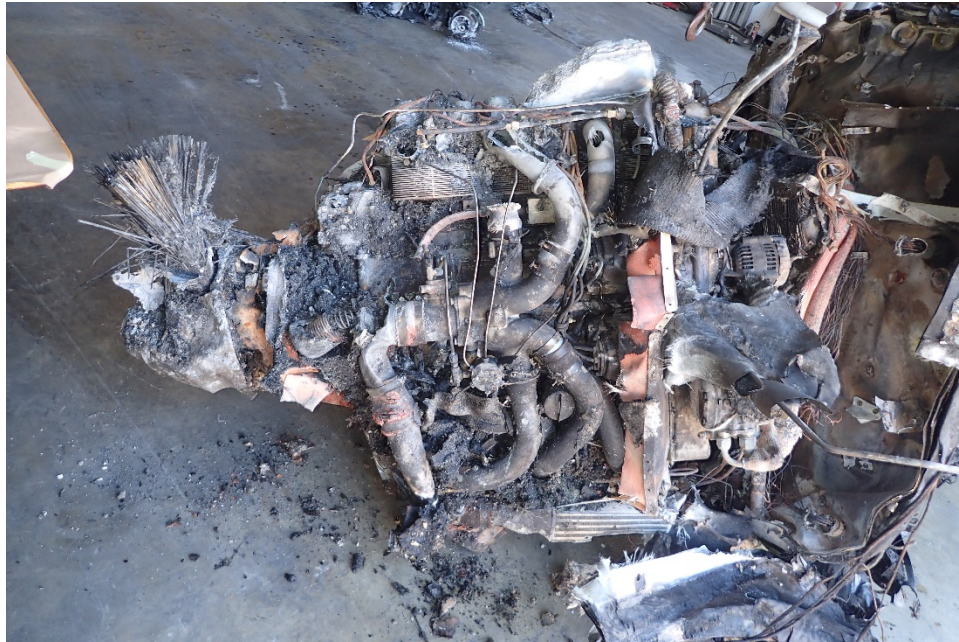
Figure 5: Top of Engine

- The engine remained attached to the firewall and instrument panel.
  - It was covered in fire related debris.
- The intake system exhibited some thermal damage and fire debris was noted within some of the tubing.

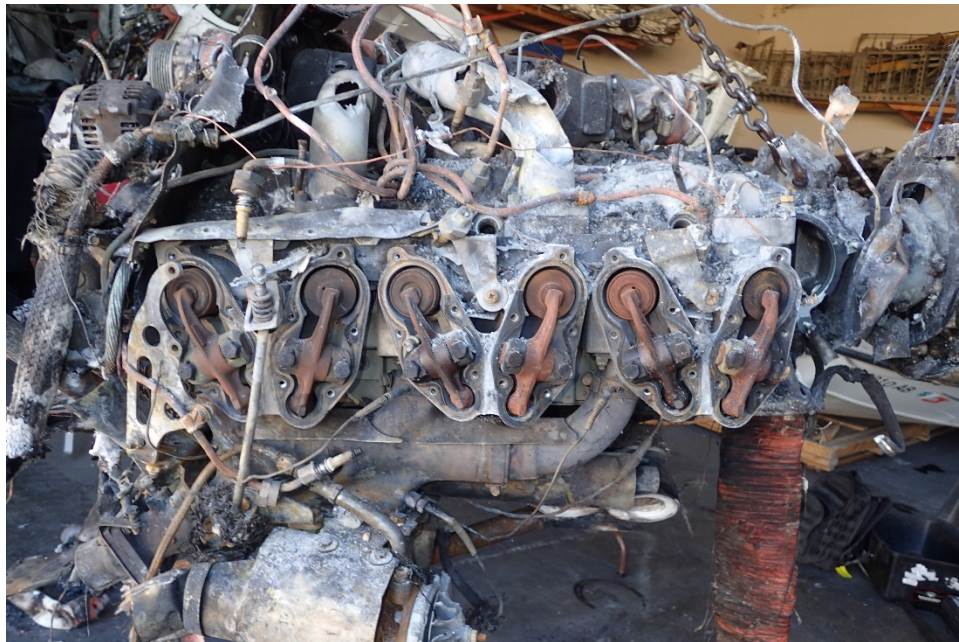
Figure 6: Right side of Engine (Cylinders 1, 3, 5)

- The rocker covers were removed from the engine:
  - The valves, rocker arms, and springs exhibited thermal damage on cylinders number 1, 2, 3, and 5.
  - The valves, rocker arms, and springs on cylinder number 4 exhibited minor thermal damage.

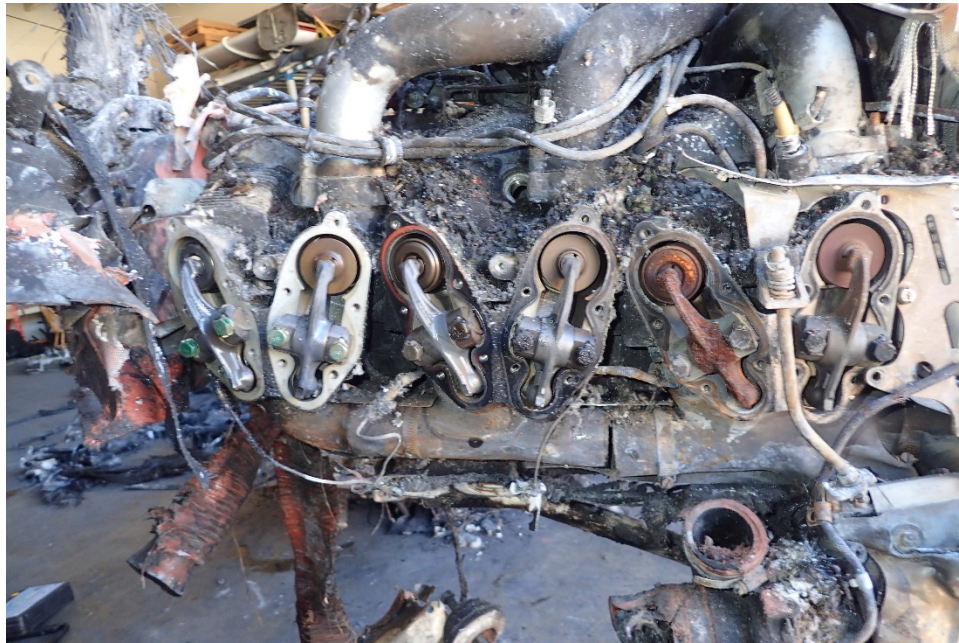
Figure 7: Left side of Engine (Cylinders 2, 4, 6)

- The valves, rocker arms, and springs on cylinder number 6 appeared almost consistent with normal.
- The fuel pump remained intact and was removed from the crankshaft.

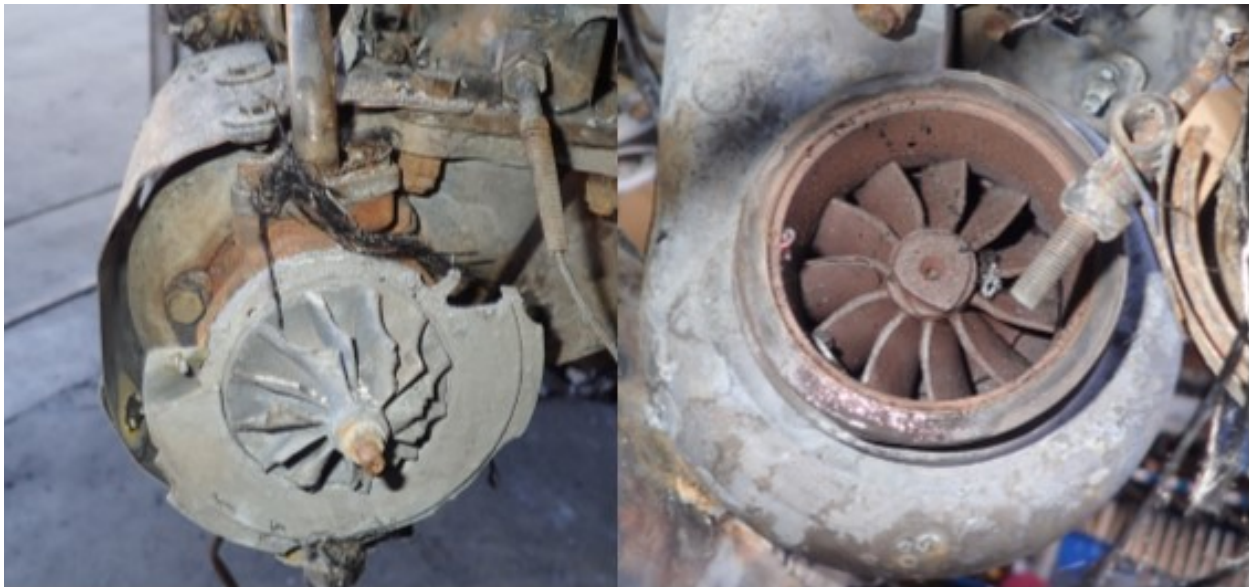
Figure 8: Right-side Compressor and Turbo

- The exhaust system was examined and exhibited heavy thermal damage.
- The turbochargers remained attached to the engine:
  - The right-side compressor housing was fracture separated.

- The compressor rotated only a few degrees consistent with impact damage to the housing.
    - The compressor blades exhibited rotational damage.
    - The turbo was mostly intact and exhibited thermal damage.

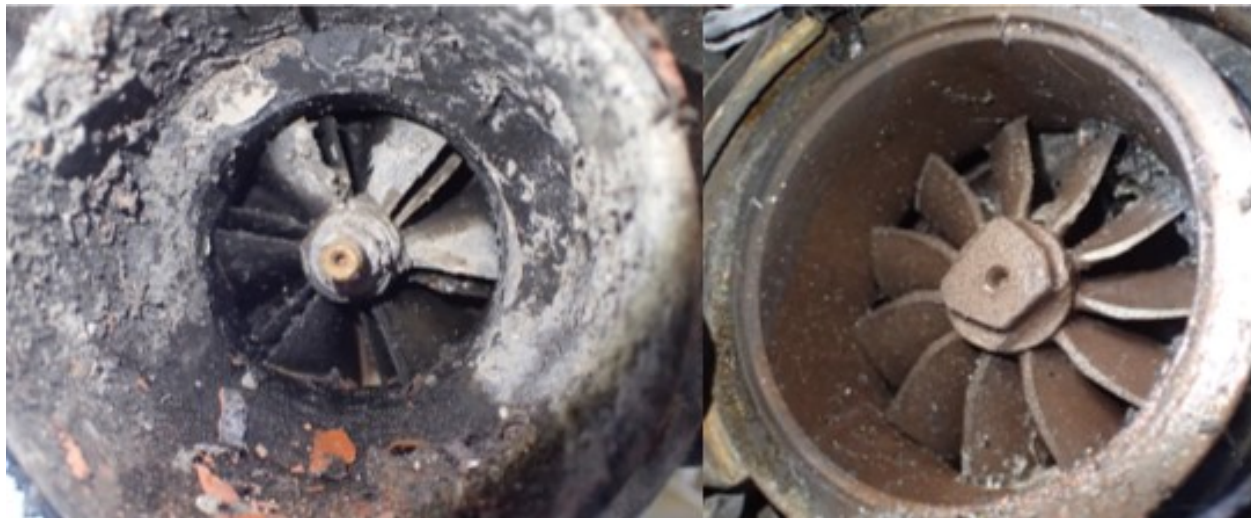
Figure 9: Left-side Compressor and Turbo

- The left-side compressor was heavily covered in fire related debris, which slightly restricted the compressor, but it rotated when manipulated by hand. The turbine rotated accordingly.

- The turbo was mostly intact and exhibited thermal damage.
- The oil filter was removed from the engine and opened. The case and filter screen exhibited heavy thermal damage; no metallic debris was noted.

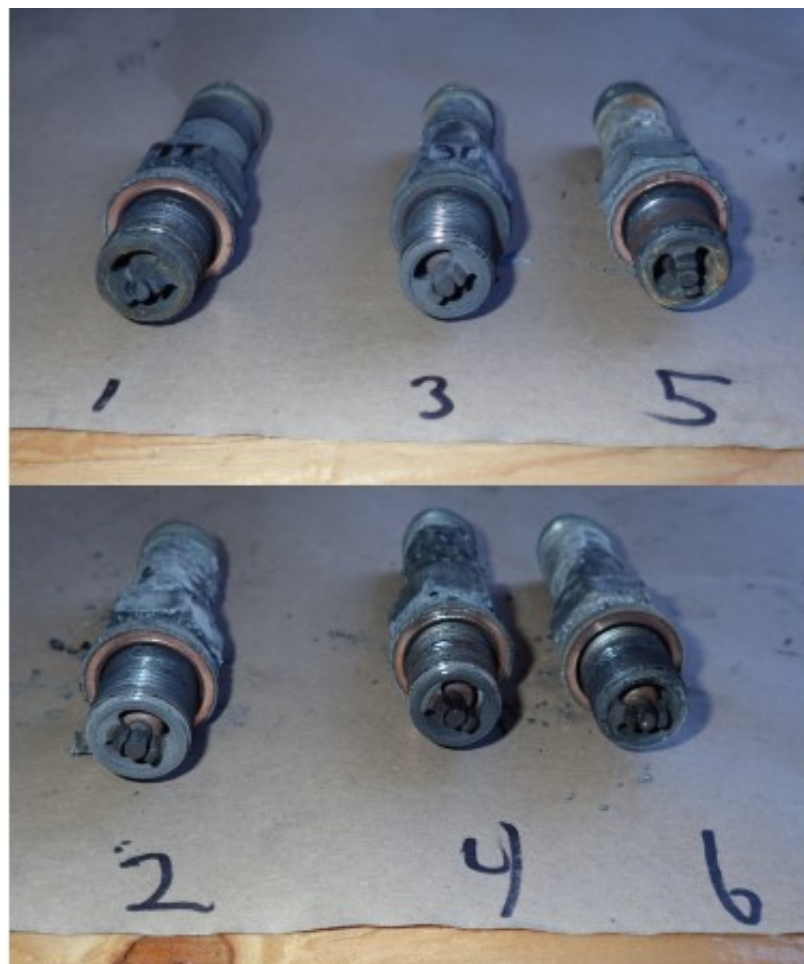
Figure 10: Upper Spark Plugs

- The upper spark plugs were removed and exhibited normal operating wear signatures.
- The crankshaft was rotated by hand and thumb compression and valve continuity was established throughout.

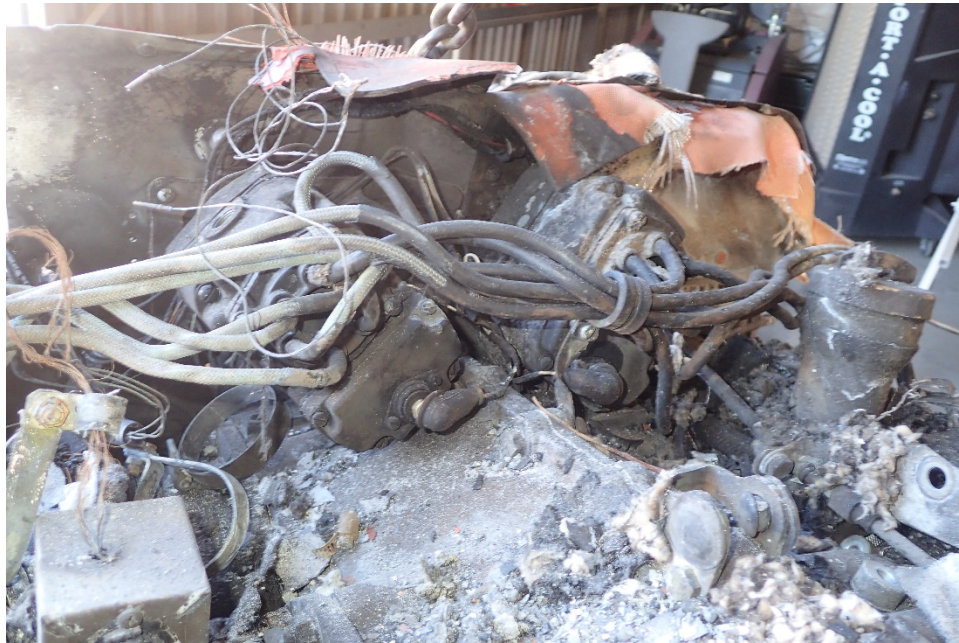
Figure 11: Magnetos

- The ignition harness was mostly intact but exhibited thermal damage.
- The magnetos were inspected for their timing marker. The right magneto timing marker was present; however, the left magneto gear was not visible in the window.

- The right magneto was removed from the engine and rotated; spark was obtained on all terminals
  - The left magneto was removed from the engine and disassembled.

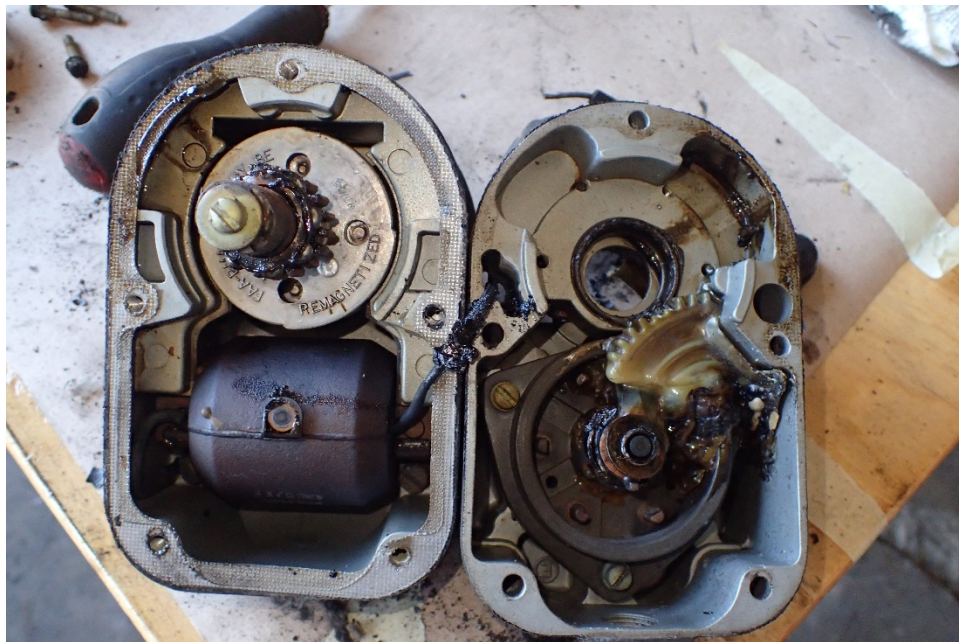
Figure 12: Left Magneto

- The timing gear was melted, otherwise the internal components were consistent with normal
- The fuel manifold remained intact but exhibited thermal damage. The fuel manifold lines remained attached and the nozzles were clear of debris with the exception of the #5 cylinder.

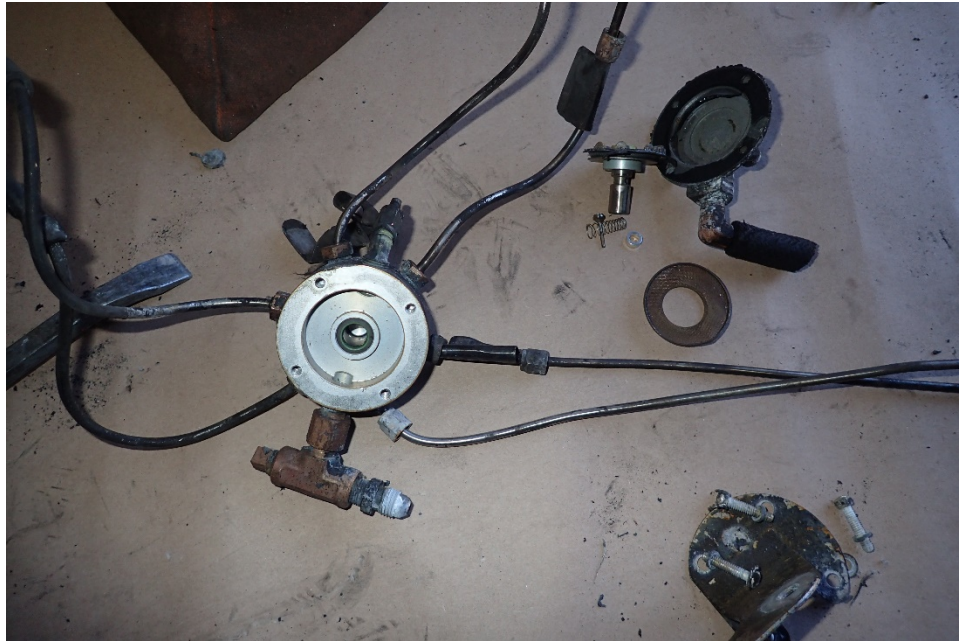
Figure 13: The Fuel Manifold

- The #5 nozzle was emptied and burned debris exited.
- The fuel manifold was disassembled
  - The screen was clear of debris.
  - The internal components exhibited significant thermal damage, but the wear was otherwise consistent with normal operation.

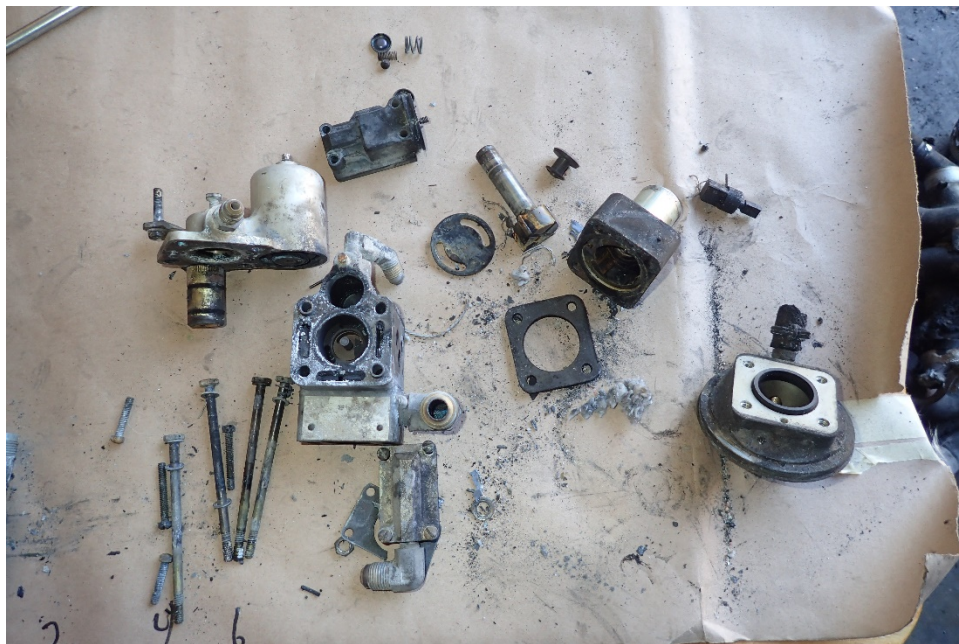
Figure 14: The Fuel Pump

- The pump was seized and would not rotate freely by hand. It exhibited heavy thermal damage.
  - The fuel pump was disassembled, and all components exhibited thermal damage, but were otherwise consistent with normal operations.

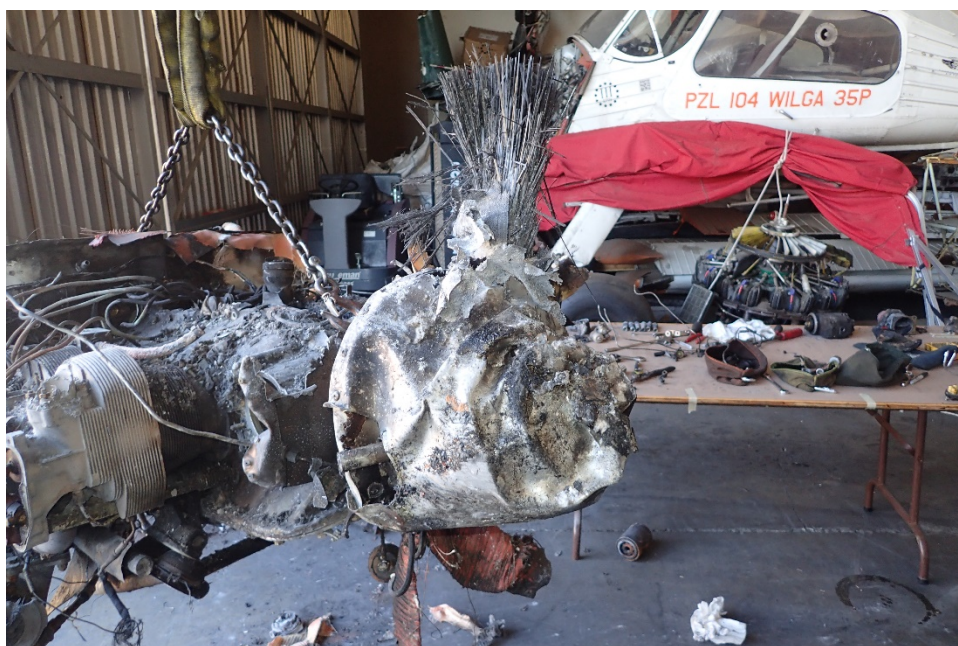
Figure 16: Spinner and Propeller Blades

- Propeller blades
  - All three propeller blades remained attached at the hub, but were separated at the blade roots
    - One blade was completely gone and only the balance tube was present. It was bent at about a 45-degree angle.

- The second blade was also completely gone with only the balance tube remaining, which was only slightly bent.
    - About 1/3 of the blade root remained on the third propeller.

- The blade root exhibited heavy thermal damage.
      - The outboard about 2/3rds was not present.
  - The spinner remained attached and mostly whole, although it exhibited some crush damage and heavy thermal damage.
