## **NATIONAL TRANSPORTATION SAFETY BOARD**

# **WRECKAGE EXAMINATION SUMMARY**

**WPR20FA031**

Location: Descanso, California  
Date: August 22, 2018  
Aircraft: N1682G, American Champion-7KCAB  
NTSB Investigator-in-Charge: Andrew Swick

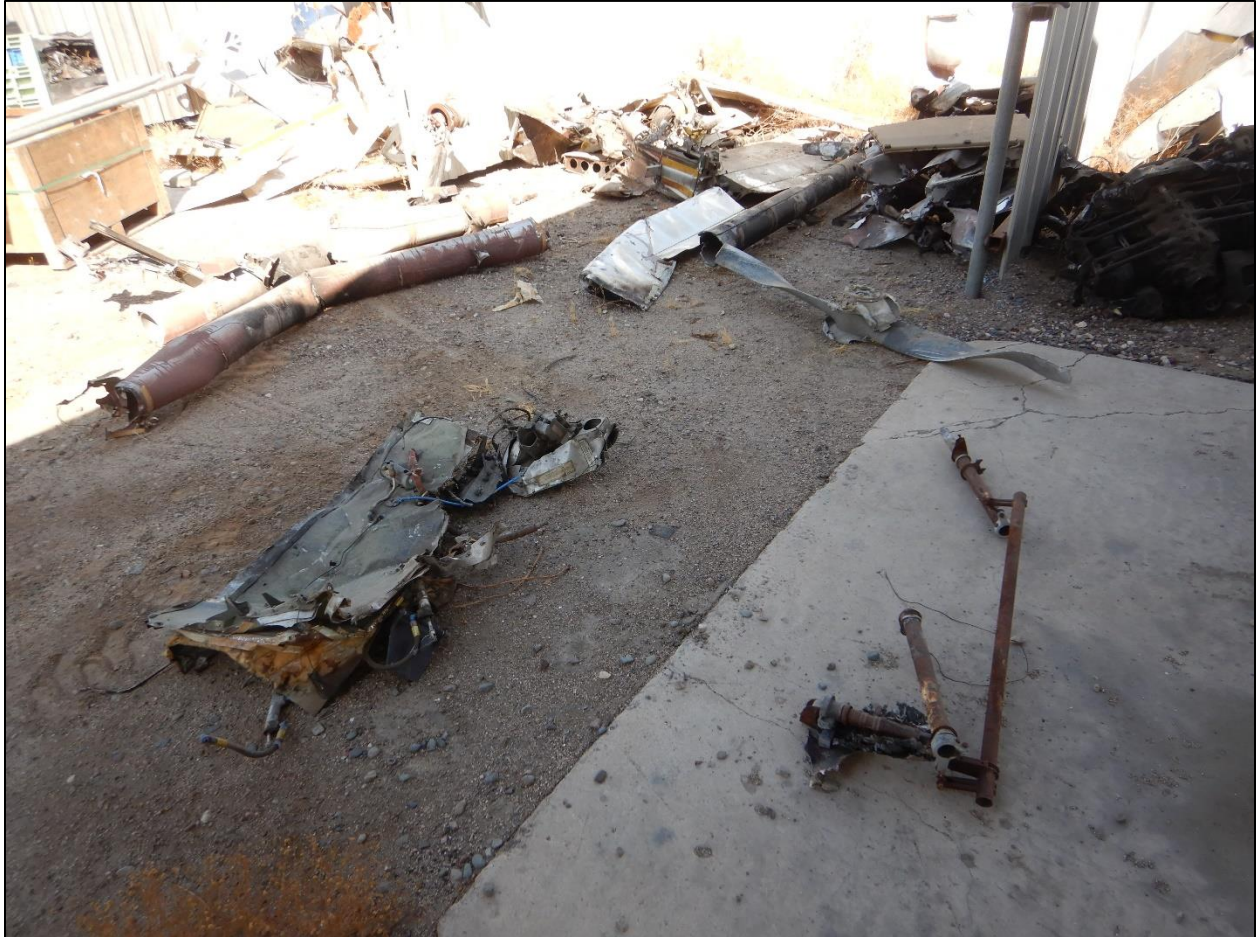
**Figure 1-Main Wreckage**

The main wreckage had excessive impact and thermal damage. Sections were laid out and parts were identified. Flight control surfaces were previously labeled [onsite examination] with a sharpie marker. The spar had impact damage and was separated into several sections. The flight control cables were found in the main wreckage and were distorted and cut during the relocation of the wreckage. Cable turnbuckles and attachment ends remained intact and undamaged.

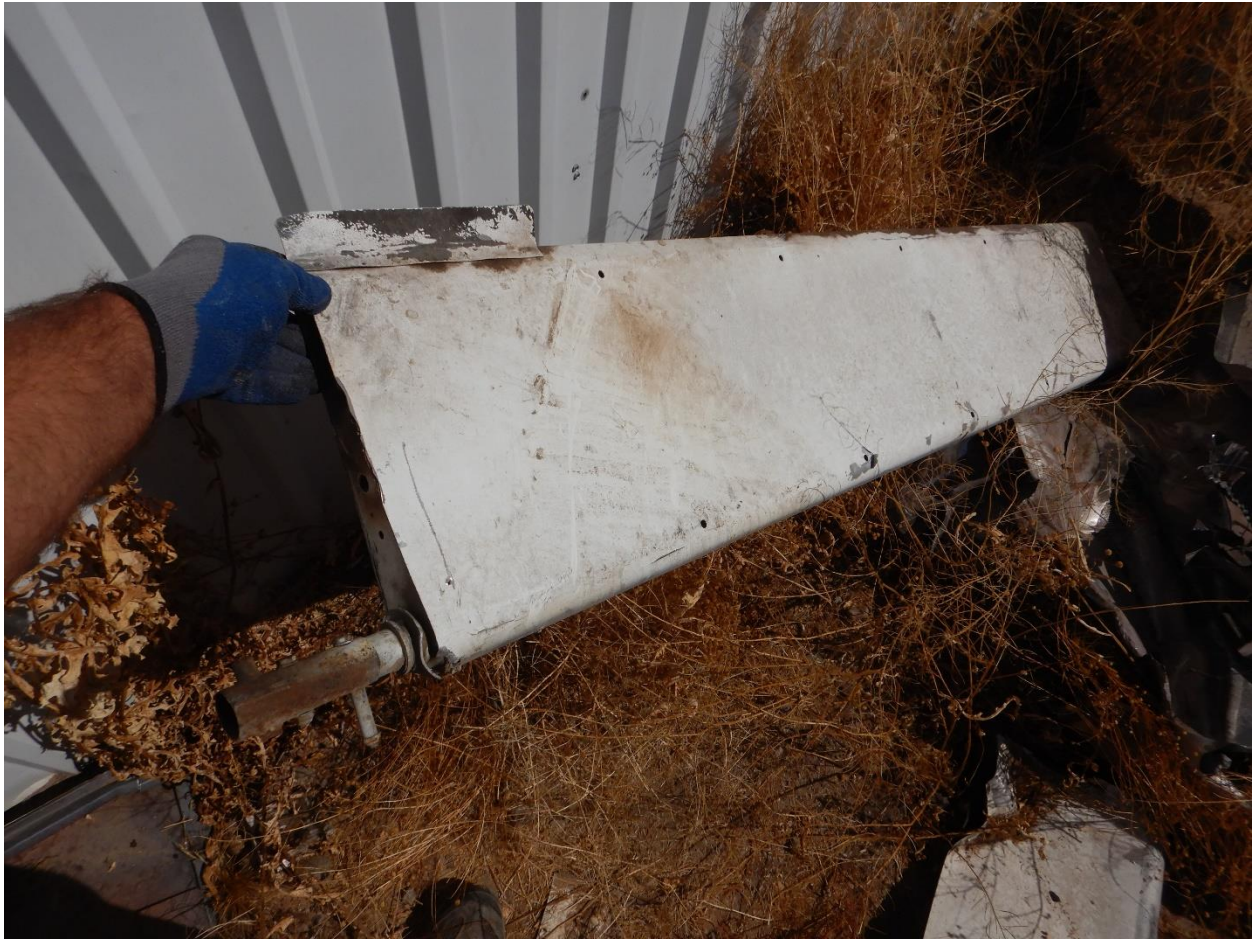
**Figure 2-Aileron**

The ailerons separated from the wing. The control cable attachment ends separated from both ailerons.

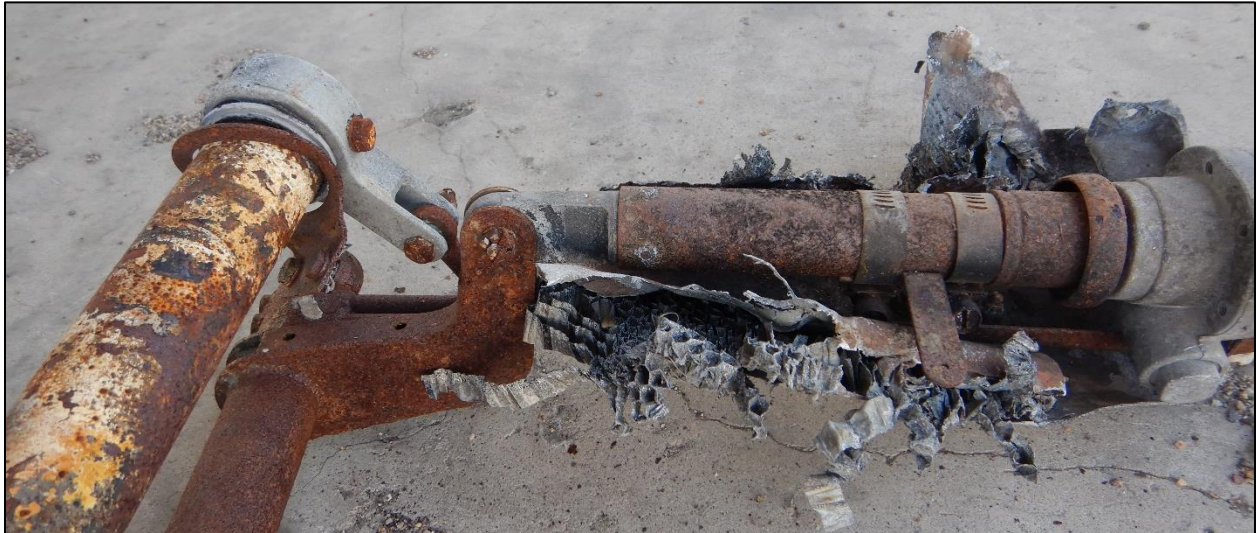
**Figure 3-Jackscrew and torque tube assembly.**

A jackscrew and attached torque tube assembly separated from the main wreckage and both had impact and thermal damage. The jackscrew appeared to be in the full retracted position.

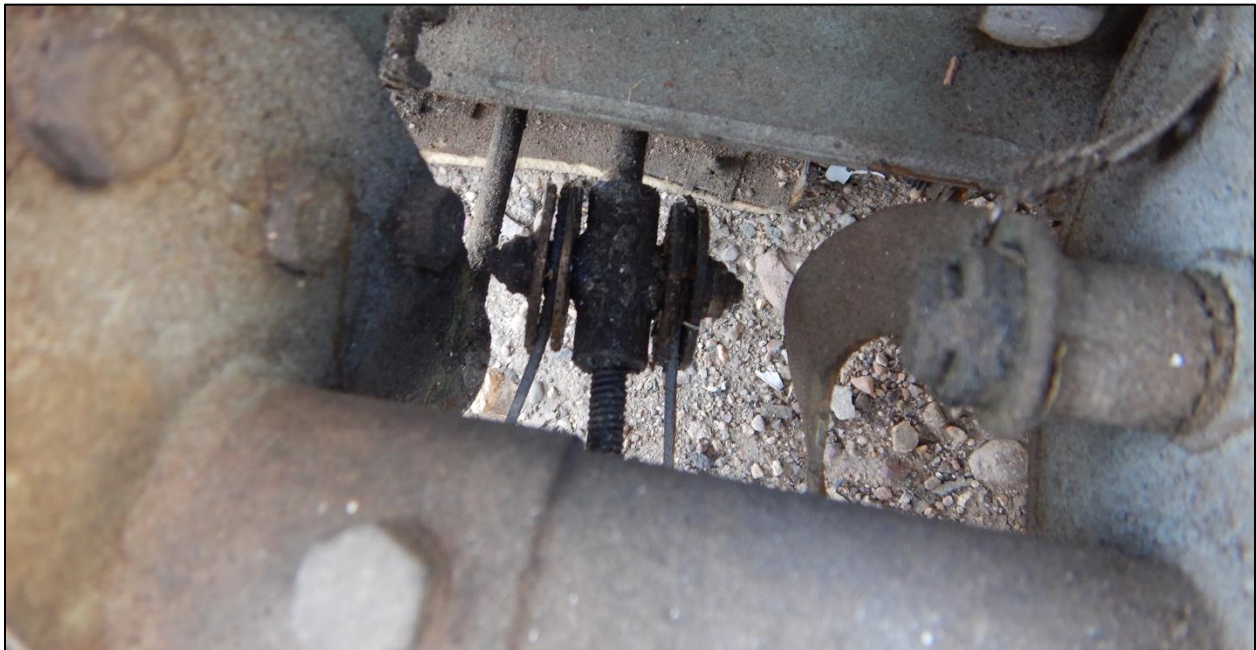
**Figure 4-Elevator trim assembly.**

The elevator trim assembly remained attached to the empennage. The aft side of the trim assembly jackscrew shaft threads were visible. The forward side of the jackscrew did not reveal any shaft threads.

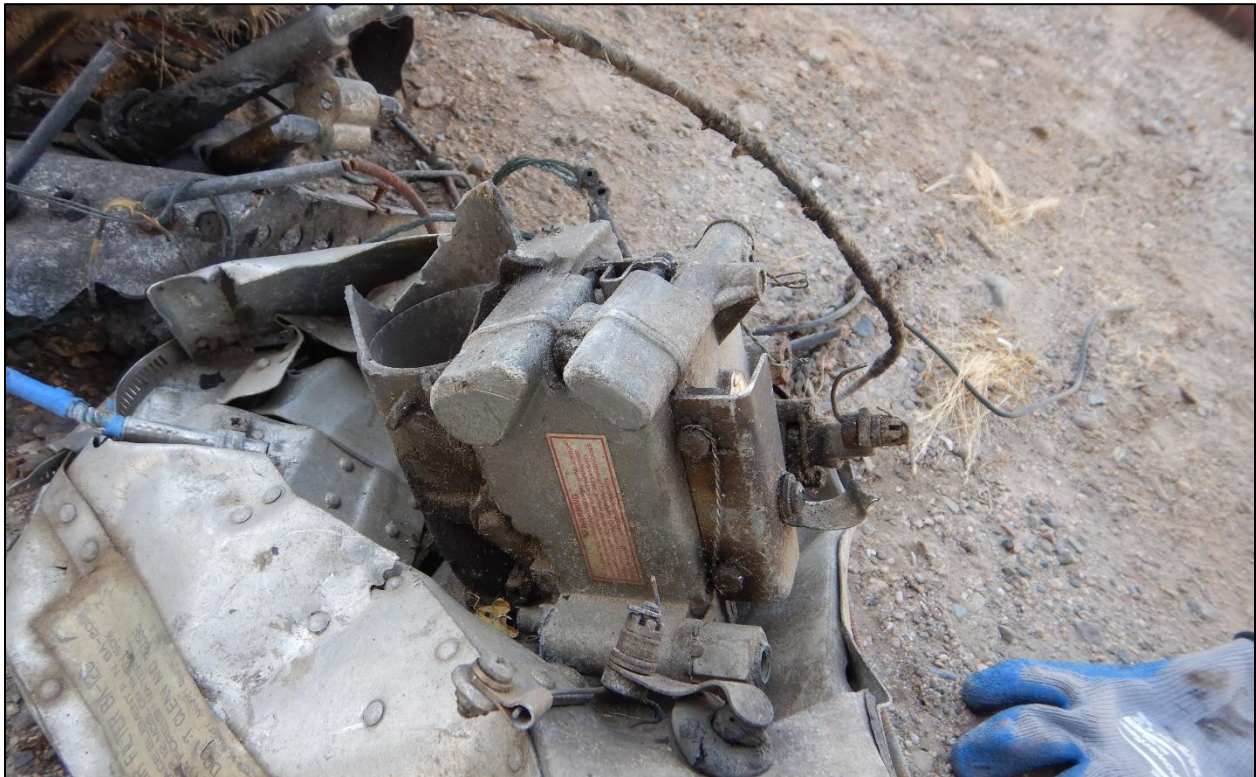
**Figure 5-Carburetor and airbox.**

The carburetor separated from the engine and was found with the main wreckage. The carburetor had impact and thermal damage. The throttle body and engine mounting flange separated. Mixture and throttle cables separated from their respective lever arms. The carburetor remained attached to the airbox.

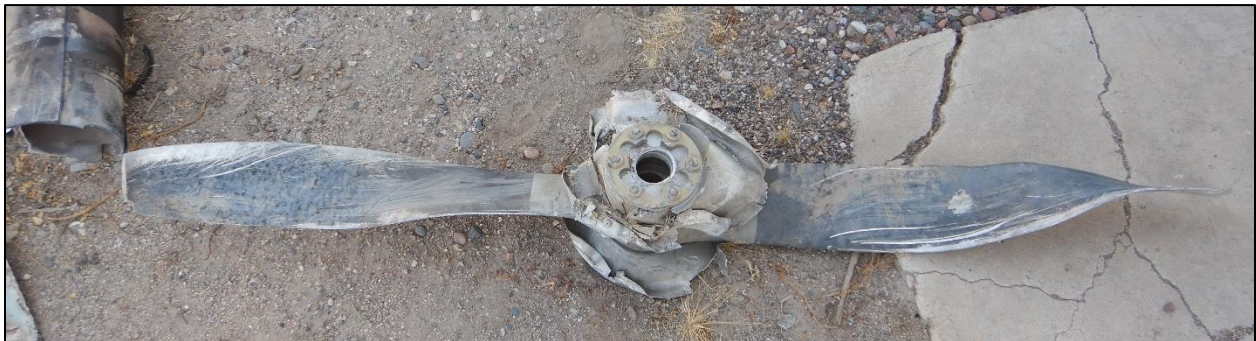
**Figure 6-Propeller assembly.**

The propeller separated from the engine and was found with the main wreckage. The propeller spinner had impact damage and only the backplate assembly and a small section of bent spinner material remained. The blades had spanwise gouging, leading edge scuffing and decrease pitch twisting. About 2 inches of blade material was missing from each blade tip.

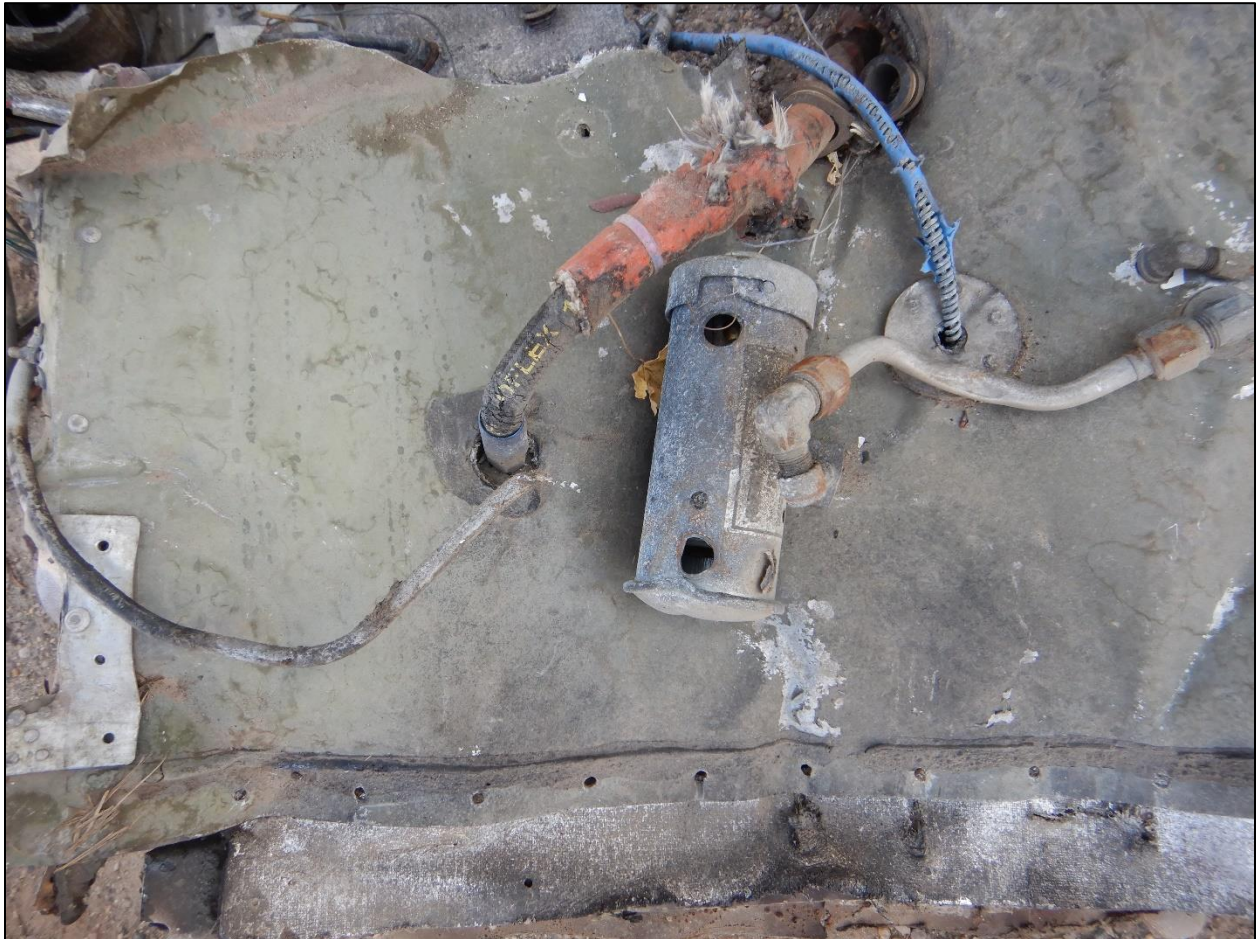
**Figure 7-Electric fuel pump.**

The inline electric fuel pump had impact and thermal damage and remained attached to the firewall which separated from the main wreckage. Both the inlet and outlet lines separated from the pump.
