## ENGINE EXAMINATION REPORT

| ENGINE MODEL | O-470-R |
| AIRCRAFT MAKE & MODEL | Cessna 182F |
| FILE NUMBER | 19-146 |

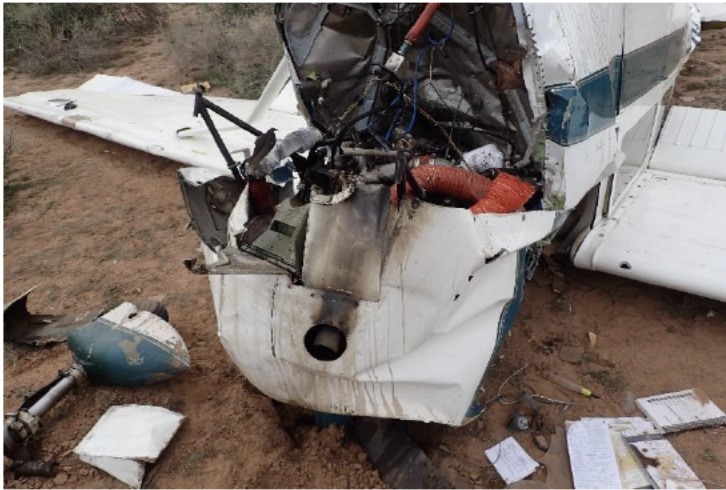
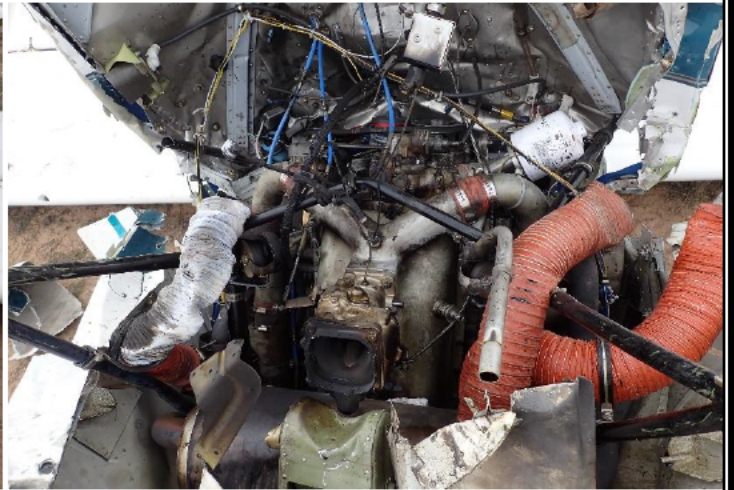
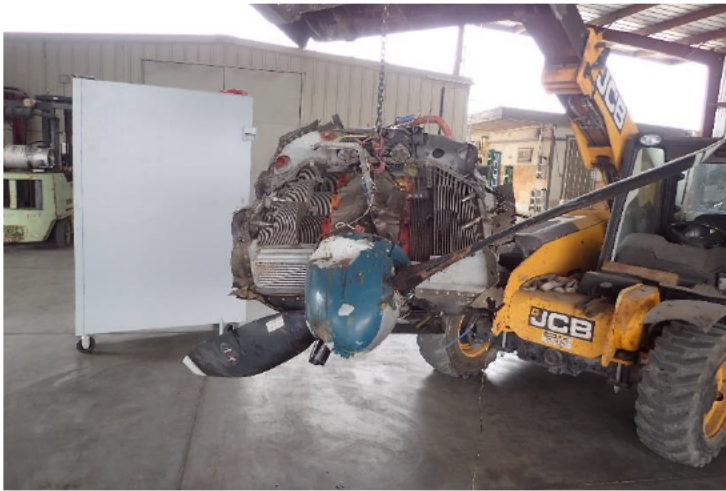
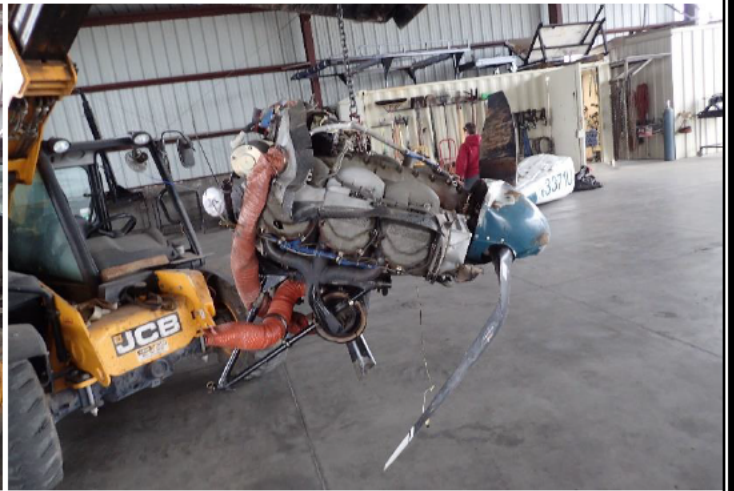
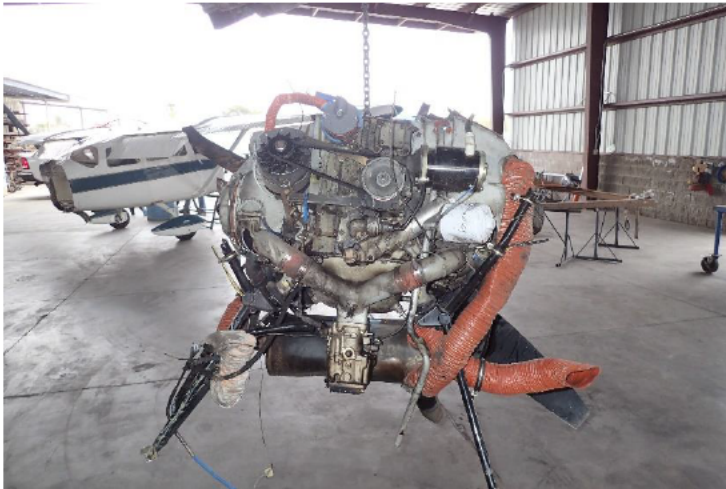
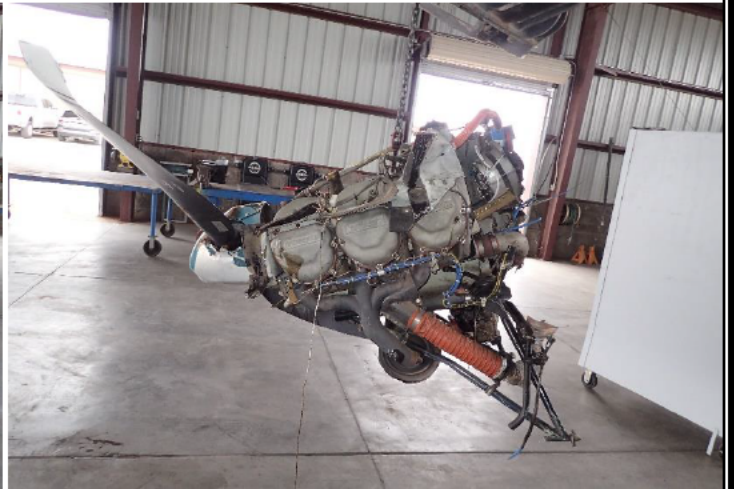
The engine remained partially attached to the airframe through cables, wires, and hoses; all four engine mounts were broken. The engine displayed impact damage signatures as well as some minor thermal damage signatures. The crankcase remained intact and there were no holes in the crankcase that would indicate a catastrophic internal engine failure. It was observed that there was significant staining on the rear of the crankcase consistent with oil staining as well as some fresh oil. The two-blade, constant speed propeller remained attached to the crankshaft and displayed impact damage signatures. The external portion of the crankshaft was noted to be intact and there were no cracks observed in the external portion of the crankshaft. All six cylinders remained attached to their cylinder bays and displayed varying amounts of impact damage signatures.

Both magnetos remained attached to their installation points and were undamaged. The ignition harness remained attached to both magnetos as well as each spark plug; the #2 top spark plug ignition lead displayed impact damage signatures to the lead end. The spark plugs remained installed in their cylinders and were undamaged.

The carburetor remained attached to its installation point and displayed minor impact damage signatures as well as minor thermal damage signatures. There were no signs of fuel leaks observed around the carburetor.

The exhaust system remained attached to the engine and displayed impact damage signatures with most of the damage occurring to the tailpipe. There were no signs of exhaust leaks observed. The induction system displayed impact damage signatures; several of the induction tubes were broken. There were no signs of intake leaks observed.

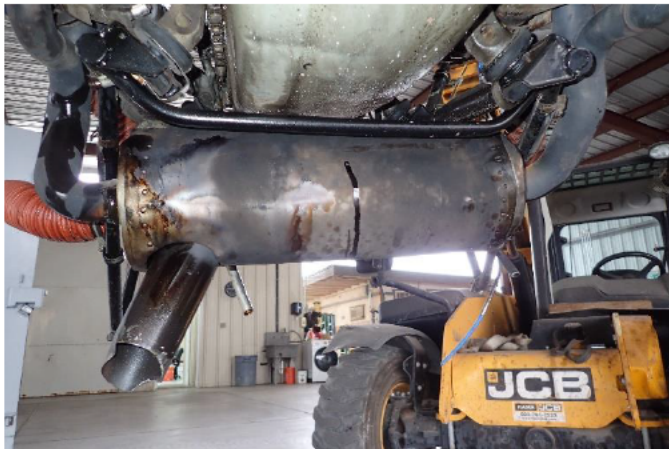
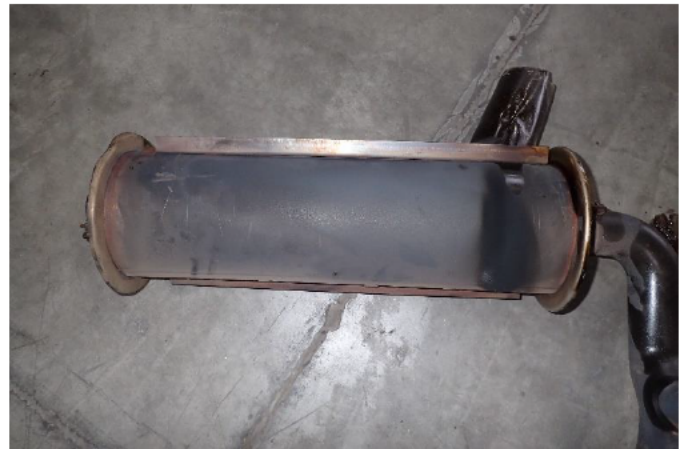
The exhaust system remained attached to the engine and displayed impact damage signatures with the most damage occurring to the tailpipe. The exhaust was removed and the heat exchanger shroud was removed. There were no signs of exhaust leaks observed. It was noted that one of the flame cones had almost completely broken away and no portion of the flame cone was observed; the other flame cone remained installed and a small portion had broken away. There were no blockages observed in the exhaust system.

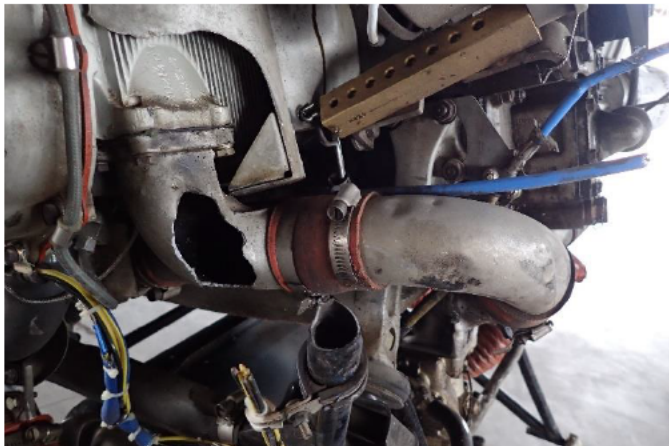
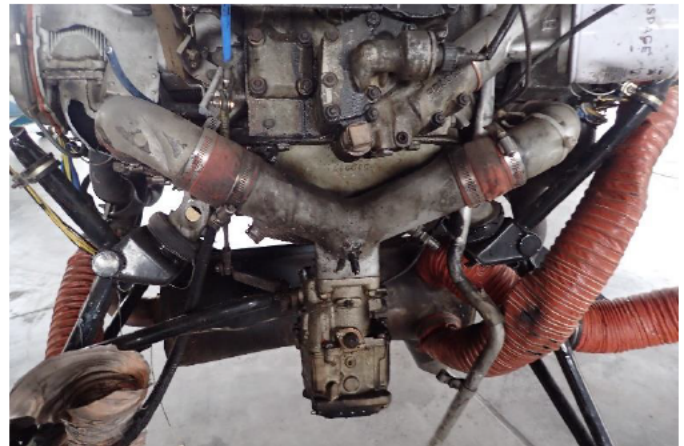
The induction system remained attached to the engine and displayed impact damage signatures; several of the intake tubes were broken. There were no signs of intake leaks or obstructions observed.

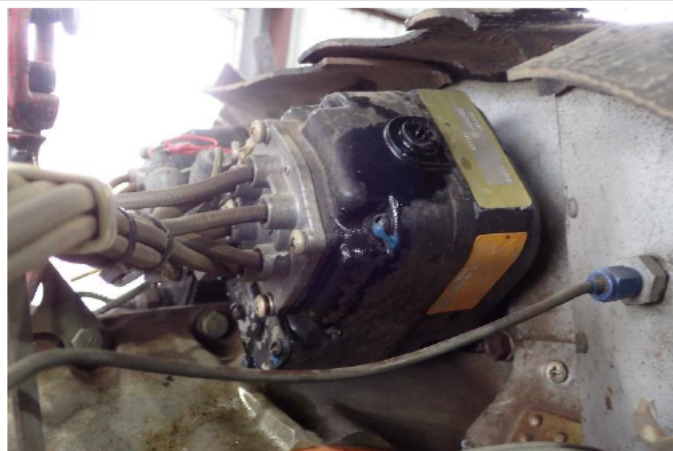
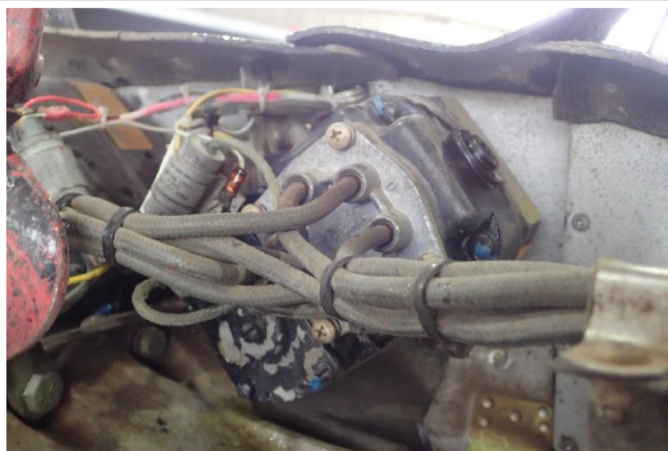
The magneto remained attached to its installation point and was undamaged. During crankshaft rotation, it was observed that the impulse coupling operated normally. The magneto was capable of producing a spark to each ignition lead in the correct firing order and was in sync with the right magneto. The magneto timing was observed to be 24° before top center (BTC). NOTE: Timing specification for an O-470-R is 22° BTC

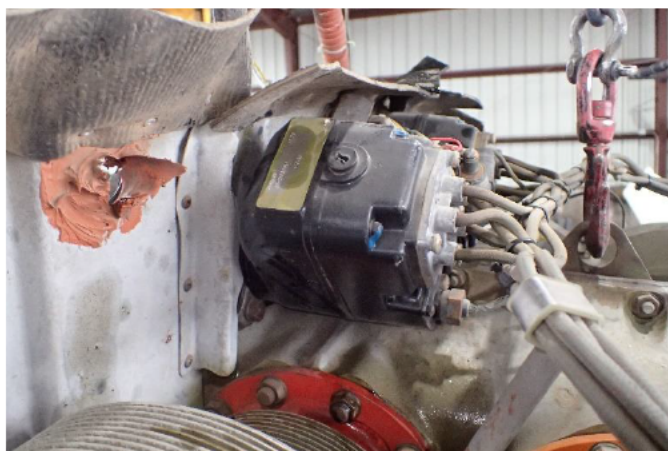
The magneto remained attached to its installation point and was undamaged. During crankshaft rotation, it was observed that the impulse coupling operated normally. The magneto was capable of producing a spark to each ignition lead in the correct firing order and was in sync with the left magneto. The magneto timing was observed to be 22° before top center. NOTE: Timing specification for an O-470-R is 22° BTC

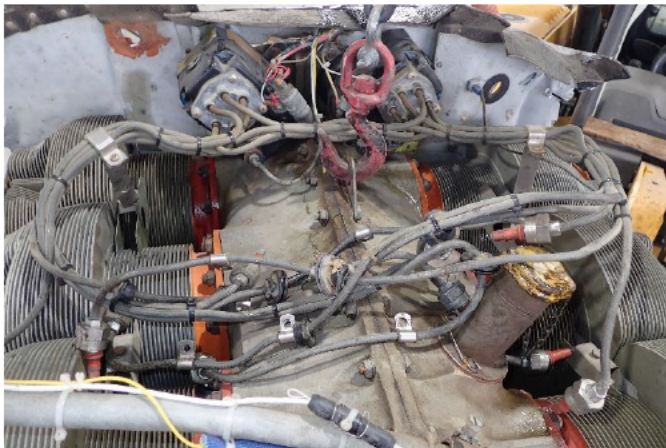
The ignition harness remained attached to both magnetos and to each spark plug. The #2 top spark plug ignition lead end displayed impact damage signatures and was partially severed. During magneto operation, it was observed that each ignition lead was capable of conducting a spark from the magneto to each ignition lead end or to the severed portion of the #2 top spark plug.

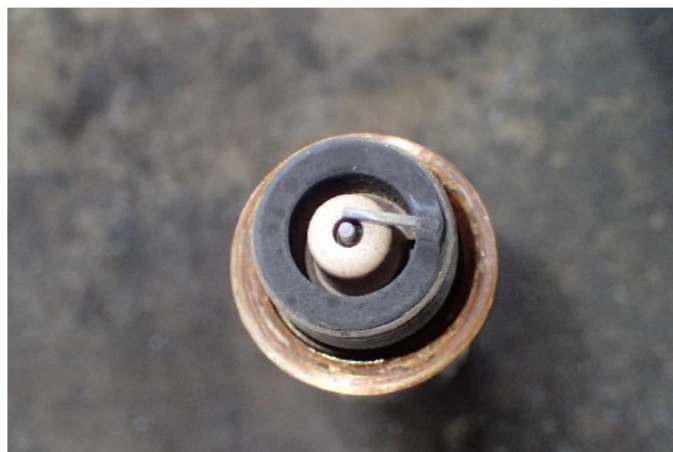
#1 Top Spark Plug

The spark plugs remained installed in their cylinders and were undamaged. The top spark plugs were removed for examination and the bottom spark plugs were examined using a lighted borescope. The spark plug electrodes displayed normal operating and wear signatures.

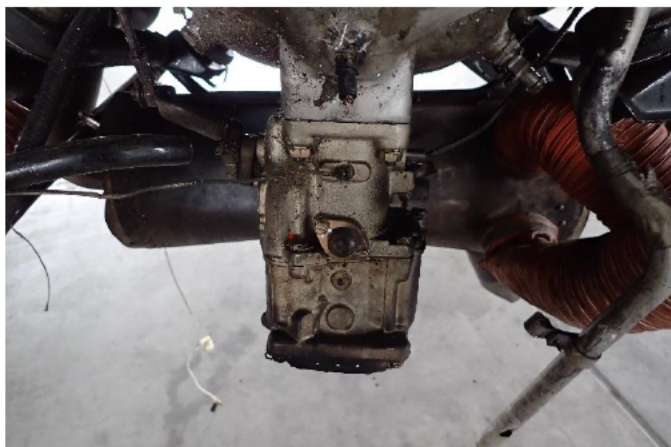
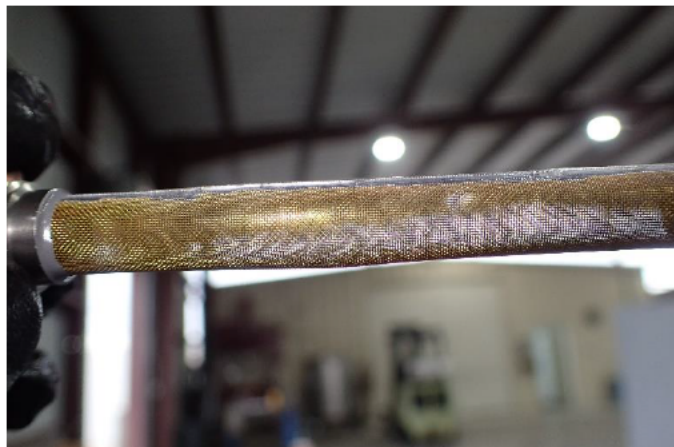
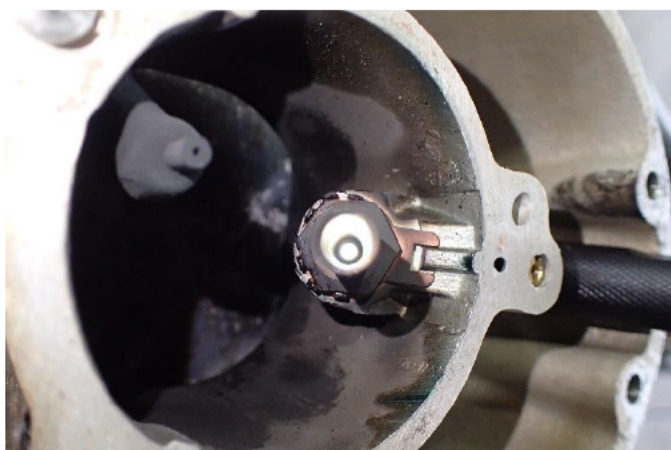
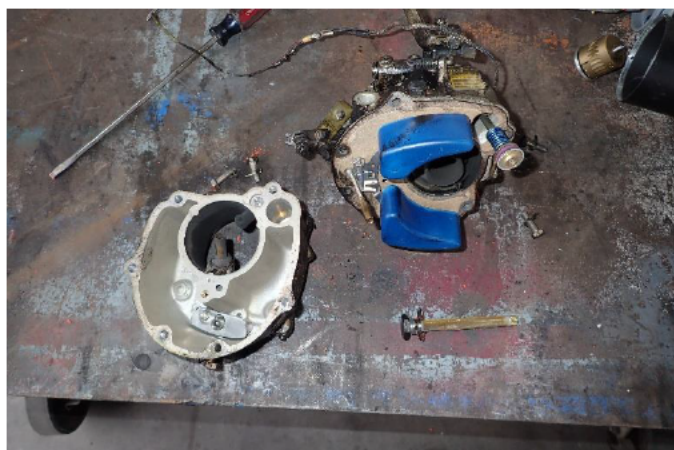
The carburetor remained attached to its installation point and displayed impact damage signature as well as some thermal damage signatures. The throttle cable rod end remained attached to the throttle control rod and was properly secured. The mixture control cable had pulled out of the mixture control attach bolt; however, the mixture cable displayed impact damage signatures. The throttle was found near idle and the mixture control arm was found near the full rich position. The carburetor was removed and disassembled; there was no fuel found in the carburetor bowl. The internal components displayed normal operating signatures; the main metering jet was checked for obstructions and was found to be clear. The fuel inlet screen was clear of any debris. Air was blown into the carburetor inlet and it was noted that the carburetor float valve was capable of operating normally.

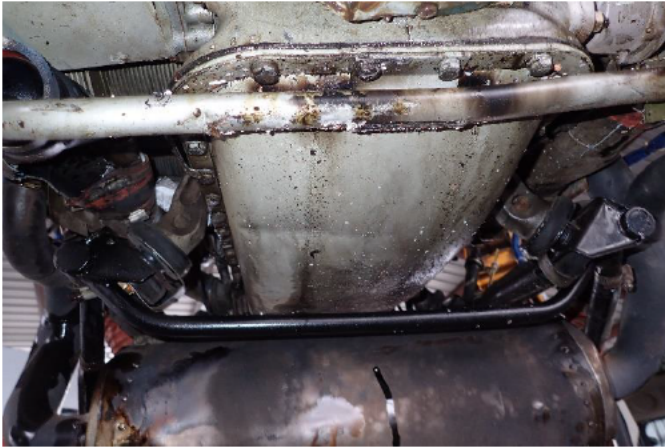
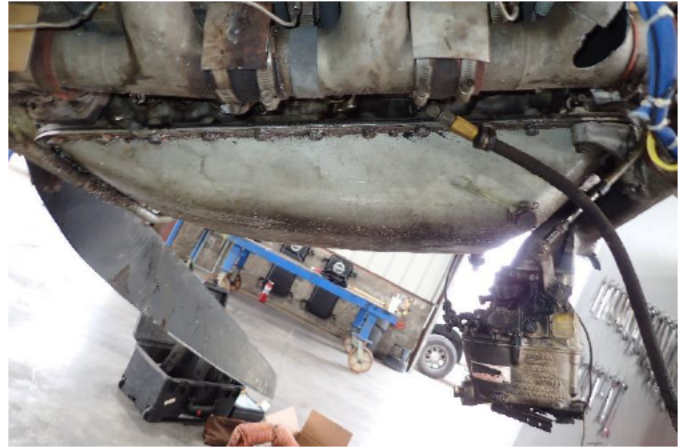
The oil sump remained attached to the engine and displayed minor impact damage signatures.

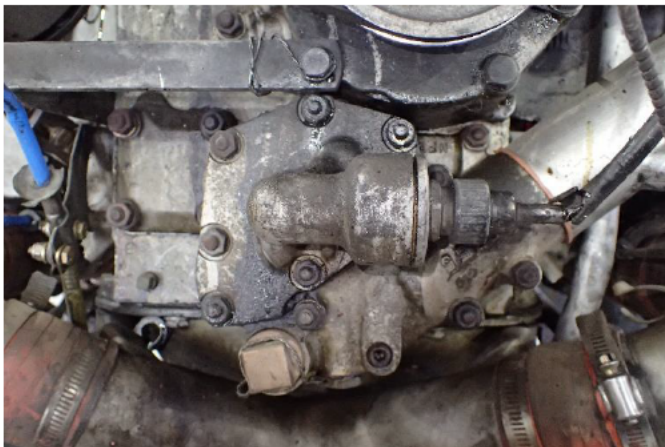
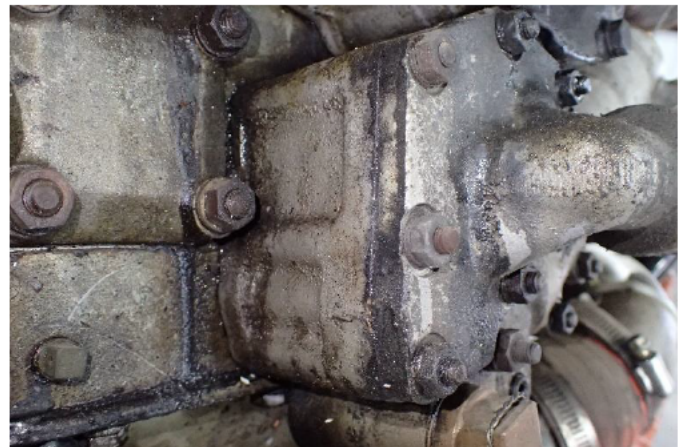
The oil pump remained attached to its installation point and was undamaged.

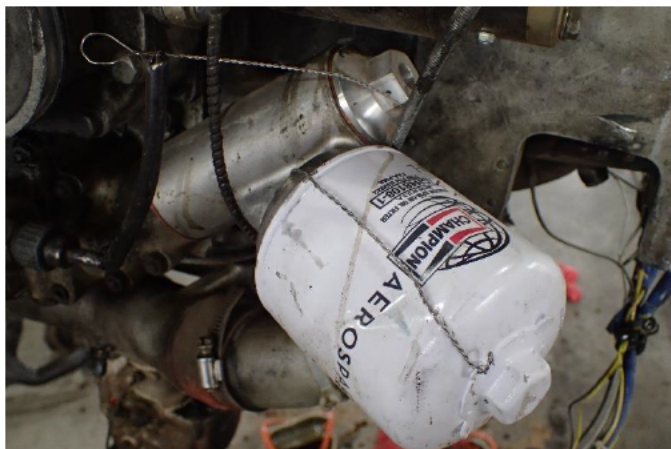
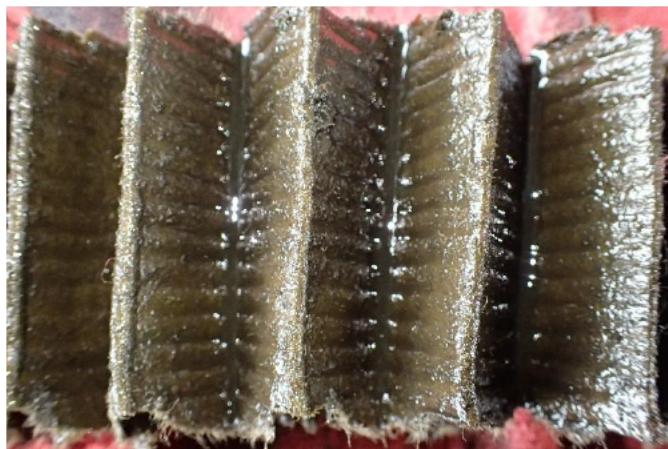
The oil filter remained attached to its oil filter adapter; it was noted that the oil filter adapter was an aftermarket STC installation. The oil filter adapter was noted to be tight. The oil filter was removed, and the oil filter housing was cut open. The filter pleats were visually inspected; there was no metallic material noted within the oil filter pleats.

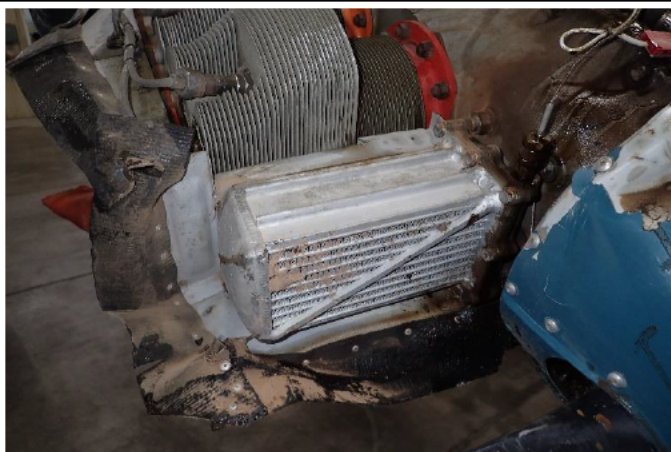
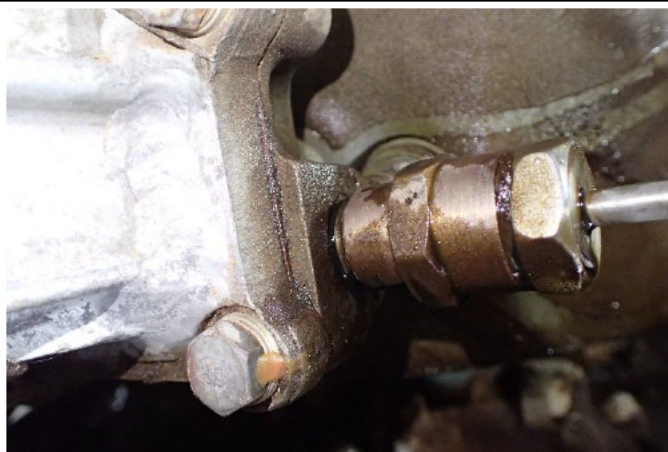
The oil cooler remained attached to its installation point and displayed impact damage signatures. The oil temperature probe was installed and displayed fresh oil residue around the probe.

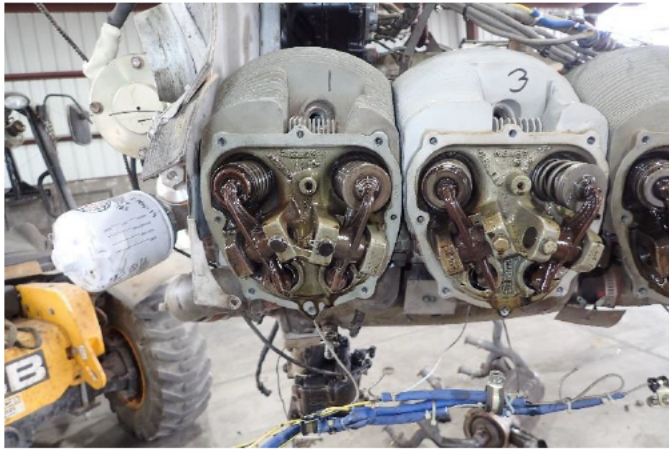
#1 Cylinder Overhead

All six cylinders remained attached to their cylinder bays and displayed varying amounts of impact damage. The cylinders were inspected using a lighted borescope; the cylinder bores, piston faces, and valve heads displayed normal operating and combustion signatures. During crankshaft rotation the cylinders displayed good thumb compression and suction. The overhead components (valves, springs, and rocker arms) displayed normal operating and lubrication signatures.

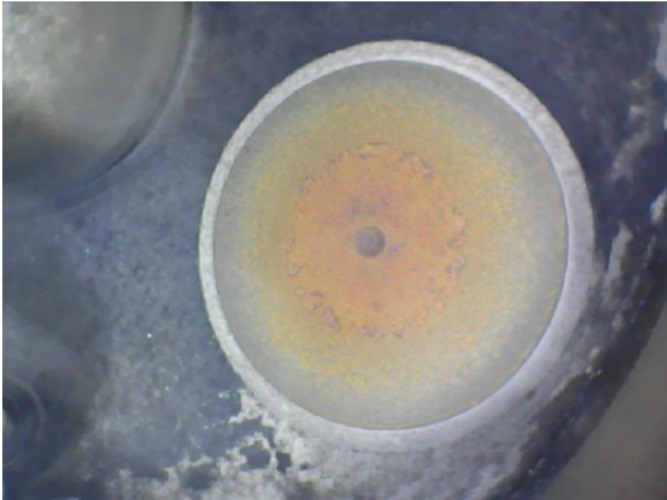
#1 Exhaust Valve

The valve heads were inspected using a lighted borescope. The #1 and #3 exhaust valves had a green, even discoloration to the valves; however, the valves remained intact and did not display any signs of being stuck. The rest of the valve heads displayed normal operating and combustion signatures. During crankshaft rotation all of the valves operated normally.

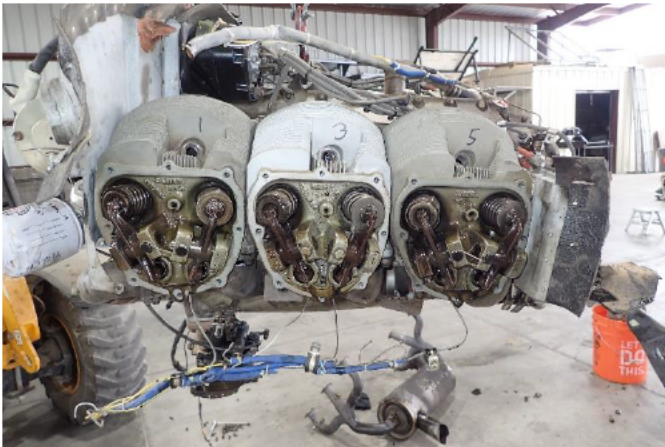
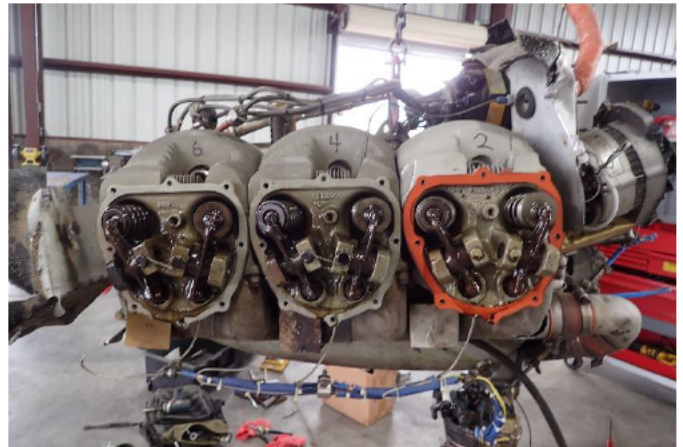
The rocker arms displayed normal operating and lubrication signatures. During crankshaft rotation all of the rocker arms operated normally.

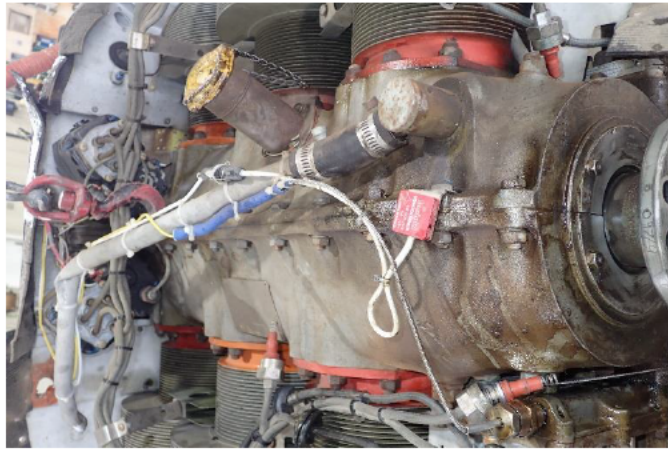
| Condition: | The crankcase remained intact and was undamaged. There were no holes in the crankcase that would indicate a catastrophic internal engine failure. There were no anomalies observed. | | | |

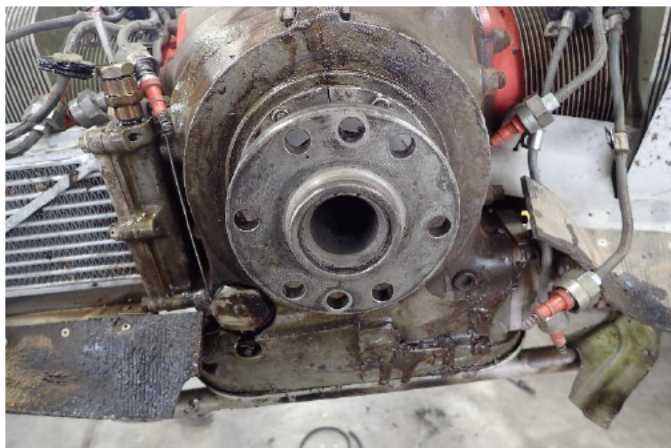
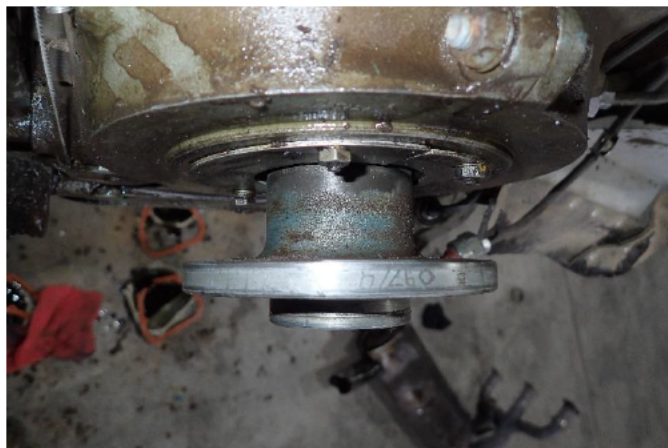
The propeller flange remained attached to the rest of the crankshaft and there were no cracks noted in the external portion of the crankshaft. The crankshaft was rotated by hand and continuity was established between the crankshaft, camshaft, connecting rods, and associated components.

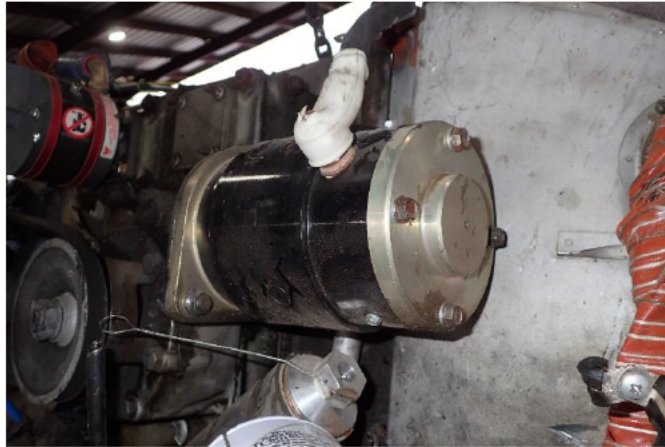
The starter remained attached to the starter adapter and displayed minor impact damage.

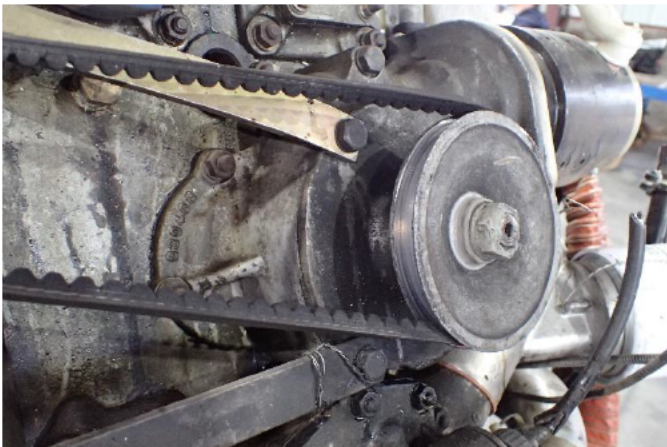
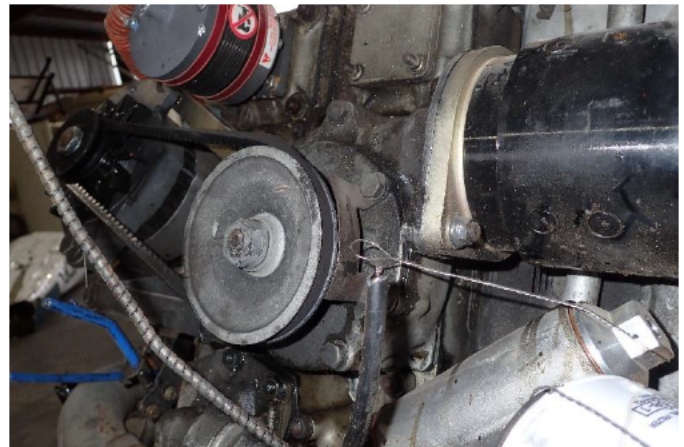
The starter adapter remained attached to its installation point and was undamaged. During crankshaft rotation, it was observed that the starter adapter pulley operated normally.

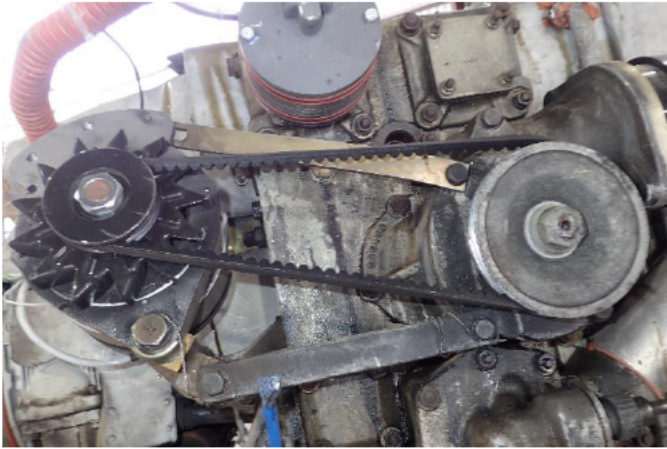
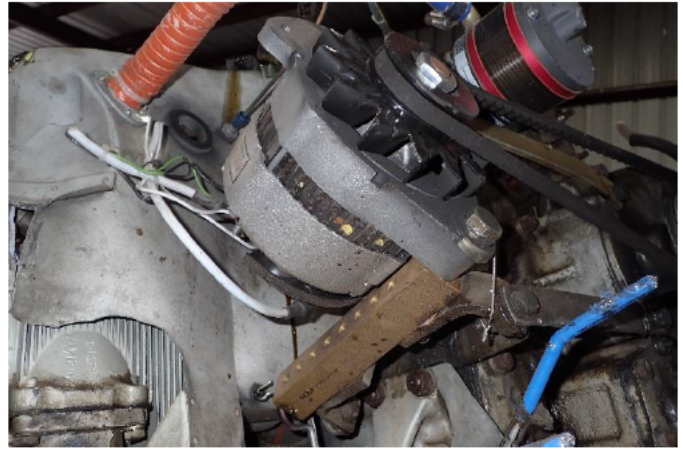
The alternator remained attached to its installation point and displayed impact damage signatures. The alternator belt remained attached to the alternator and to the starter adapter pulley. The alternator drive was capable of partially rotating with resistance which was consistent with the impact damage observed.

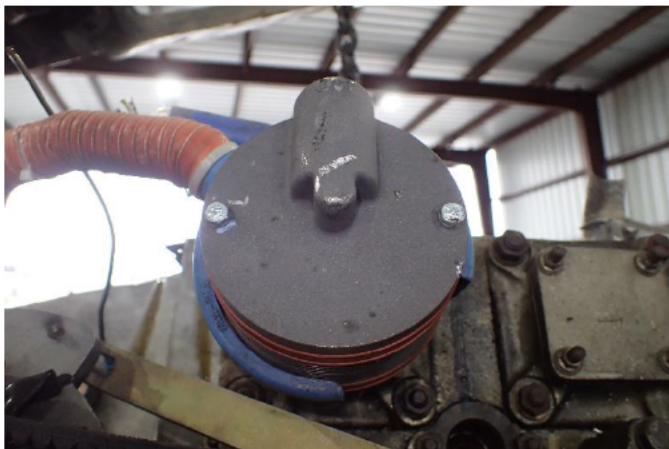
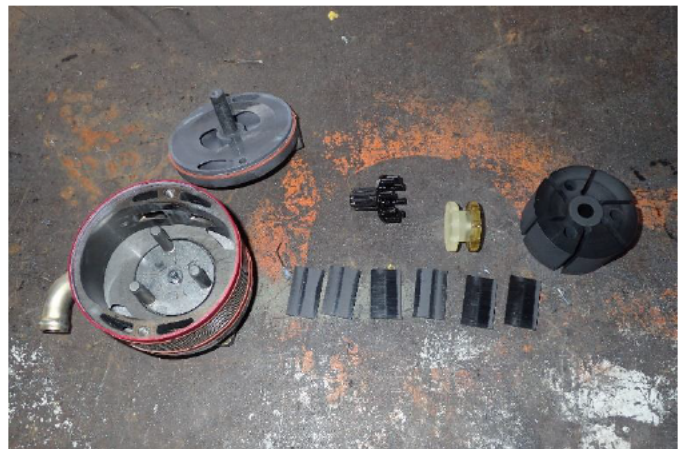
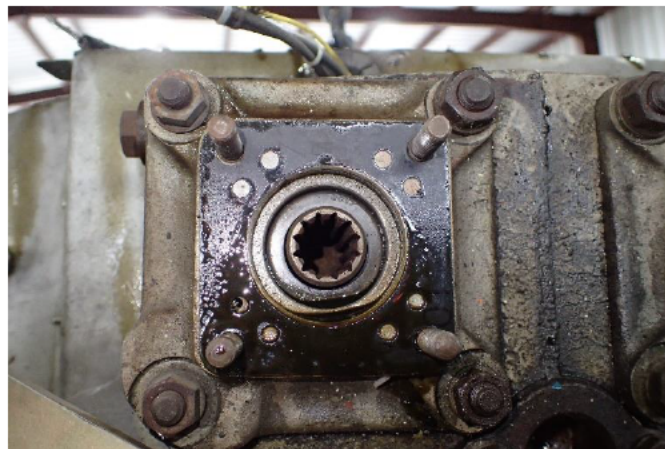
The vacuum pump remained attached to its installation point and displayed minor impact damage signatures. The vacuum pump was removed, and the drive coupling was observed to be intact. The driveshaft was rotated by hand and the vacuum pump was noted to be capable of suction. The vacuum pump was disassembled, and the internal components displayed normal operating signatures. It was noted while removing the vacuum pump that the attaching nuts were not tight. After removal it was observed that oil coated the entire bottom portion of the gasket as well as the vacuum drive and coupling. The entire back side of the crankcase was oil stained and fresh oil was noted on the back of the crankcase and several of the components on the rear of the crankcase.

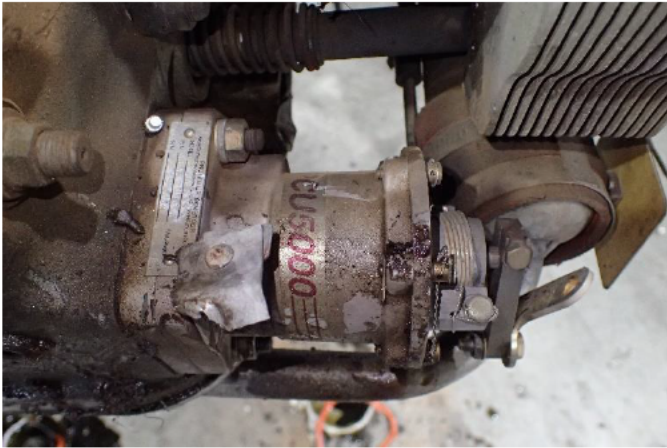
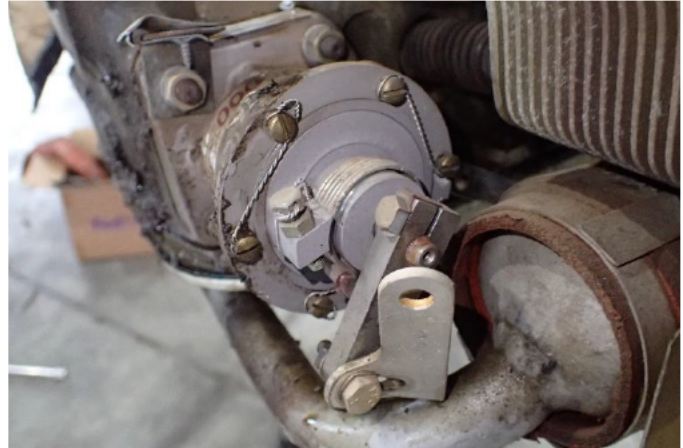
The governor remained attached to its installation point and displayed impact damage signatures. The propeller governor control cable rod end remained secured to the control arm.

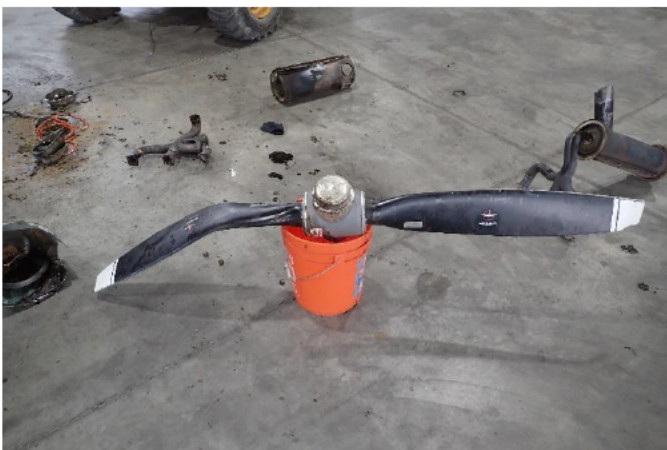
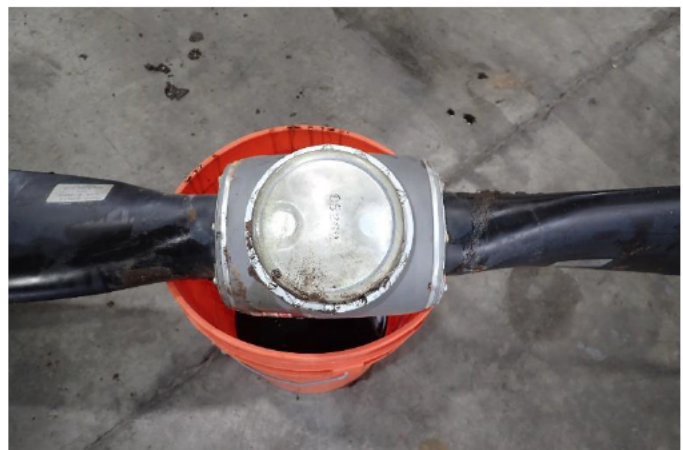
The two-blade, constant speed propeller remained attached to the crankshaft and displayed impact damage signatures. Propeller blade #1 displayed minor forward bending of the blade and the blade tip was bent aft. Propeller blade #2 displayed aft bending deformation.
