## Air Safety Investigations Aircraft Incident/Accident Technical Report

| Aircraft Incident/<br>Accident Information | Year: 1963 | Make: Cessna | Model: 182F |
| Air Safety Investigator: Jennifer D. Barclay | | Report #: ASI-19-DH-T | Report date: 07-27-20 |

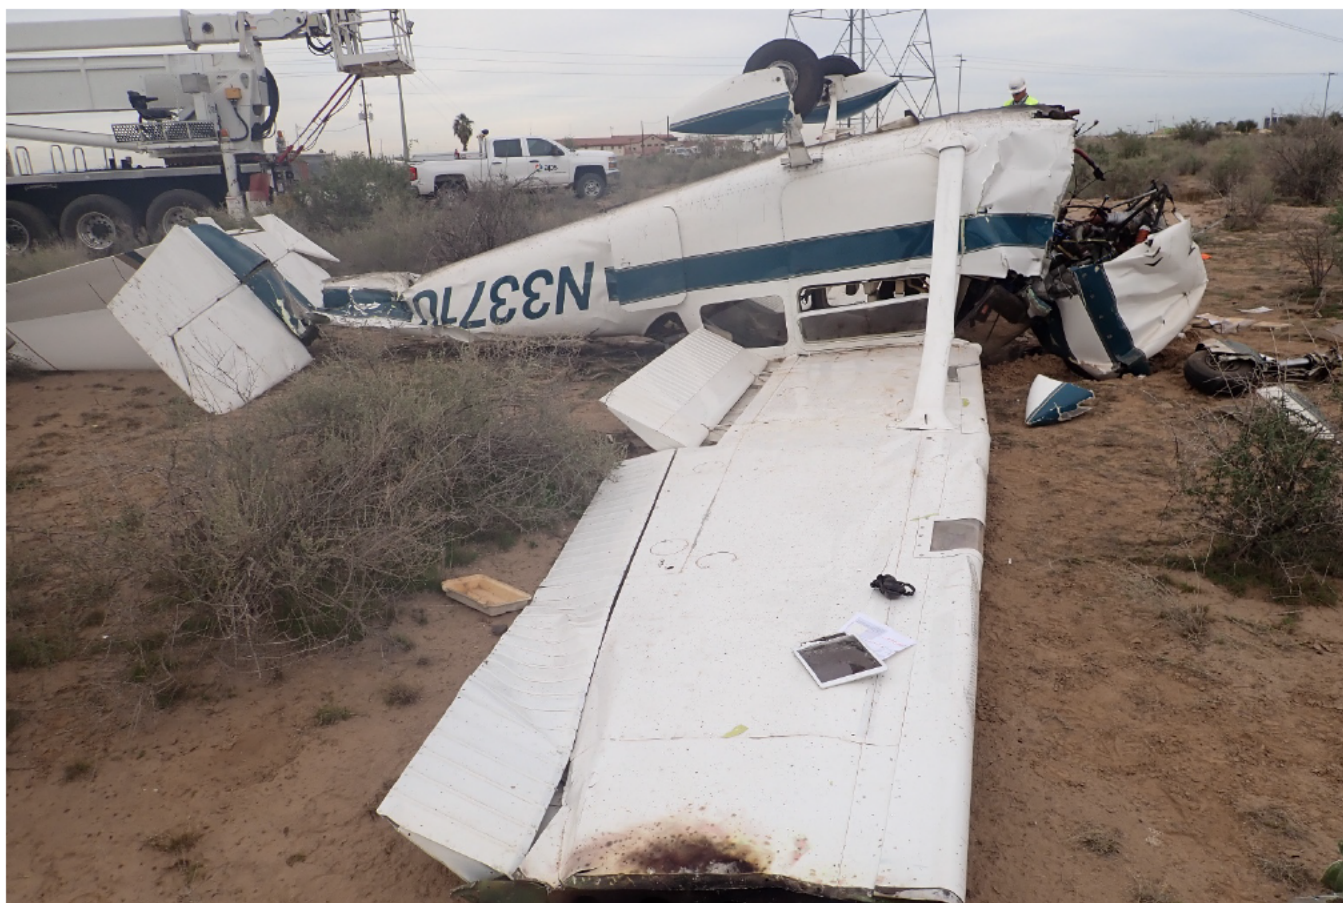
The aircraft impacted powerlines in a left-wing low attitude followed by terrain in a nearly vertical descent. Powerline striations were observed along the entire length of the left wing leading edge. The left wingtip was separated and observed with burn marks and multiple pieces of wire on the ground. The right horizontal stabilizer was observed with wire striations at the inboard leading edge and skin separation along the leading edge. The empennage separated at approximately Fuselage Station (FS) 209.

Wreckage overview, ASI-19-DH-007

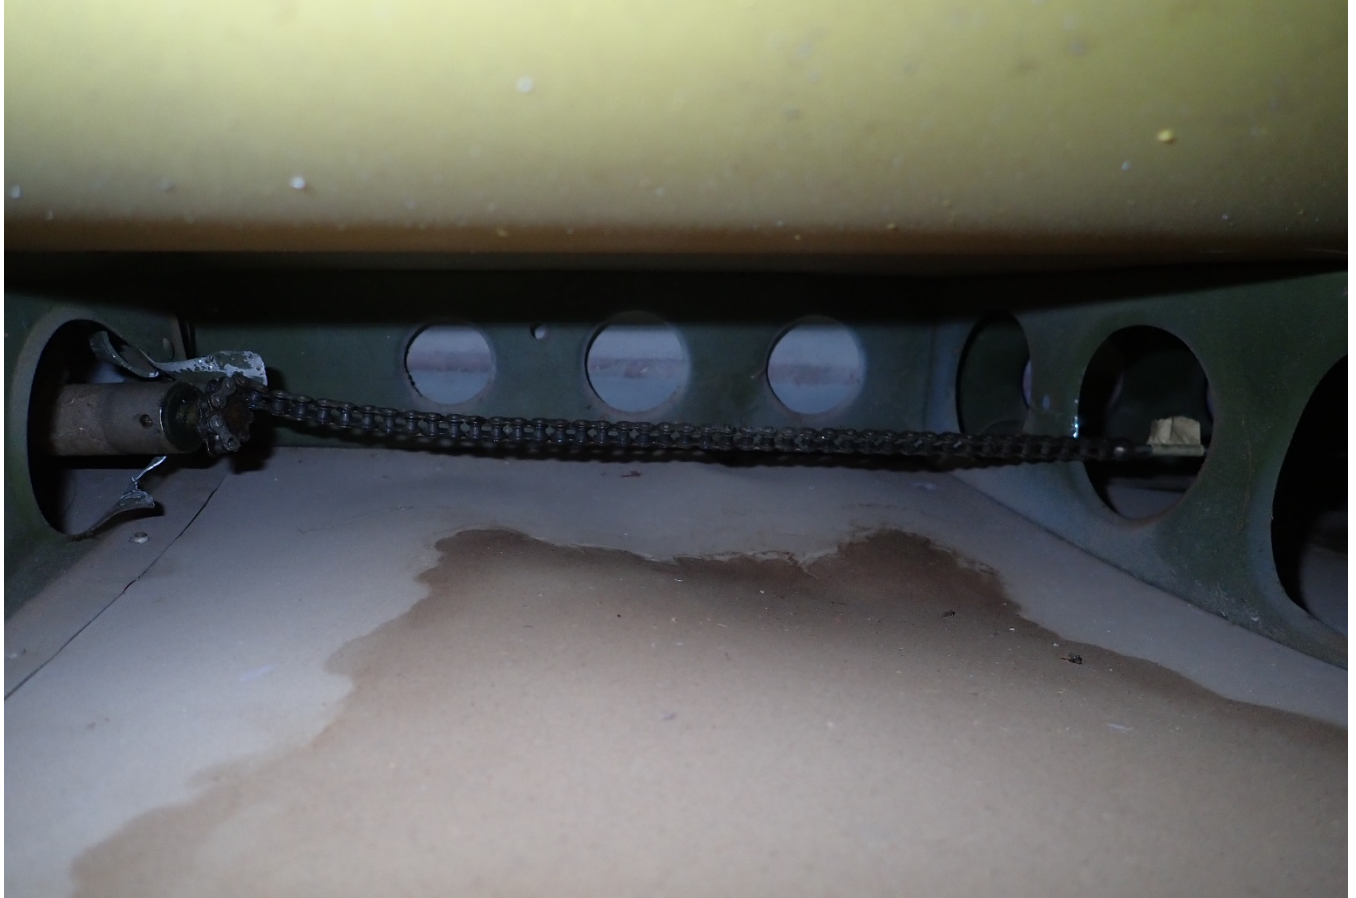
All flight control surfaces remained attached. The elevator push-pull link was fractured at the separation of the empennage at approximately FS 209. The elevator trim tab actuator was pulled inboard from its mounting position. The chain was observed fractured. The elevator trim tab push-pull tube was fractured at the attach point to the trim tab. The bolt, castellated nut and cotter pin remained installed.

Elevator trim tab actuator, ASI-19-DH-076

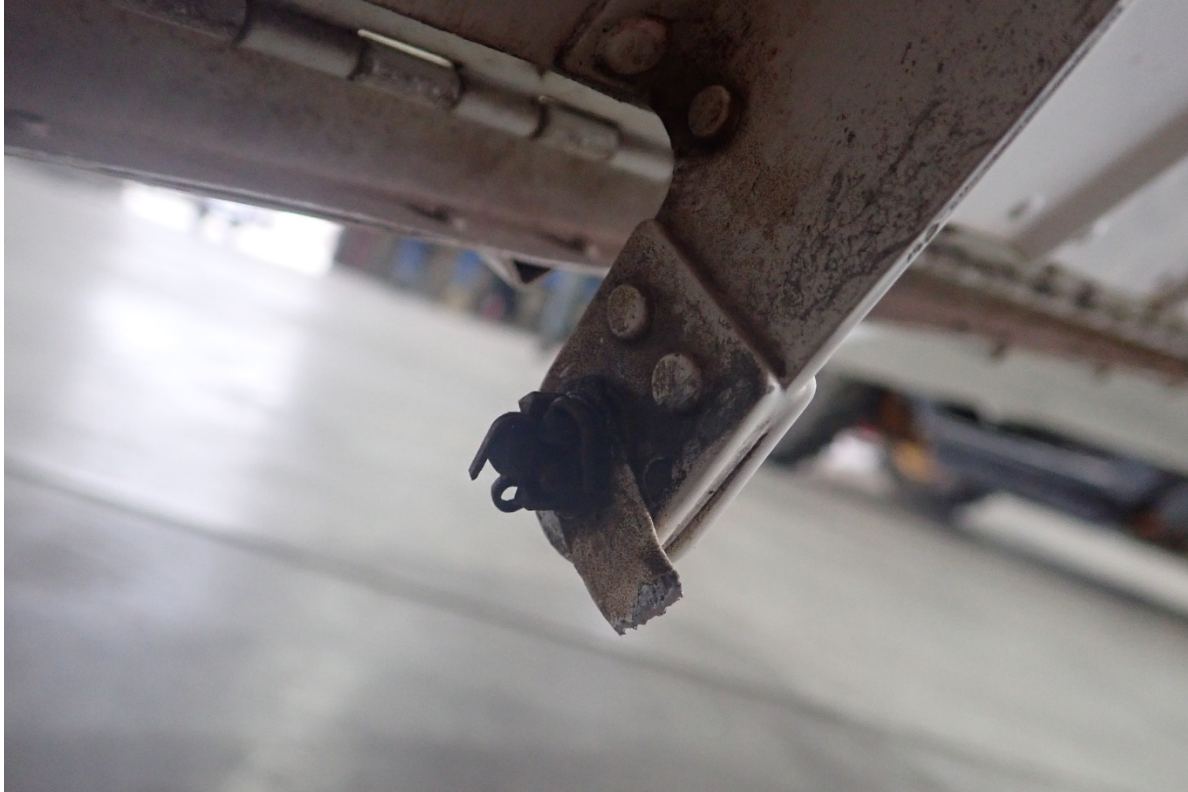
Elevator trim tab push-pull tube attach point, ASI-19-DH-079

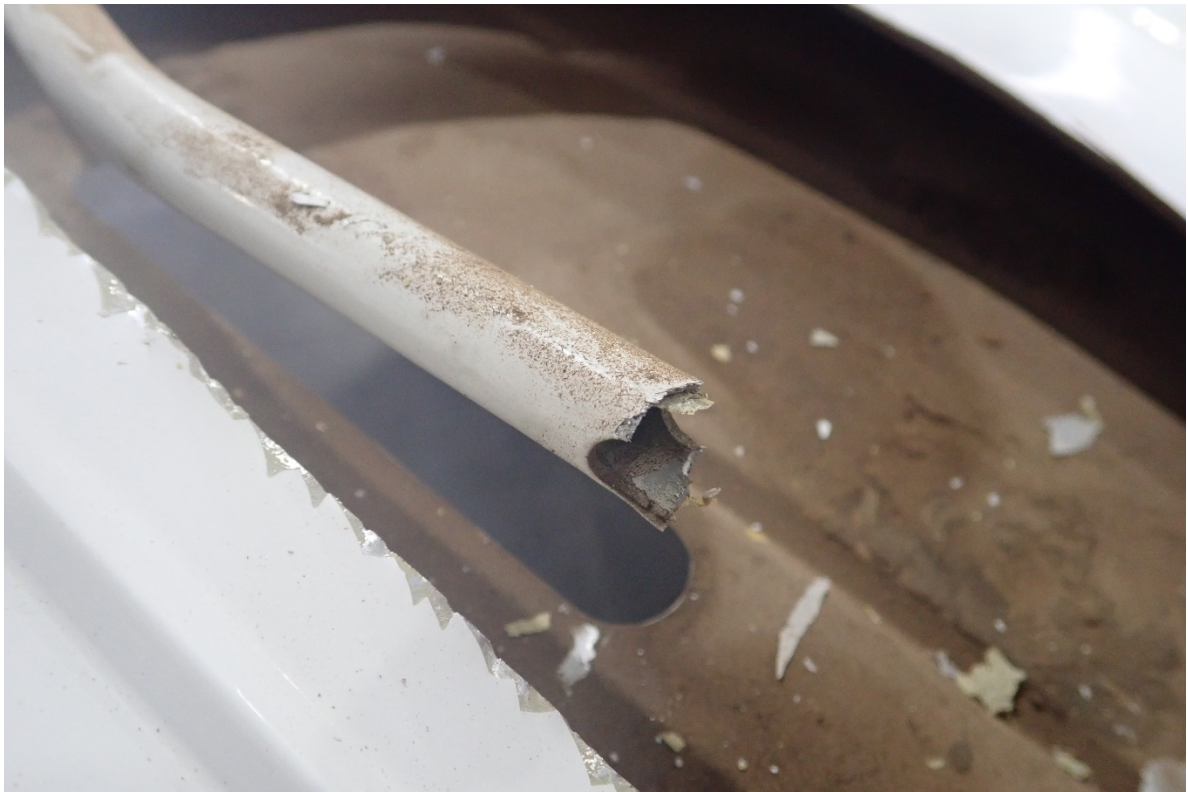
Elevator trim tab push-pull tube, ASI-19-DH-080

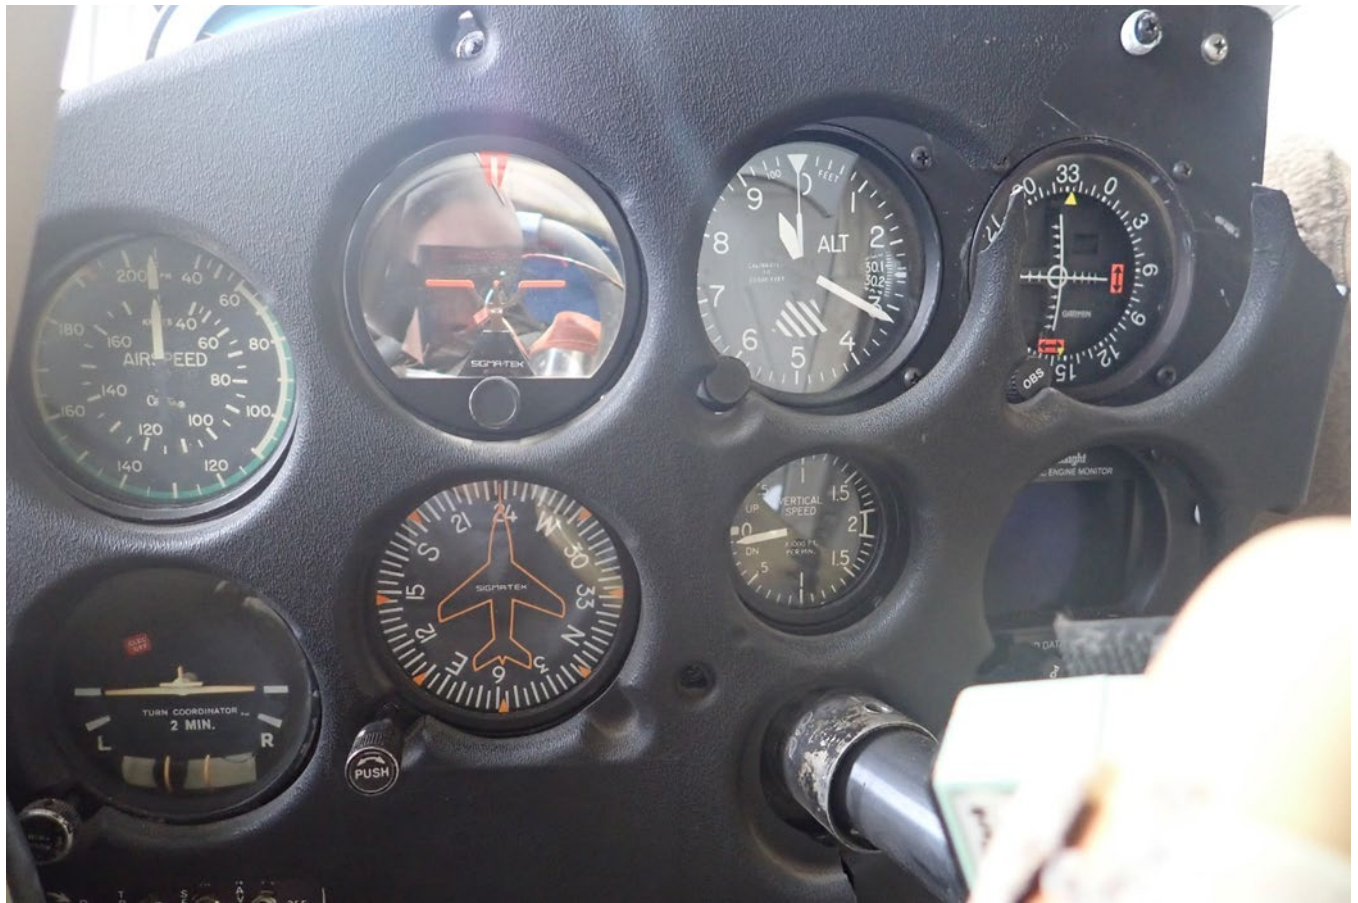
The Navigation and Rotating Beacon switches were broken, and their position could not be determined.

The attitude indicator was disassembled and showed little evidence of rotational scoring.

Instrument panel, ASI-19-DH-112

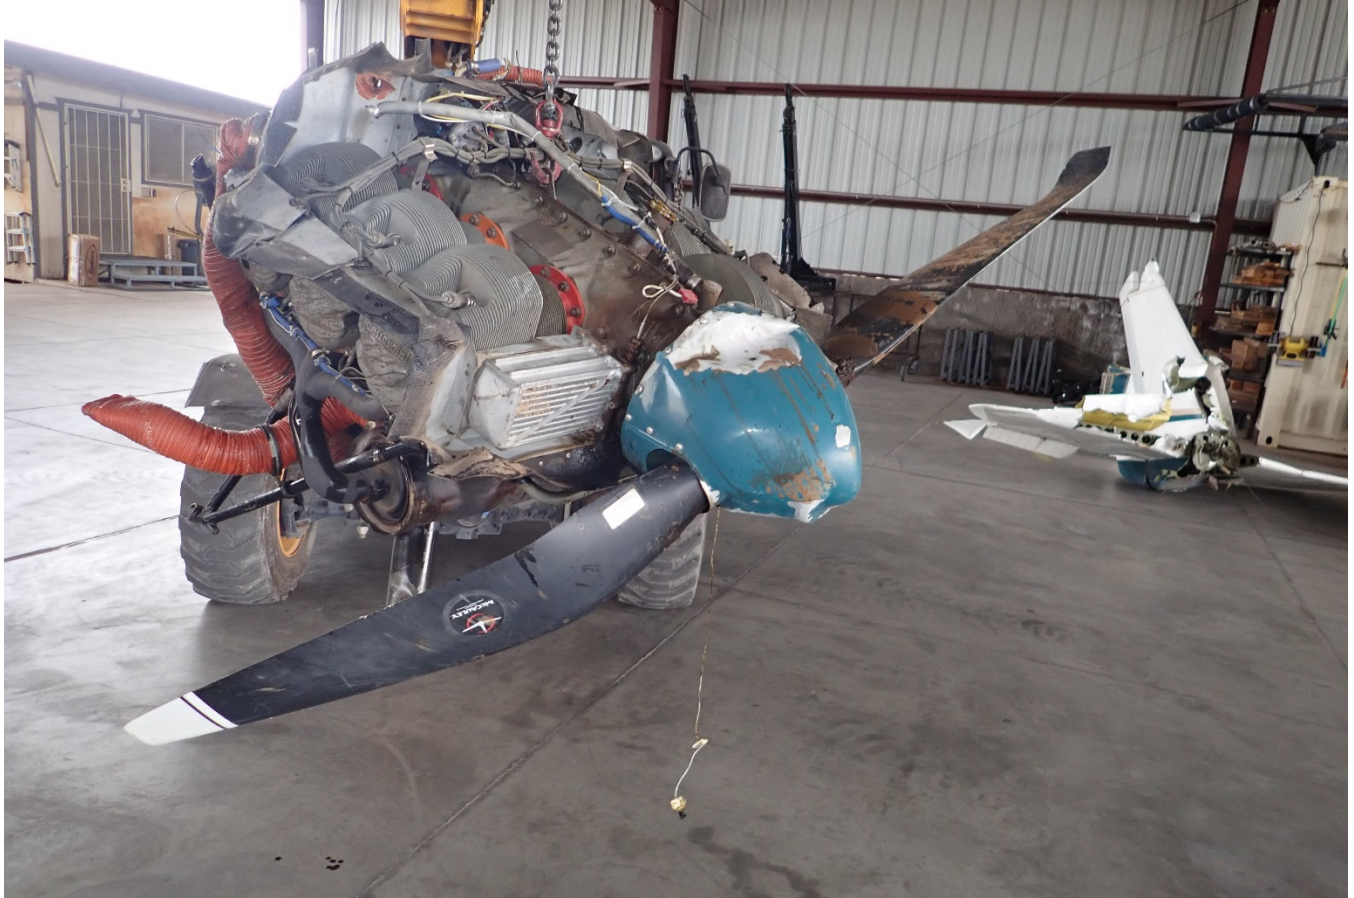
Blade 1 was observed with slight S-bending and two trailing edge gouges near the tip. Blade 2 was observed bent aft near the root.

Propeller, ASI-19-DH-057
