**Number:** SBA5X-23-03

**SNS SUBJECT:** 23-50 AUDIO INTEGRATING - Disable Non-Essential 3.5 mm Audio and Microphone Jacks

SF50 Serials 0005 thru 0176, 0178

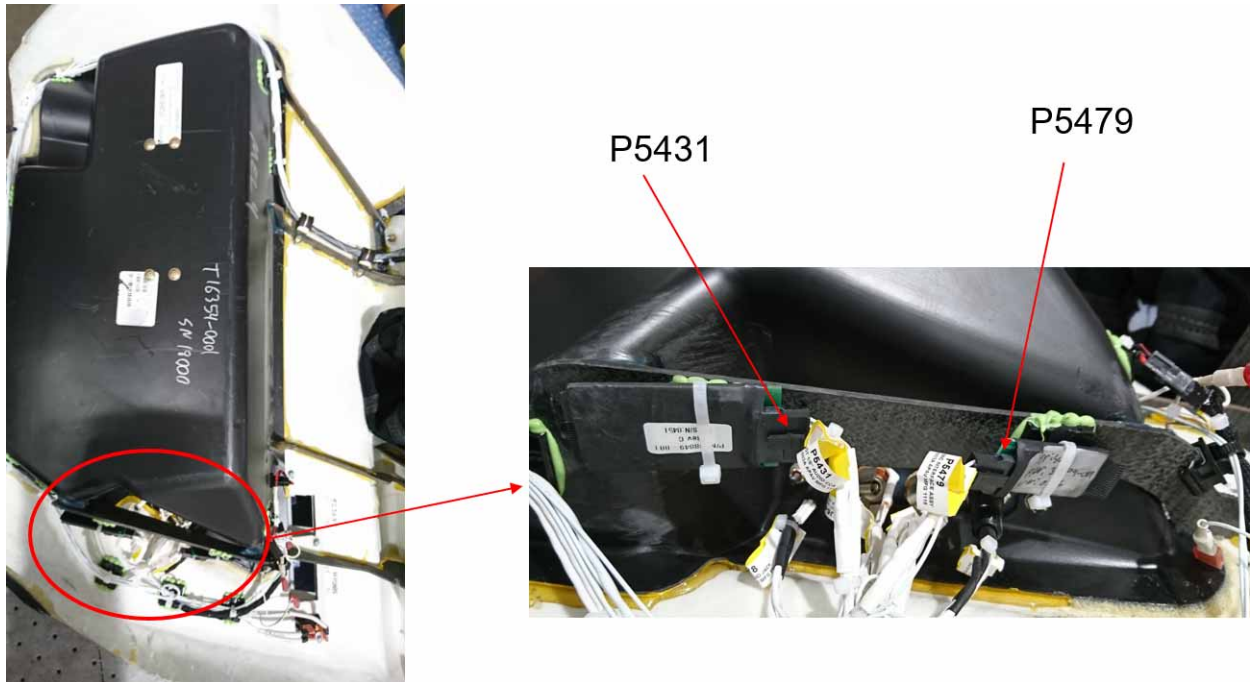
**Figure 01**  
**Pilot Connectors**

- G. Disconnect pilot headset amplifier and microphone interface circuit card assemblies.
  - (1) Locate pilot connectors behind pilot side panel, on back of storage pocket. (See Figure 01)

- (a) P5479 MIC CCA
    - (b) P5431 AUDIO CCA
  - (2) Disconnect connectors from circuit card assemblies.
  - (3) Remove circuit card assemblies from aircraft.

- (4) Cap and stow connectors.
  - (5) Label each connector "DO NOT CONNECT SYSTEM DISABLED PER SBA5X-23-03".
- H. Disconnect co-pilot headset amplifier and microphone interface circuit card assemblies.

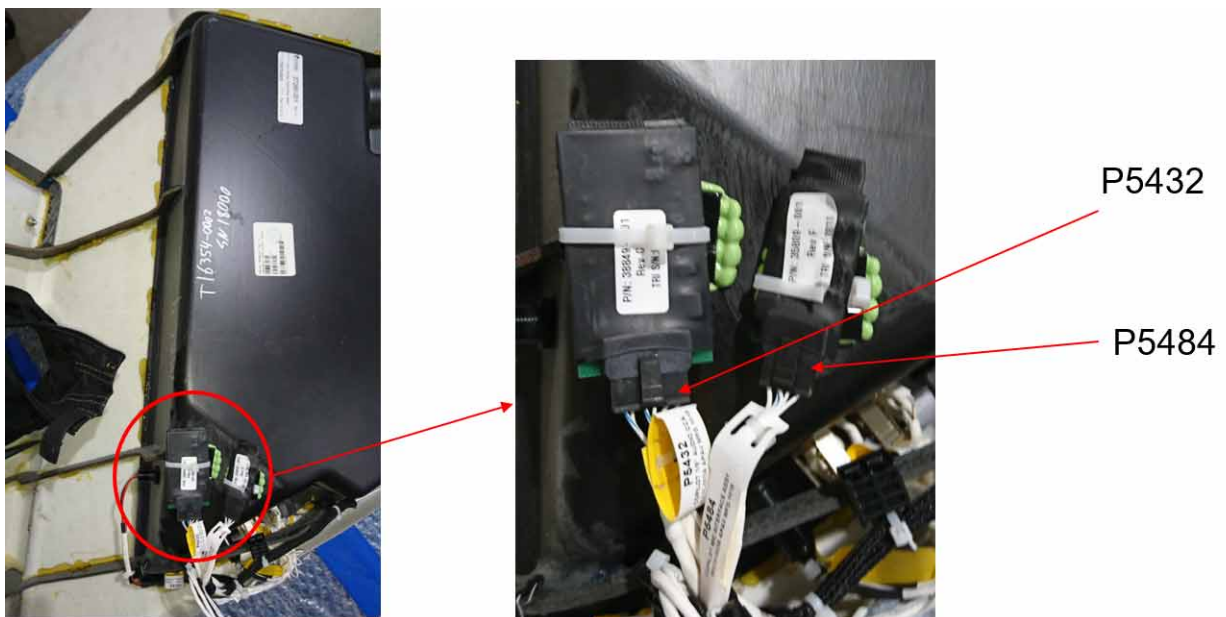
**Figure 02**  
**Co-Pilot Connectors**

- (1) Locate co-pilot connectors behind co-pilot side panel, on aft side of storage pocket. (See Figure 02)
    - (a) P5484 MIC CCA
    - (b) P5432 AUDIO CCA

- (2) Disconnect connectors from circuit card assemblies.
  - (3) Remove circuit card assemblies from aircraft.
  - (4) Cap and stow connectors.
  - (5) Label each connector "DO NOT CONNECT SYSTEM DISABLED PER SBA5X-23-03".

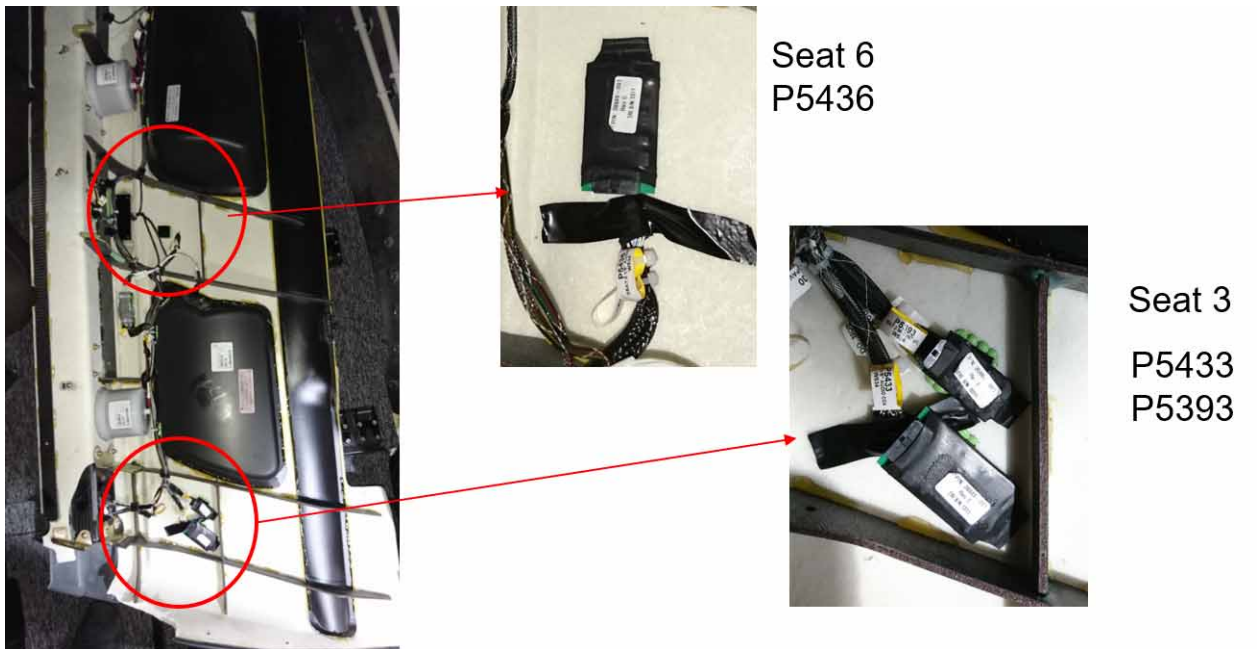
**Figure 03**  
**Seat 3 and Seat 6 Connectors**

- I. Disconnect seat 3 and seat 6 headset amplifier and microphone interface circuit card assemblies.
  - (1) Locate seat 3 connectors left of seat 3, in forward area of inside wall of LH lower panel. (See Figure 03)

- (a) P5393 MIC CCA
    - (b) P5433 AUDIO CCA
  - (2) Locate seat 6 connector left of seat 6, in middle area of inside wall of LH lower panel.
    - (a) P5436 AUDIO CCA

- (3) Disconnect connectors from circuit card assemblies.
  - (4) Remove circuit card assemblies from aircraft.
  - (5) Cap and stow connectors.
  - (6) Label each connector "DO NOT CONNECT SYSTEM DISABLED PER SBA5X-23-03".

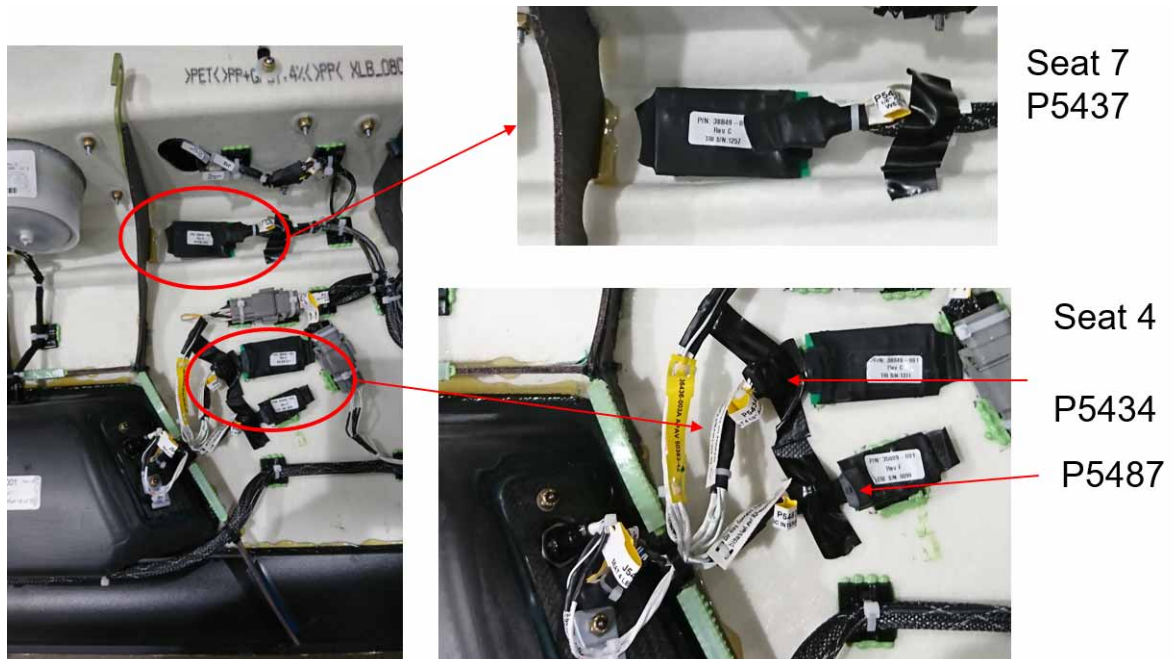
**Figure 04**  
**Seat 4 and Seat 7 Connectors**

- J. Disconnect seat 4 and seat 7 headset amplifier and microphone interface circuit card assemblies.
  - (1) Locate seat 4 connector right of seat 7, on inside wall of RH aft lower panel in front of jack assembly. (See Figure 04)

- (a) P5487 MIC CCA
    - (b) P5434 AUDIO CCA
  - (2) Locate seat 7 connector right of seat 7, in middle area of inside wall of RH aft lower panel.
    - (a) P5437 AUDIO CCA

- (3) Disconnect connectors from circuit card assemblies.

- (4) Remove circuit card assemblies from aircraft.
  - (5) Cap and stow connectors.
  - (6) Label each connector "DO NOT CONNECT SYSTEM DISABLED PER SBA5X-23-03".

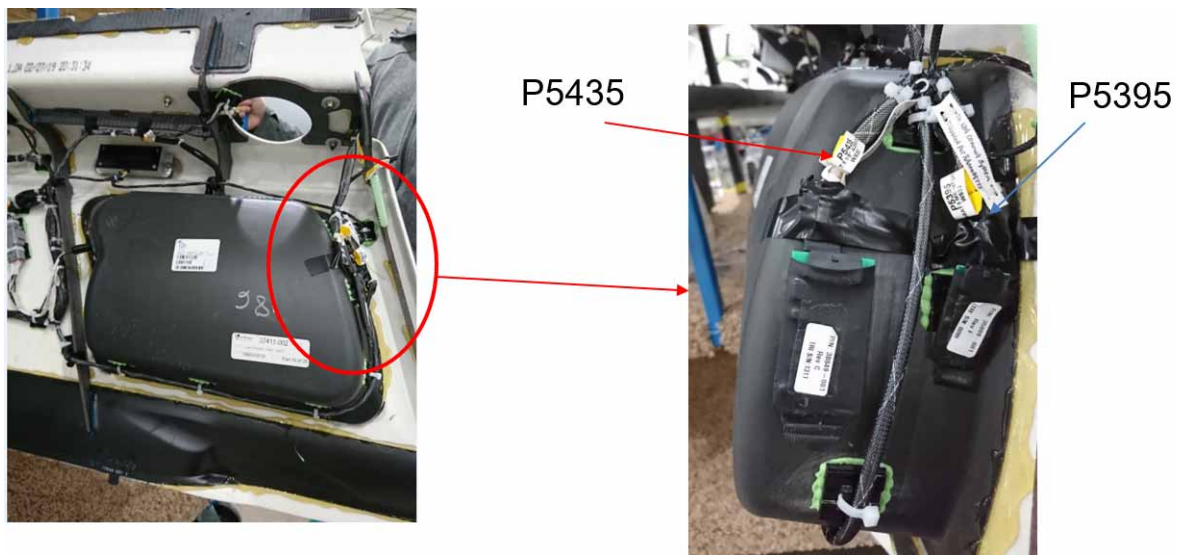
**Figure 05**  
**Seat 5 Connectors**

- K. Disconnect seat 5 headset amplifier and microphone interface circuit card assemblies.
- (1) Locate seat 5 connectors right of seat 5, on inside wall of RH mid lower panel on front side of seat 5 pocket. (See Figure 05)

- (a) P5395 MIC CCA
    - (b) P5435 AUDIO CCA
  - (2) Disconnect connectors from circuit card assemblies.
  - (3) Remove circuit card assemblies from aircraft.

- (4) Cap and stow connectors.
  - (5) Label each connector "DO NOT CONNECT SYSTEM DISABLED PER SBA5X-23-03".
- L. Install RH aft lower panel. (Refer to AMM 25-10)
