# NATIONAL TRANSPORTATION SAFETY BOARD

## MATERIALS LABORATORY FIRE FACTUAL REPORT

Report No. 21-031

Place : Santa Monica, California  
Date : December 27, 2019  
Vehicle : Cirrus Design SF50, Registration N52CV, S/N 0010  
NTSB No. : WPR20FA051  
Investigator : Elliott Simpson AS-WPR

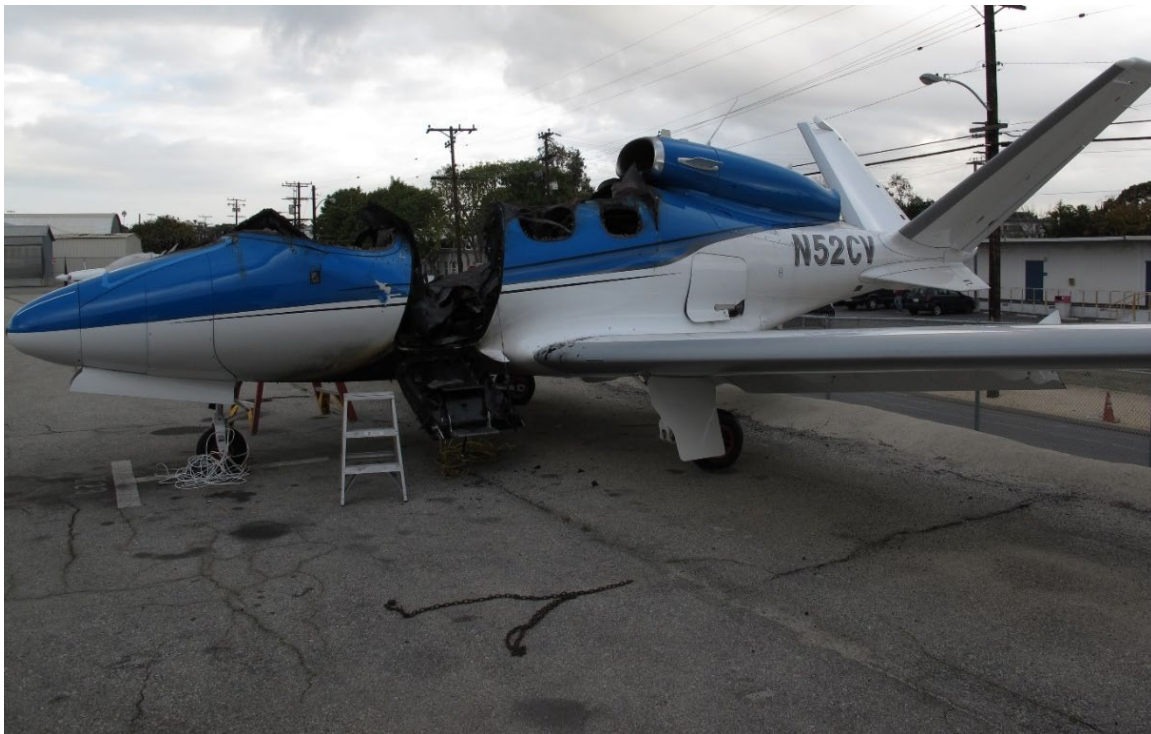
**Figure 1. Overall photograph of aircraft on day of examination.**

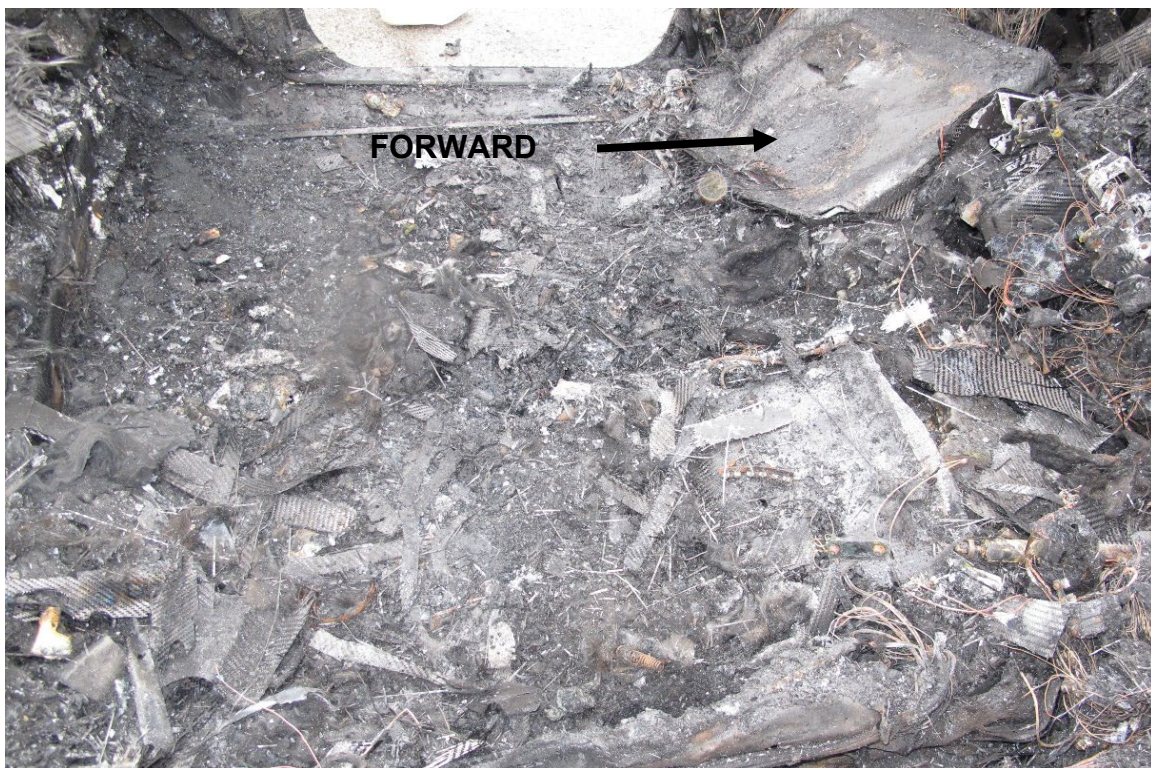
**Figure 2. Cabin floor prior to debris removal.**

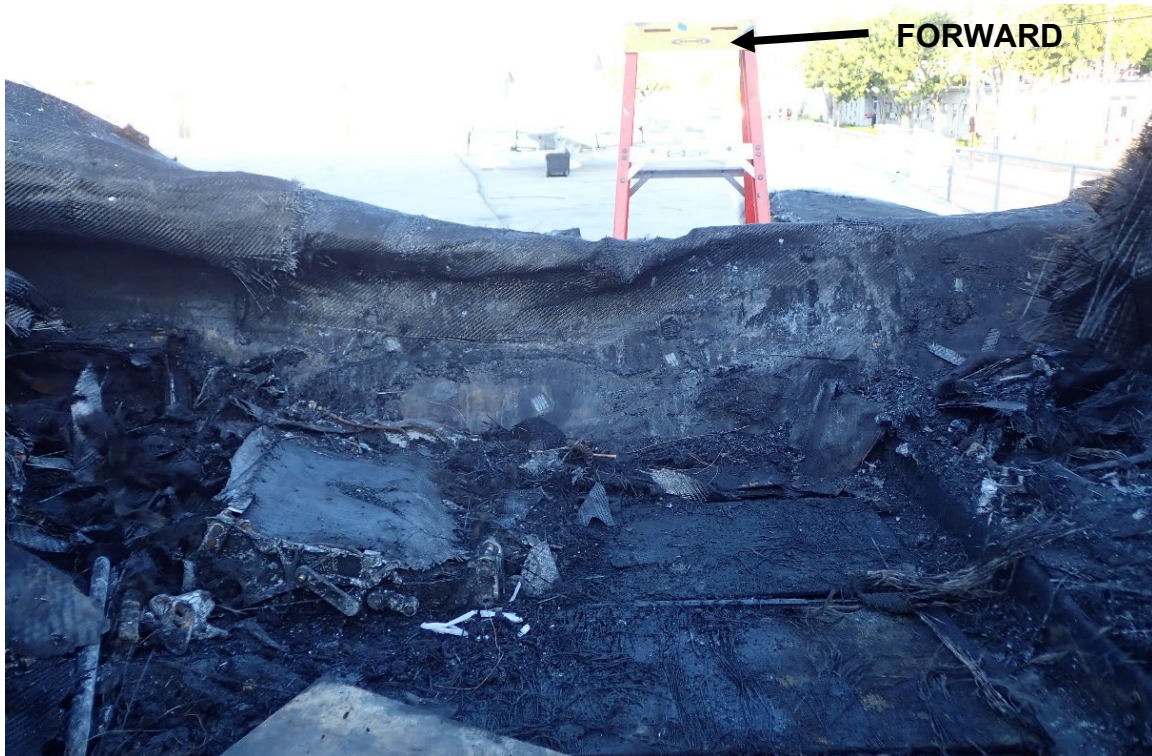
**Figure 3. Floor area after debris removal.**

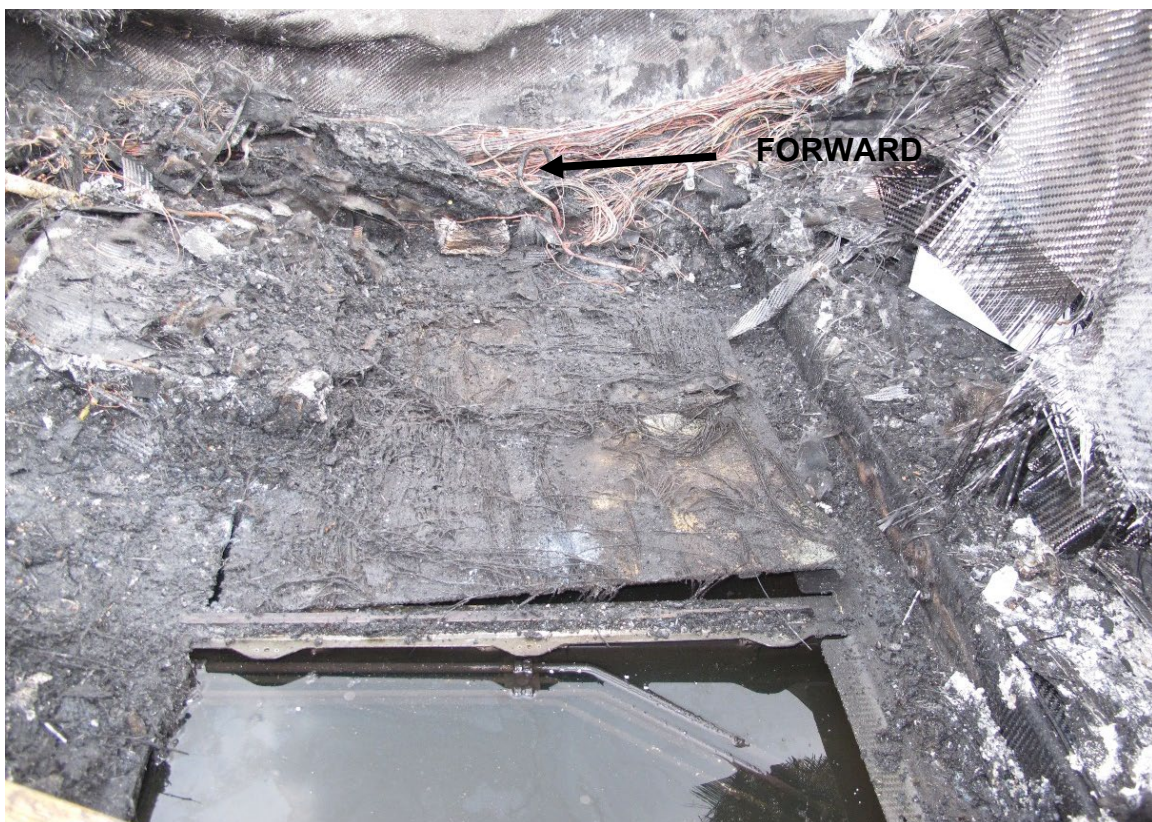
**Figure 4. Area under cabin floor prior to water removal.**

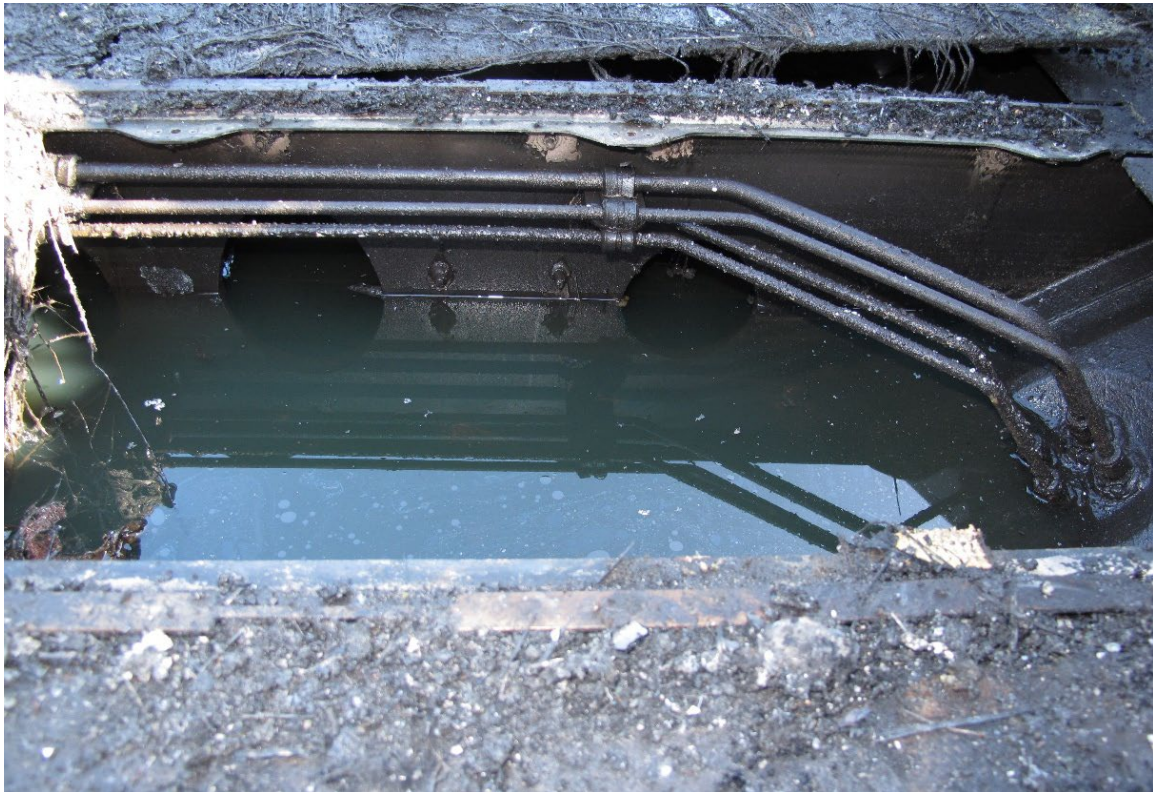
**Figure 5. Close-up of hydraulic lines on left side of aircraft.**

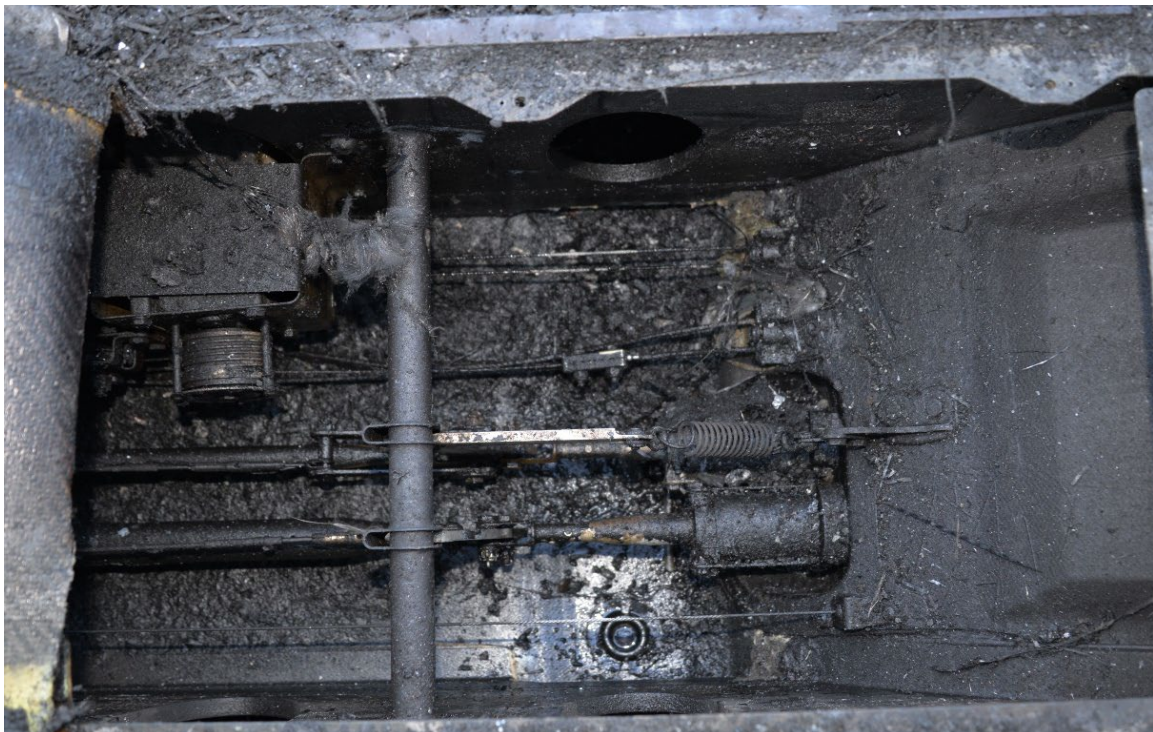
**Figure 6. Servo located centerline under floorboards.**

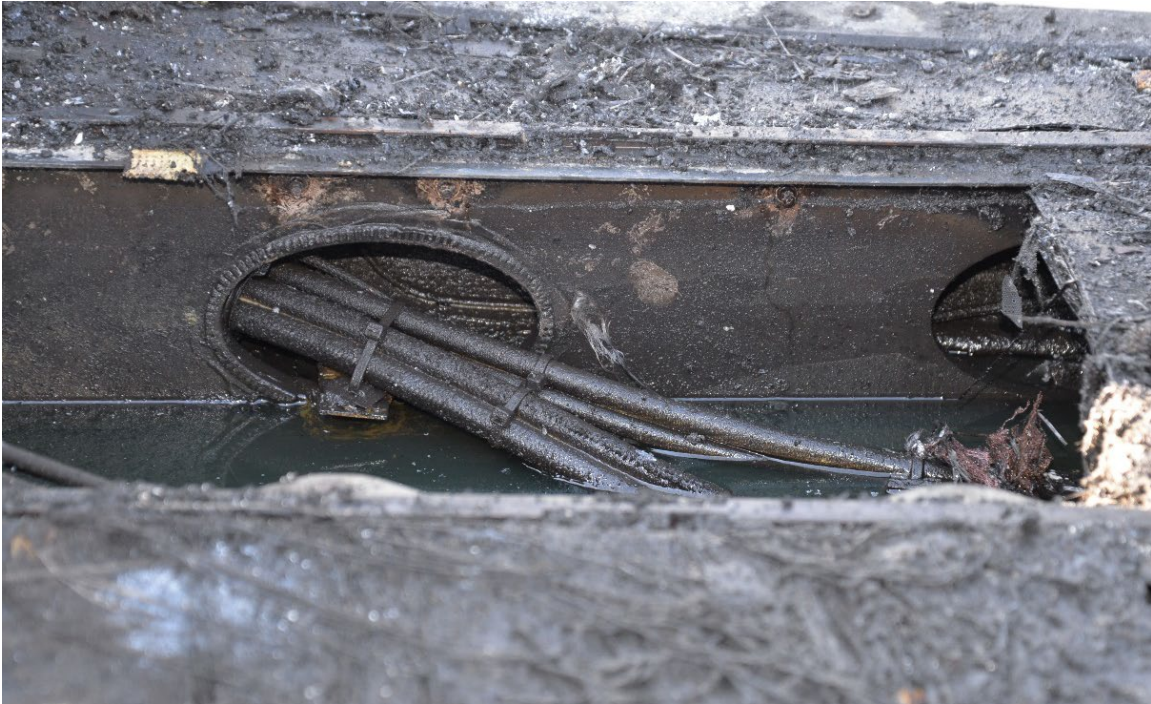
**Figure 7. Wiring under left side floorboard.**

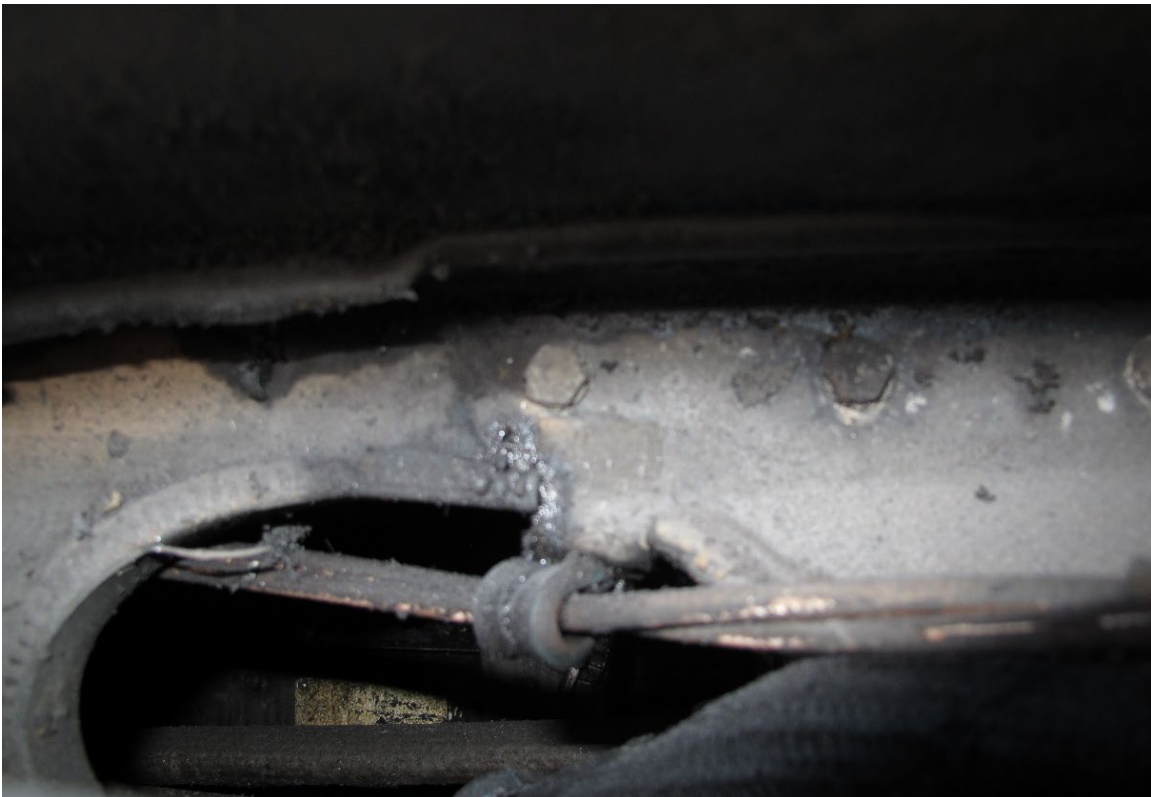
**Figure 8. Close-up of underfloor wiring.**

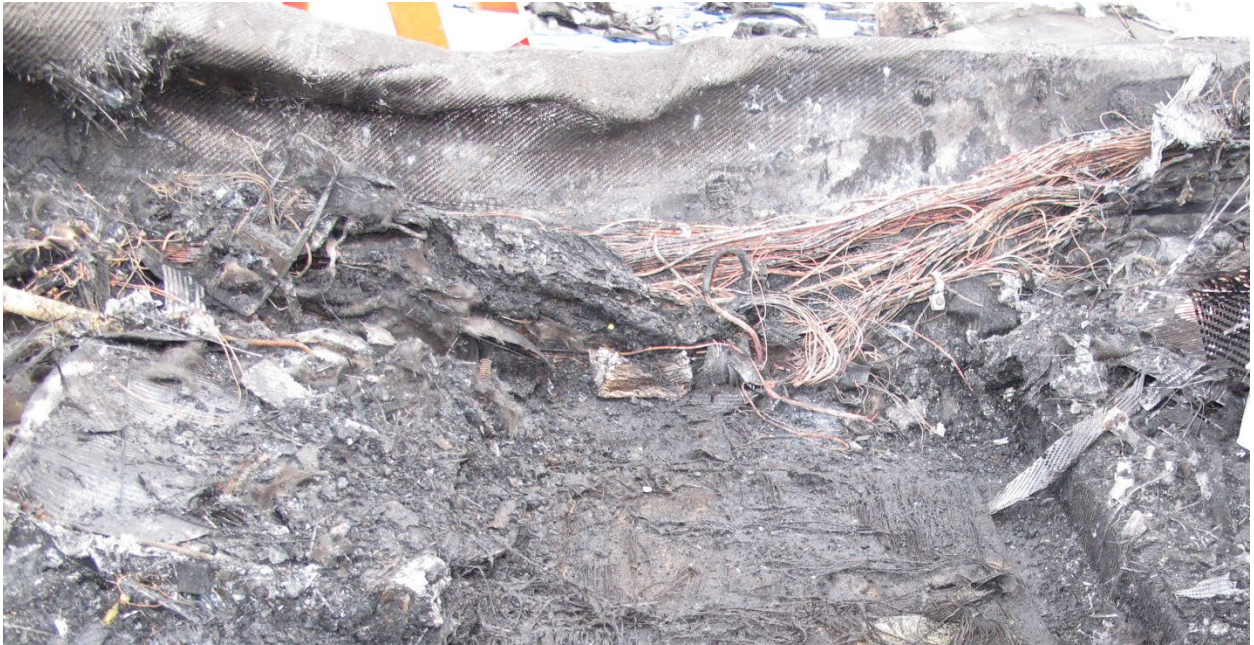
The three wire bundles located on the right fuselage wall were examined from the aft cannon plug junction to the most forward undamaged section as shown in Figure 9. The polymeric wire insulation on these bundles was largely missing except for a few areas. These intact areas still showed thermal damage in the form of partial melting and thermal discoloration. Fiber mats used as anti-chafe protection were still present but exhibited thermal damage and discoloration. The exposed wire conductors were intact and sooted except the section located below the right egress window. In this area, the conductors were bright, shiny, and not sooted-a possible indication of elevated temperatures as shown in Figure 10. In addition, there was evidence of welding and beading on several of the conductors. The bundles were

**Figure 9. Section of wiring on right side wall under right egress window.**

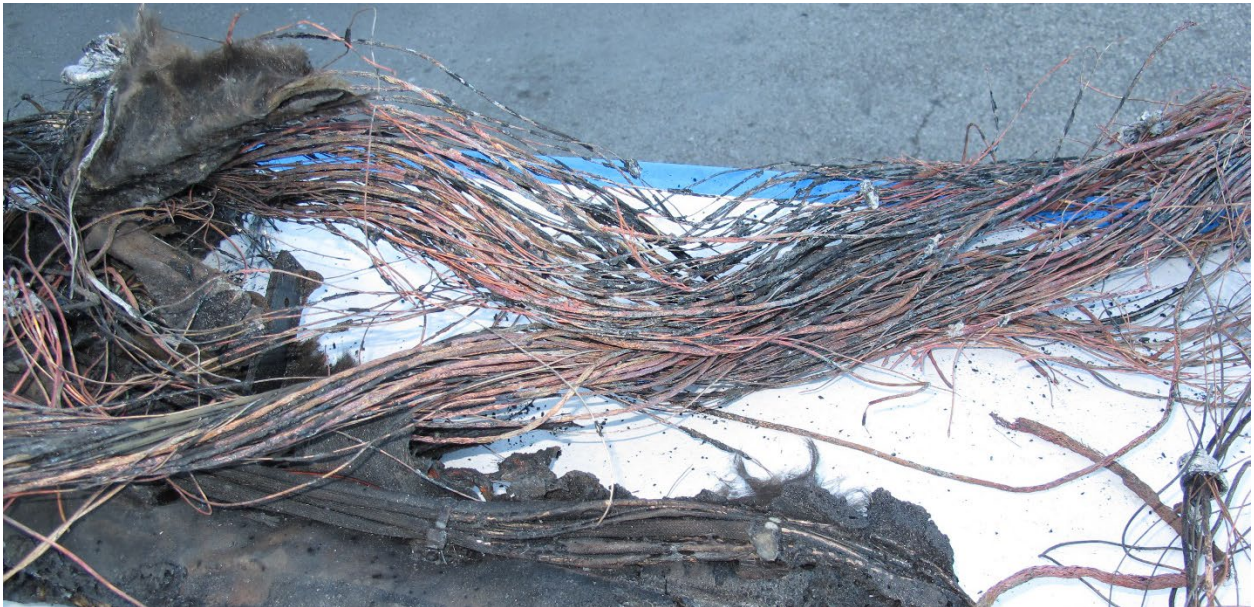
**Figure 10. Closeup of damaged section of right-side wire bundles.**

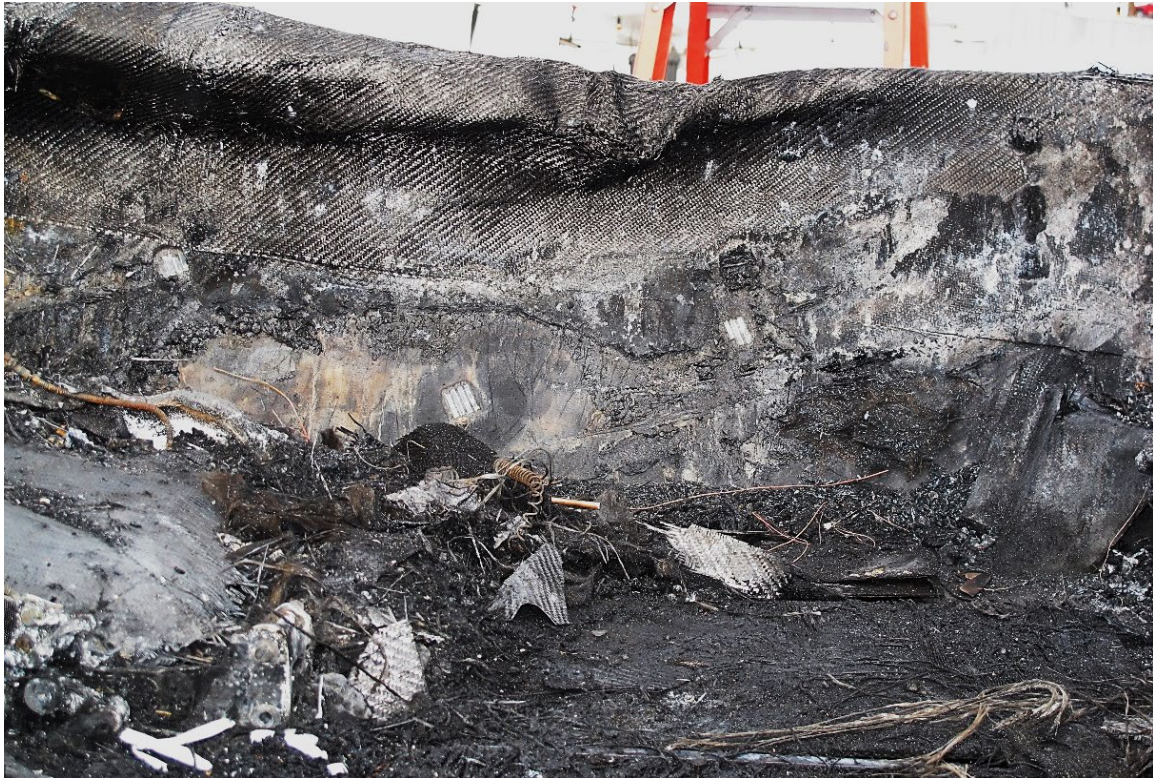
Once the wire section was removed, a line of damage demarcation was noted on the fuselage sidewall where the wire section was located as shown in Figure 11. Below the line, the resin in the carbon fiber was charred on the surface but the damage did not extend further into the composite. In the area directly behind the removed section and above, the resin was largely missing from the carbon fiber cloth. As the damage extended up towards the roof, the intensity of the damage increased. Adjacent to the damaged section of wiring, a copper-colored metallic deposit was found on the aircraft sidewall as shown in Figures 12-14. Also adjacent to this area within the cabin area, an area of melting was found on the seat attachment hardware near the floor as shown in Figure 15. Only the seat structure was damaged, and thermal damage was not found on components and floor structure below this area.

**Figure 11. Damage demarcation line on right sidewall after wire bundle removal.**

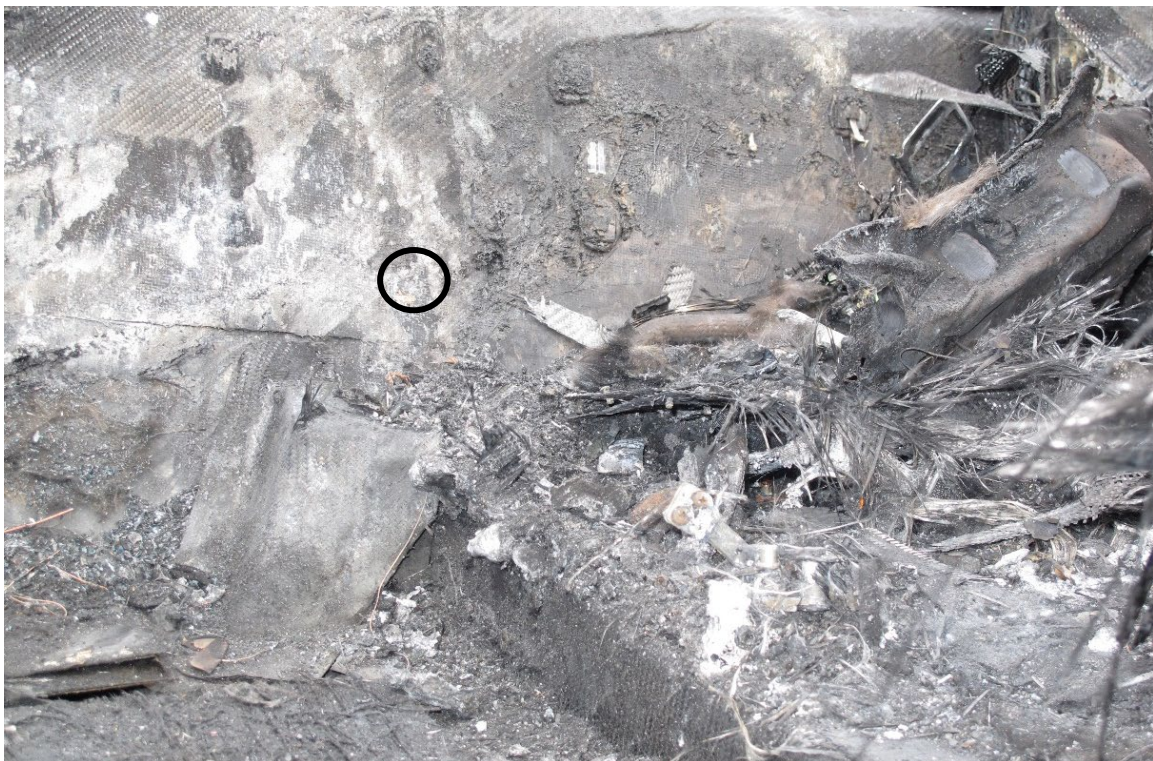
**Figure 12. Close-up of demarcation line on right sidewall. Copper-colored residue (close-up shown in Figure 13) highlighted by black circle.**

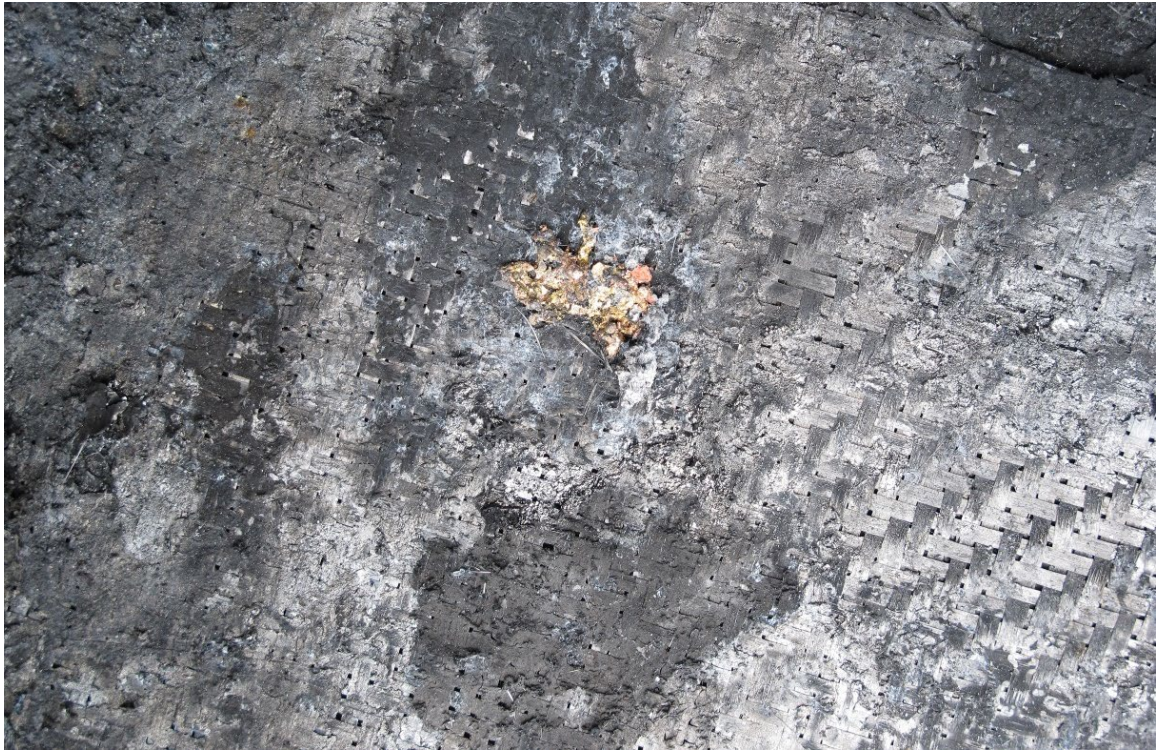
**Figure 13. Close-up photograph of copper-colored deposit on right sidewall.**

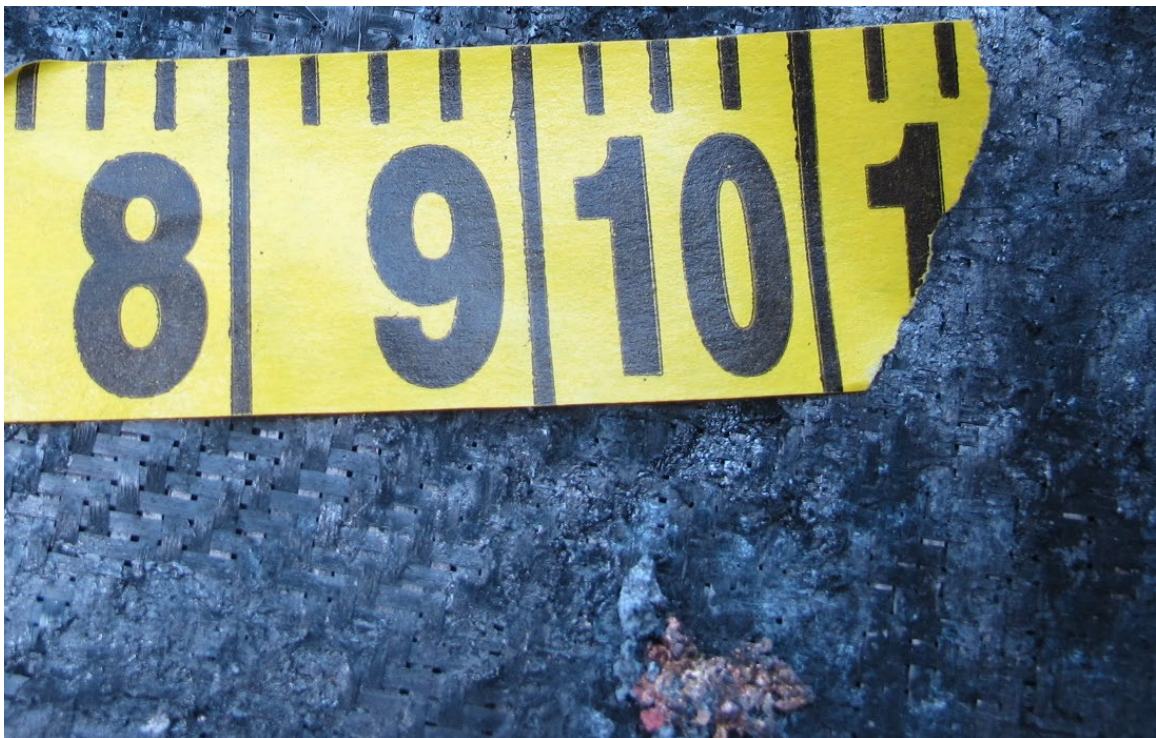
**Figure 14. Copper-colored deposit with scale.**

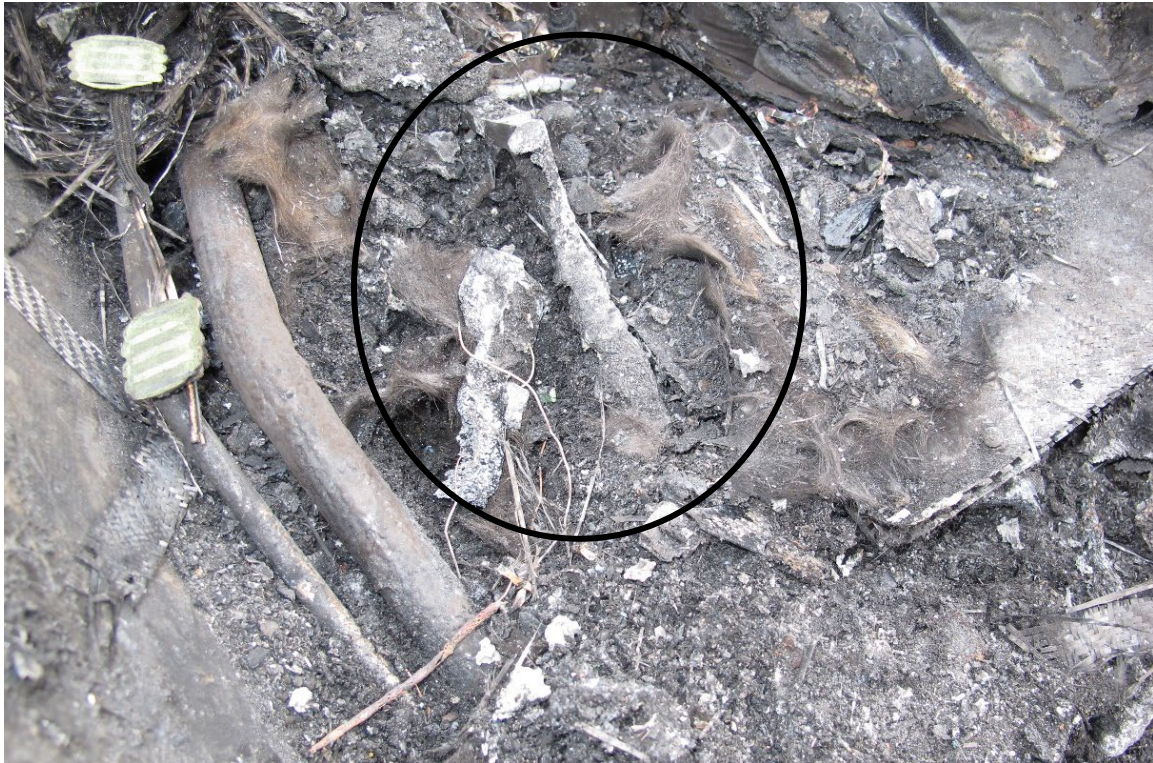
**Figure 15. Area of thermal damaged seat structure (highlighted by black circle).**
