## **NATIONAL TRANSPORTATION SAFETY BOARD**

### **AIRFRAME EXAMINATION**

**WPR20FA051**

Location: Santa Monica, CA  
Date: December 27, 2019.  
Aircraft: Cirrus Design SF50, Registration N52CV, S/N 0010  
NTSB IIC: Elliott Simpson

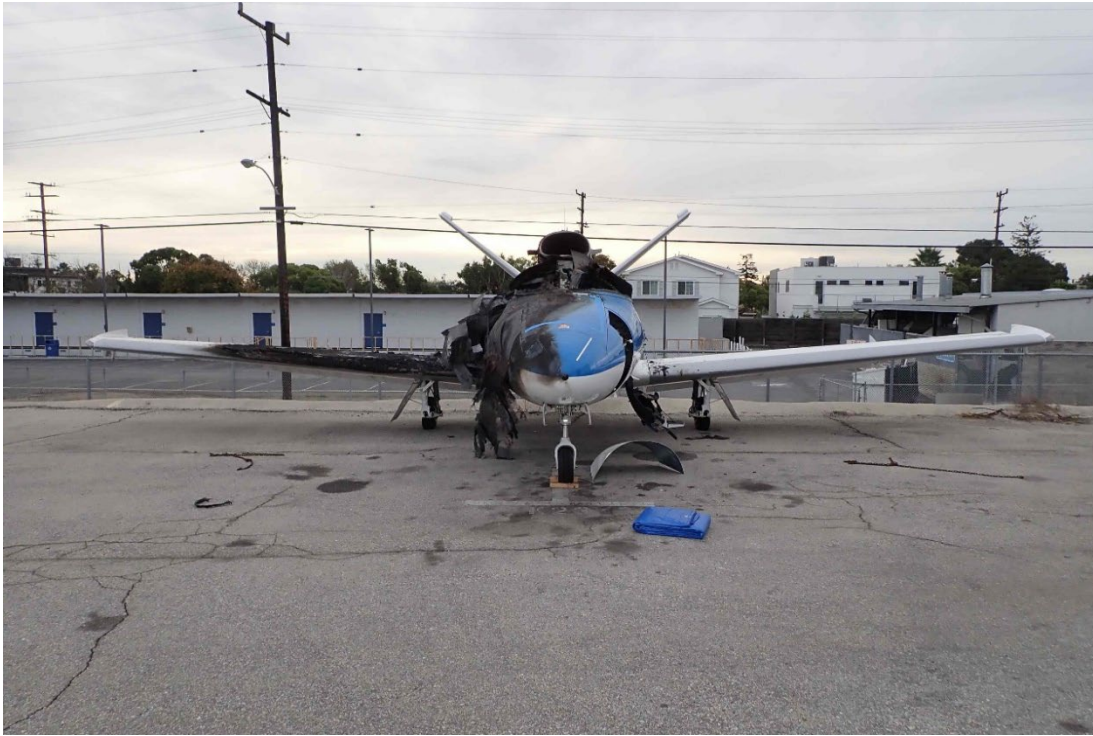
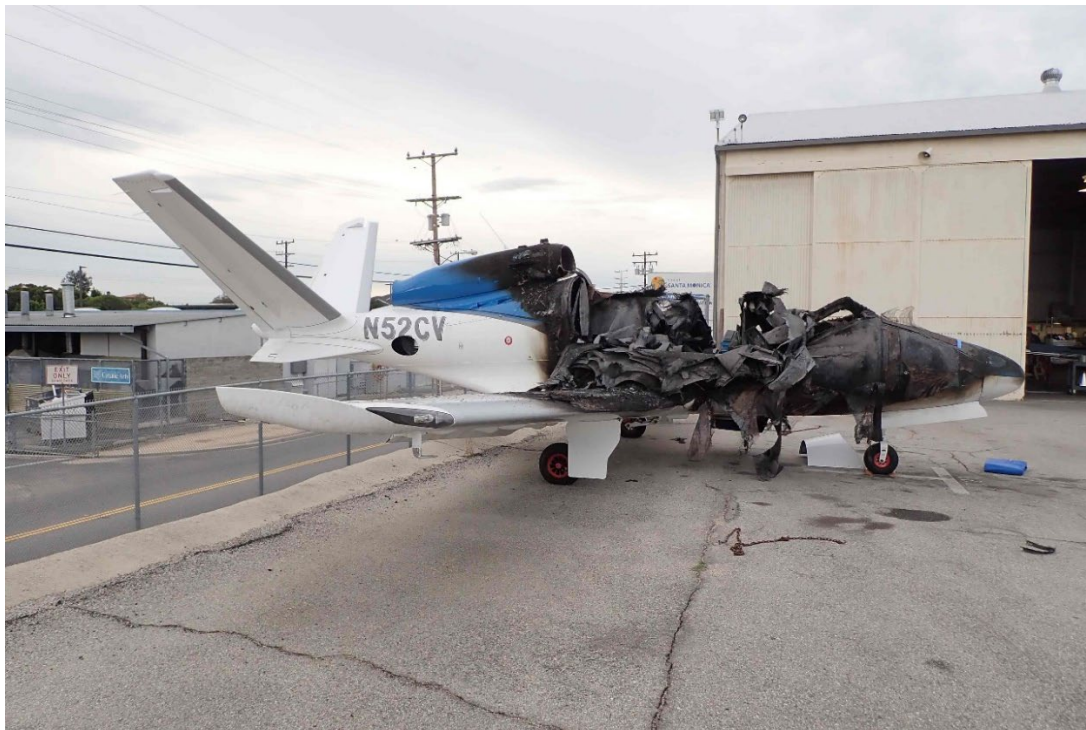
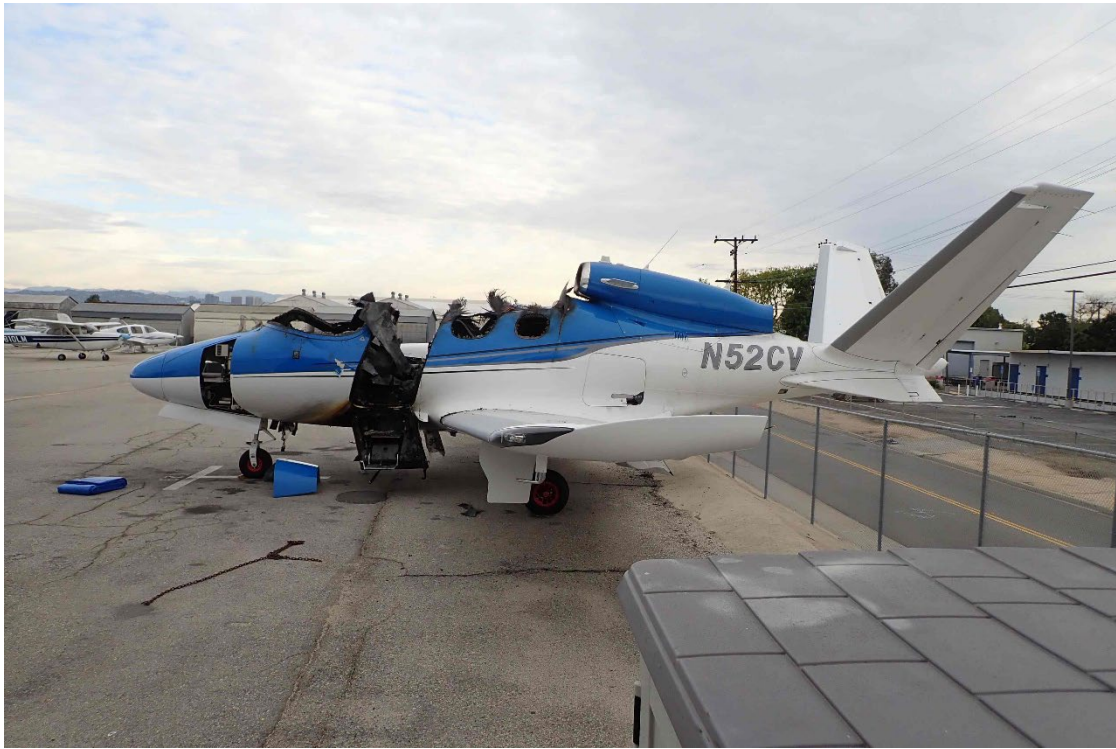
The airplane sustained extensive thermal damage, with fire consuming the cabin roof and destroying the cabin contents from the aft wall of the parachute (CAPs) enclosure through to the engine inlet nacelle (figure 1, 2, 3). Only carbon fiber cloth remnants of the cabin wall and seat structures remained. The airplane remained on its main landing gear, and was able to support its own weight without significant structural deformation. The flaps were in the extended position. The cabin door (left side of the airframe) was open during the fire, and thermal damage was

Fire damage was more extensive on the right side of the airframe, from the nose through to the wing trailing edge. Fire had consumed the lower right walls of the cabin down to the wing root, with only carbon fiber cloth remaining. The right wing was intact, but sustained thermal damage to the upper skin from the root outboard about 4 ft short of the tip. The left wing, and lower left exterior skins of the cabin were largely free of fire damage.

Figure 1 – Airplane Viewed from Front

Figure 2 – Airplane Viewed from Right

Figure 3 – Airplane Viewed from Left

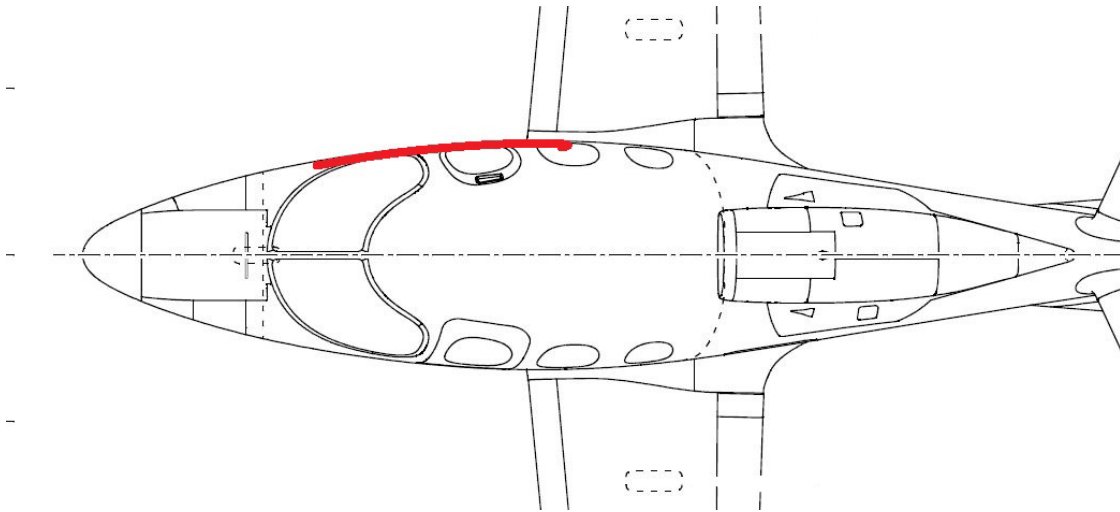
Remnants of the various electrical systems harnesses along the lower right side of the cabin structure were examined. The insulating sleeve material for all conductors had burnt away, leaving brittle copper wire remnants. Multiple areas of the harnesses exhibited molten and globule-like breaks to their copper conductors (figure 4). The molten damage was consistent with electrical arcing, and was located at the following stations (the tape measure zero in the images is at the forward pressure bulkhead, station 93).

Figure 4 – Area of Arcing damage to Electrical Harnesses

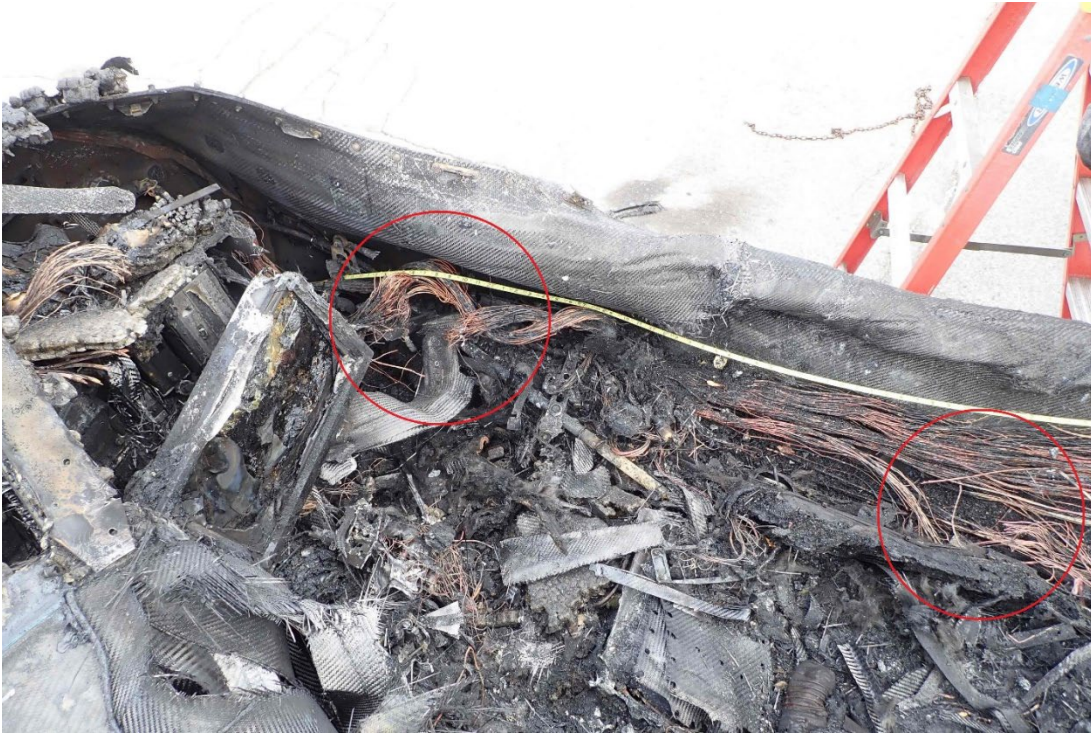
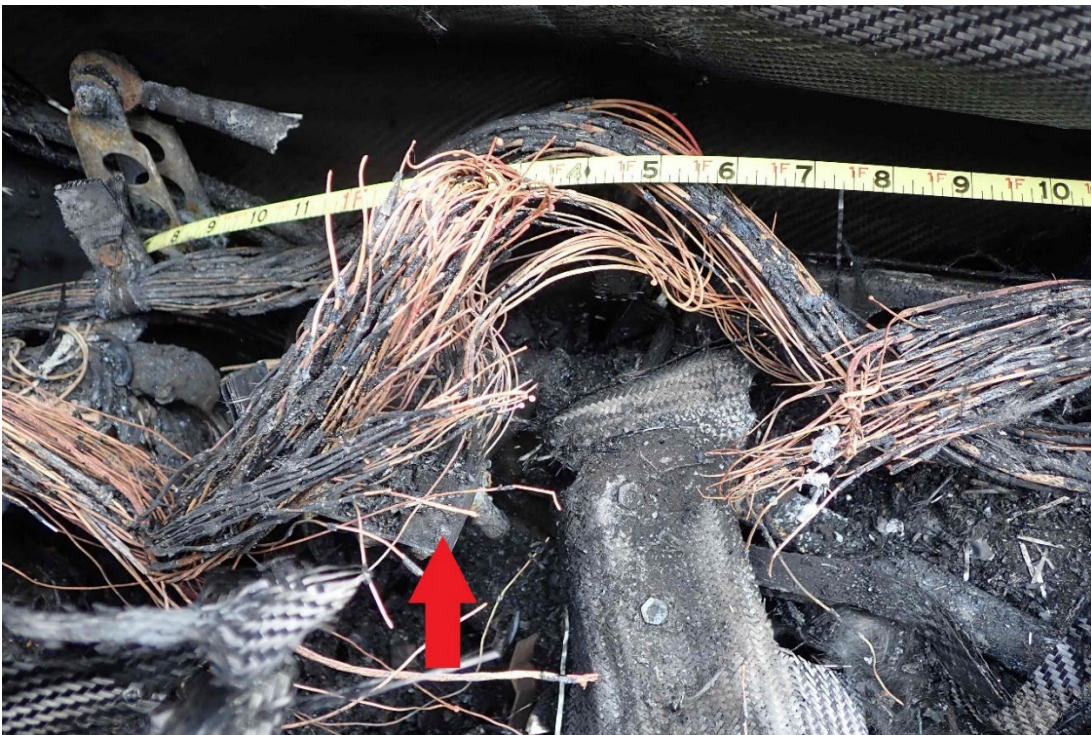
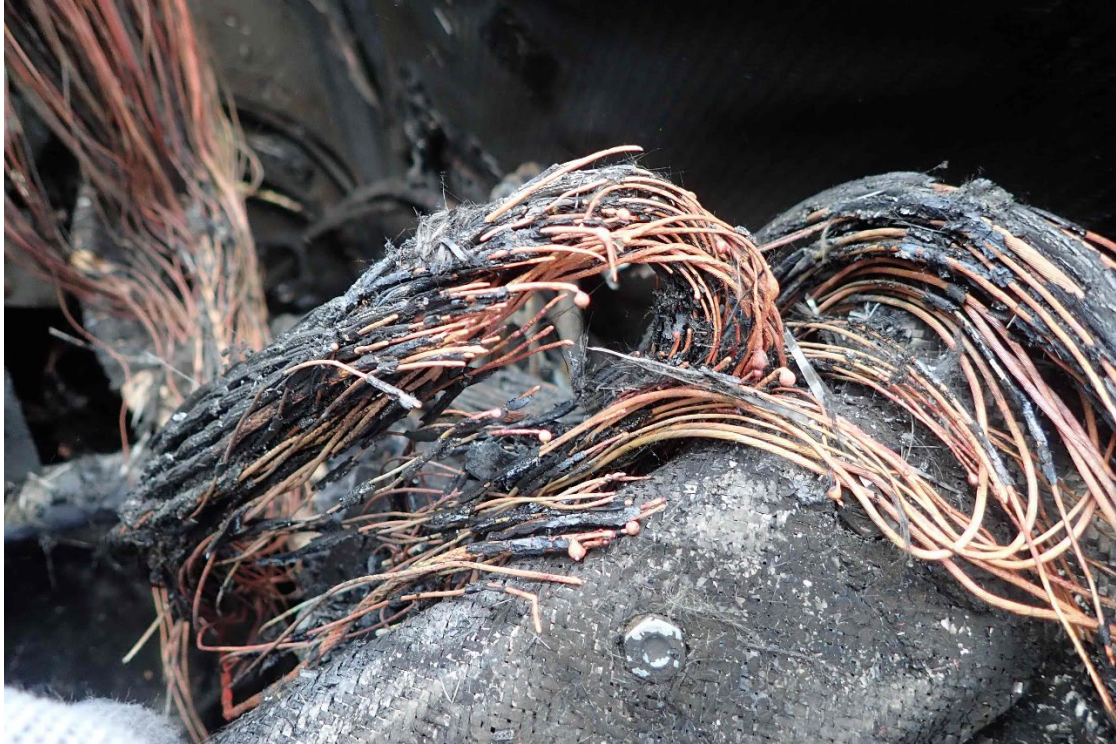
Station 113 – Damage and separation of ground conductors at a curve in the wire harness at the forward right ground blocks (figures 5, 6, 7).

Figure 5 – Arcing Damage at Forward Grounding Block at Station 113

Figure 6 – Arcing Damage at Forward Grounding Block at Station 113 (block indicated by red arrow)

Figure 7 – Arcing Damage at Forward Grounding Block at Station 113

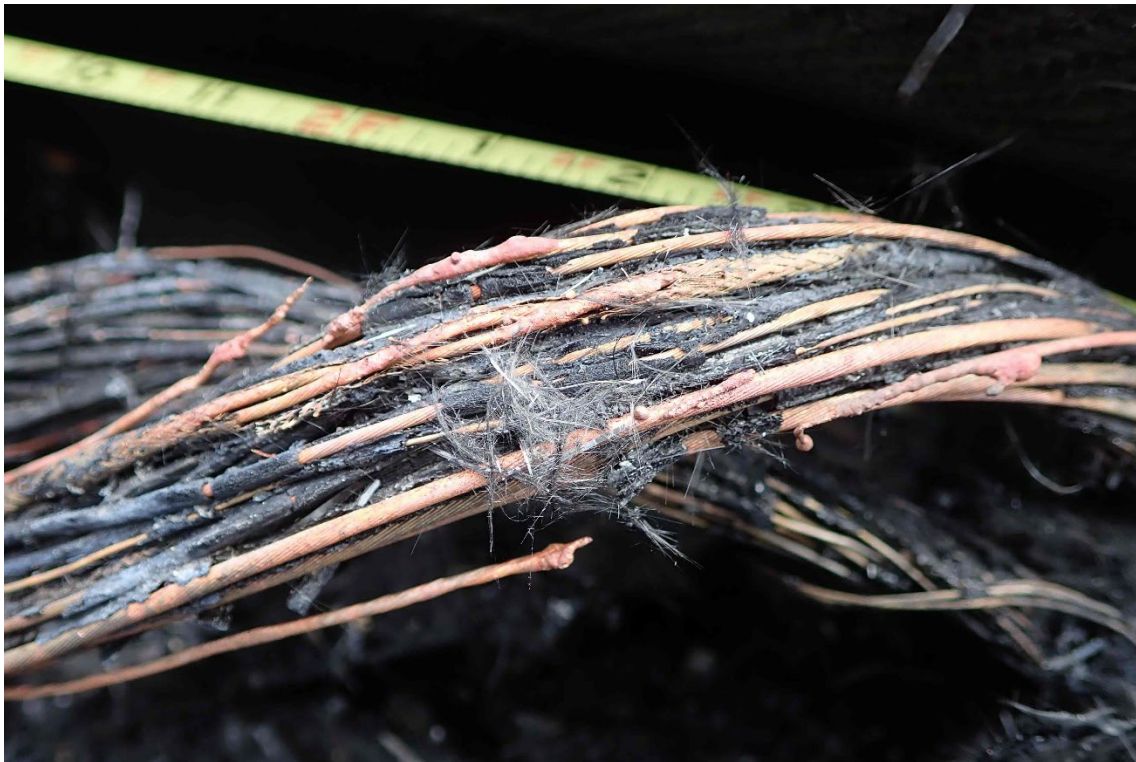
Station 120 – Damage and breaks to multiple conductors (figure 8).

Figure 8 – Arcing Damage at Station 120

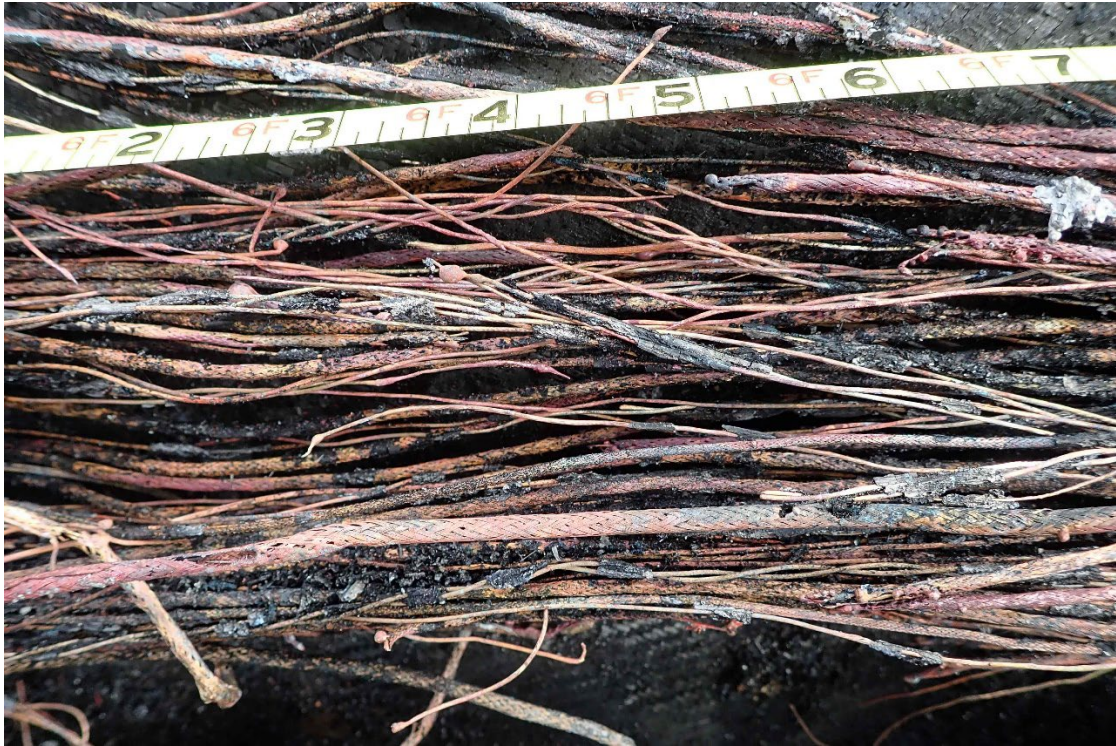
Station 151 through 179 – Multiple conductor breaks, and globular copper material. (figure 9).

Figure 9 – Close Image of Arcing Damage in General Area Between Station 151 through 179

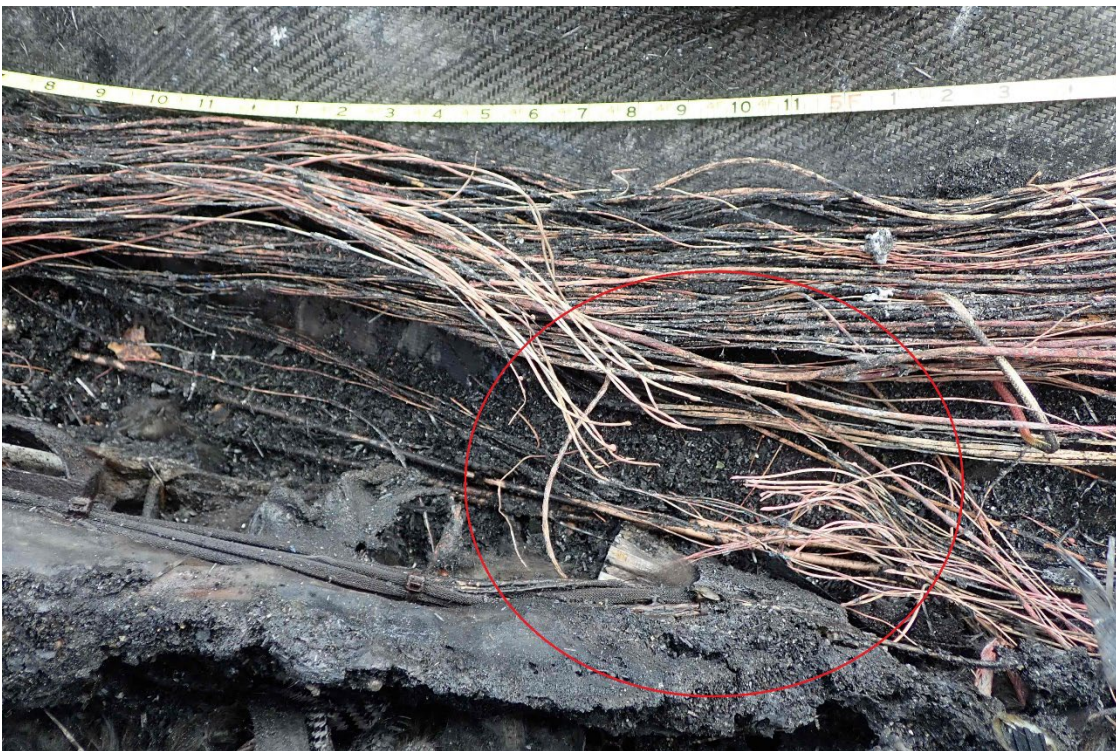
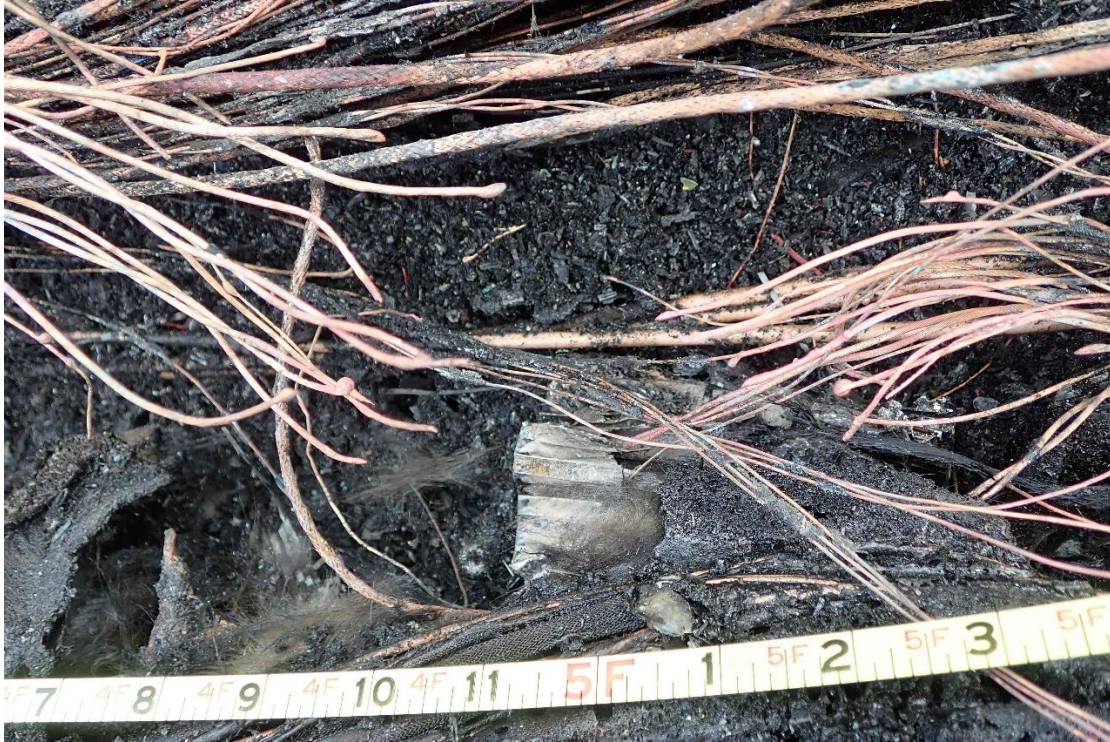
Station 151 – Separation of conductors to smaller bundle (figure 10, 11).

Figure 10 – Arcing Damage in General Area Between Station 151 through 179

Figure 11 – Arcing Damage in General Area Between Station 151 through 179

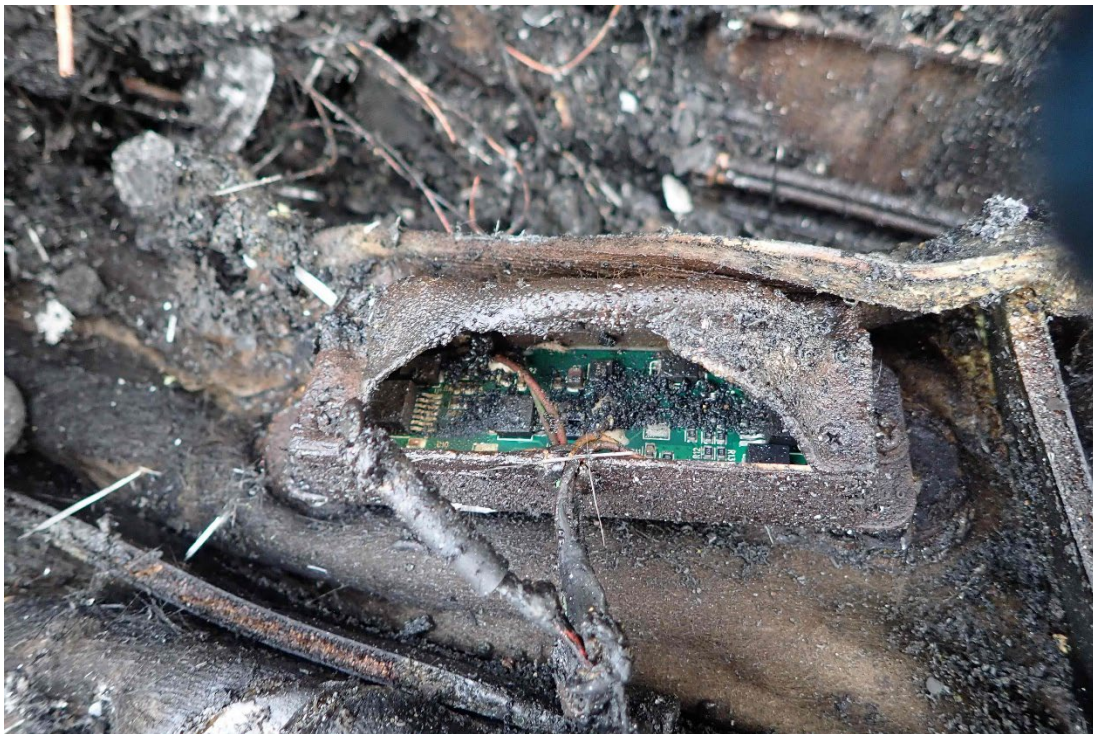
Fire damaged remnants of the USB power supplies were located. The forward dc-to-dc USB power supply sustained melting to its outer case, but was largely intact (figure 12). The aft power supply (seat 5/7, P5362) printed circuit board was exposed and sustained extensive thermal damage, with the separation of multiple components (figure 13).

Figure 12 – Forward dc-to-dc USB Power Supply

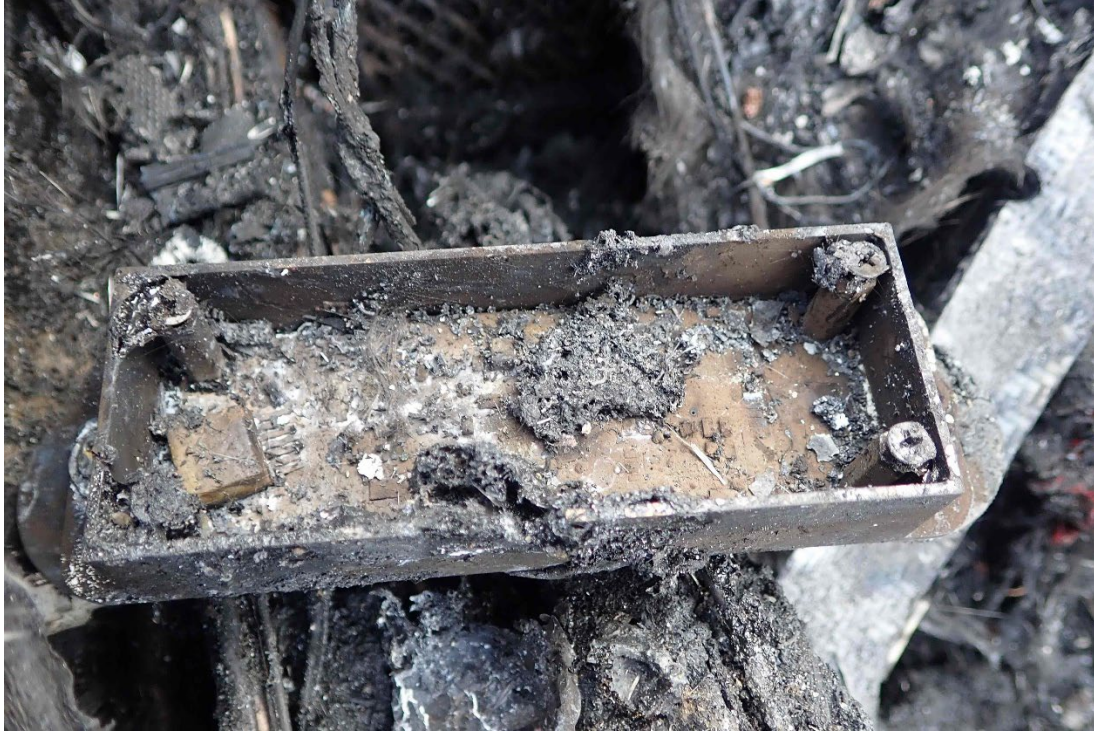
Figure 13 – Aft dc-to-dc USB Power Supply

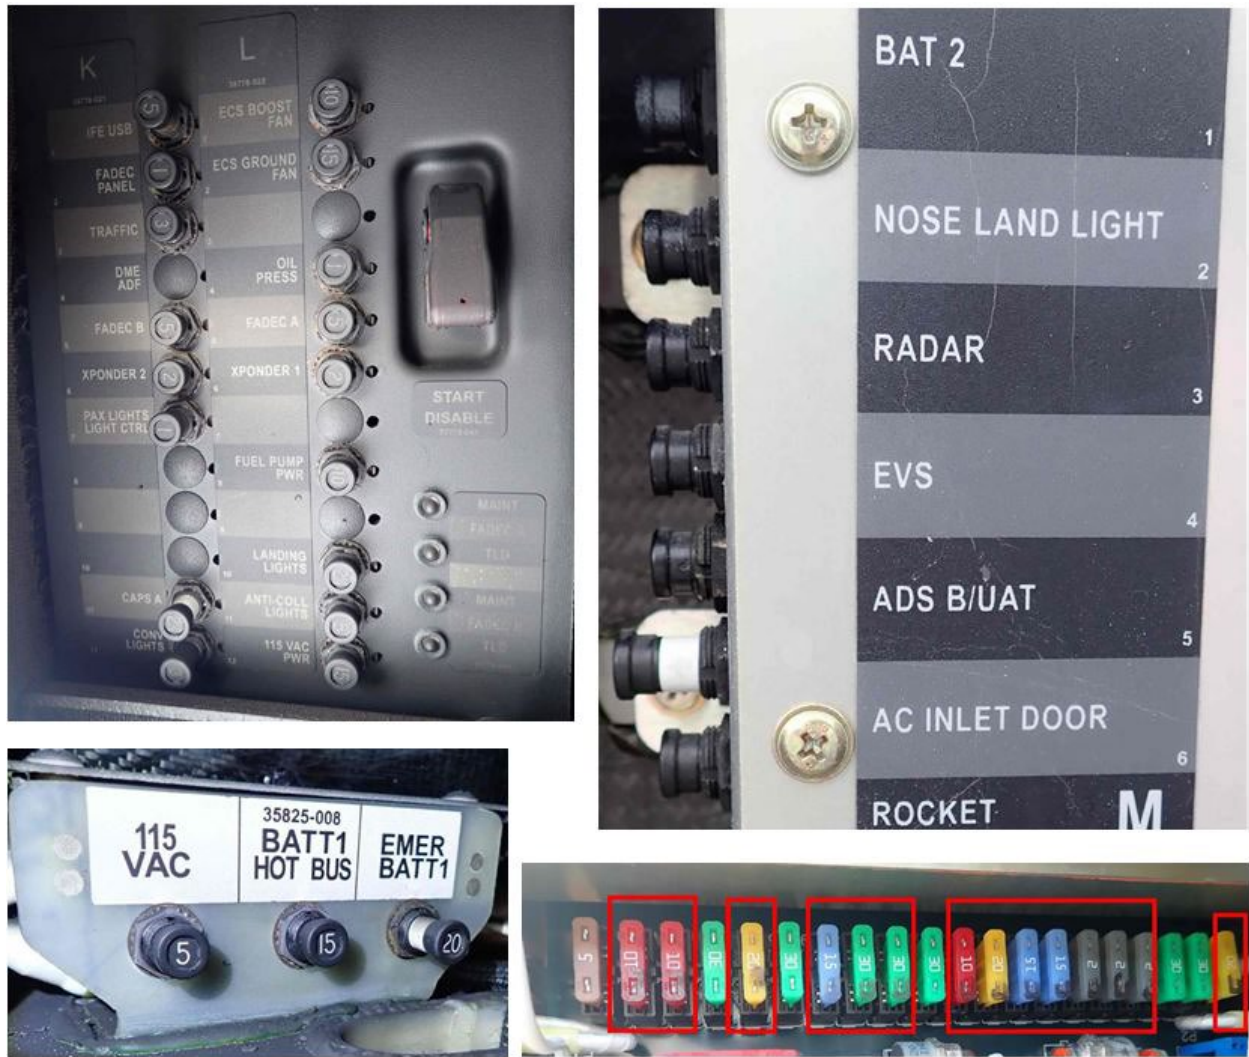
The following circuit breakers were in the open circuit “tripped” condition (figure 14):

IFE USB  
PAX LIGHTS LIGHT CTRL CAPS A  
CONV LIGHTS  
EMER BATT1  
AC INLET DOOR

None of the aft MCU fuses had blown. A group of fuses in the forward MCU had blown (figure 14).

Figure 14 – Circuit Breaker Panels and Forward MCU Fuses (red boxes indicate blown fuses)

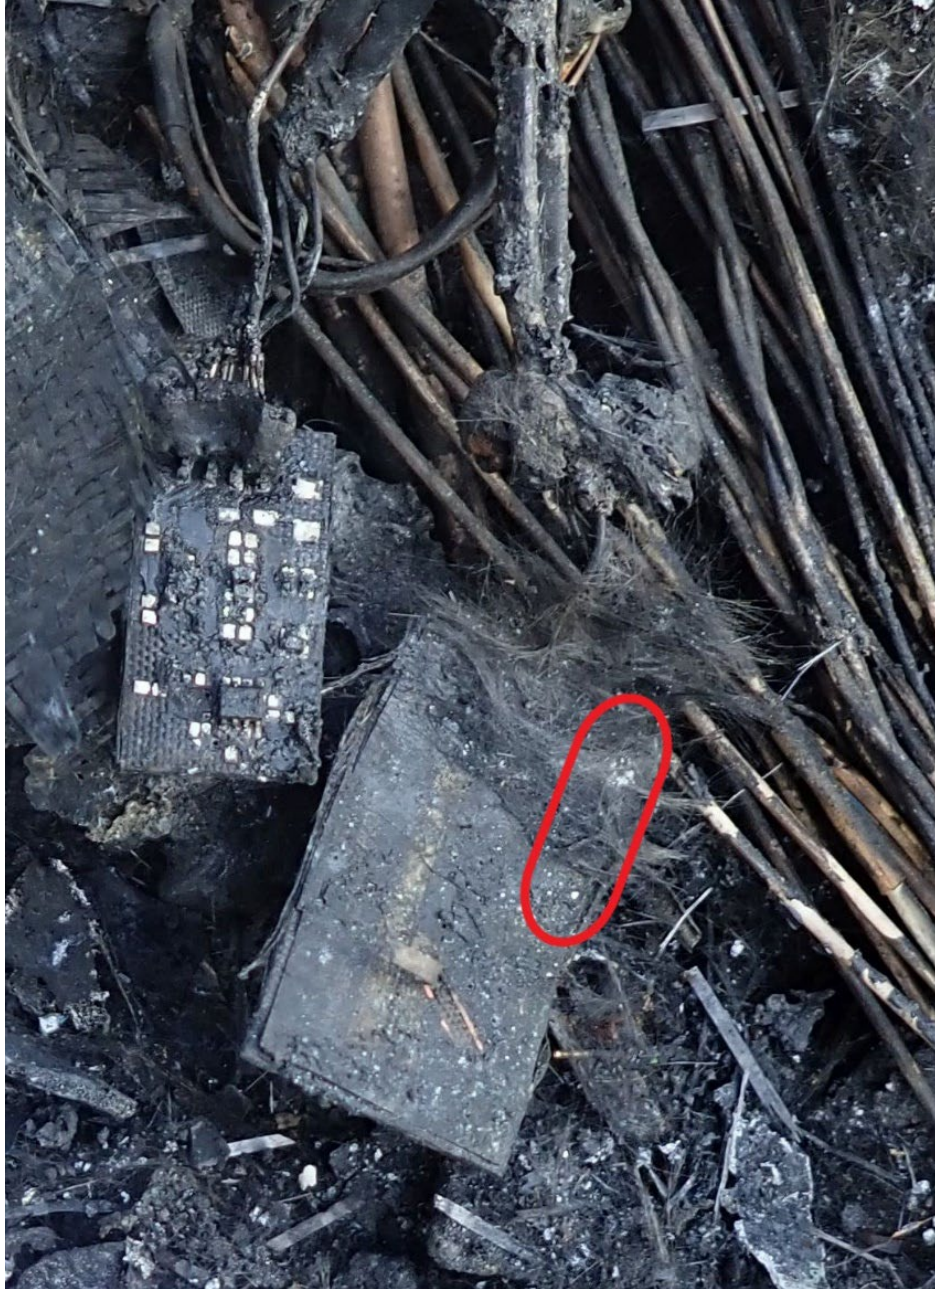
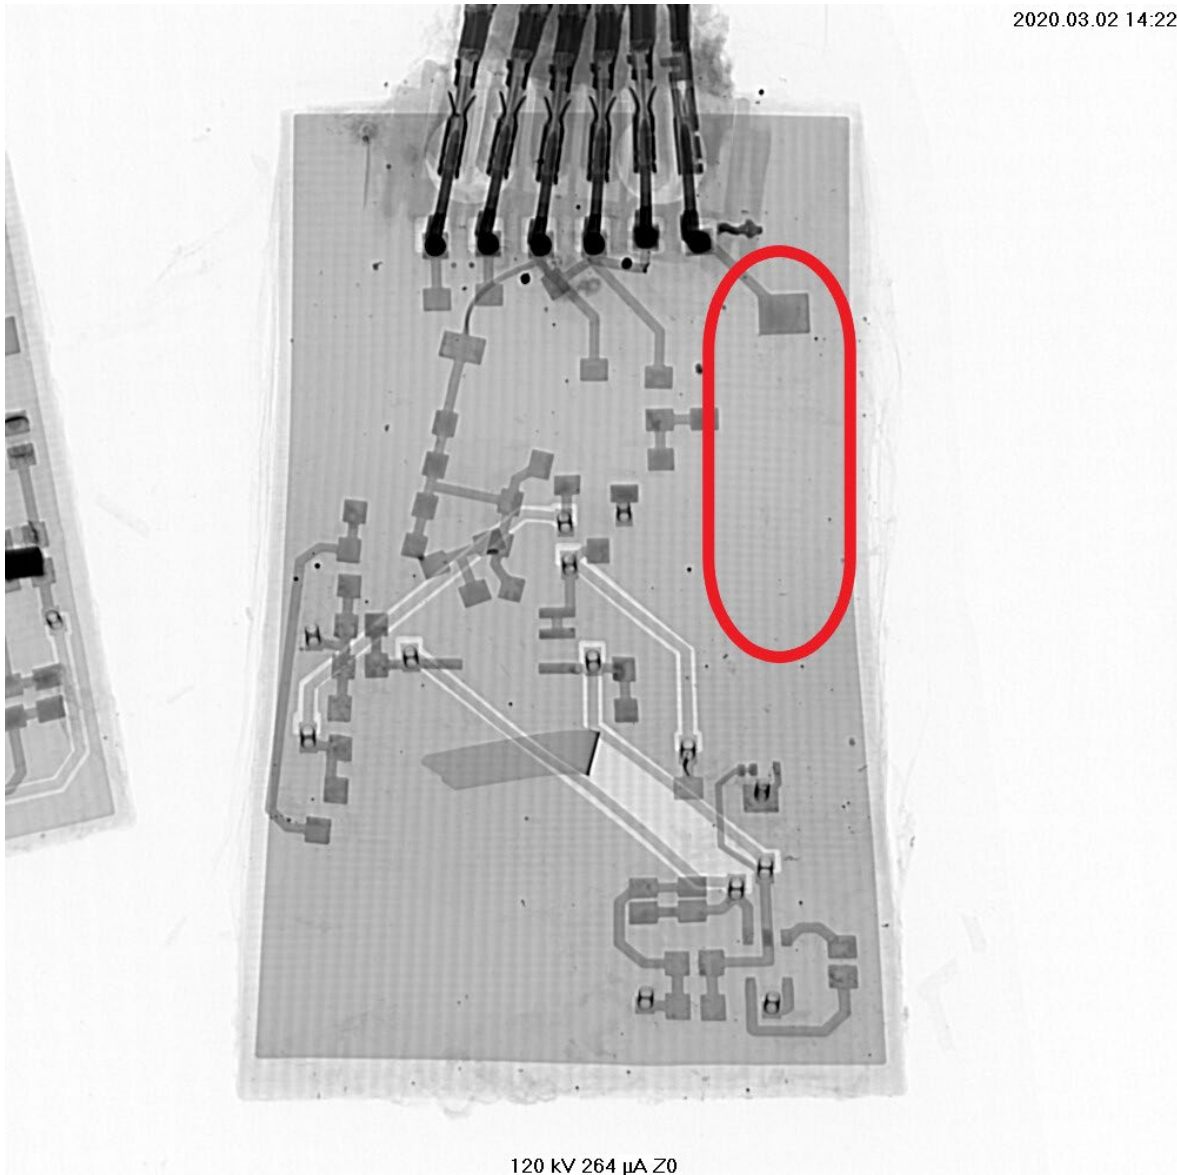
The audio card for seat four sustained thermal damage that resulted in all of its components detaching from the circuit board, along with the debonding of most of its copper tracks (figure 16,17). The input pad for the current-limiting resistor remained (figure 17).

Figure 16 - Seat four audio card with location of current-limiting resistor circled

Figure 17 – X-ray image of seat four audio card with location of current-limiting resistor and input pad circled

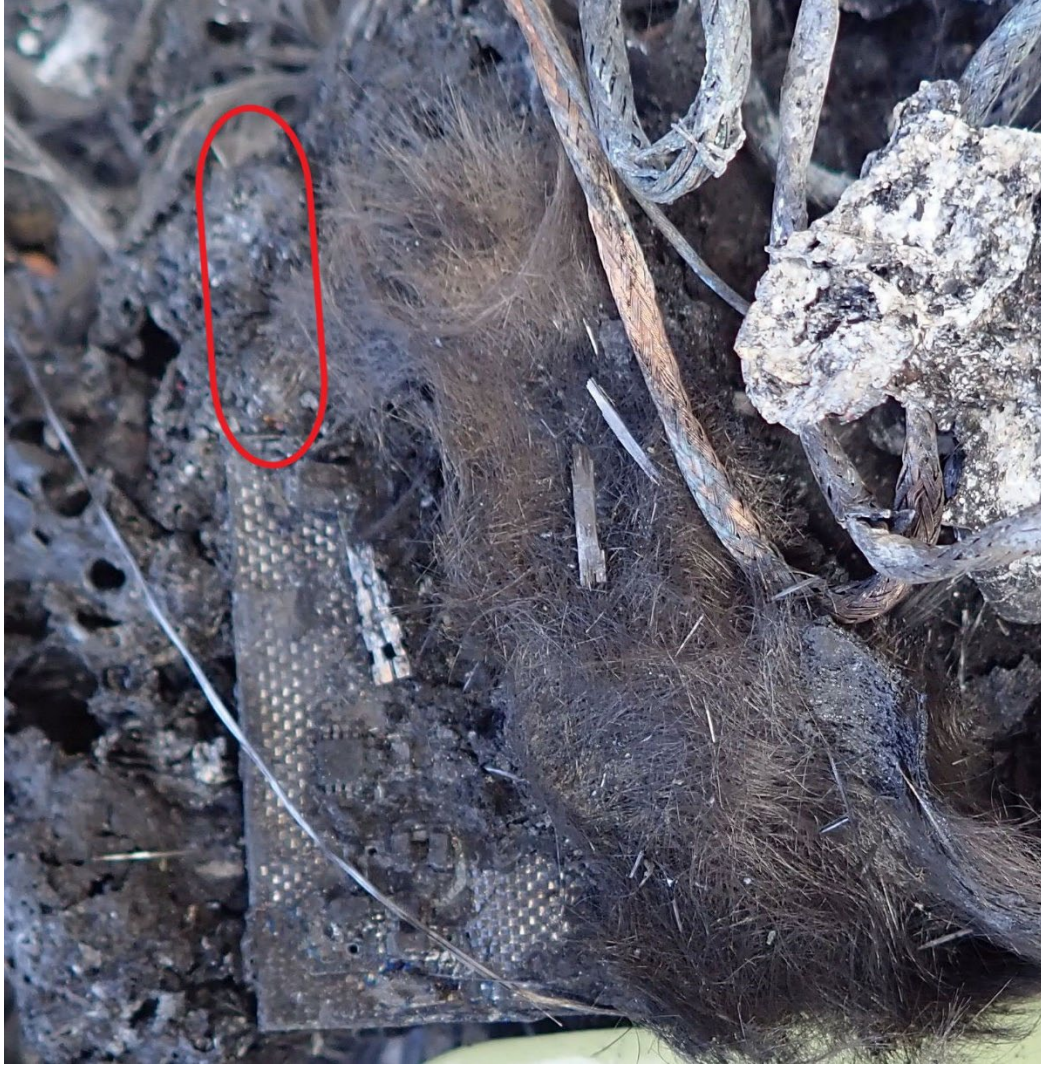
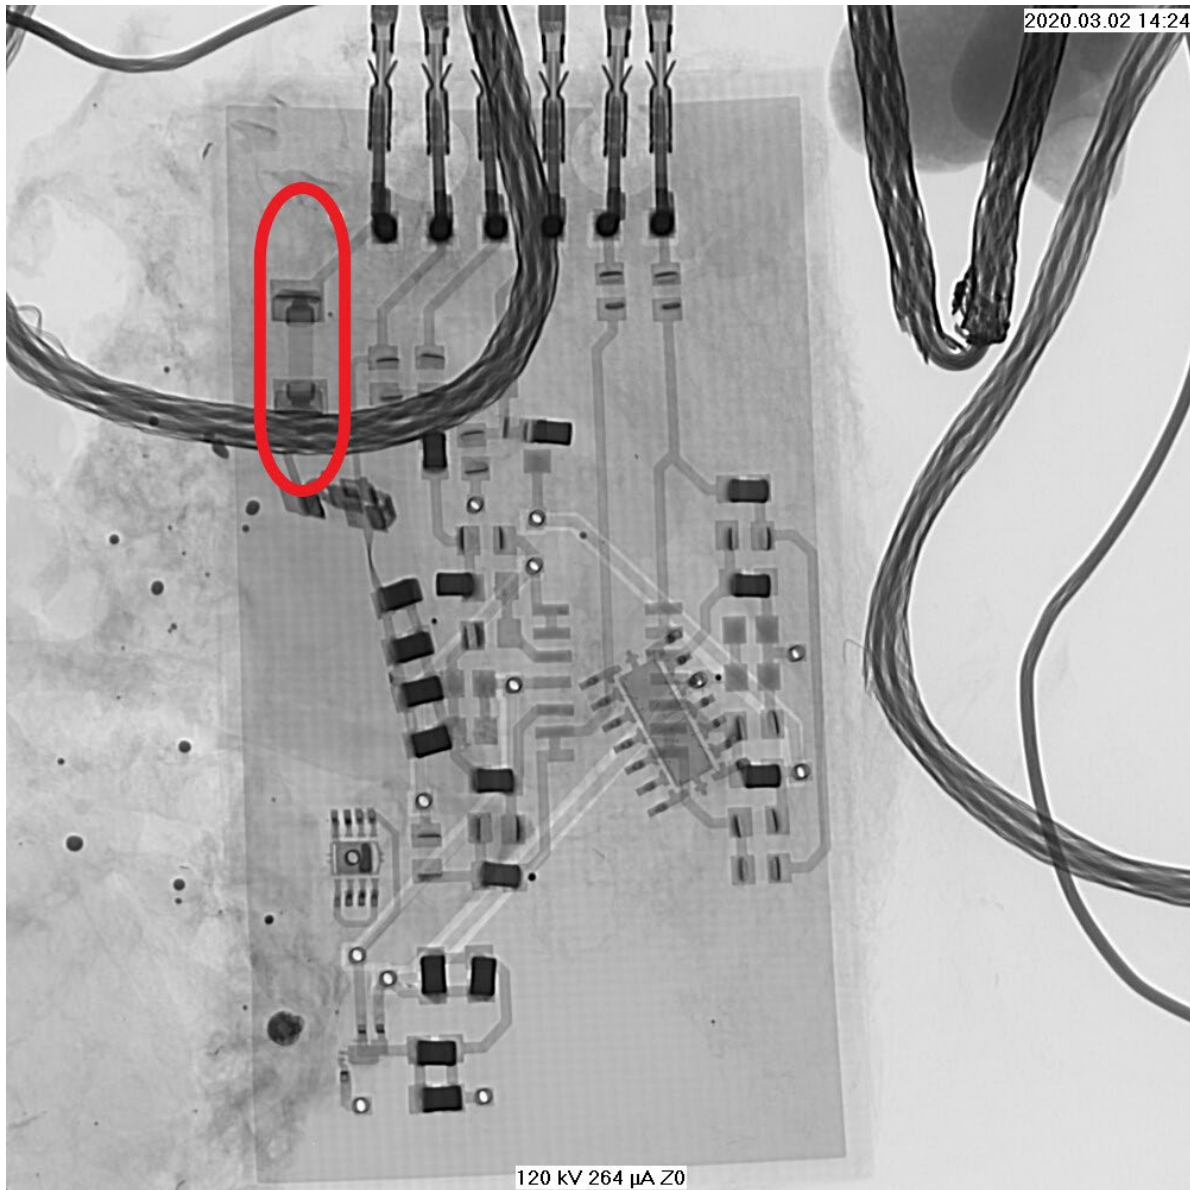
For seat five, the audio card exhibited thermal damage that resulted in the detachment of the input filter capacitors and Integrated Circuit 1 from the board (figure 18, 19). X-ray analysis revealed that the current-limiting resistor was the wire-wound type and remained attached to the board and the copper track of the input capacitors.

Figure 18 - Seat five audio card with location of current-limiting resistor circled

Figure 19 – X-ray image of seat five audio card with current-limiting resistor (circled) intact

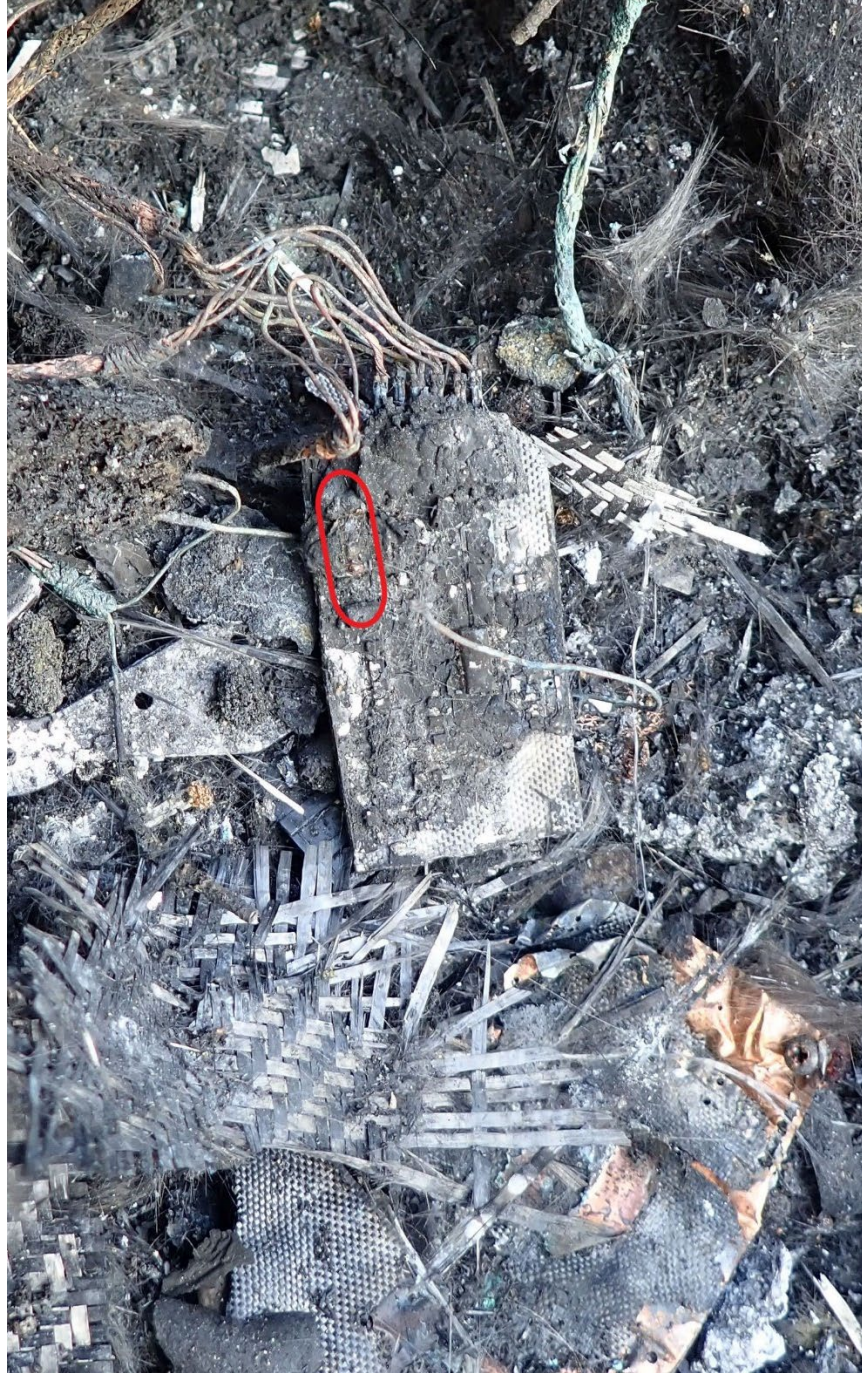
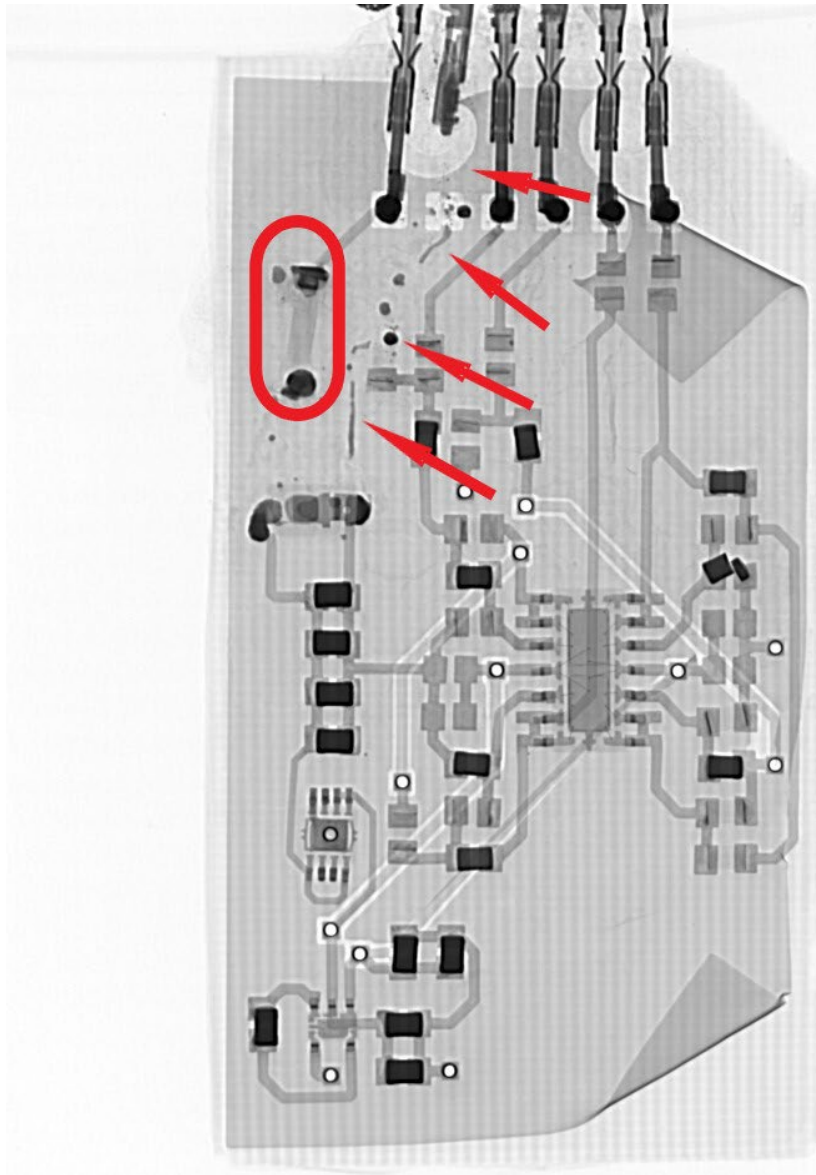
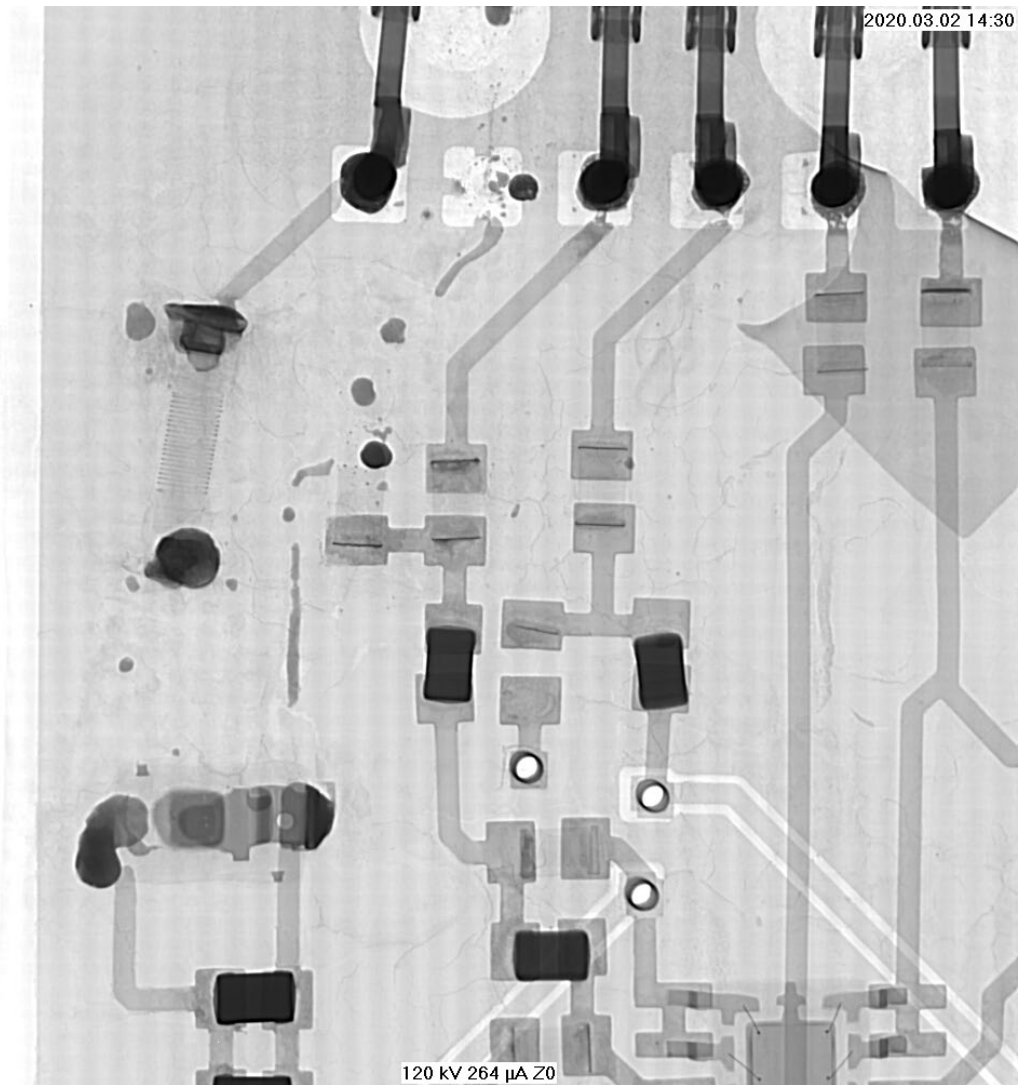
Although seat seven audio card sustained thermal damage, most components appeared intact. X-ray analysis revealed that the current-limiting resistor was the wire-wound type and had partially detached from the board. The copper tracks connecting the resistor to the TVS diode, along with the track connecting the ground line were missing, leaving only partial remnants behind (figure 20,21,22).

Figure 20 - Seat seven audio card with location of current-limiting resistor circled

Figure 21 – X-ray image of seat seven audio card with current-limiting resistor (circled) and arrows indicated areas of missing track for ground line

Figure 21 – Close-up X-ray image of seat seven audio card showing resistor area along with missing tracks
