## Air Safety Investigations Aircraft Incident/Accident Technical Report

| Aircraft Incident/<br>Accident Information | Year: 1967 | Make: Cessna | Model: 150G |
| Air Safety Investigator: Jennifer D. Barclay | | Report #: ASI-20-AE-T | Report date: 07-16-20 |

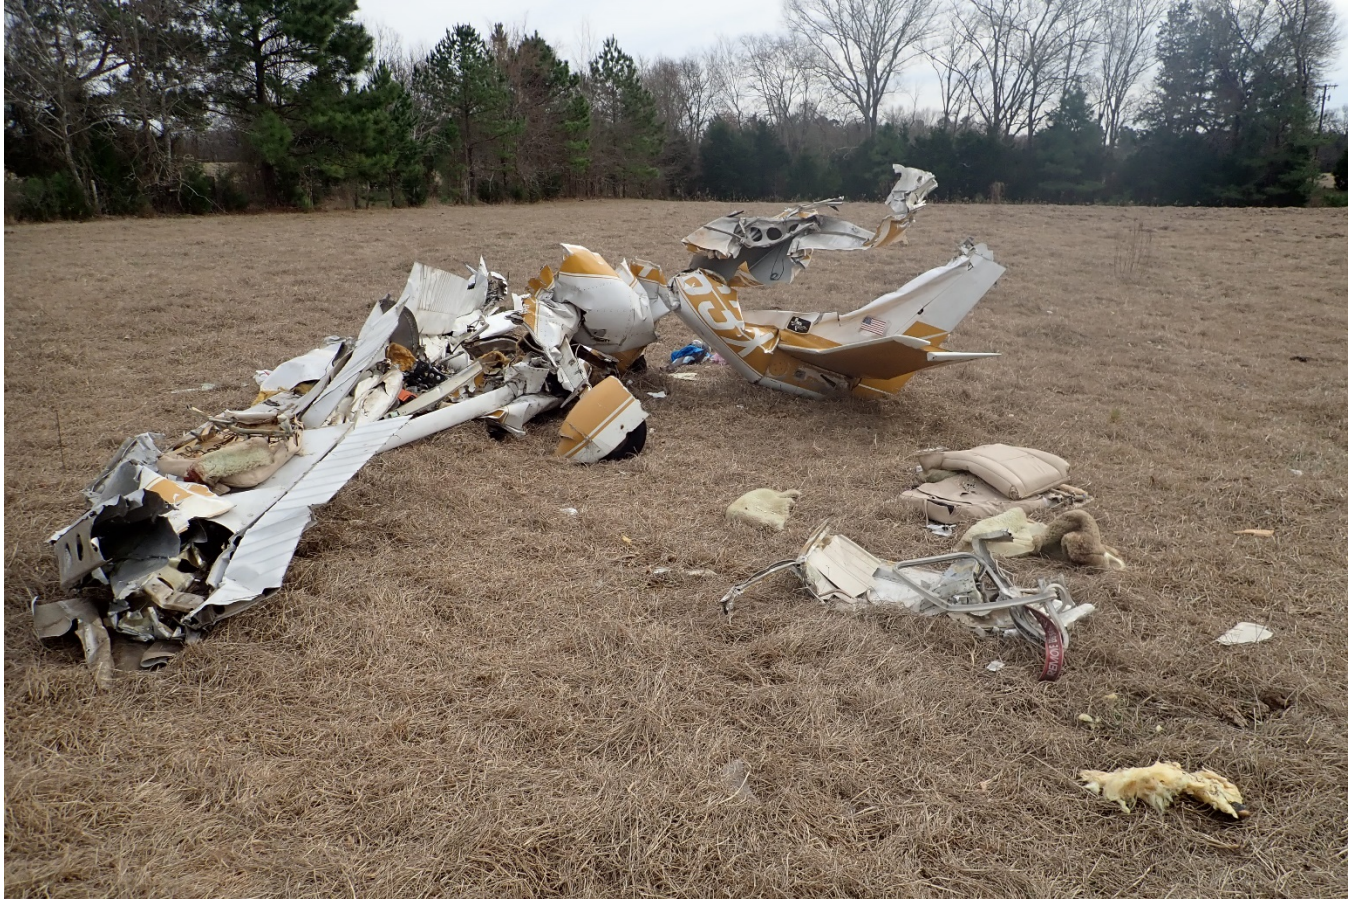
The aircraft contacted a guy wire securing a television tower causing the separation of an approximately 5' section of the left outboard wing with aileron attached. The aircraft then impacted terrain in a nose-low, near vertical flight attitude approximately 1,200' from the base of the tower. Both wings sustained significant compression damage along the entire length of the leading edge. The empennage folded over the fuselage in a scorpion-like fashion. The upper rudder cap was separated, and the vertical stabilizer sustained crush damage to the left.

Wreckage overview after tail was moved, ASI-20-AE-010

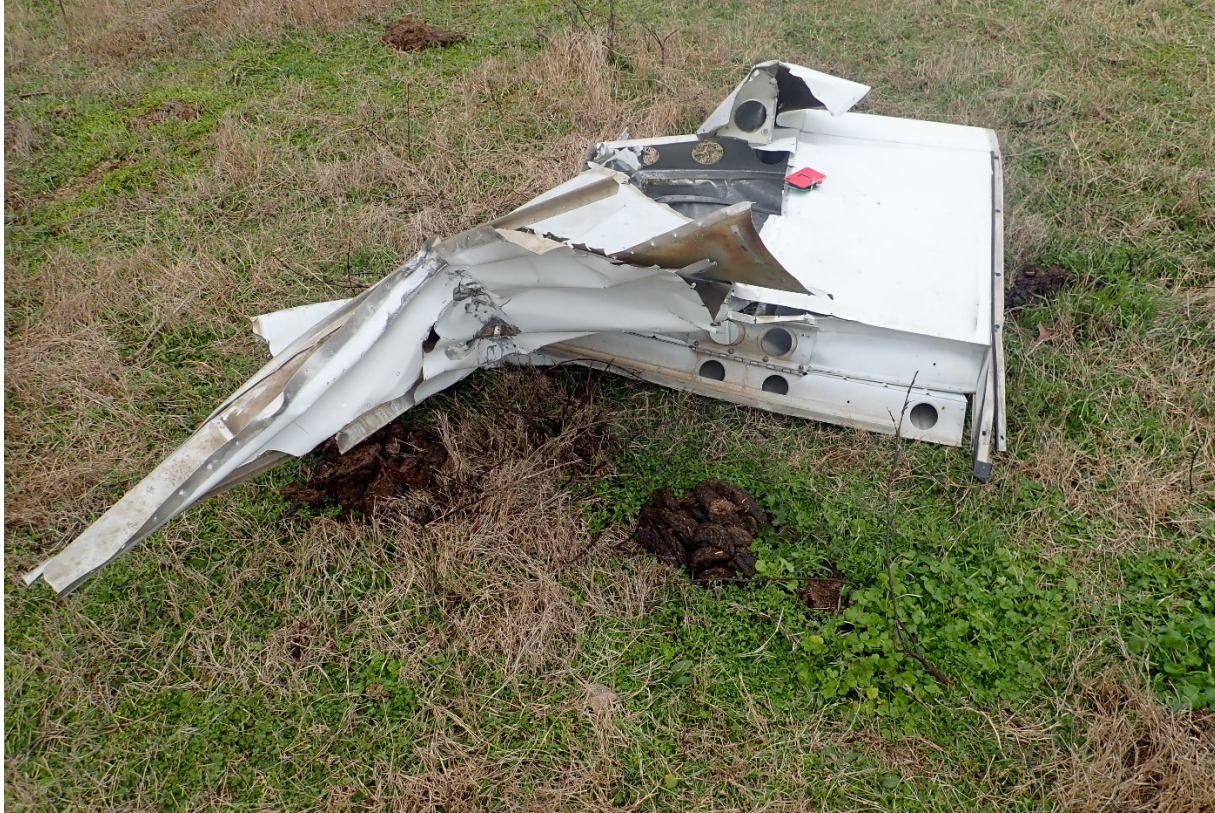
Separated section of left outboard wing, ASI-20-AE-079

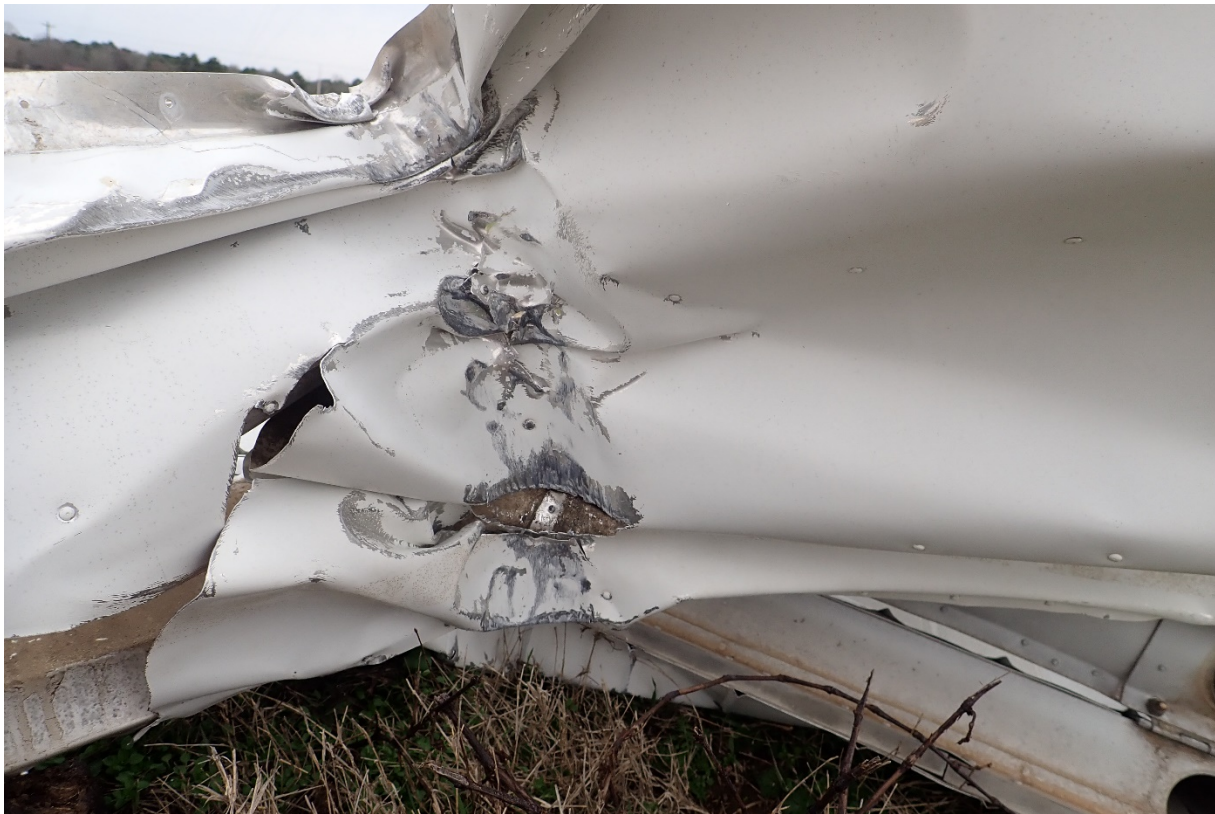
Wire marks on left outboard wing section, ASI-20-AE-081

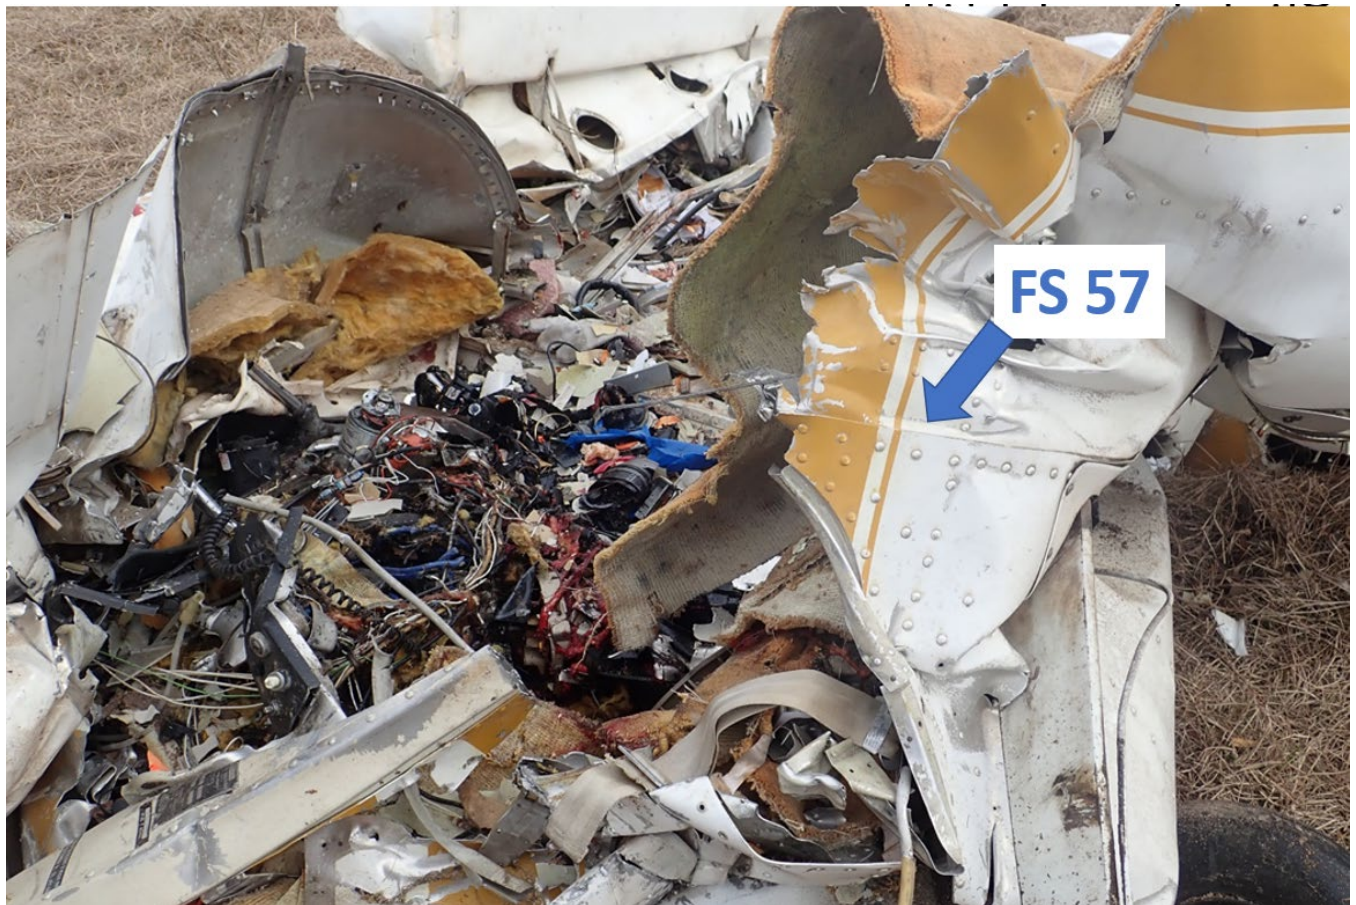
Partial control cable continuity was established due to compression damage to the cockpit and cabin area. Continuity was established from the tail flight control surfaces to approximately Fuselage Station (FS) 57 and from the aileron and flap bellcranks to the wing root.

Both control yokes were fractured. Rudder pedals were visible on the pilot side. No cables were observed due to impact damage to the fuselage.

Cockpit overview & FS 57 location, ASI-20-AE-060

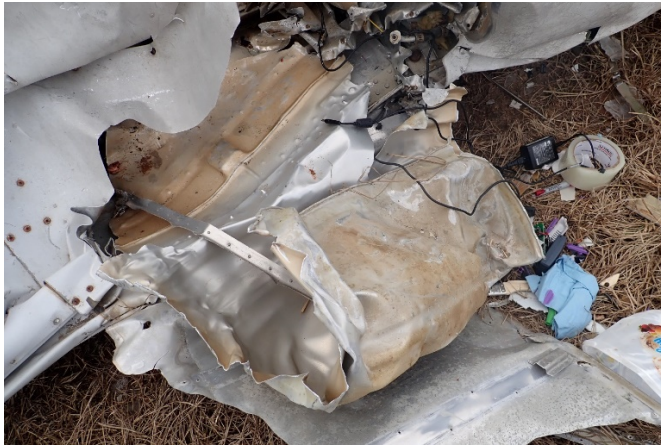
The fuel selector handle and valve were not observed due to impact damage to the cockpit area. The right fuel tank separated with one portion remaining in the wing, another was located approximately 100' from the main wreckage. The left fuel cap was observed closed and secured; the right fuel cap was not observed.

Right fuel tank in wing, ASI-20-AE-038

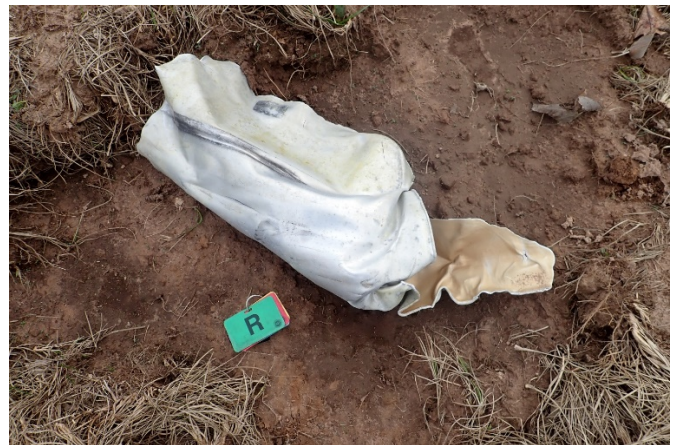
Right fuel tank portion, ASI-20-AE-072

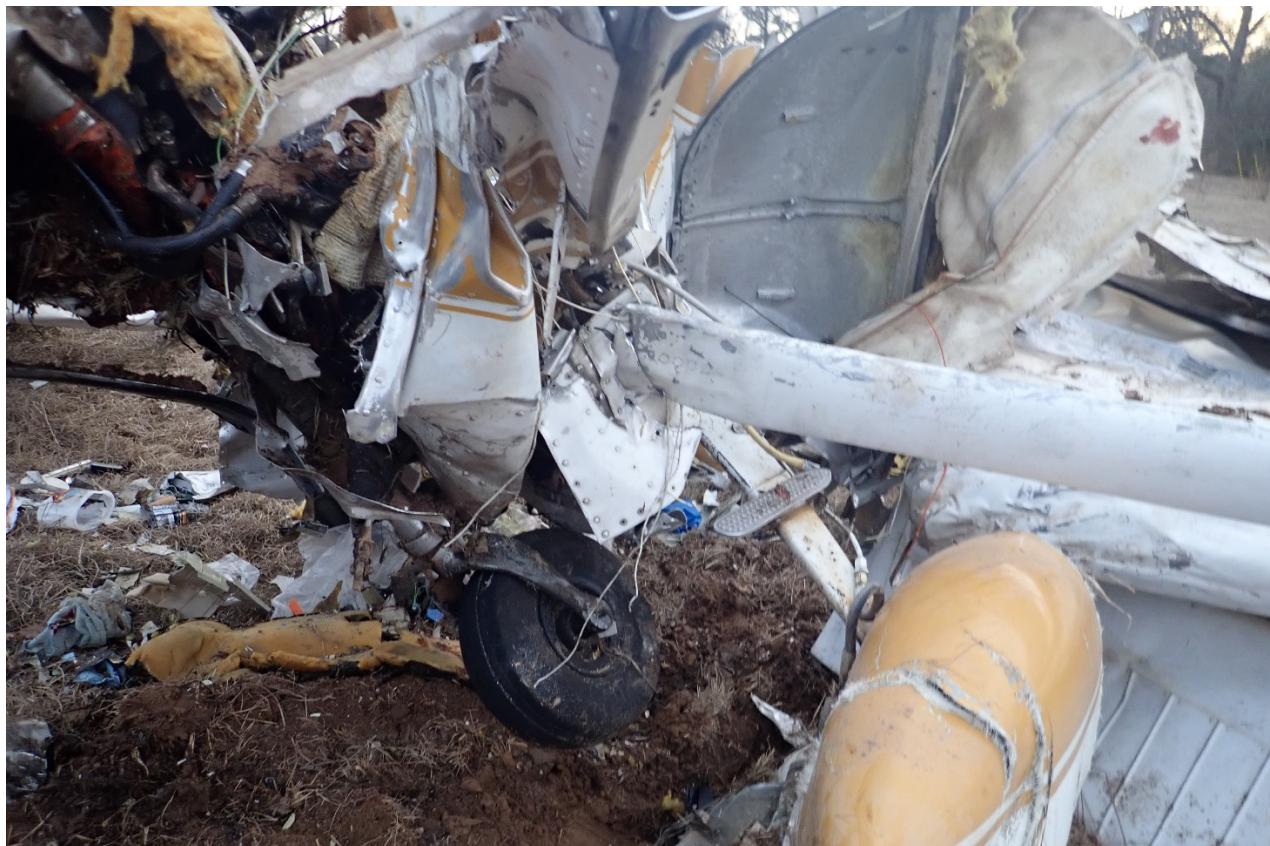
All three landing gear remained attached to the aircraft. The nose landing gear was forced aft during the impact sequence.

Nose and left main landing gear, ASI-20-AE-110

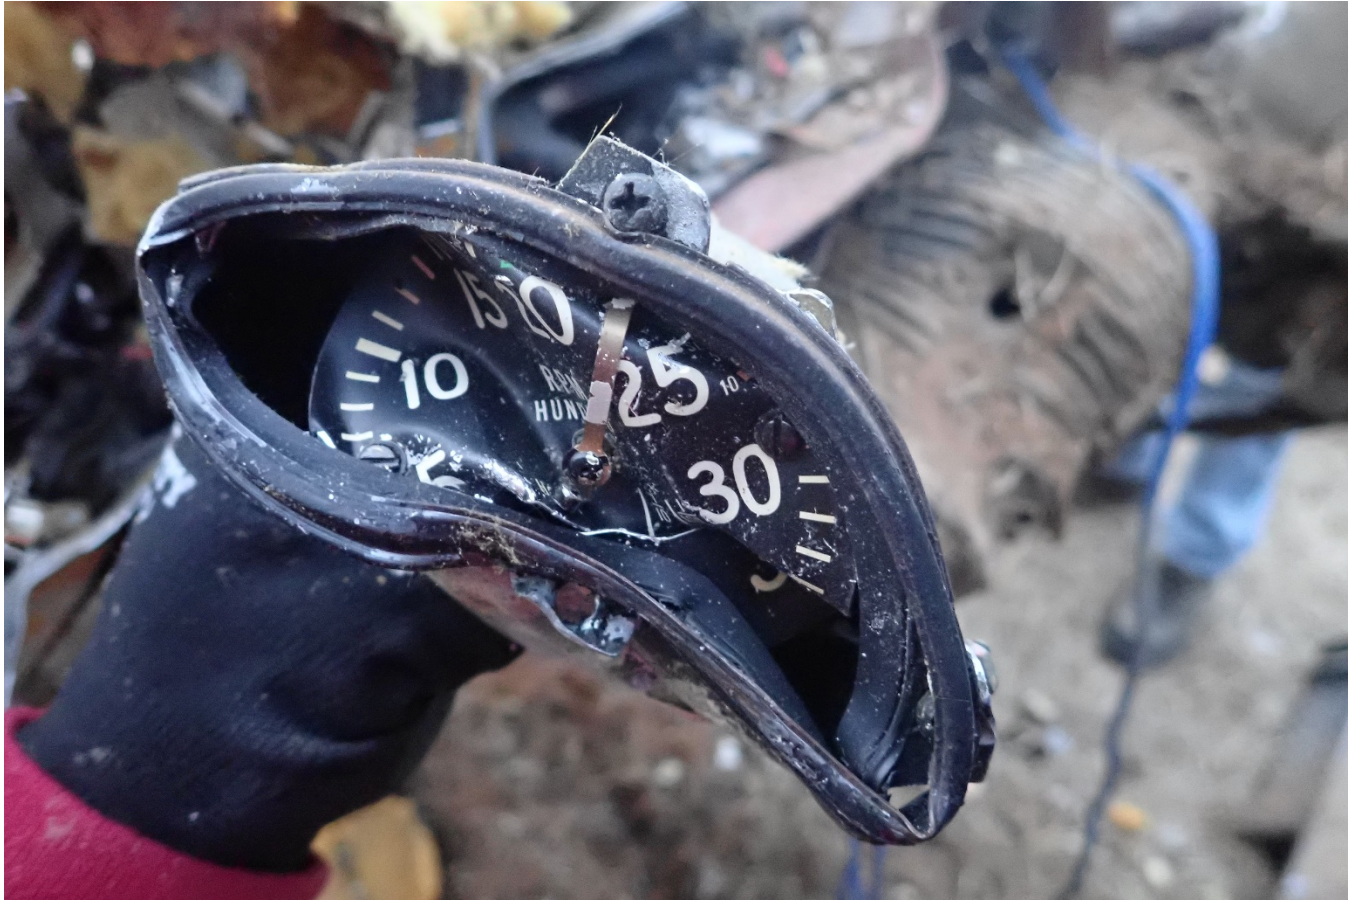
The tachometer was identified in the wreckage; the needle was pegged at 2300.

Tachometer, ASI-20-AE-119
