## **NATIONAL TRANSPORTATION SAFETY BOARD**

### **ENGINE EXAMINATION NOTES**

**WPR20FA077**

Location: Auburn, CA  
Date: January 24, 2020  
Aircraft: N50249  
NTSB IIC: Albert Nixon

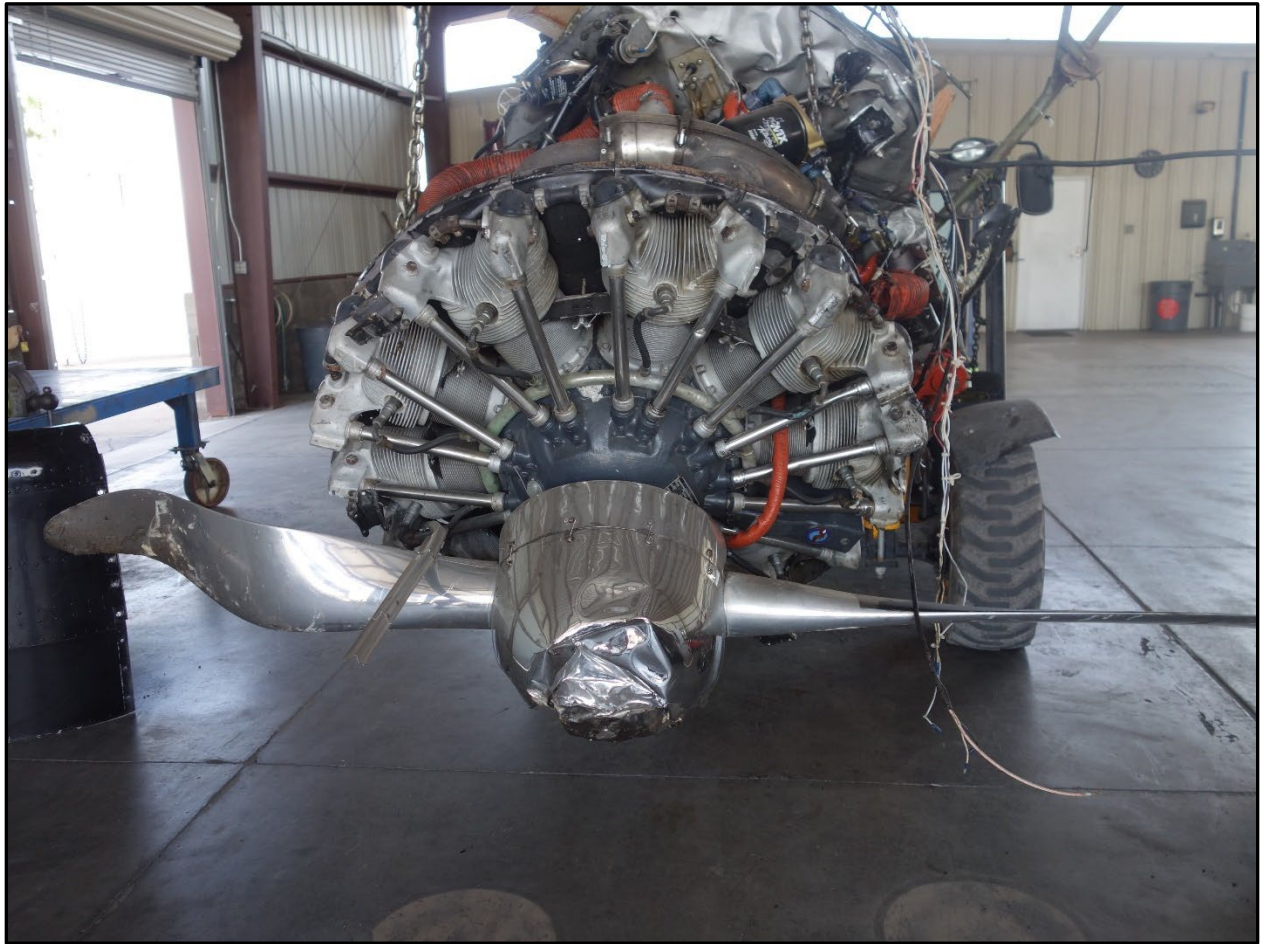
**Figure 1: Engine at the examination facility as viewed from the front.**

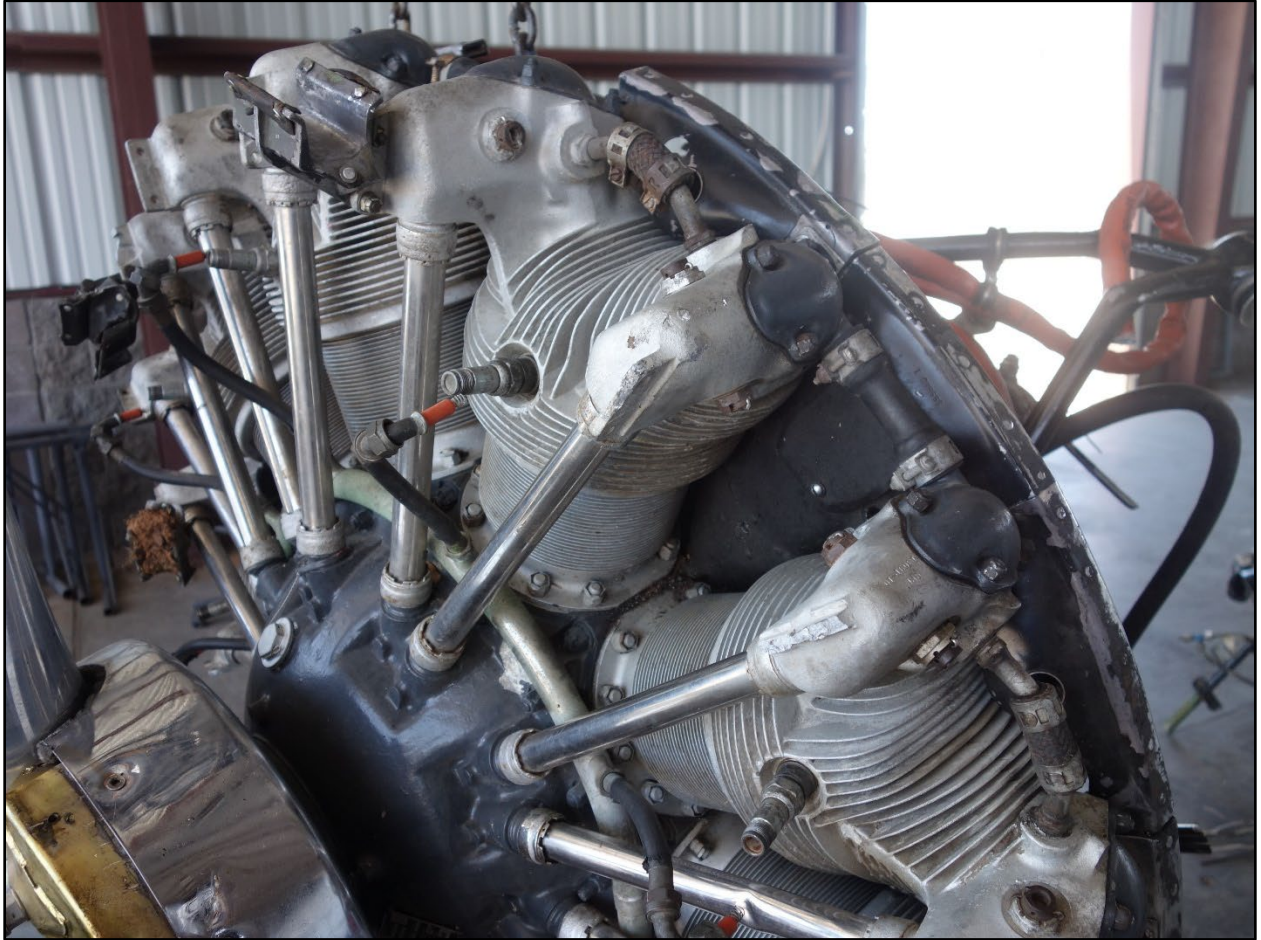
All engine accessories were attached. Removal and examination of the magnetos revealed that during manual rotation with a powered drill, spark was observed at all the ignition leads. The front sparkplug of the No. 2 cylinder was determined to be defective. The ignition harness displayed some degree of wear and fraying on the wires. Additionally, the front Nos. 2 and 4 cylinder's ignition leads wire coating were worn and cracked and observed to arc during magneto checks.

**Figure 2: Ignition wire exhibiting wear and fraying as viewed from the front of the engine.**

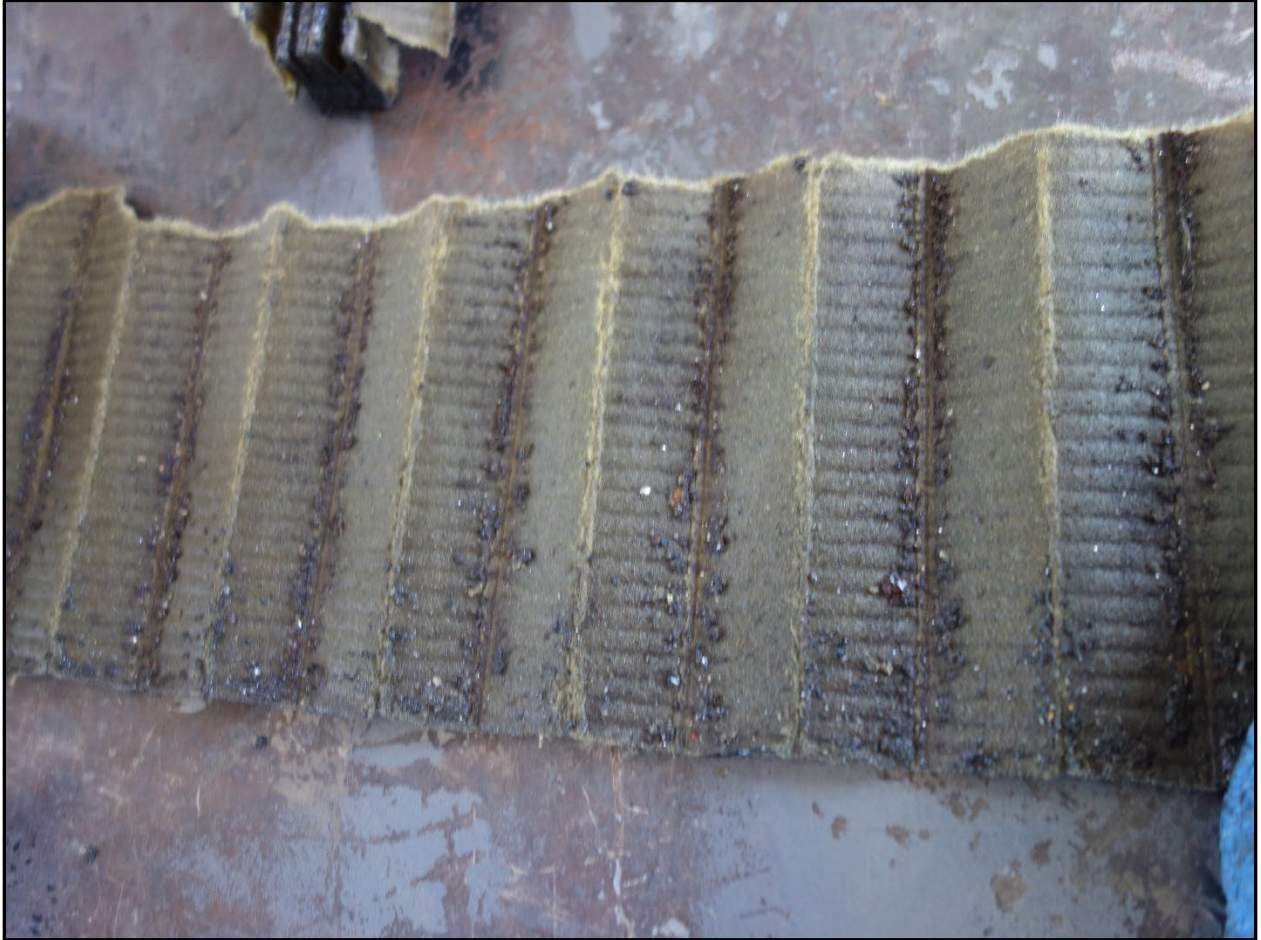
The oil filter was removed and examined. Examination of the filter element folds revealed dark and shiny debris consistent with carbon and metal contamination. The oil pump was removed and examined, and no anomalies were noted.

**Figure 3: Oil filter element folds contained dark and shiny debris.**
