## **NATIONAL TRANSPORTATION SAFETY BOARD**

### **ONSITE EXAMINATION NOTES**

**WPR20FA077**

Location: Auburn, CA  
Date: January 24, 2020  
Aircraft: N50249  
NTSB IIC: Albert Nixon

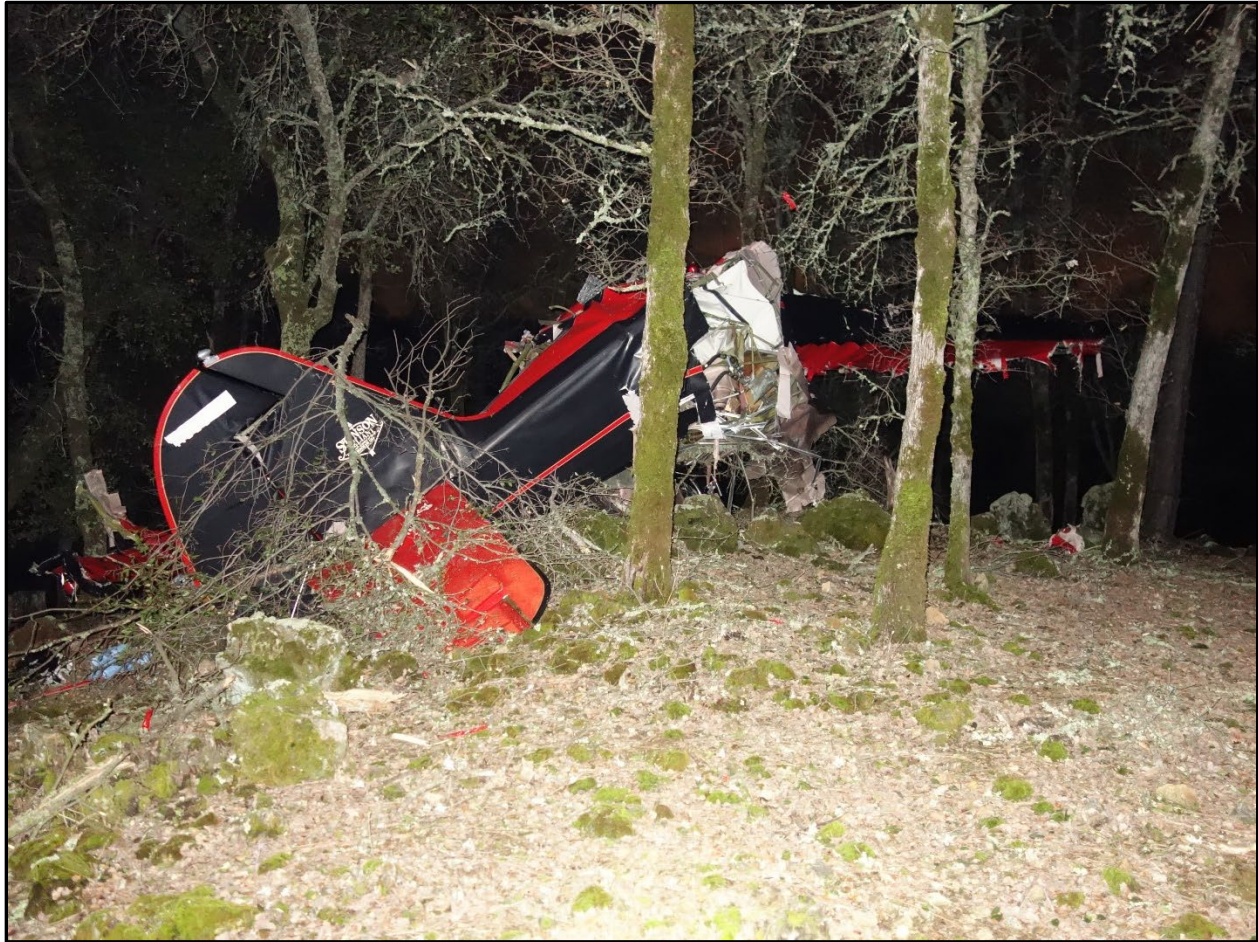
**Figure 1: Airplane wreckage as viewed from the right side.**

The left wing had separated from the fuselage and was located in front of the main wreckage. The fuselage came to rest pointed downward on a heading of about 206° magnetic. Rescue personnel had cut the left side of the cabin and seat belts. Recovery personnel separated the right wing from the fuselage and cut the engine from the main fuselage. There was no postimpact fire.

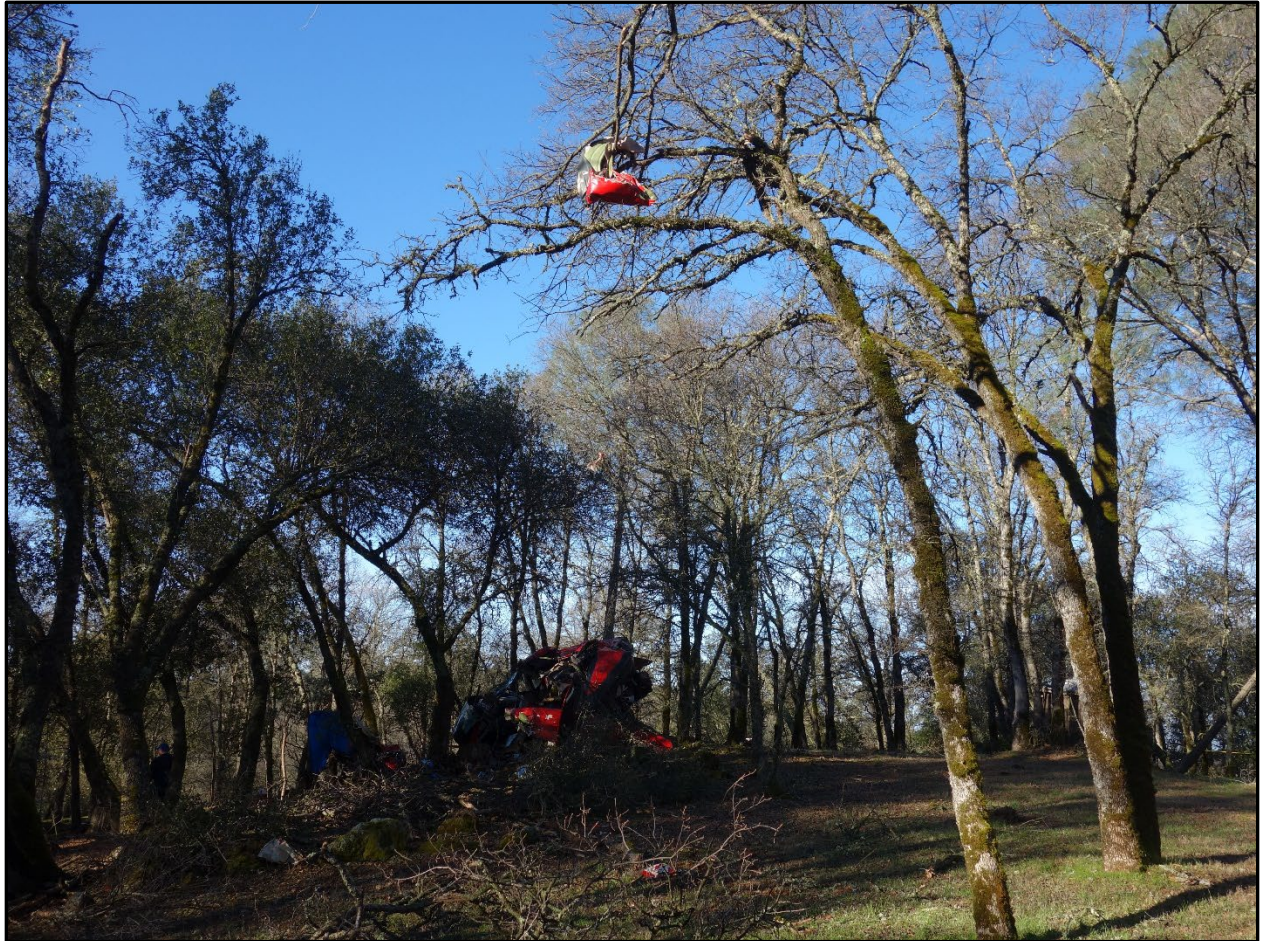
**Figure 2: Airplane wreckage with airplane parts lodged in the trees above.**
